**MARINE ACCIDENT
INVESTIGATION REPORT**

Vessel type and name: Chemical Tanker "SULPHUR GARLAND"
IMO number: 9209013
Gross tonnage: 3,498 tons

Vessel type and name: Oil Tanker "WAKOMARU NO. 2"
IMO number: 141721
Gross tonnage: 2,018 tons

Accident/Incident type: Collision
Date and time: Around 03:26:39, October 17, 2015
Location: East off Mutureshima Island, Shimonoseki City, Yamaguchi Prefecture
(Kanmon Passage, Kanmon Port)
Around 071° true bearing, 1,360 meters from the Mutureshima Lighthouse
(approximately 33°58.9'N, 130°52.9'E)

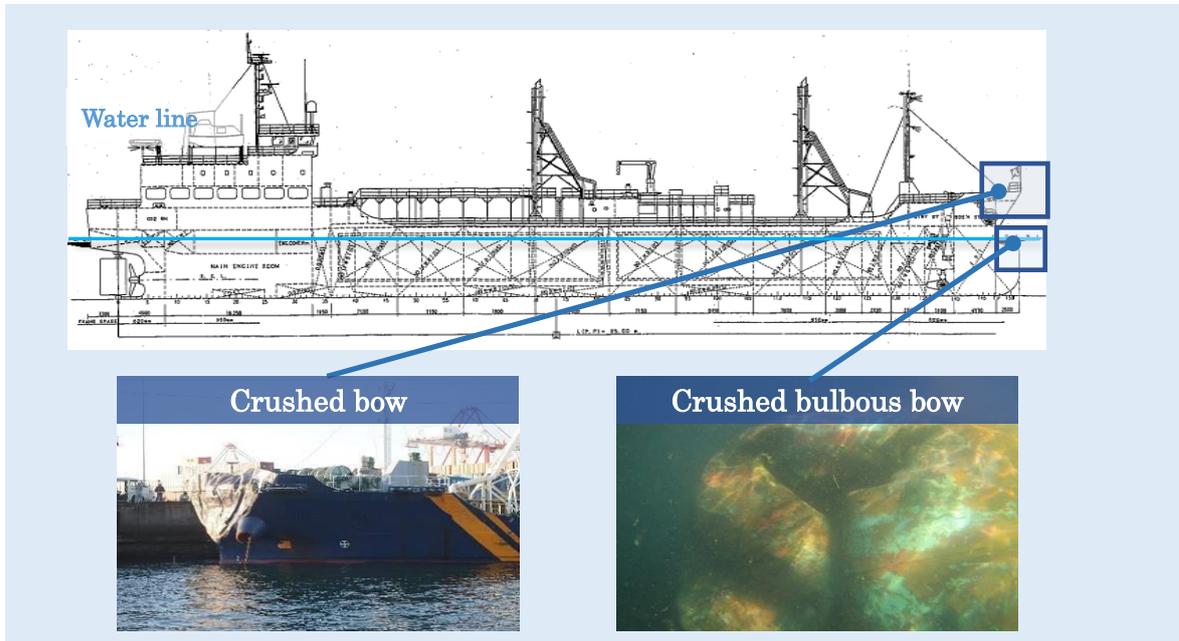
Figure 2.3-1 Damage to Vessel A

According to the statement of Master A and the reply to the questionnaire by Daiichi Tanker Co., Ltd., which is the operator of Vessel A (hereinafter referred to as “Company A₁”), the bow and bulbous bow of Vessel A were crushed. (See Figure 2.3.1)

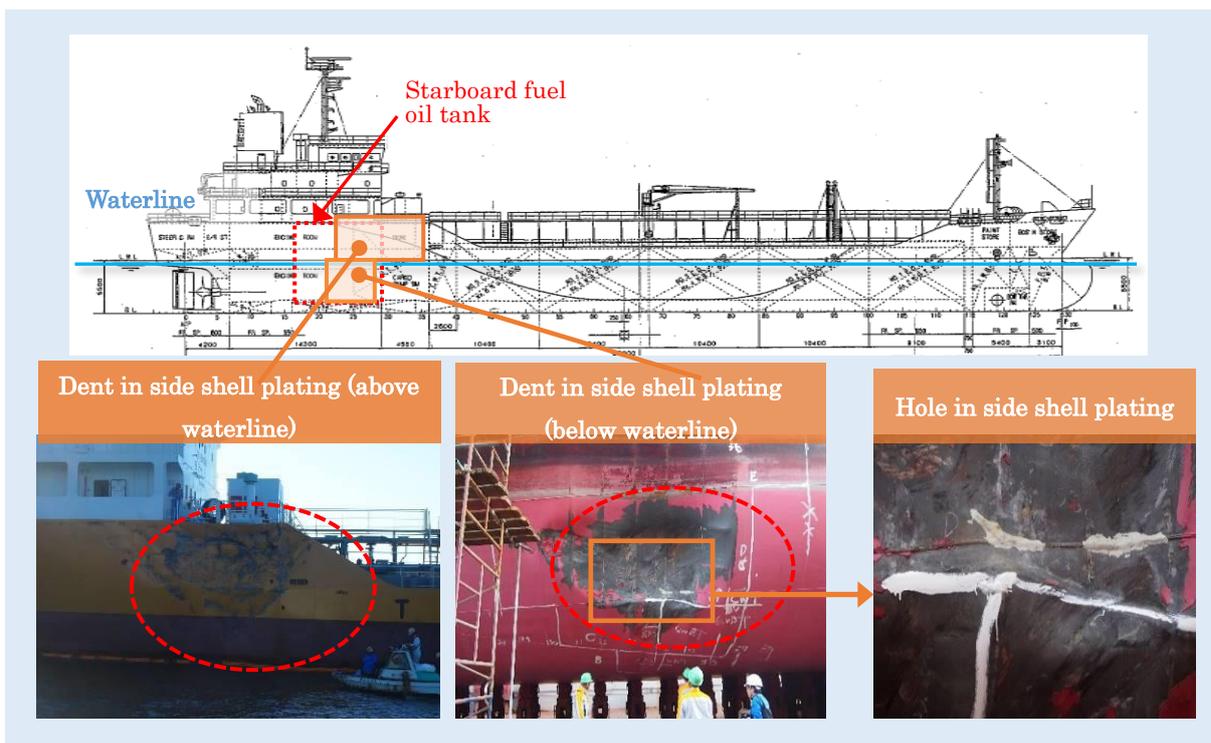
Figure 2.3-2 Damage to Vessel B

According to the reply to the questionnaire of Showa Nittan Corp., which is the operator of Vessel B (hereinafter referred to as “Company B₁”), the aft starboard side shell plating was holed and dented. (See Figure 2.3.2)

- (3) From (1) and (2), it is probable that approximately 13 kl of fuel oil C spilled from the hole caused by the collision in Vessel B's aft starboard side shell plating, and that, during the time that elapsed until the tide turned westerly at about 08:56, the oil flowed on Kanmon Passage's current to the sea area east of Hikoshima in the passage.

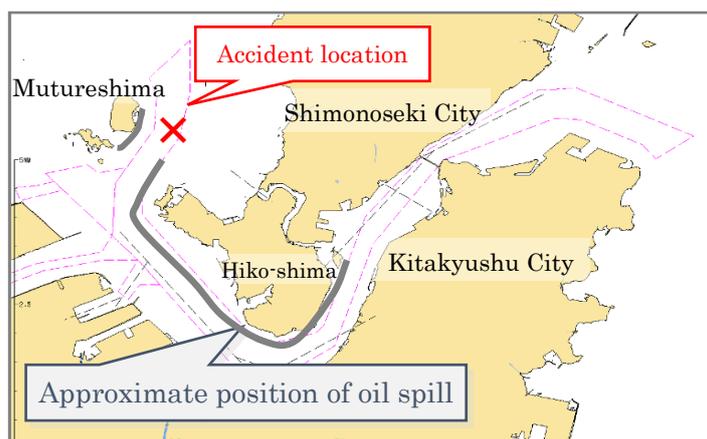
Figure 2.9 Approximate Position of Oil Spill

- 1) At about 11:00 on October 17, the fuel oil that was spilled from Vessel B was observed to be in a band of floating oil that covered an area stretching from near the West Entrance of Kanmon Passage to the sea area on the eastern side of Hikoshima Island in the passage. (See Figure 2.9)
