# BAHAMAS MARITIME AUTHORITY

Report of the investigation into the collision between the passenger vessel "Norwegian Dream" and the container vessel "Ever Decent" in the approaches to the Dover Strait at 0055 on 24 August, 1999

12 April, 2000

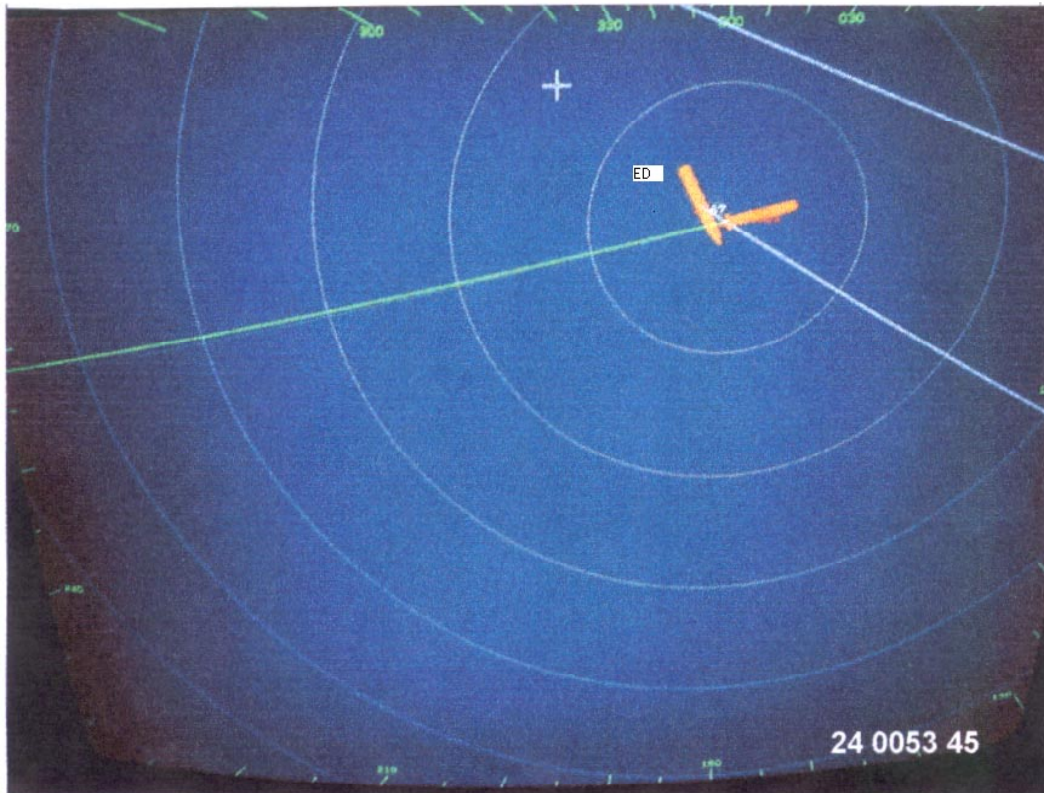
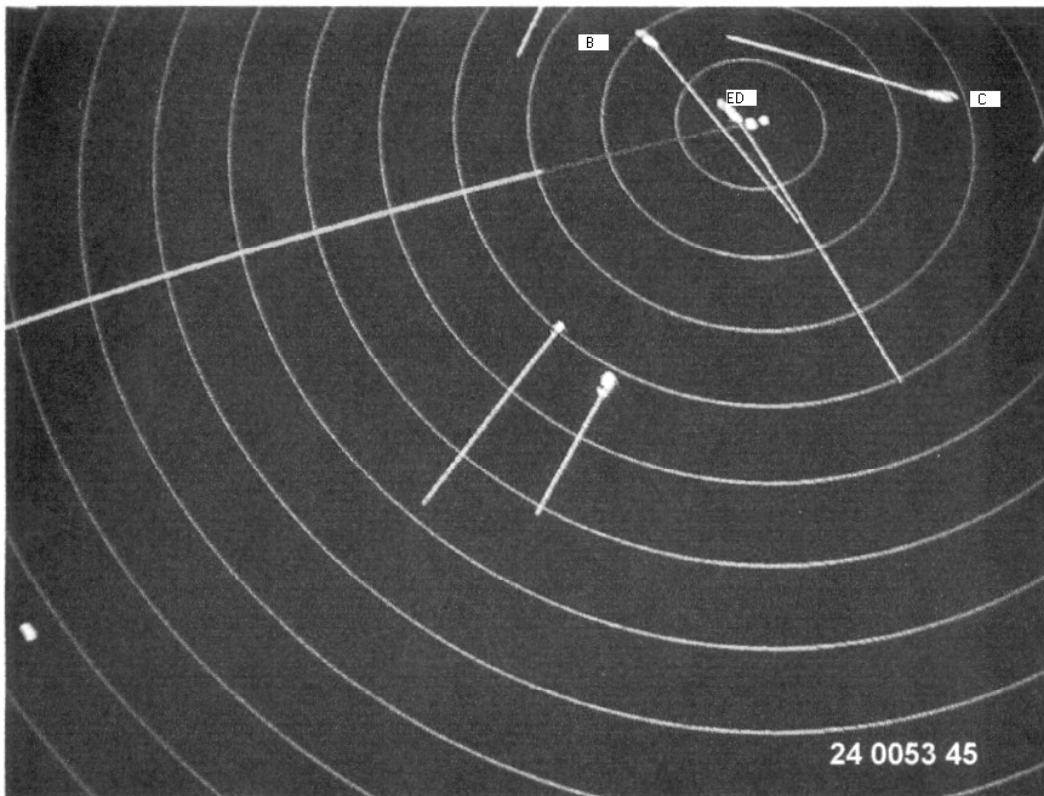
**Time: 0054**  
(see opposite)

The Norwegian Dream hit the port side of the Ever Decent (ED) approximately at right angles. The pitch and revolutions of both Norwegian Dream propellers tripped to zero on impact. The momentum of the two ships swung the Norwegian Dream to port and as the ships separated the stern of the Ever Decent hit the starboard side of the Norwegian Dream causing some further damage.

At the time of the collision the two ships were 319°, 3.2 miles from the F3 buoy.

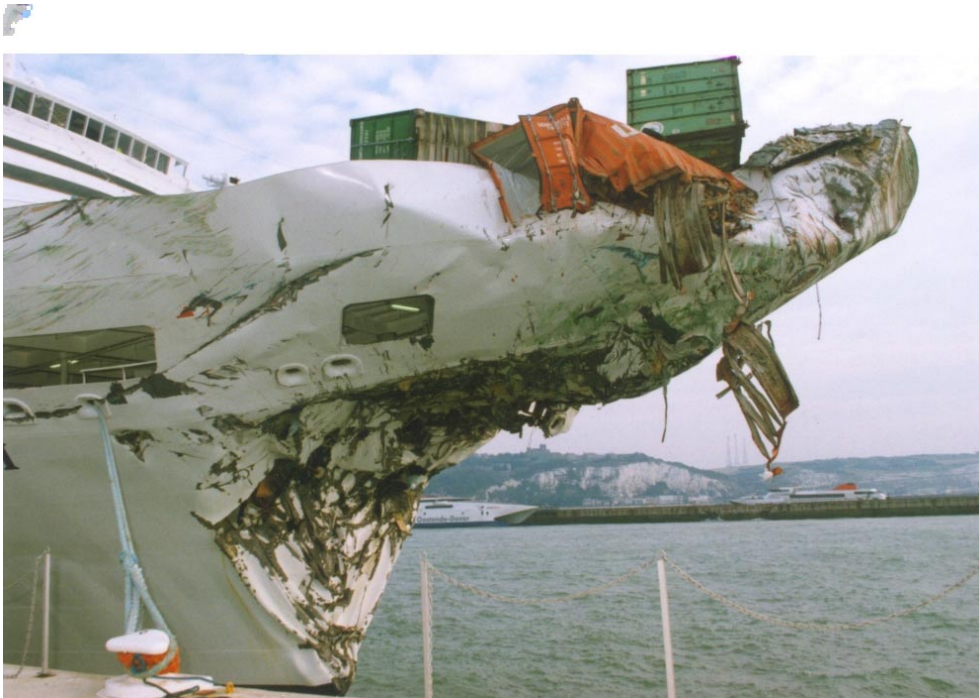
#### THE UPPER BOW

The main area of impact was at the forward part of the vessel when the bow struck the side of EVER DECENT. Some containers from the Ever Decent landed on the bow of the Norwegian Dream.

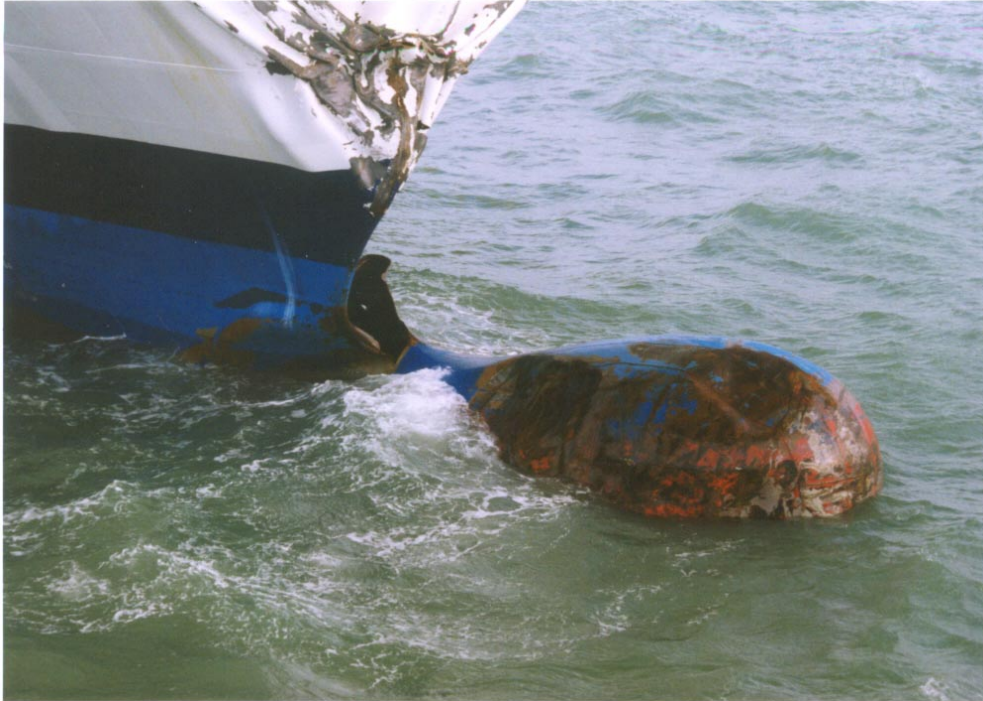
## **BULBOUS BOW**

Steelwork torn and open to the sea but shape of bulb largely intact despite being slightly twisted and offset to the port side.

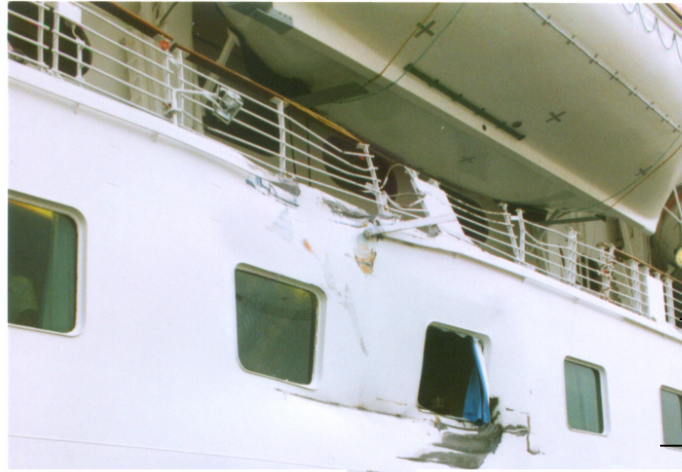
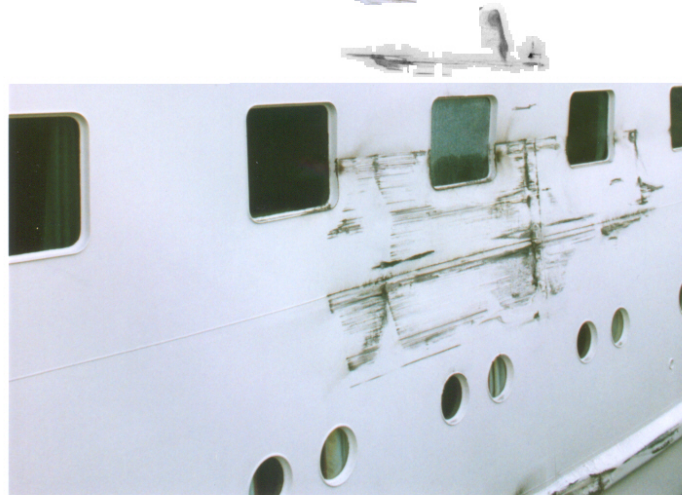
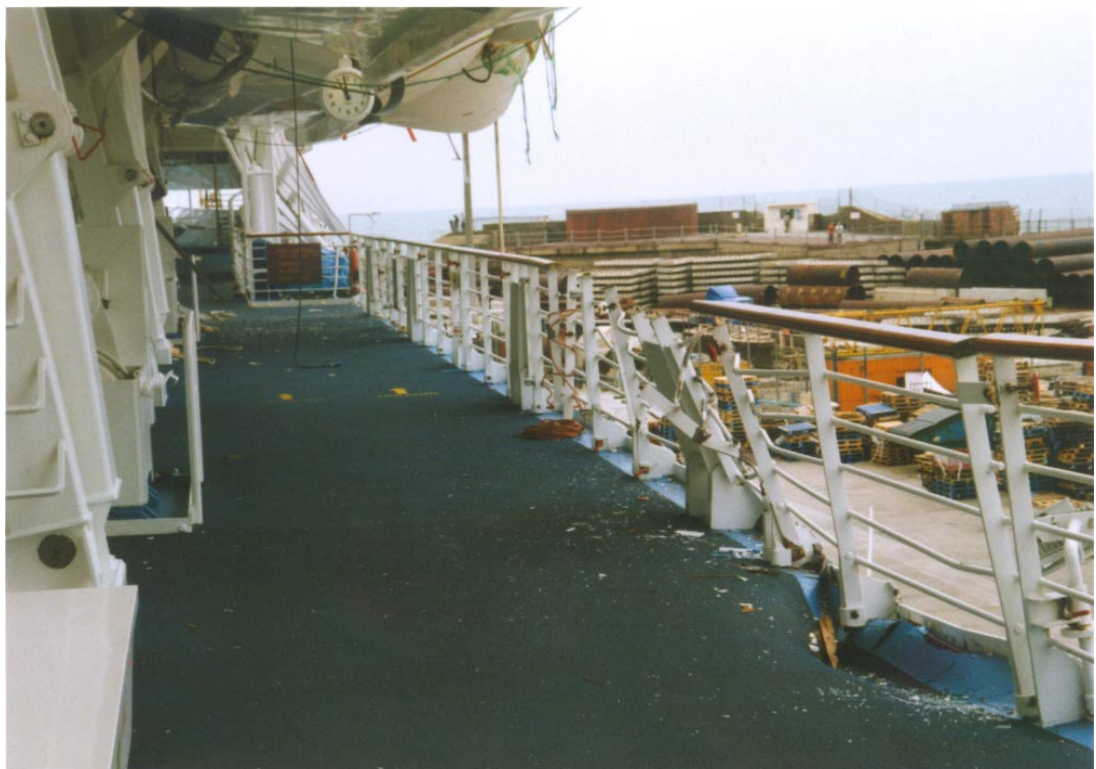
**THE STARBOARD SIDE**

Damage was caused to the starboard side affecting the shell plating, decks and associated passenger cabin fittings

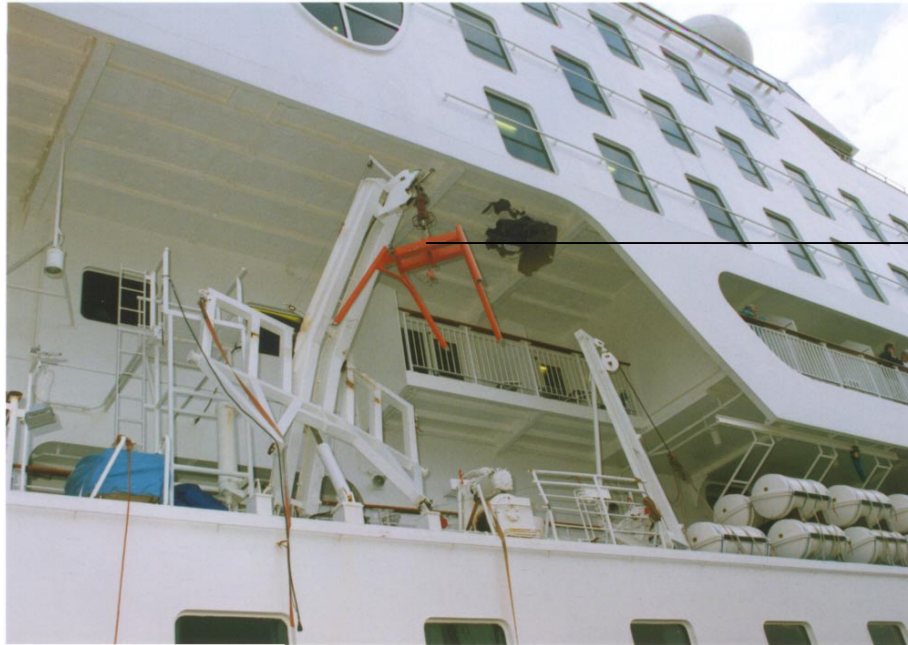
Davit & Lifting cradle of missing No. 1 Lifeboat

No 1 lifeboat, a semi-rigid hulled craft (starboard rescue boat), was torn from its davit in the later stages of the collision.

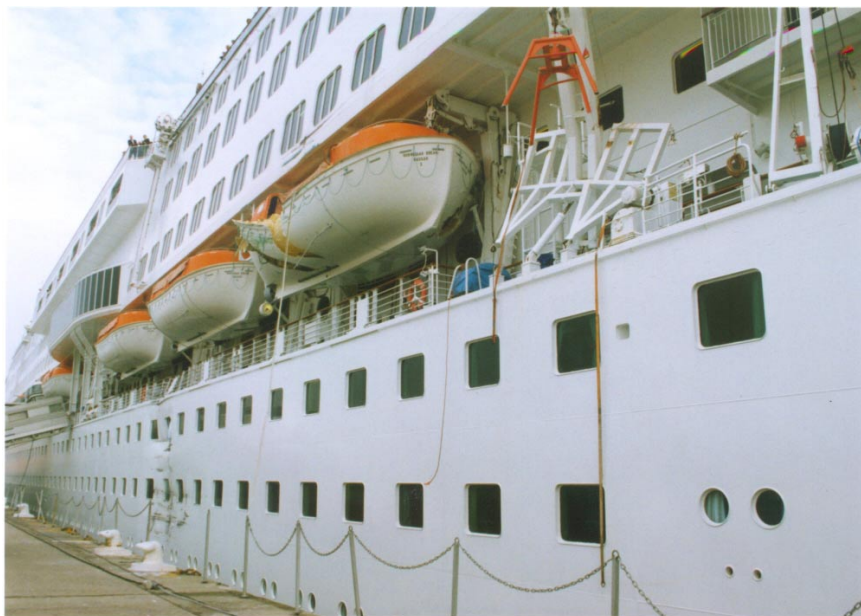
Damage

The aft part of No 3 lifeboat was damaged.

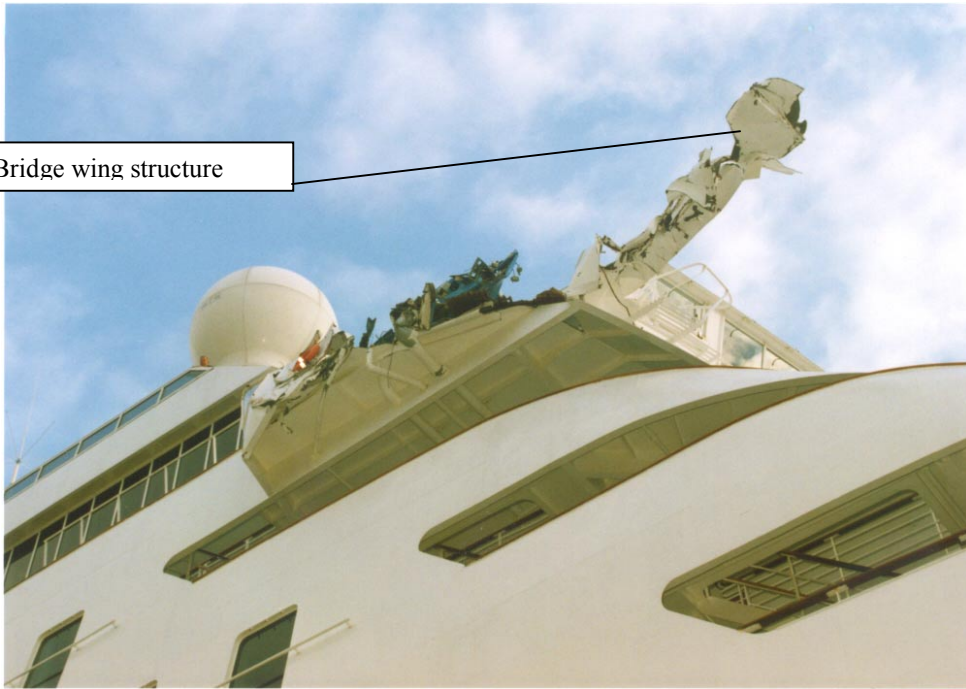
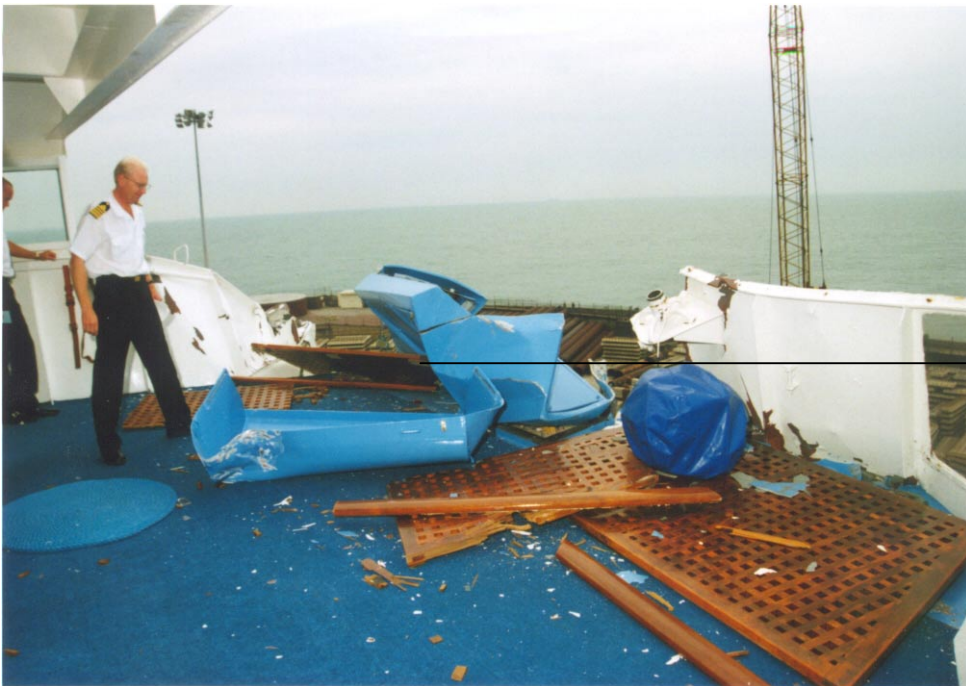
### BRIDGE WING

The starboard bridge wing of the NORWEGIAN DREAM was severely damaged.

Bridge wing structure

Bridge wing console and controls

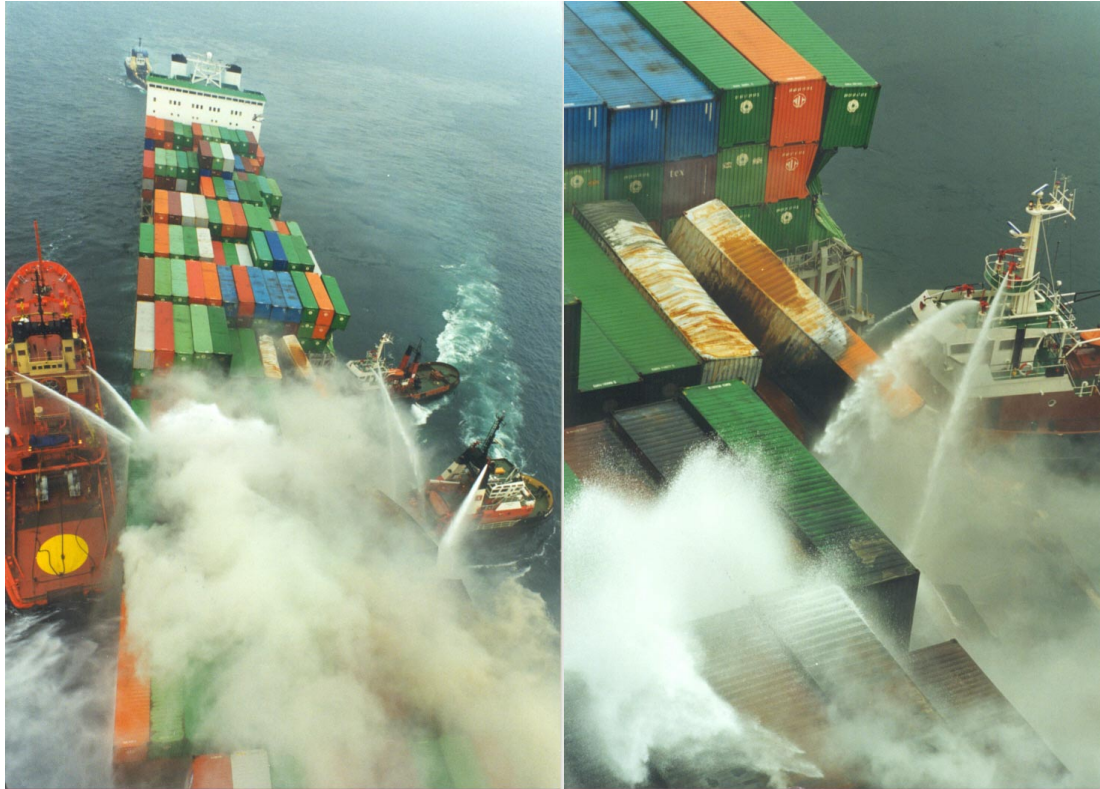
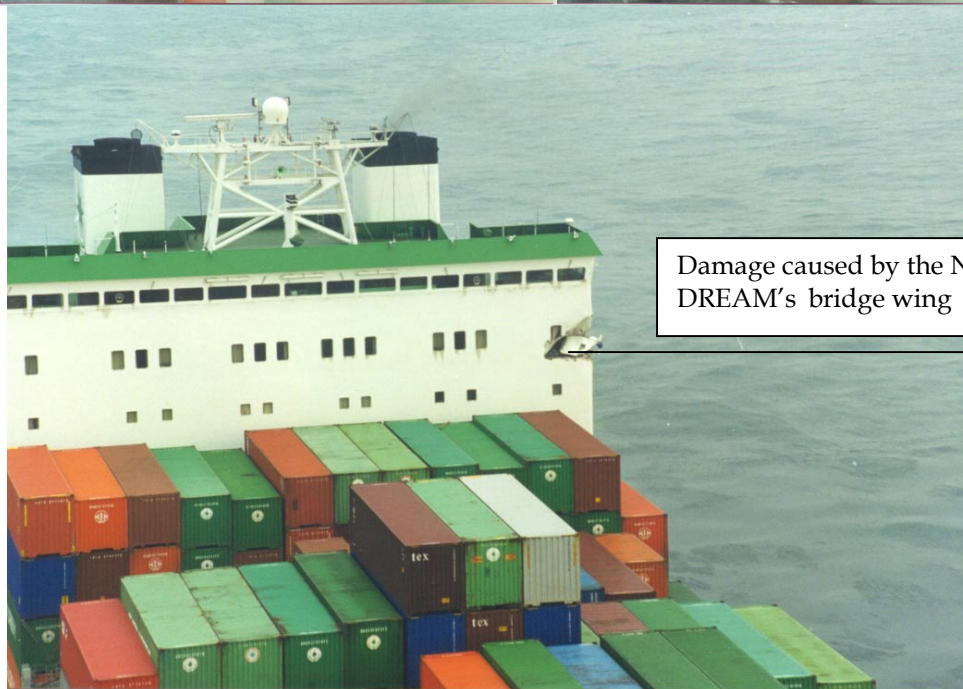
The exact nature of the damage to the Ever Decent is not known, however, the following photographs illustrate the general damage caused including the extent of the fire in the cargo.

Damage caused by the NORWEGIAN DREAM's bridge wing

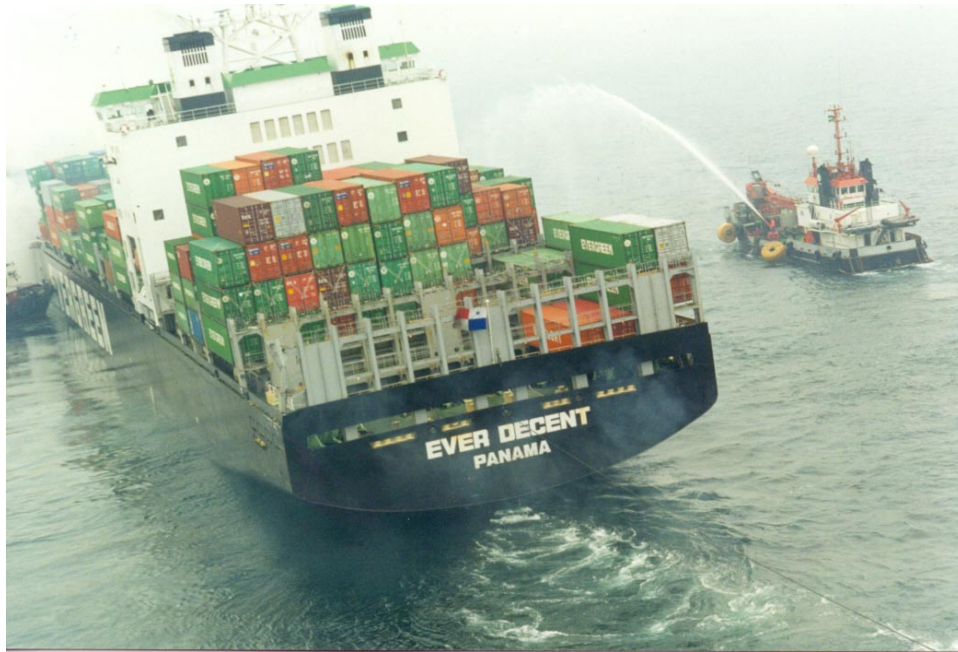
It is understood that there was a hole made in the port side shell of EVER DECENT, below the waterline. This initially allowed sea water to flow into the vessel causing a severe port list.

There was minor scraping damage to the port side, aft of EVER DECENT at main deck and sheer strake level.
