Bundesstelle für Seeunfalluntersuchung
Federal Bureau of Maritime Casualty Investigation
Federal Higher Authority subordinated to the Ministry of Transport
and Digital Infrastructure

Investigation Report 58/14

Less Serious Marine Casualty

**Collision between the JADE and
MV WILSON FEDJE on 5 March 2014 in the
port of Hamburg**

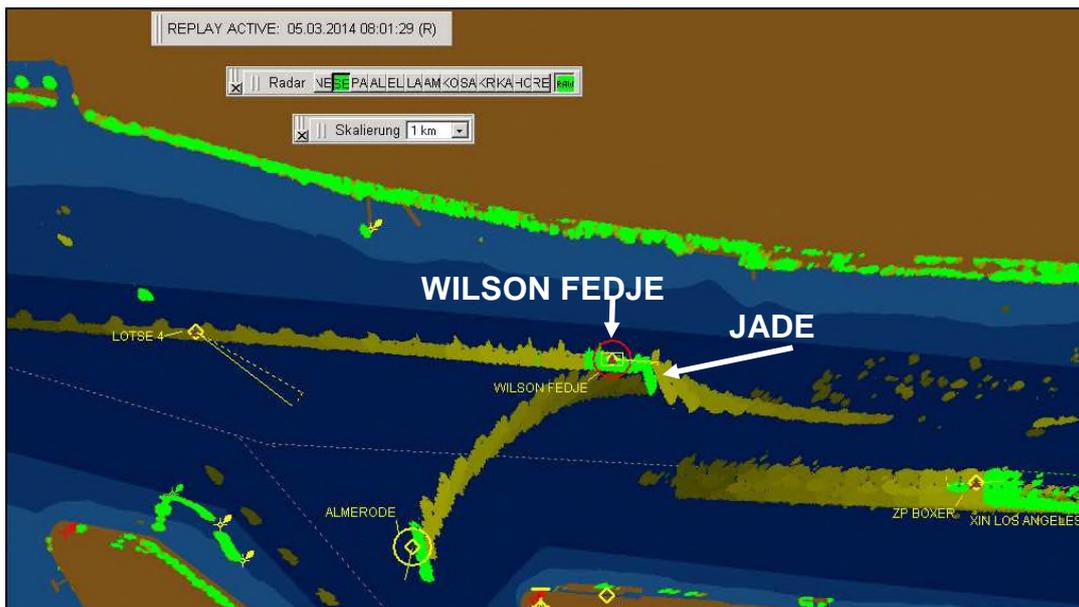
Figure 15: Radar/AIS recording from Hamburg Port Traffic (080129) (time of the collision)

About 15 seconds later (between **0801** and **0802**), without any further intermediate radio communication sent from the WILSON FEDJE or concerning her or the JADE on channel 19 or 74, collision noises can be heard in the VDR's audio recording of the microphones on the bridge. Accordingly, the radar echoes of the WILSON FEDJE and the JADE merge at this point (see **Fig. 15**). It is at this precise moment that the two vessels collide at an angle of nearly 90 degrees, despite having already initiated collision avoidance action (stop followed by a full astern manoeuvre; no alteration of course).

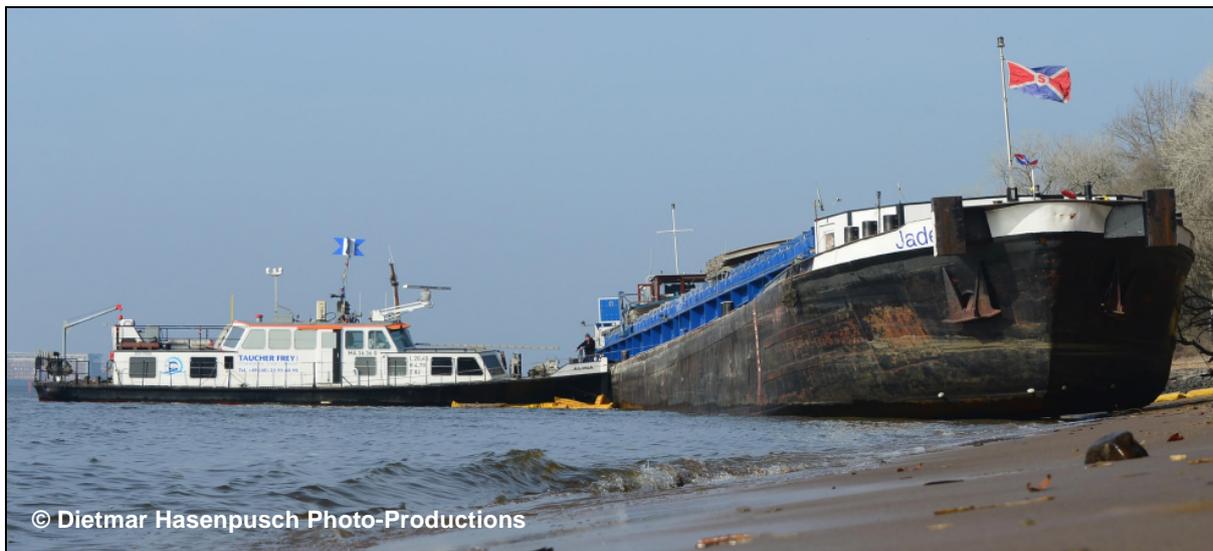
Figure 19: The JADE on the embankment

The JADE was lightened on the embankment and her buoyancy temporarily restored in the days that followed. The inland waterway vessel was then towed to the Jöhnk-Werft shipyard in Hamburg-Harburg, where she was scrapped because a repair would not have been economically viable.

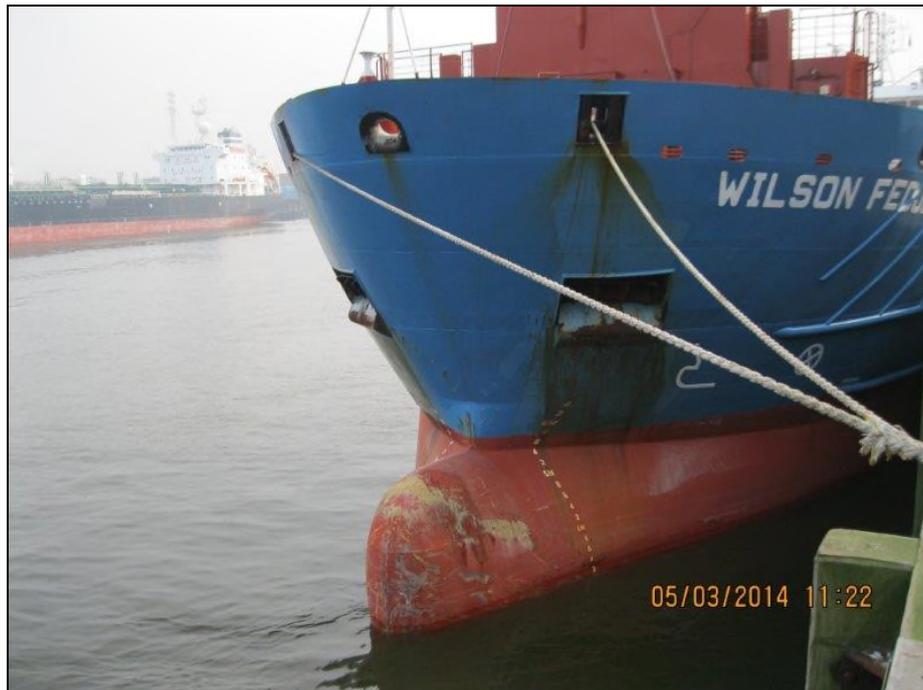
Figure 21: Paint abrasions on the WILSON FEDJE's bulbous bow

The WILSON FEDJE sustained only very minor damage in the area of the bulbous bow (Fig. 21) during the collision with the JADE.

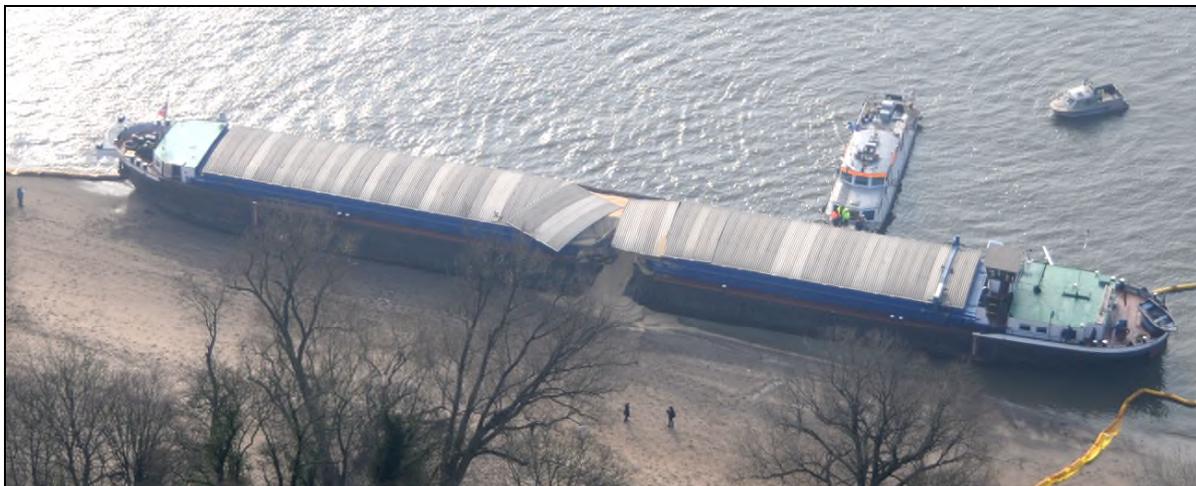
Figure 22: JADE – photo of the damage (top view)

The JADE was torn open amidships on the port side due to the heavy impact with the WILSON FEDJE's bulbous bow, which caused a huge gash of several metres wide in her hull.

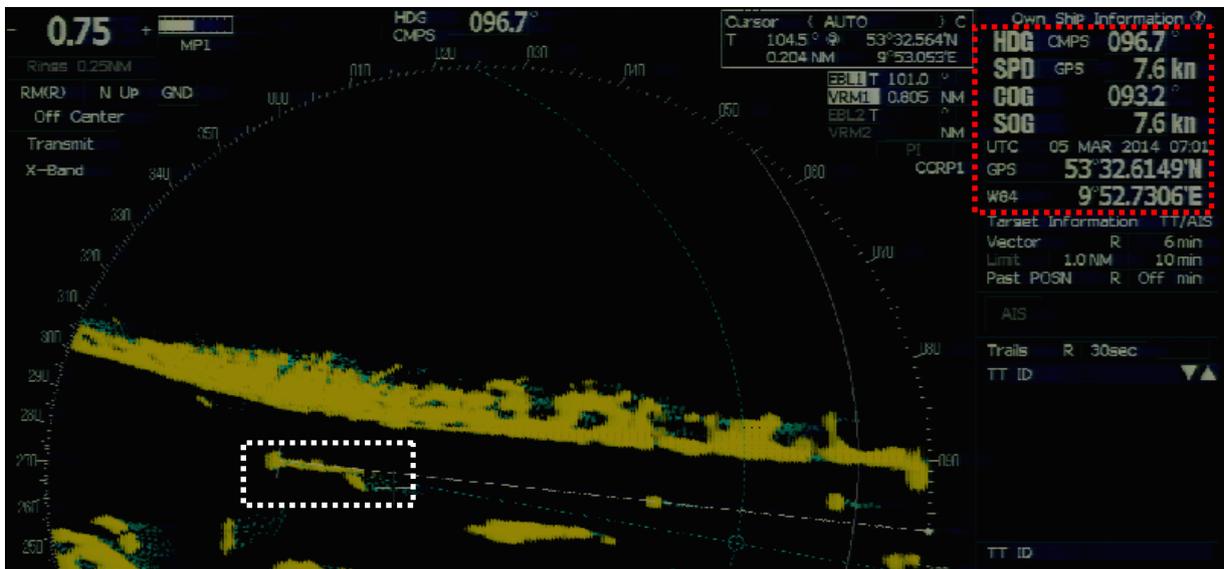
Figure 32: Extract from the WILSON FEDJE's radar image (X-band) at about 080125³⁰ (the collision between the WILSON FEDJE and JADE is imminent)

The JADE's starboard turn is more clearly visible below (see Fig. 32). The WILSON FEDJE still maintains an essentially consistent course and speed.

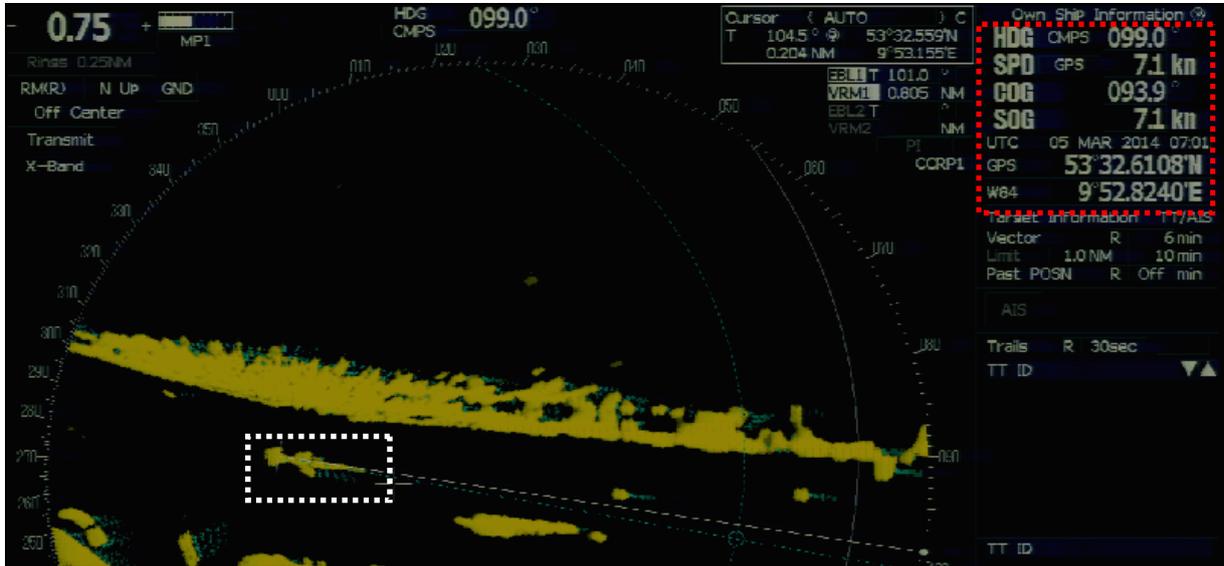
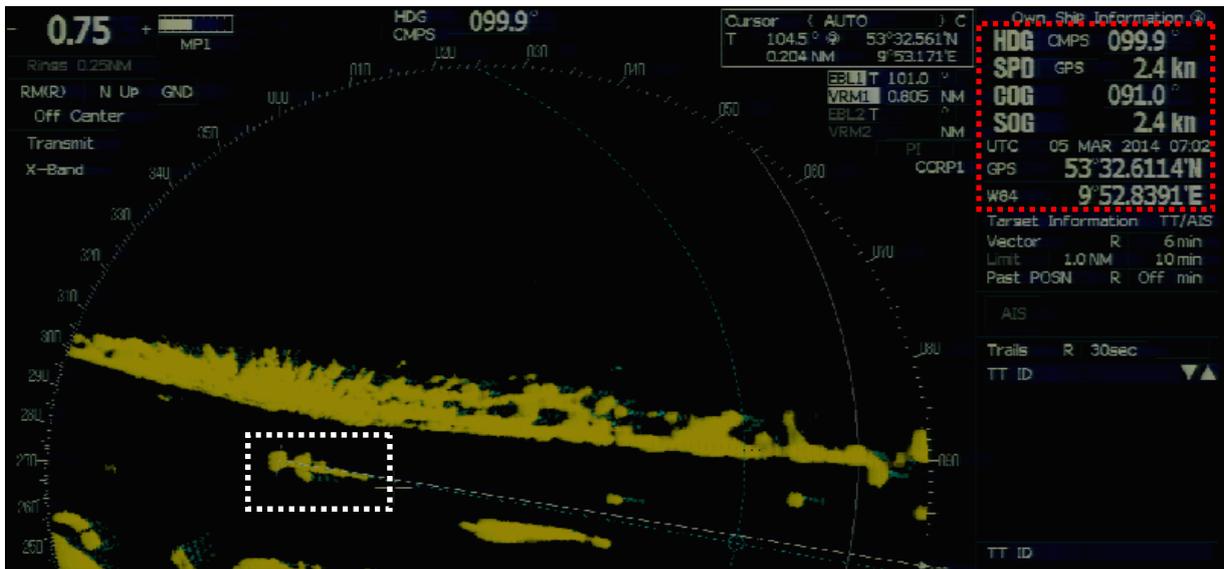
Figs. 33 f. below were stored in the WILSON FEDJE's VDR in immediate succession (i.e. at an interval of 15 seconds). The significant reduction in the WILSON FEDJE's speed visible in the track data field of Fig. 34 demonstrates that the collision between

the two vessels must have happened in the meantime, i.e. roughly within the time window **080145** to **080200**.
