SAFETY INVESTIGATION REPORT

REPORT NO.: 17/2019

MV ADAM ASNYK **Collision with MV DK IMAN** **in position 38° 35.8' N 120° 46.0' E** **08 September 2018**

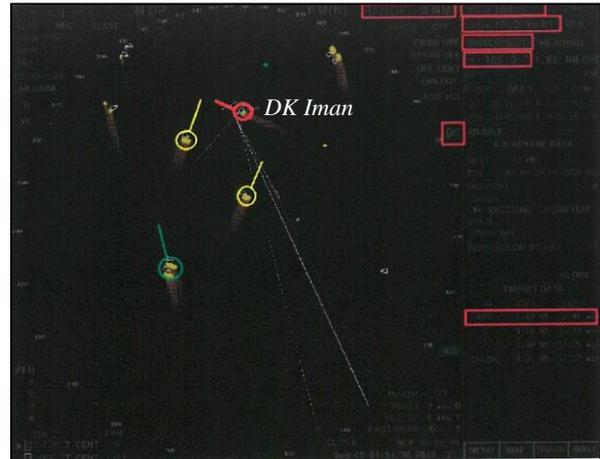
Figure 1: Radar screen shot at 0151:44

At around 0151:44 (Figure 1), the second officer instructed the third officer to call the master to the bridge, while he switched over to manual steering and continued altering the course of the vessel to starboard. It was noticed that the course of *DK Iman* was being continuously altered to port.

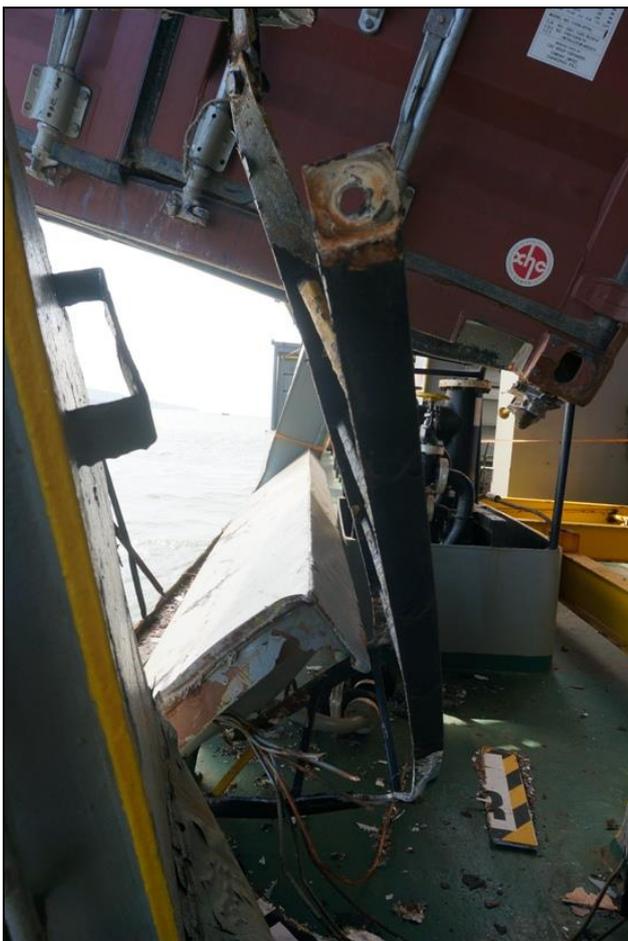
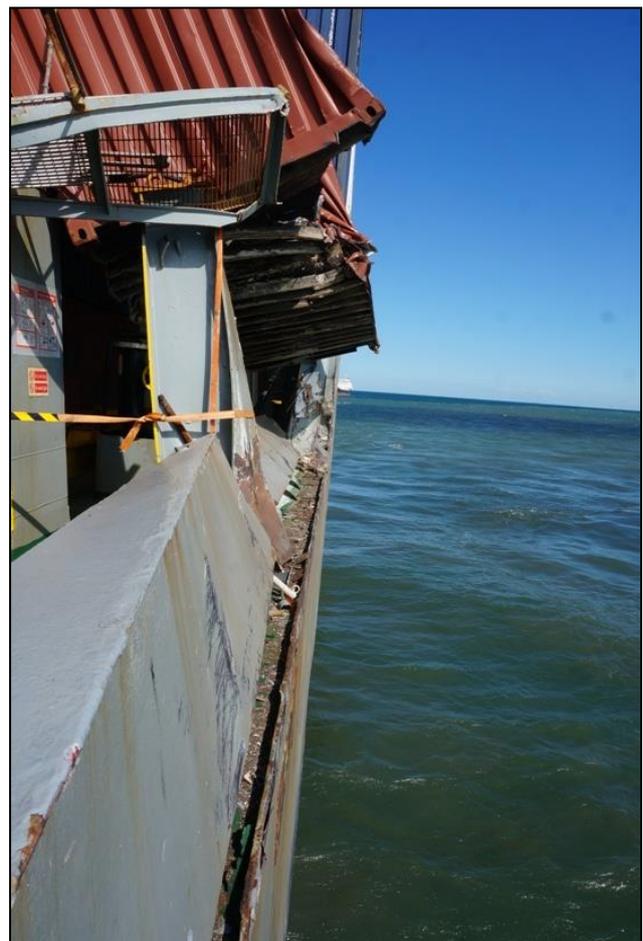
Figure 2: Damages sustained by *Adam Asnyk*

Adam Asnyk sustained minor damages above the waterline. The damages were located on the vessel's port side, just forward of her accommodation (Figure 2).

Damages were reported to a section of the bulwark, three container support pillars, three air vents and mooring bitts in the vicinity. In addition, the shore connection pipes for sewage and steam, and a cable for the emergency stop for the oily water separator were damaged.

Six empty containers, which were above the damaged pillars, also sustained structural damages.

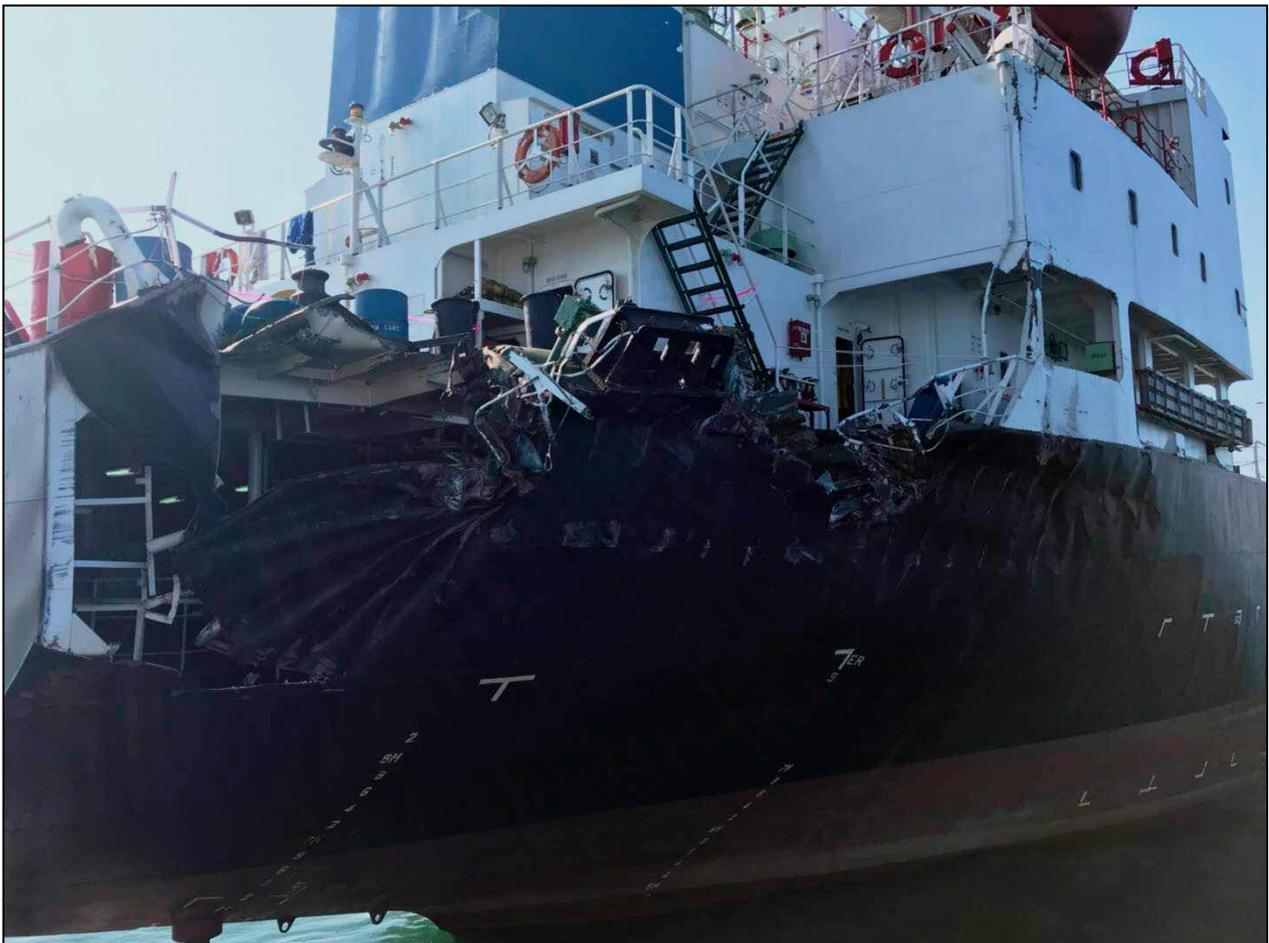
Figure 3: Damages sustained by *DK Iman*

As indicated in Figure 3, the vessel sustained serious structural damages to her starboard side shell plating in way of the poop deck and the engine-room. There was also damage to the railing and bulwark on the aft deck. Damages to the mooring equipment and several air vents were also noticed.
