MARINE SAFETY INVESTIGATION REPORT

Safety investigation into the collision of the
Maltese registered passenger ship
CELESTYAL CRYSTAL
with the Marshall Islands registered tanker
STI PIMLICO

In the Çanakkale Strait's Traffic Separation Scheme
on 27 June 2015

MARINE SAFETY INVESTIGATION REPORT NO. 10/2016

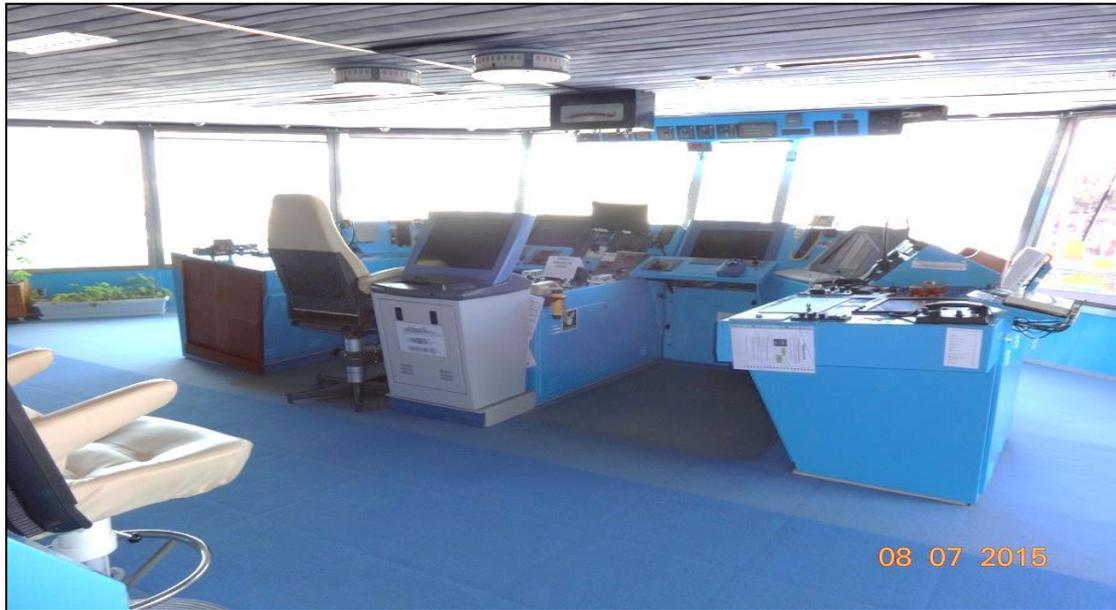
Figure 3: Main bridge console

fitted at the aft end of the centre of the console (Figure 3). The starboard forward radar display is for the bow radar, but was not operational at the time³.

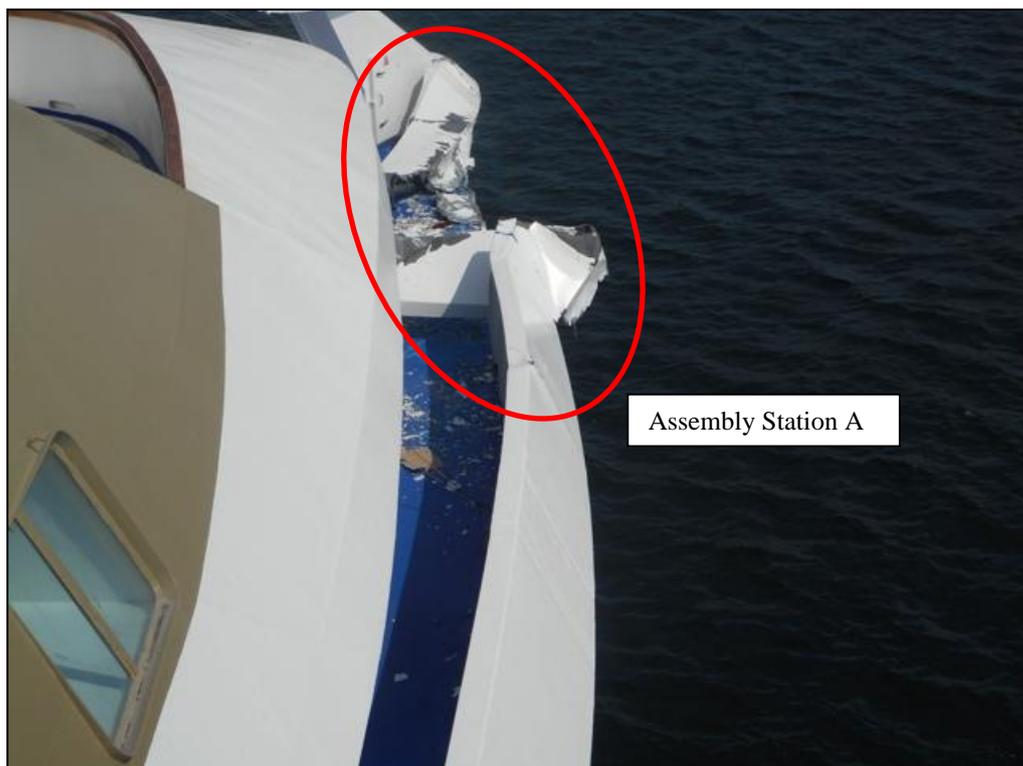
Figure 11: View of the damage from starboard bridge wing

The master looked from the starboard bridge wing and could see damage to the starboard bow and the decks forward (Figure 11). The forward deck on deck no. 5 had been badly damaged in the collision. This area was one of the designated assembly stations¹⁰ for the passengers in the event of an emergency but now was no longer safe. Since there were no reports of water ingress and one of the main assembly stations was unsafe, the master made the decision not to sound the General Emergency Signal¹¹.

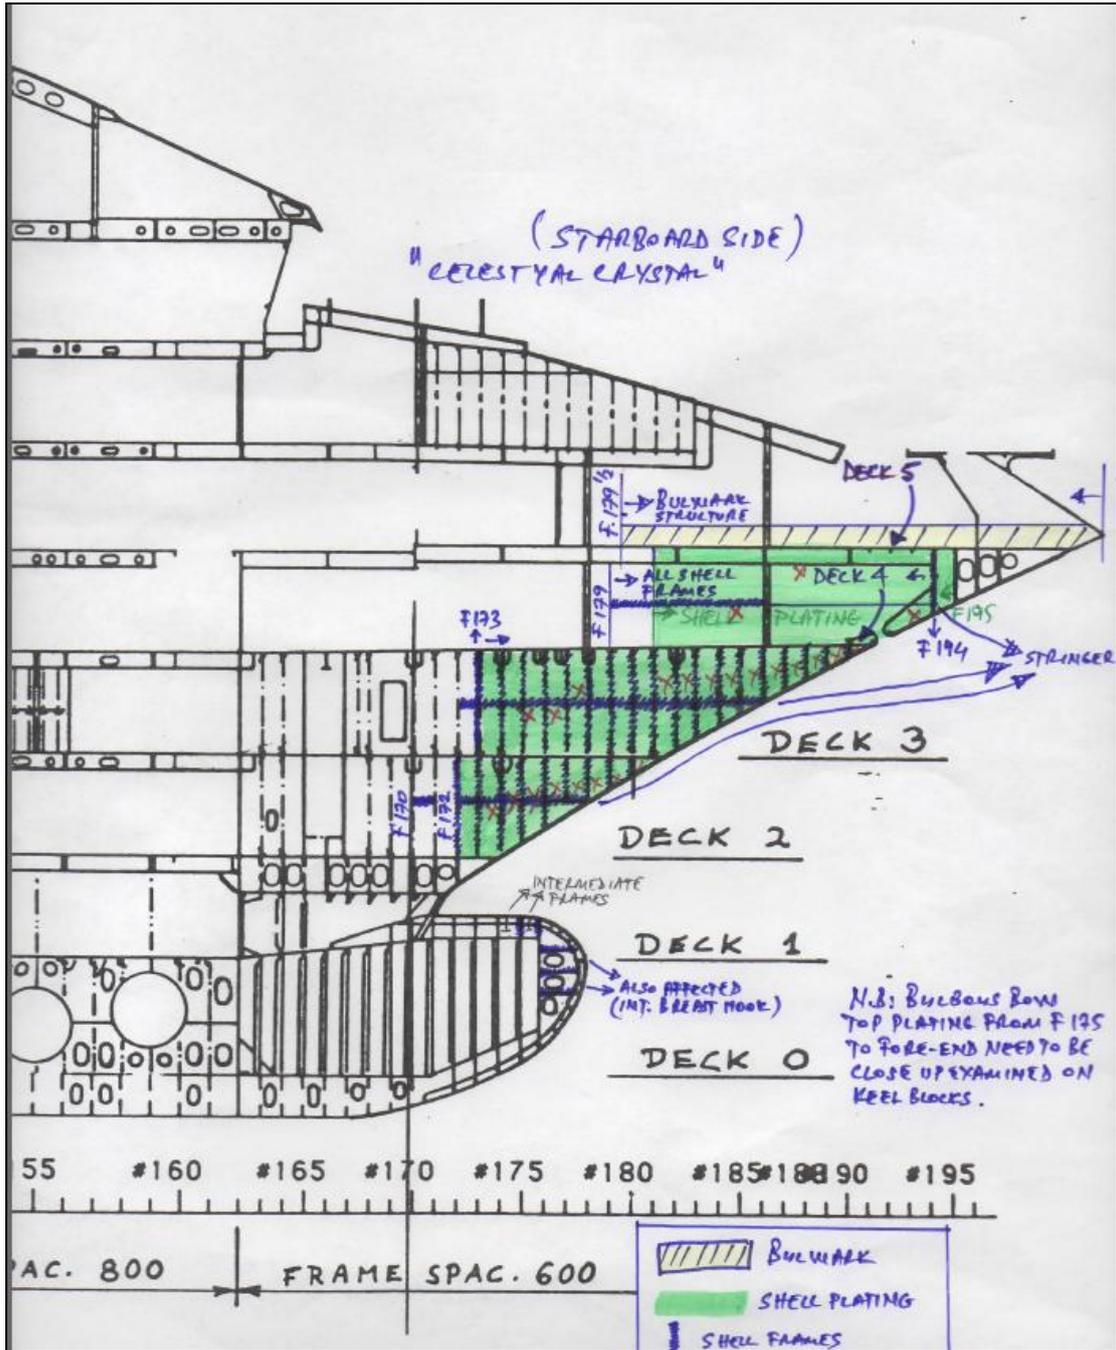
Figure 13a: Damages to the bow

Celestyal Crystal sustained damage to her starboard bow (Figures 13a-d and 14) that included:

- Deck 2 damage to steelwork from frame 172 to fore end;
- Deck 3 damage to steelwork from frame 173 to fore end;
- Deck 4 damage to steelwork from frame 181 to fore end;
- Deck 5 damage to steelwork from frame 179 to fore end; and
- Internal damage to bulbous bow but no leaks or cracks.

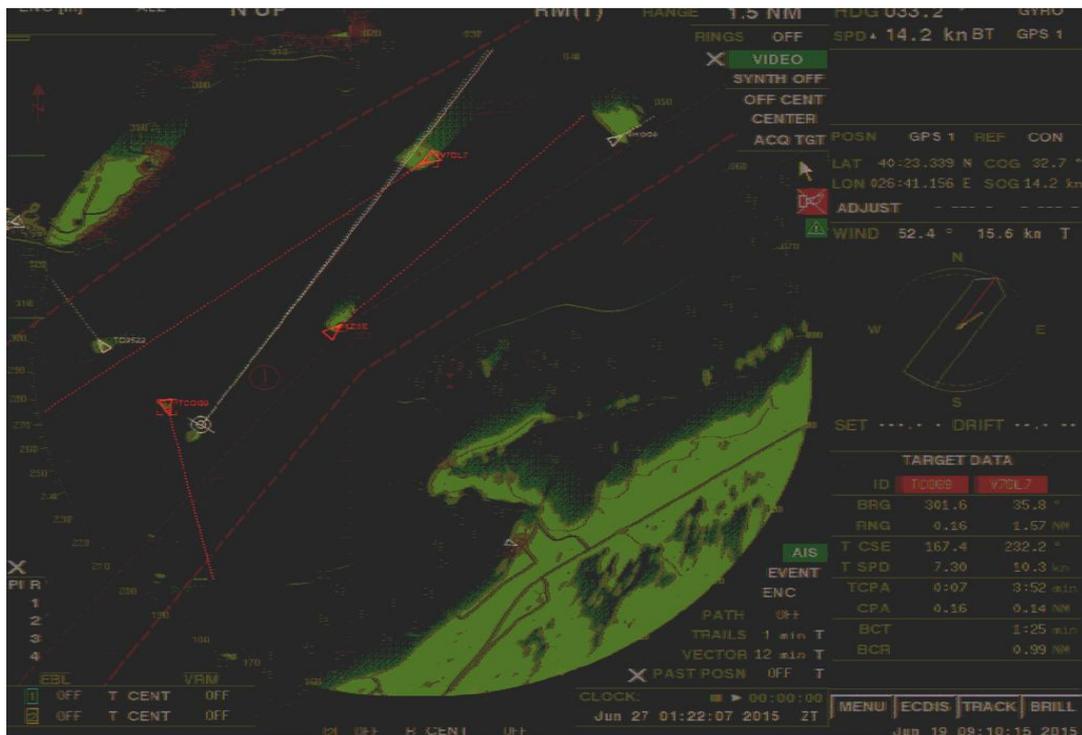
Figure 17: Radar screen showing vessels at 0122:07

At about 0122, shortly before the apprentice officer left the bridge, the OOW ordered a course of 030° and then 028° to increase the closest point of approach with the vessel to what he thought was *Emona* (Figure 17). In response to his subsequent alterations of course to port, the OOW expected the bearing of the vessel to open. Instead, the bearing closed. He then shifted his position from the radar to the bridge window to visually observe the vessel.

Although the OOW was looking ahead, he was aware neither of own vessel's position in the TSS nor the danger of his vessel heading into the Southbound traffic lane.

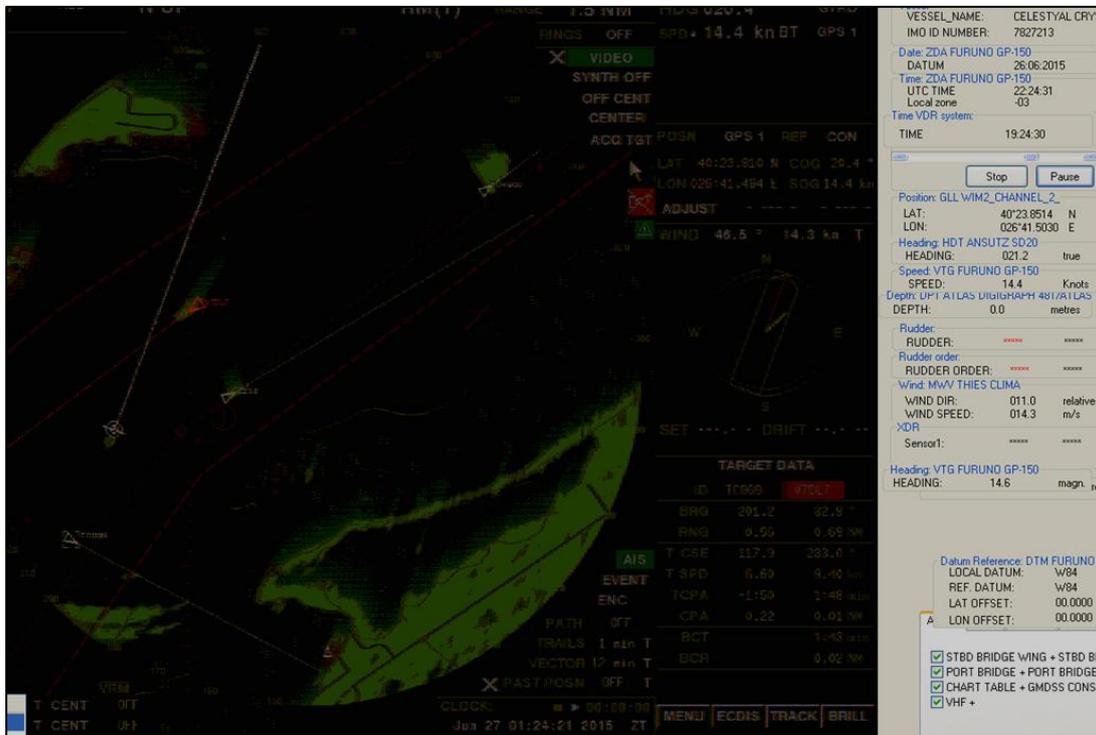
Figure 18: Radar screen showing vessels at 0124:31

Two minutes before the collision, VTS first called *Celestyal Crystal* on the VHF to warn of a ship on her port side. The OOW acknowledged the call and stated “negative, not possible to come to starboard”¹⁸. It seemed evident to the safety investigation that even at this stage, the OOW remained convinced that if he were to alter course to starboard, he would run in the danger of colliding with *Emona* which was on his starboard side. It was only after VTS called him a third time at 0125 that he realised that the vessel he was overtaking was not *Emona* and that he was on a collision course with *STI Pimlico* which, until that moment had remained undetected by the chief mate (Figure 18).

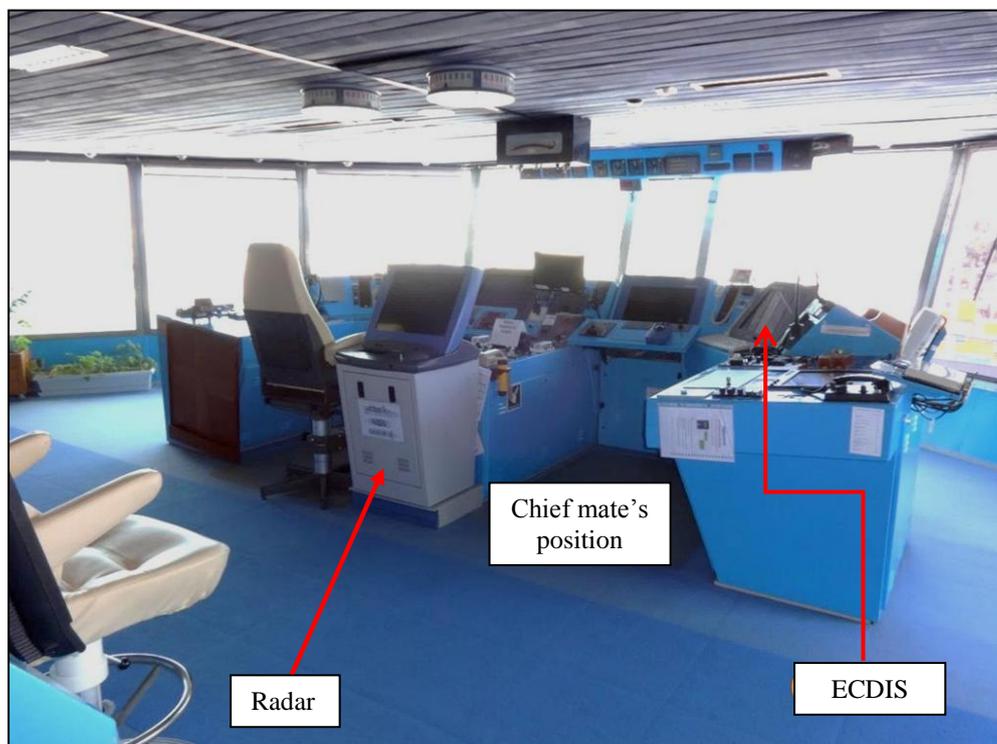
Figure 19: Navigation Conning Console

The SAM Electronics ECDIS was located on the starboard forward part of the console and the Kelvin Hughes Radar had been retro-fitted to the end of the T shaped console (Figure 19). This meant that the OOW had to stand on the starboard side of the console, which allowed him to see the ECDIS and then by stepping back slightly, to view the radar display.

The position of the new radar at the end of the 'T' was not ideal, as the layout of the console was originally designed so that the operator sat in a chair and had visibility of all the instrumentation grouped in front of him.
