MARINE SAFETY INVESTIGATION REPORT

Safety investigation into the collision between the
Maltese registered general cargo

KATRE

STATENGRACHT

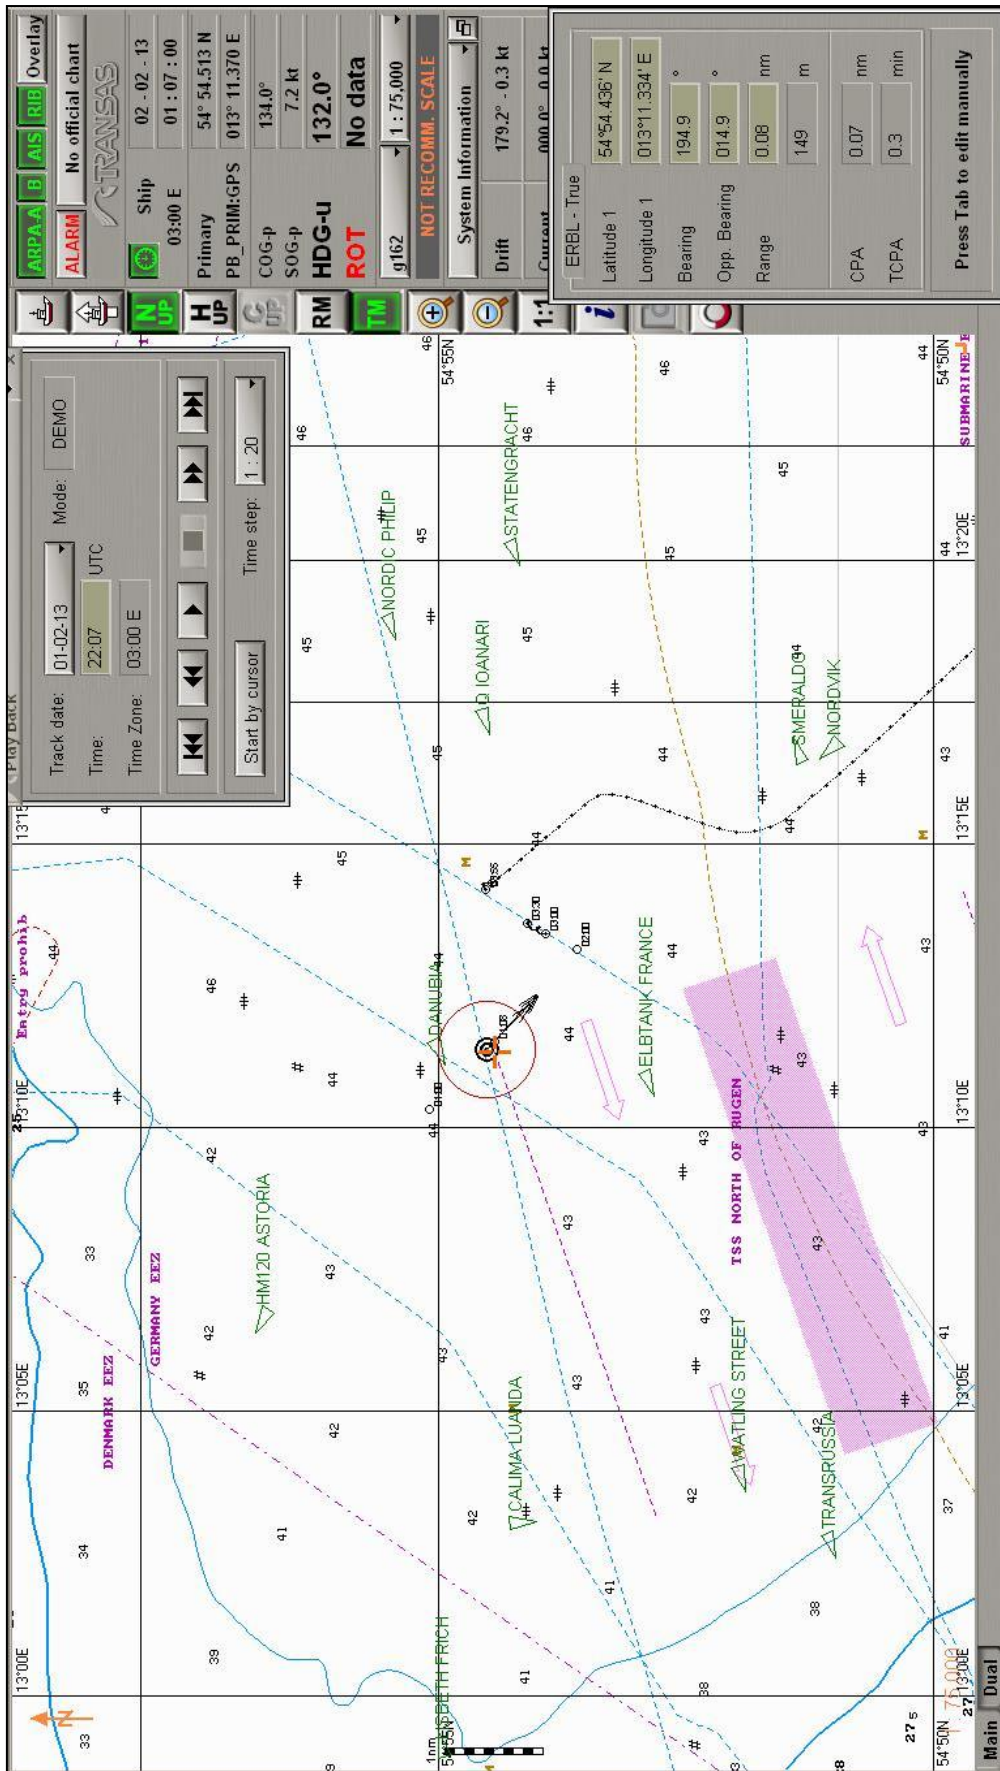
Figure 5: Screen shot at 2207

On a reciprocal course and ahead of *Katre*, was the Faeroe Island registered cargo ship *Nordvick*, which was also passing close to the entrance of the TSS, North of Rugen. As indicated above, the chief mate was using only the Kelvin Hughes starboard radar; port side radar, *i.e.* the Furuno FM-2010, was not in use. The radar in use was kept on True Motion, centred and 'True North Up'. Superimposed on the ARPA was the electronic chart together with the Automatic Identification System (AIS) information. Hence, all the vessels detected had their name displayed against their echo (Figure 5).

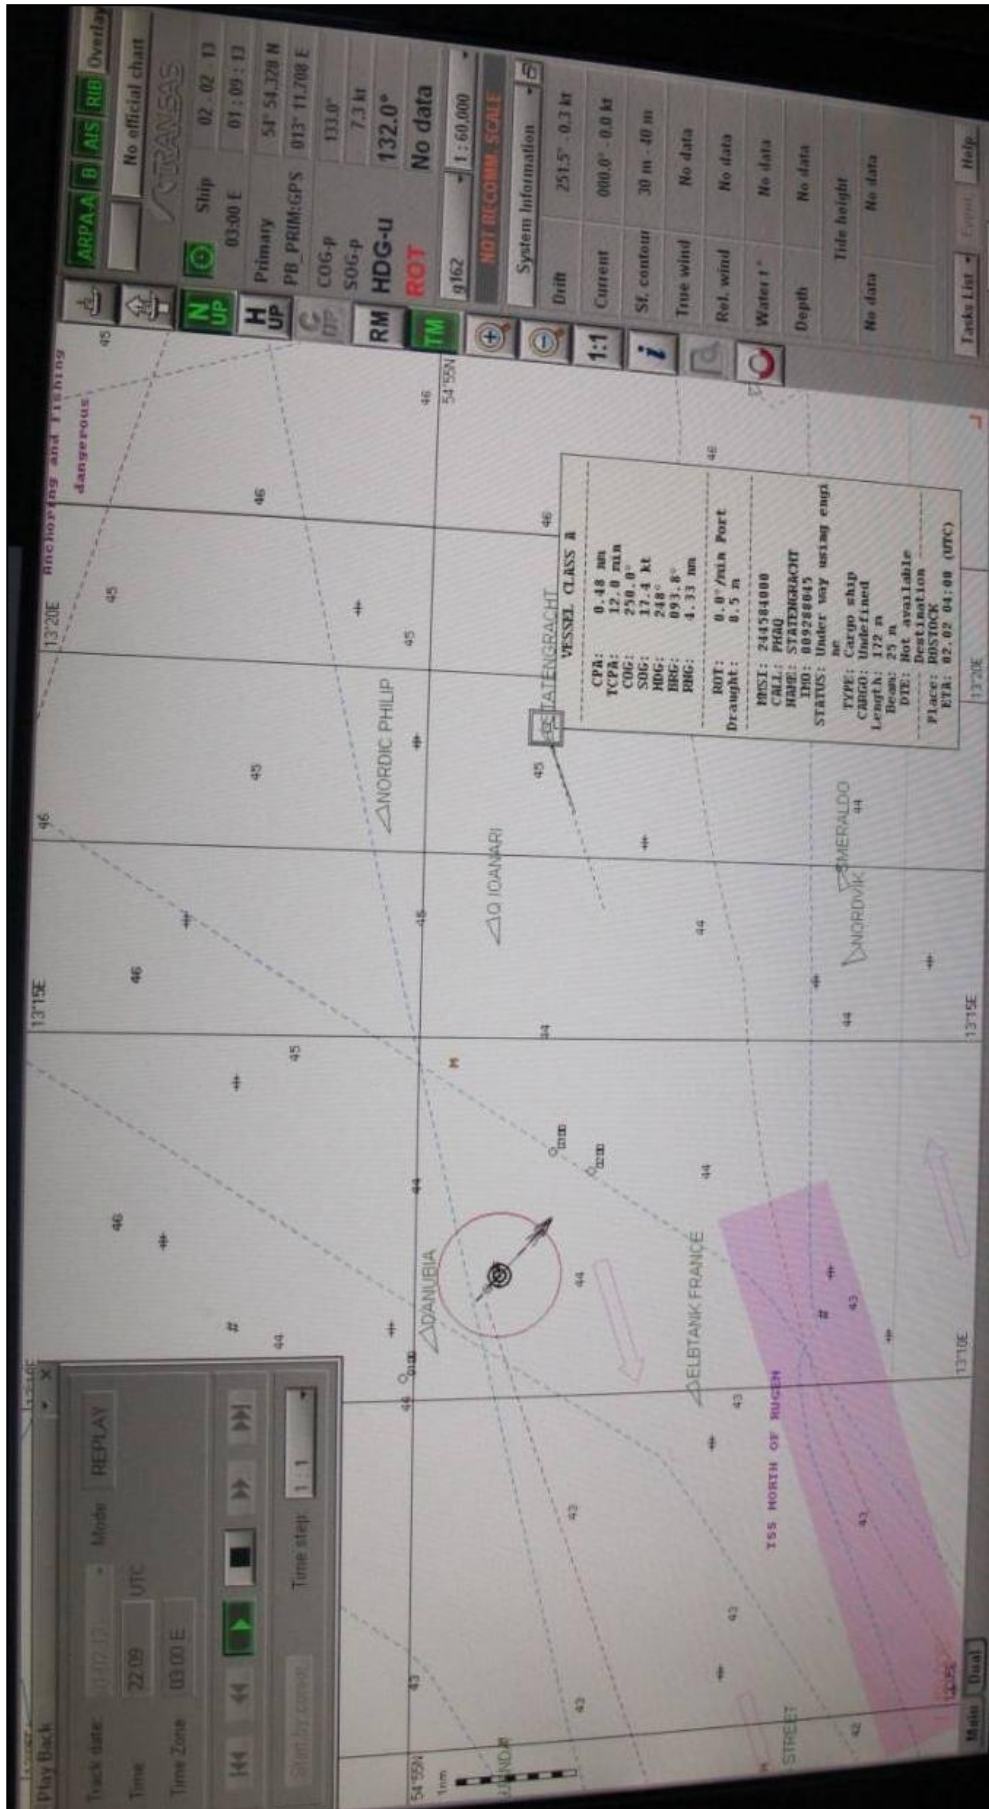
Figure 6: Screen shot at 2309

Although as indicated above, there were other vessels in the vicinity, it was only *Statengracht* and *Katre*, which were developing a 'Close Quarter Situation' with a constant Closest Point of Approach (CPA) of around 0.5 nm. At 2308, the chief mate altered course from 134°(T) to 138°(T) in order to put the vessel on the new course in accordance with the courses laid down on BA Chart 2365. At this point, *Statengracht* was still some 4 nm away with a time of closest point of approach (TCPA) of around 12 minutes. The CPA remained about 0.4 nm (Figure 6).

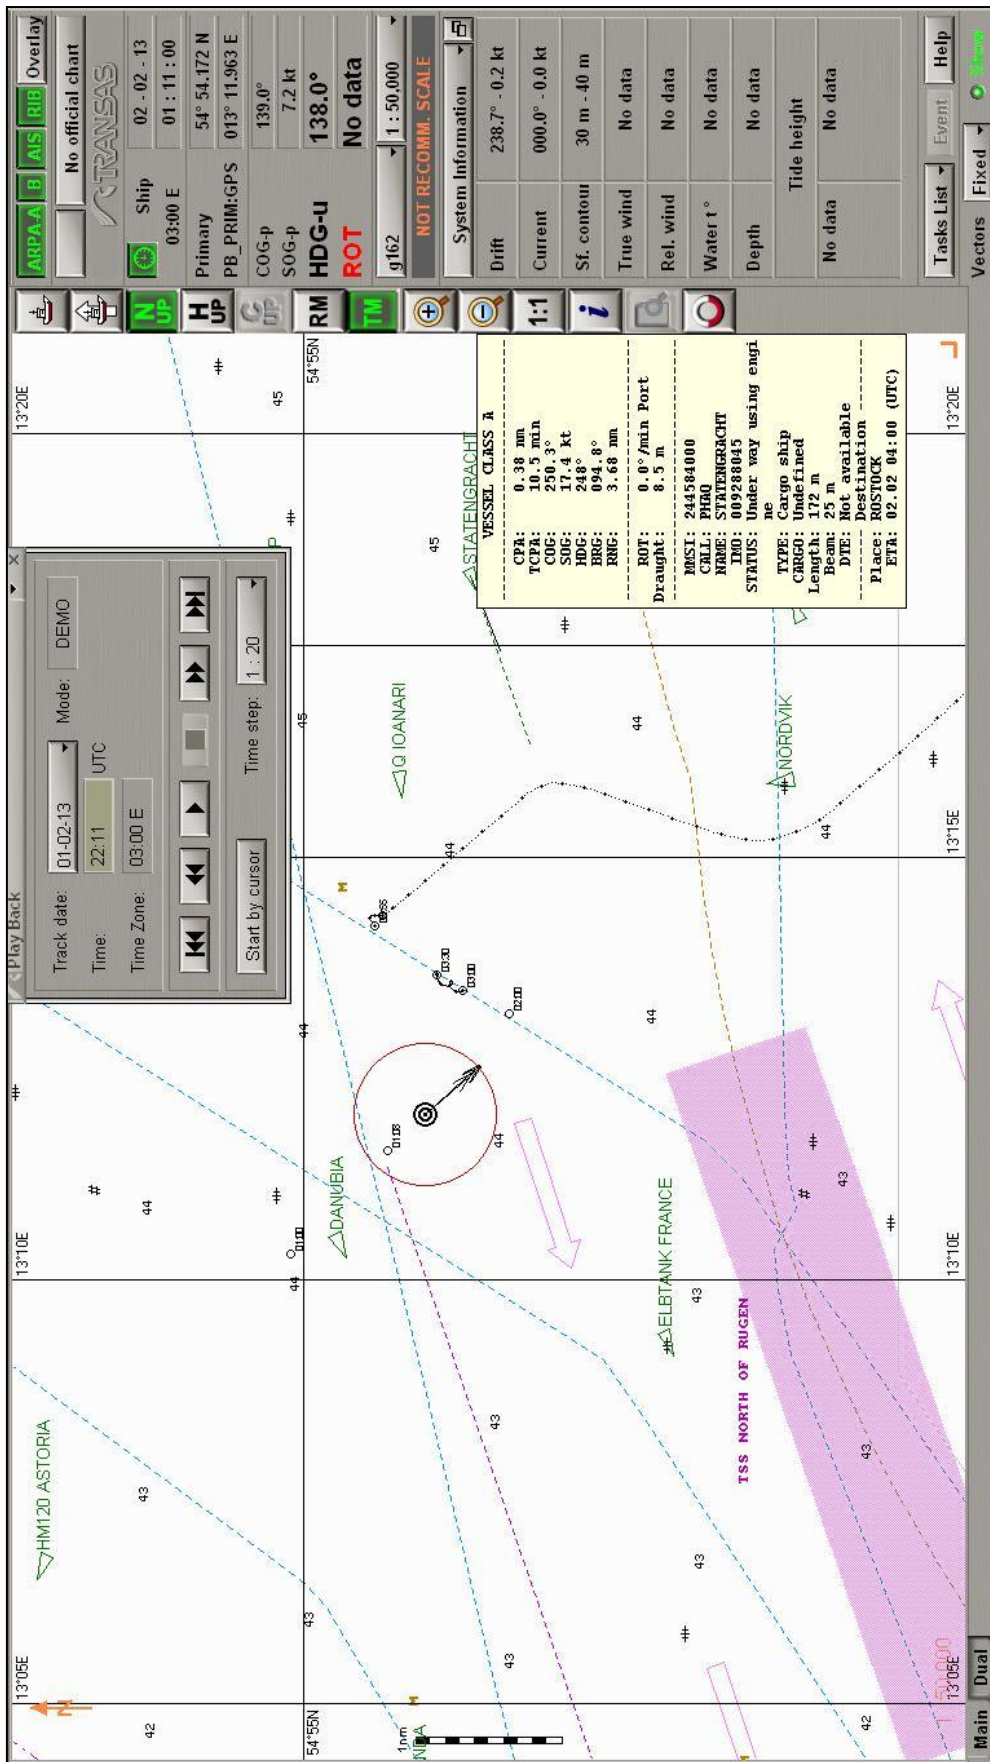
Figure 7: Screen shot at 2311

According to the data collected from *Katre's* ARPA system, the chief mate had *Statengracht* constantly monitored (Table 1). The closest vessel to *Katre* approaching from the port side was *Q Ioanari* which, at about 2311 had altered course to starboard for *Katre* and went around her stern without any problems. At about this time, *Katre* reduced her speed to approximately 6.5 knots in order to maintain her Estimated Time of Arrival (ETA) at her destination (Figure 7).

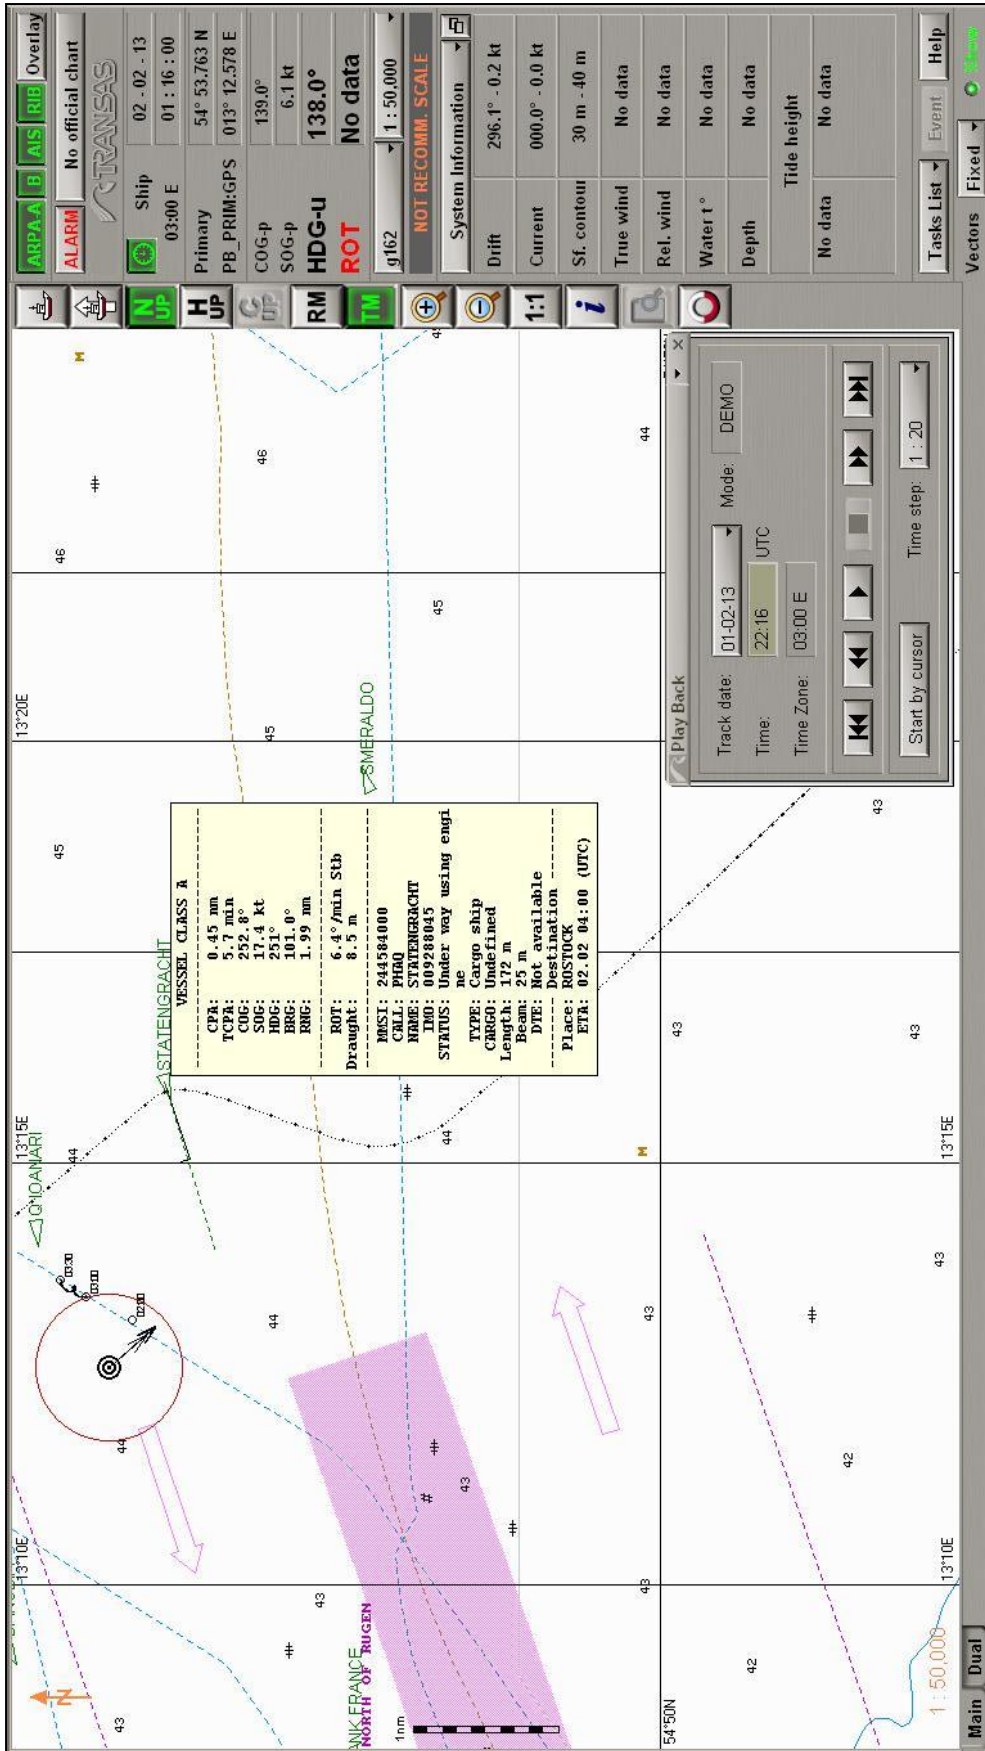
Figure 8: Screen shot at 2316

While *Katre* maintained her course of 138°(T) and a speed of about 6 knots, *Q Ioanari* was keeping clear, slowly going around the *Katre's* stern (Figure 8).

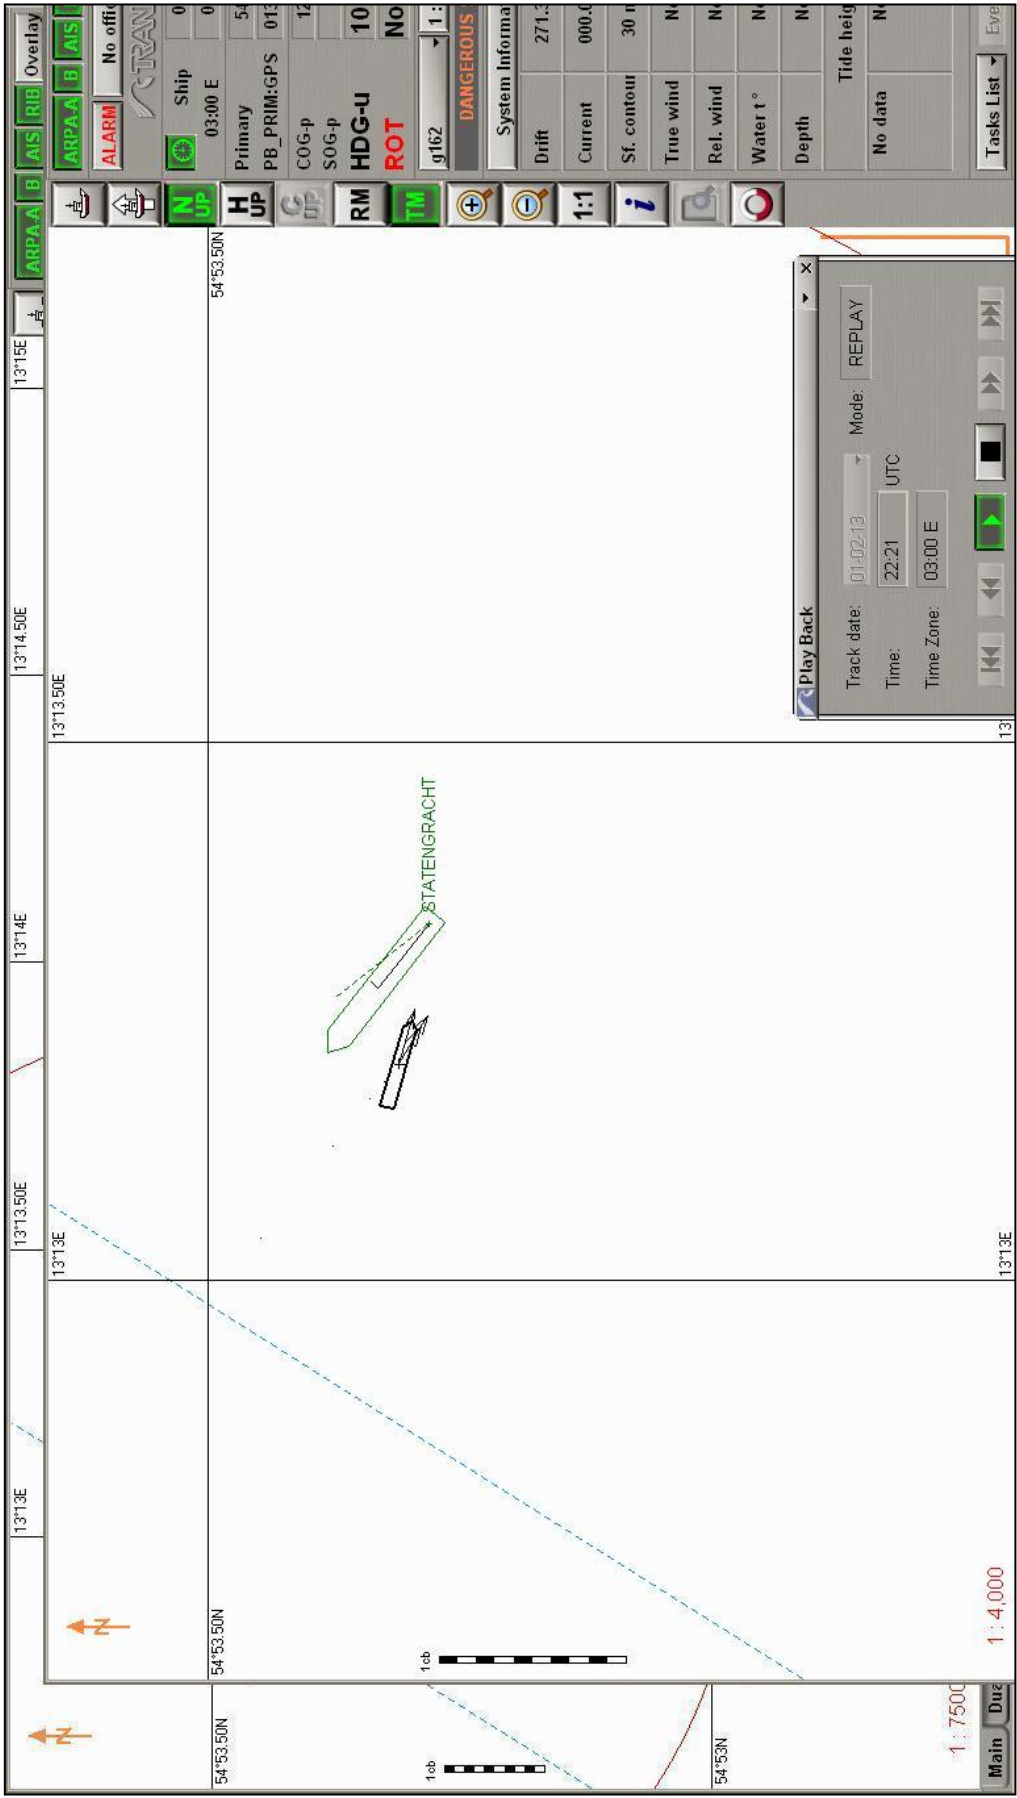
Figure 10: Screen shot at 2321

The chief mate further noticed that *Statengracht* was continuing her course alteration to starboard and immediately ordered his helmsman to put the wheel hard to starboard. However, this last helm order did not take effect. At 2321, *Katre's* bow collided with *Statengracht's* port side in way of the latter's cargo hold no. 2 (Figure 10).

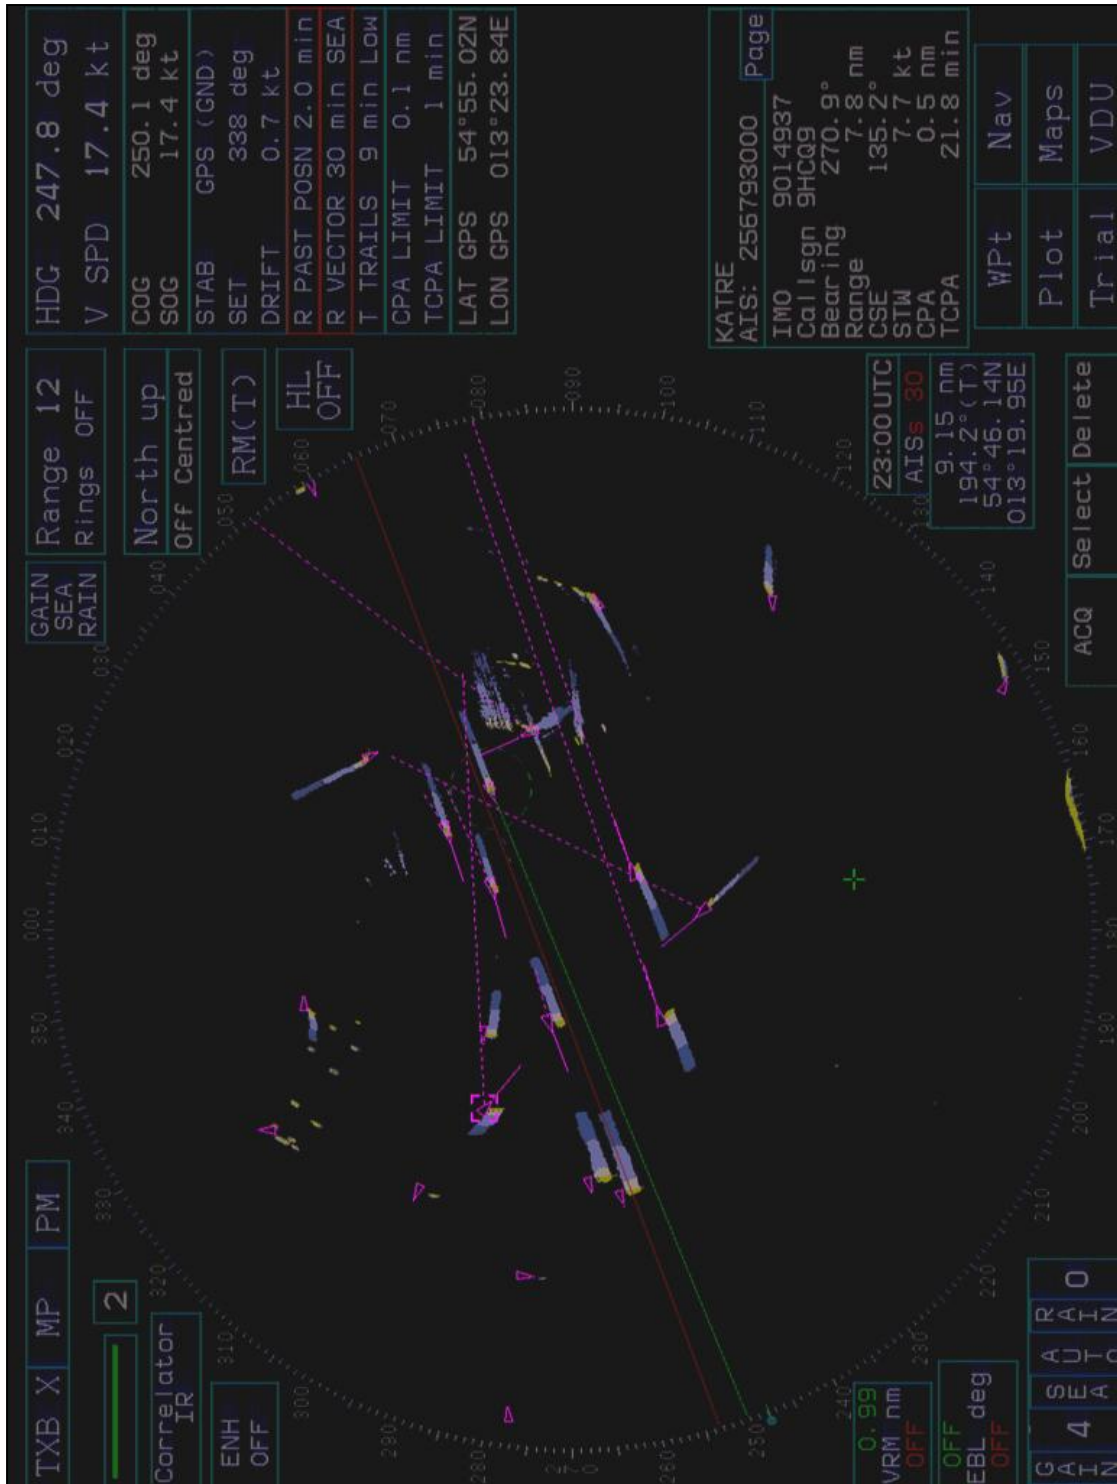
Figure 11: Screen shot at 2300

approximately 12 knots; *Nordic Philip*, which was about 1.5 nm on its starboard beam, was also on a similar course to the one followed by *Statengracht* but making 15 knots. *Nordvik*, which was Northbound, was about 7 nm on the *Statengracht*'s port bow, making approximately 12.5 knots, and crossing from port to starboard. The motor tanker *Smeraldo* was on a reciprocal course to the South of *Statengracht*, passing close to *Nordvik* and *Katre*, which was on the starboard bow some 8 nm away, with a CPA of 0.5 nm (Figure 11).

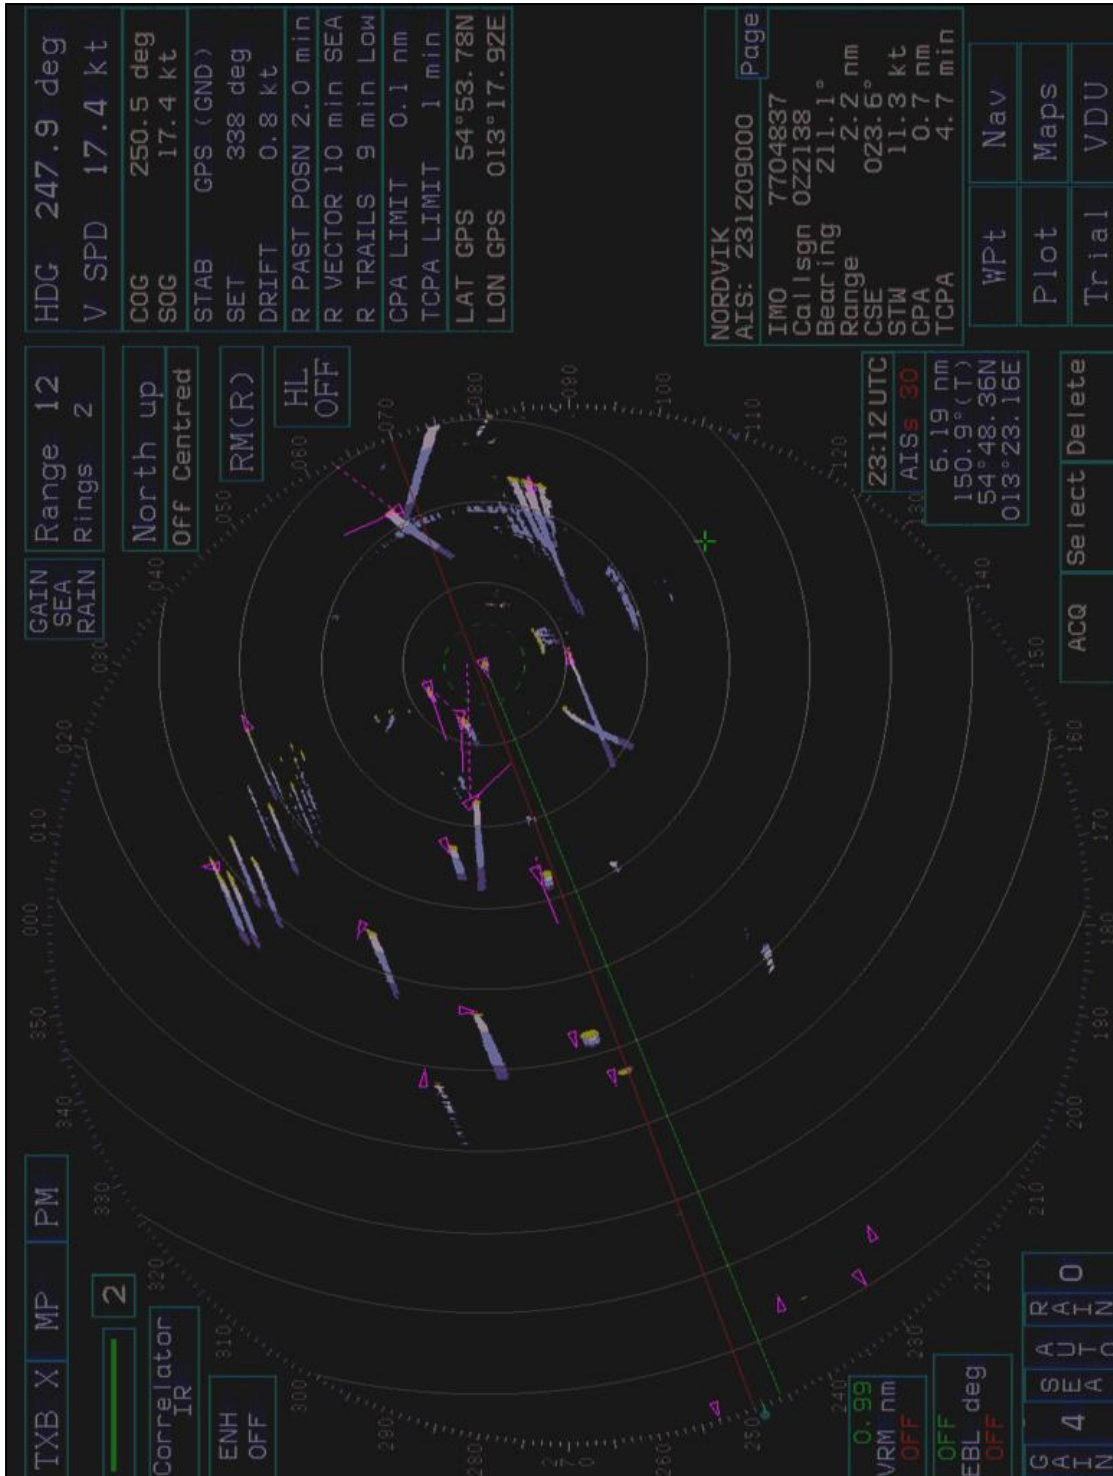
Figure 12: Screen shot at 2312

With a speed of just over 17 knots, *Statengracht* was slowly overtaking both vessels on her starboard side, namely *Nordic Philip*, which was by now already abaft her starboard beam, and the *Q Ioanari* which, at 2310 and a distance of 1.5 nm from *Statengracht*, altered course to starboard for *Katre*, which was on her starboard side (Figure 12).

At 2312, *Nordvik*, which was crossing *Statengracht*'s path from the port side, made a broad alteration of course to starboard while it was still at a distance of 2.5 nm from *Statengracht* (Figure 12). This was well observed by the master and the second mate on board *Statengracht*.

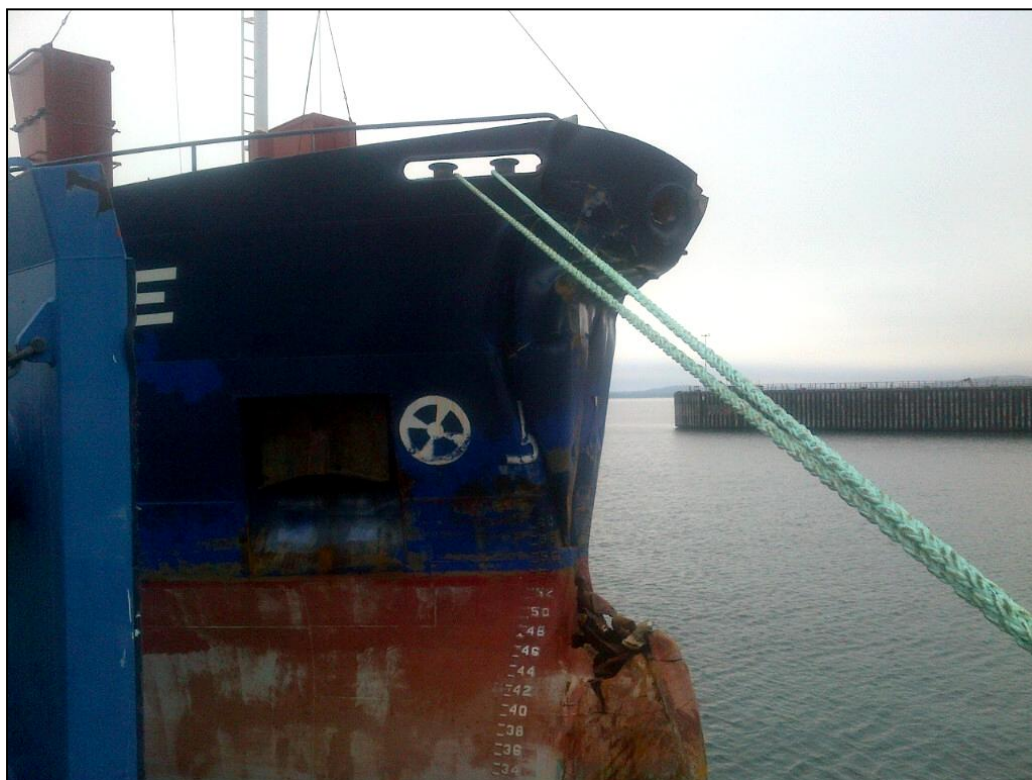
Figure 14: Damages to *Katre*'s bow area and bulbous bow

Katre sustained severe damages to her bow area, including the bulbous bow and the forecastle's bulwark (Figure 14). The forepeak tank was also affected with distorted stiffeners and a crack from frames 135 to 131, although there was no damage to the collision bulkhead. *Statengracht* was also severely damaged as a result of the collision with a full penetration in way of her cargo hold no. 2, just above the waterline. Apart from the side shell plating, *Statengracht* also sustained damages to the stiffeners in way of the damaged cargo hold (Figure 15).

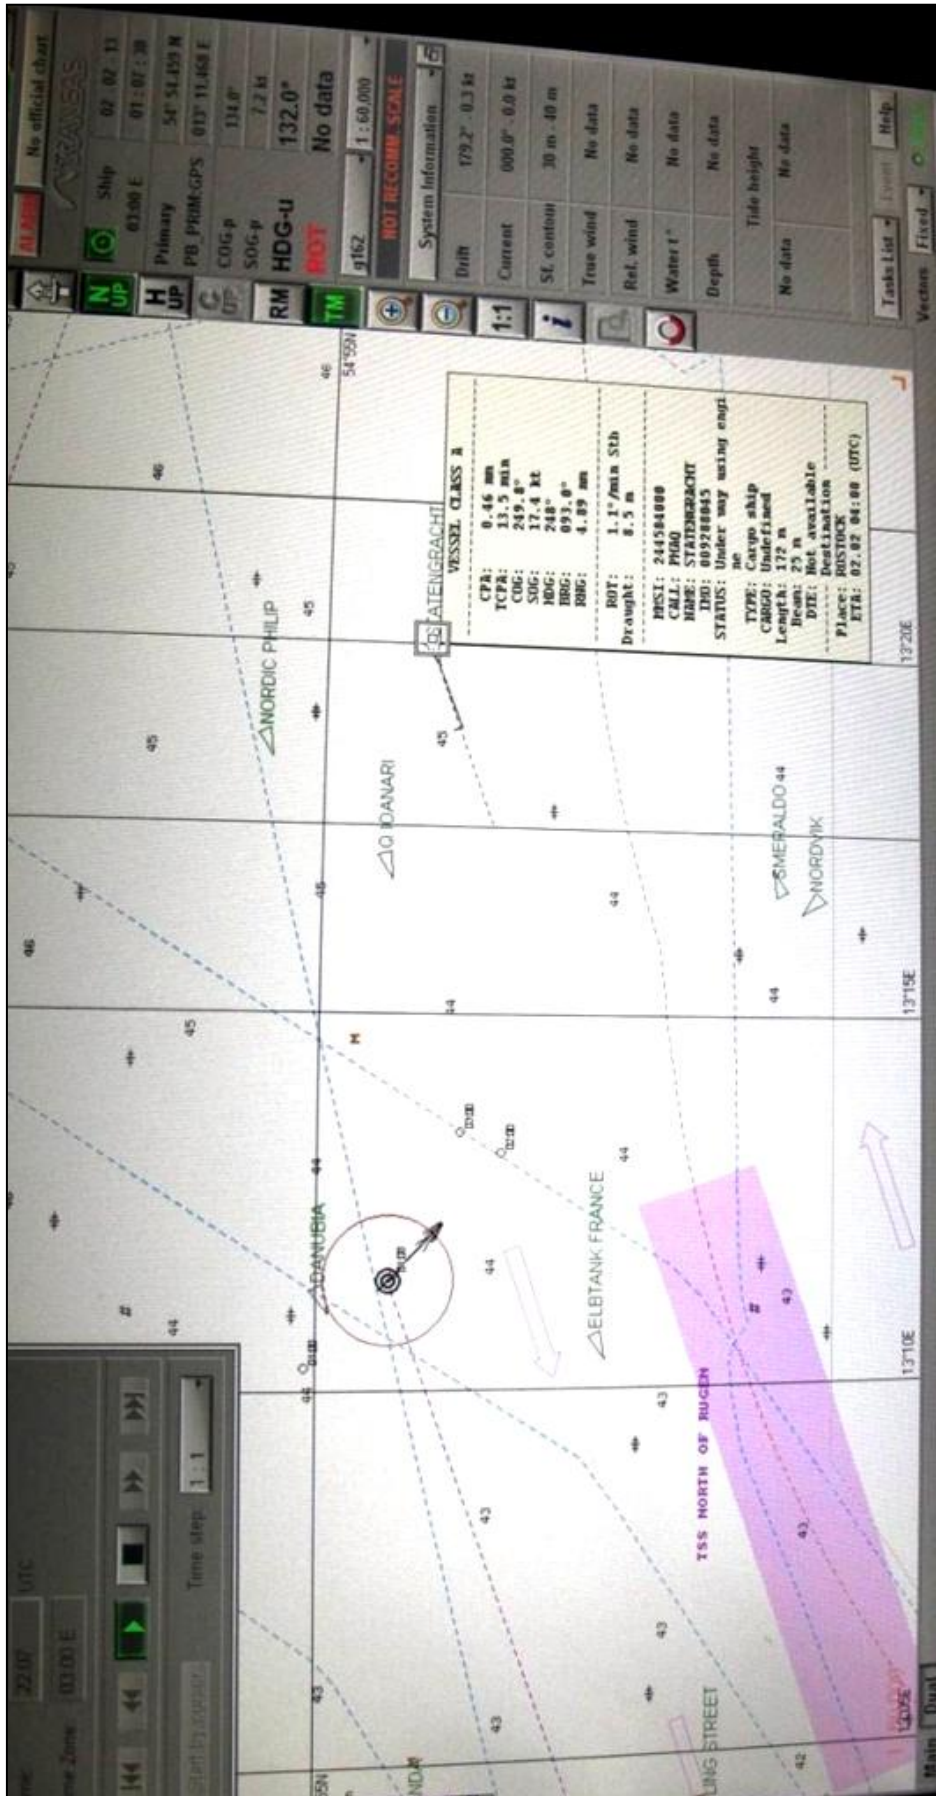
Figure 16: Screen shot at 2202 UTC (0002 ship's time)

Nordic Philip was not posing any danger as its path was to take her astern of *Katre*. However, *Q Ioanari* and *Statengracht* had to be watched carefully because of their course and CPA, even though both of these vessels were 'Give Way Vessels' (Figure 16).
