MARINE SAFETY INVESTIGATION REPORT

Safety investigation into the collision between the
Maltese registered bulk carrier

LIGARI

DL SUNFLOWER

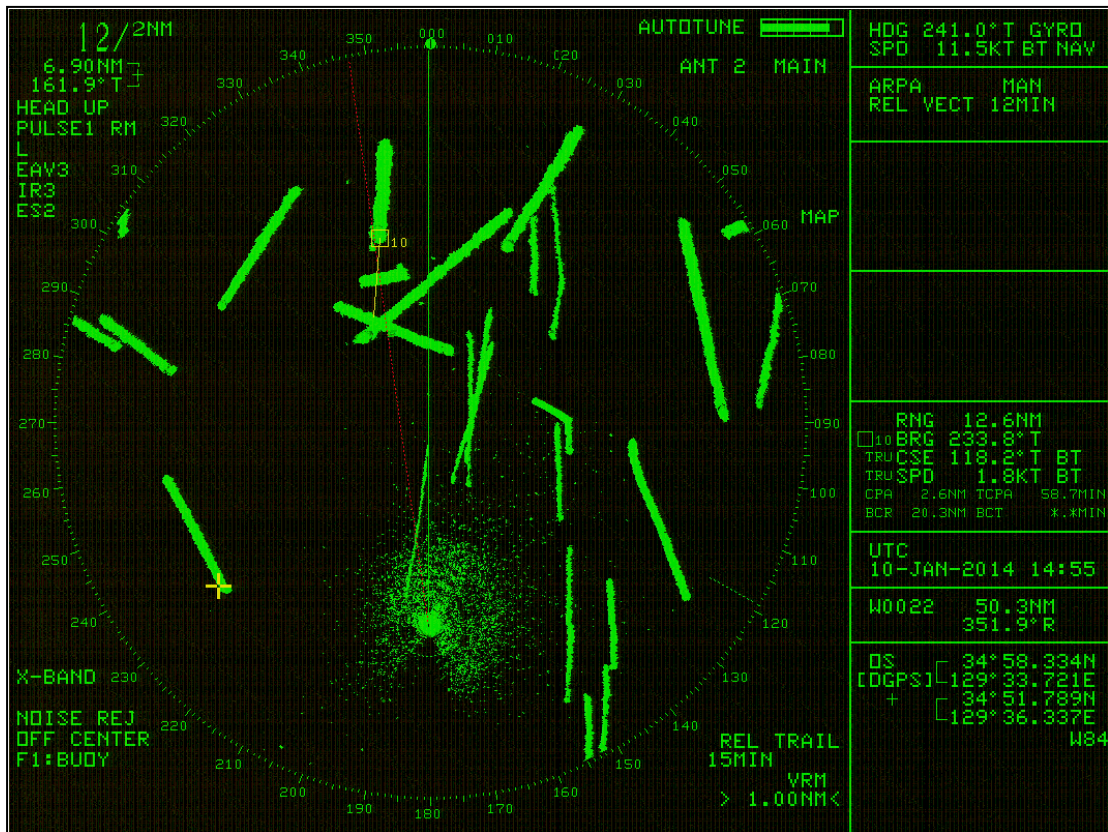
Figure 3: Screen shot at 2355 (LT) on 10 January

This encounter with heavy traffic (Figure 3) was also mentioned by the third mate during his navigational watch handover to the second mate at midnight on 11 January 2014.

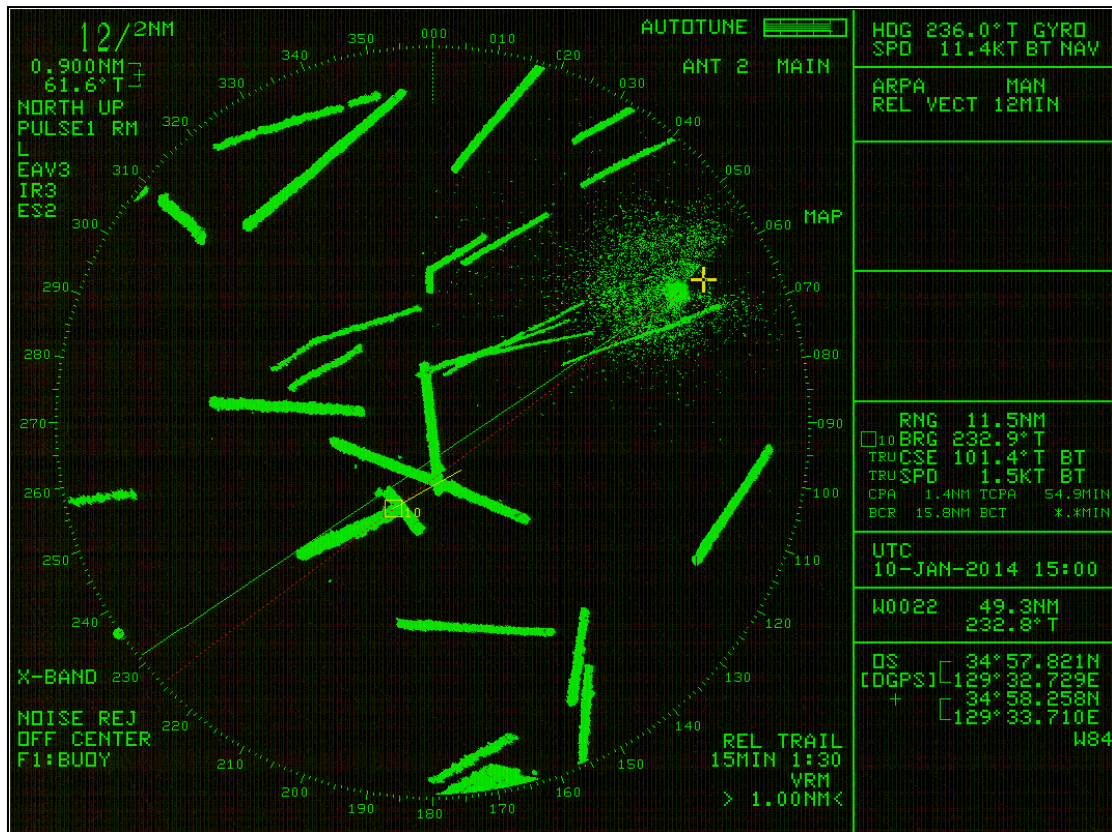
Figure 4: Radar screen shot at 0000 (LT) on 11 January

As soon as the Second mate took over the watch, at midnight on 11 January 2014, he adjusted the X-band ARPA³, which was located on the portside of the bridge, to operate on North Up, off-centre, in relative motion, and on the 12 nm range. The Relative Target Trails of 15 minutes were on and so was the True Target Vectors of 12 minutes. The VRM was on, at 1 nm (Figure 4). The S-band ARPA, which was located on the starboard side of the bridge, was also set to operate on North Up in relative motion but with a centre display and on the 6 nm range. The Relative Target Trails function was not activated on this radar set.

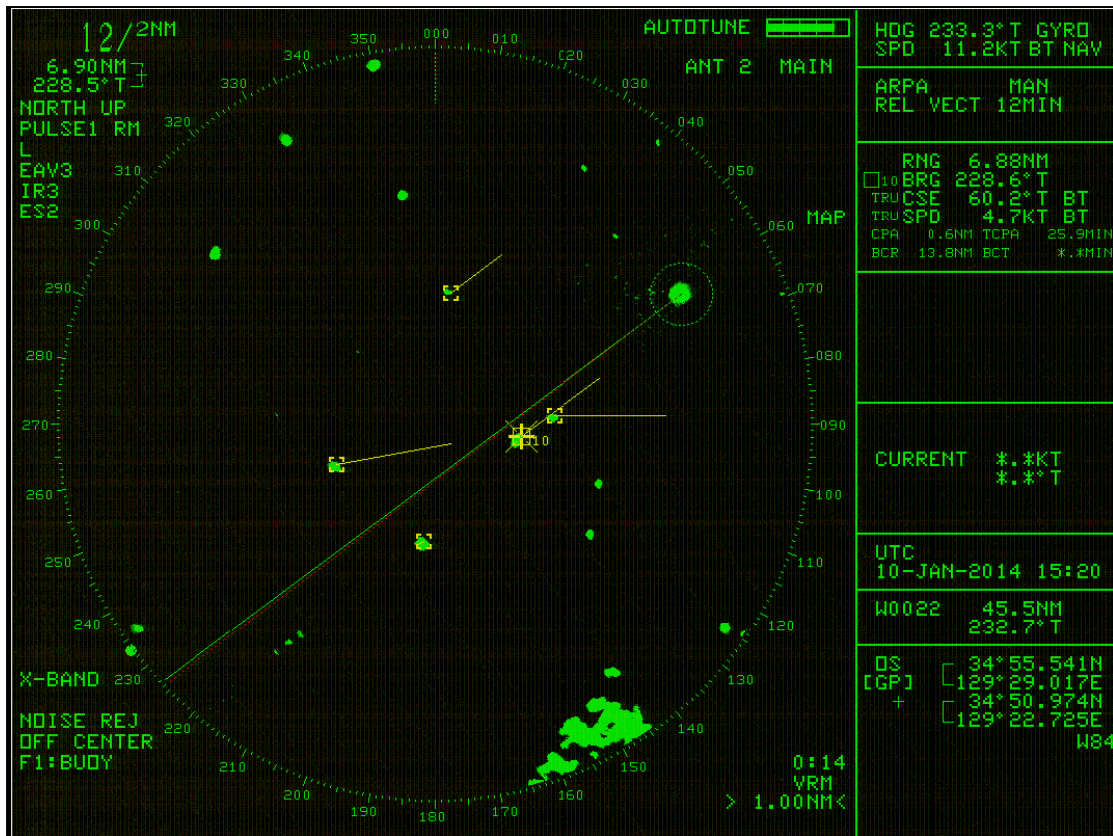
Figure 5: Screen shot at 0020 LT

Soon after taking over the watch, at about 0020 (1520 UTC on 10 January), the AB enquired with the OOW about the target trails on the X-band ARPA (Figure 5). After explaining to the AB what the target trails represented, the OOW gave the AB permission to occasionally use the X-band ARPA as part of his lookout duties. The OOW used the S-band ARPA.

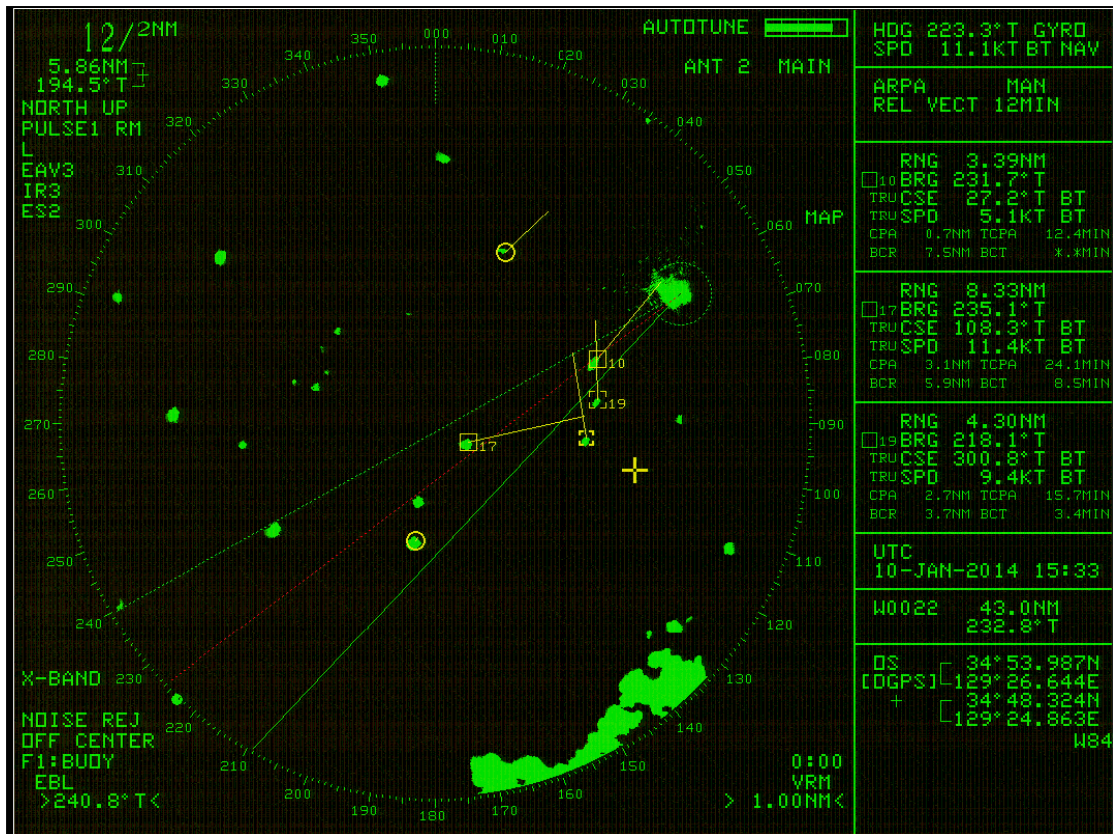
Figure 6: Screen shot at 0033 LT on 11 January

At the time, at least two other vessels were also on the port bow (Figure 6).

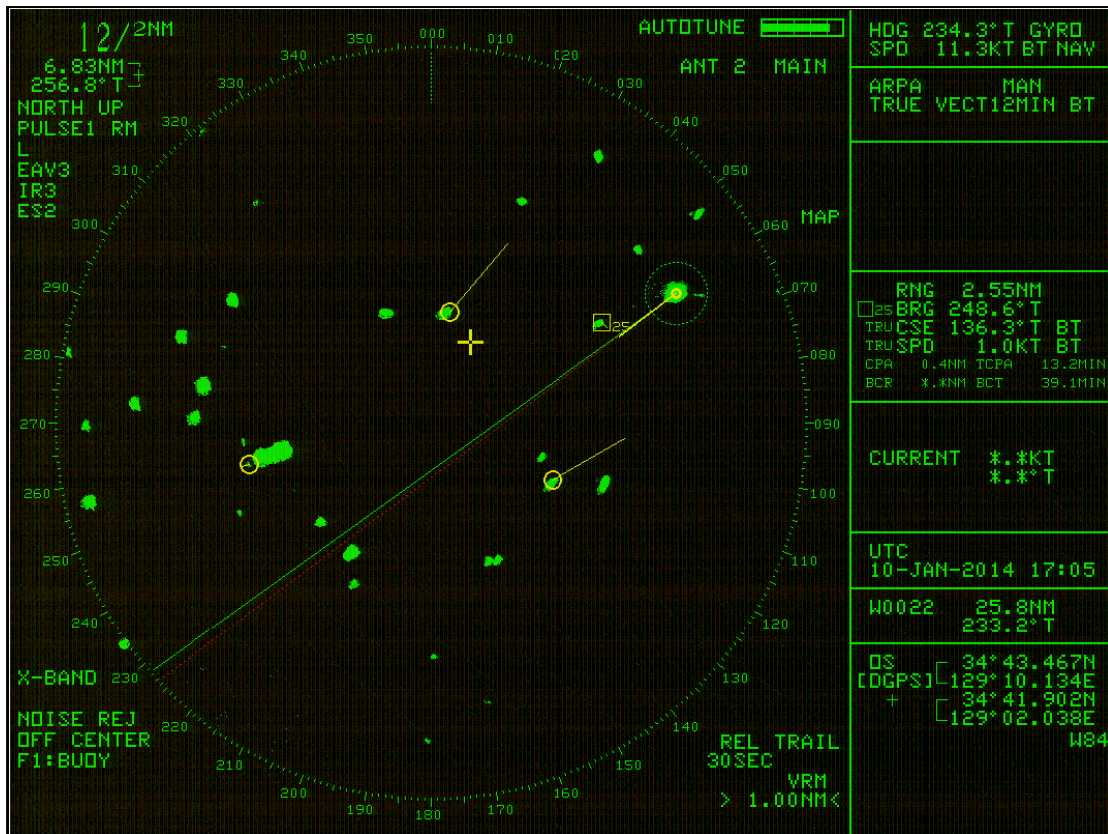
Figure 7: Screen shot at 0205 LT on 11 January

At 0205 (1705 UTC on 10 January), the look-out reported (for the first time) the visual sighting of *DL Sunflower* on the starboard beam. The OOW then verified the look-out’s report visually and on the S-band ARPA (Figure 7). He noticed that *DL Sunflower* was right on the starboard beam at a distance of about 2 nm and showing her port side light and its two masthead lights. However, at this time, the OOW recalled that *DL Sunflower*’s target was not acquired on the ARPA sets.

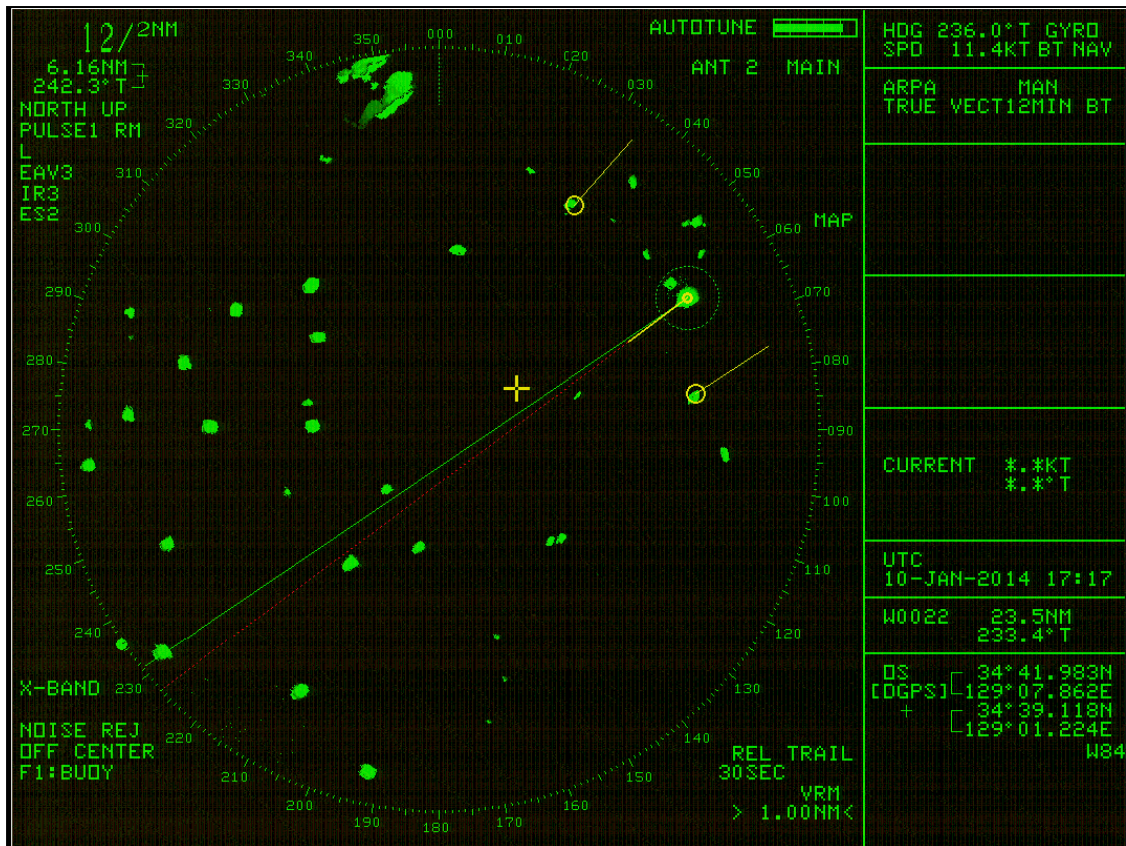
Figure 8: Screen shot at 0217 LT on 11 January

At about 0215 (1715 UTC on 10 January), *Cool Runner* passed down the starboard side (Figure 8) and once clear, the OOW on *Ligari* altered the vessel’s course back to 235°(T), using the autopilot course selector dial. At this time, the OOW acquired the target of *DL Sunflower* on the S-band ARPA.

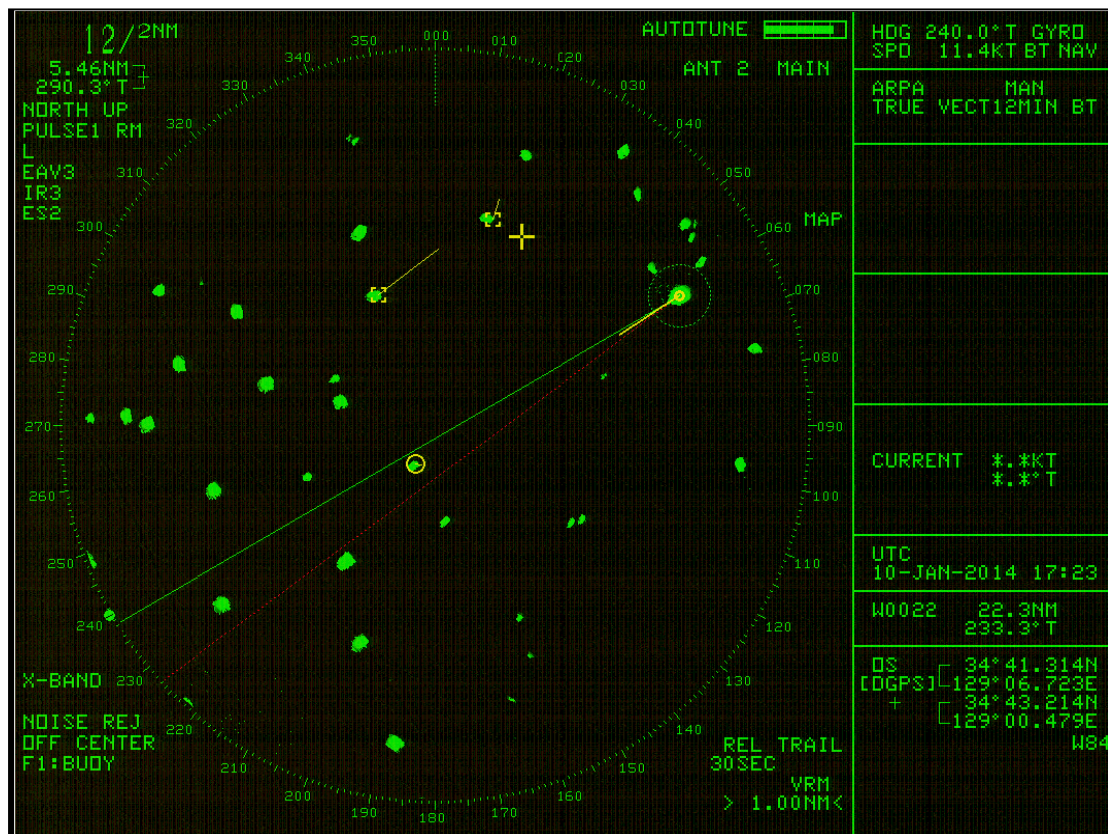
Figure 9: Screen shot at 0223 LT on 11 January

In the meantime, after finishing the 'Safety and Security Patrol', the AB returned to the bridge at about 0220. According to the OOW, after observing *DL Sunflower* commence altering her course to port, at 0222 (Figure 9), he altered *Ligari's* course by 5° to starboard to 240°(T), again using the autopilot course selector dial.

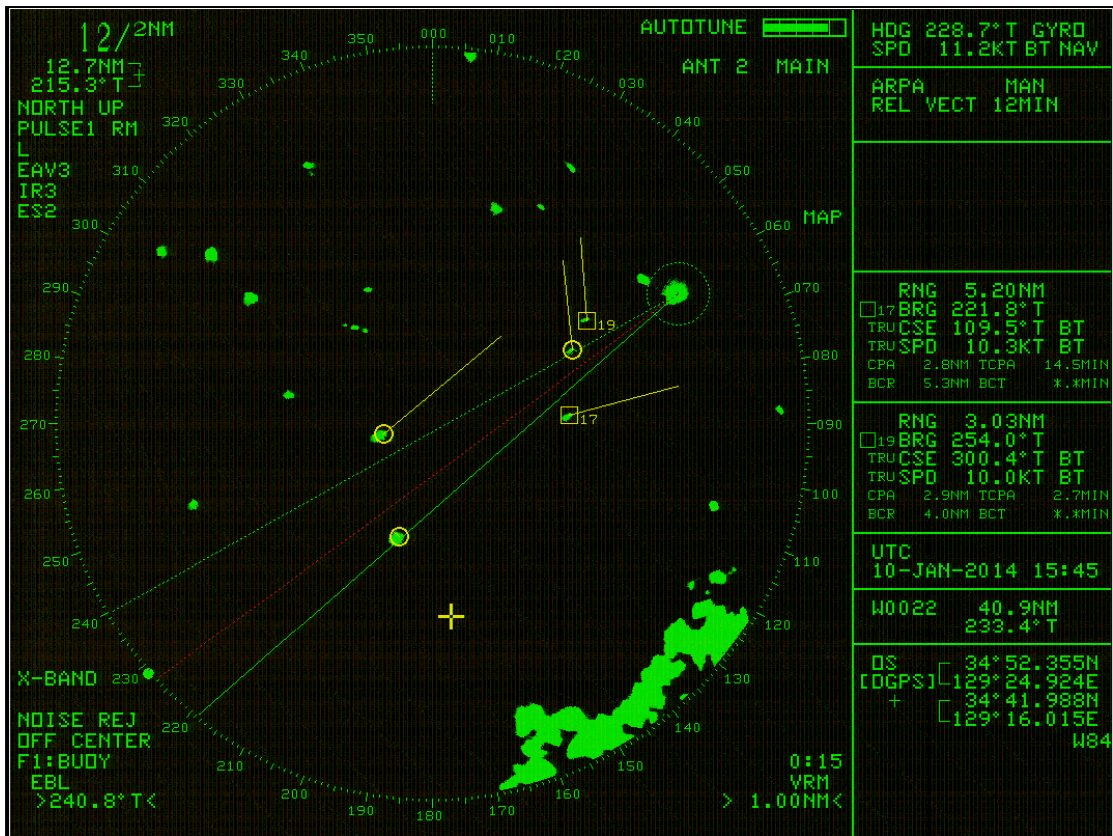
Figure 10: Screen shot at 0045 LT on 11 January

The X-band ARPA was set on 'off-centre'. Although the set-up increased the scanning range ahead from 12 nm to about 18 nm, it had the disadvantage of reducing the scanning range on the ship's beam and astern. Hence, *DL Sunflower*, which was crossing from the starboard side on the starboard beam of *Ligari*, only appeared on the X-band radar screen at around 0045 (Figure 10), when she was at a range of about 7 nm.

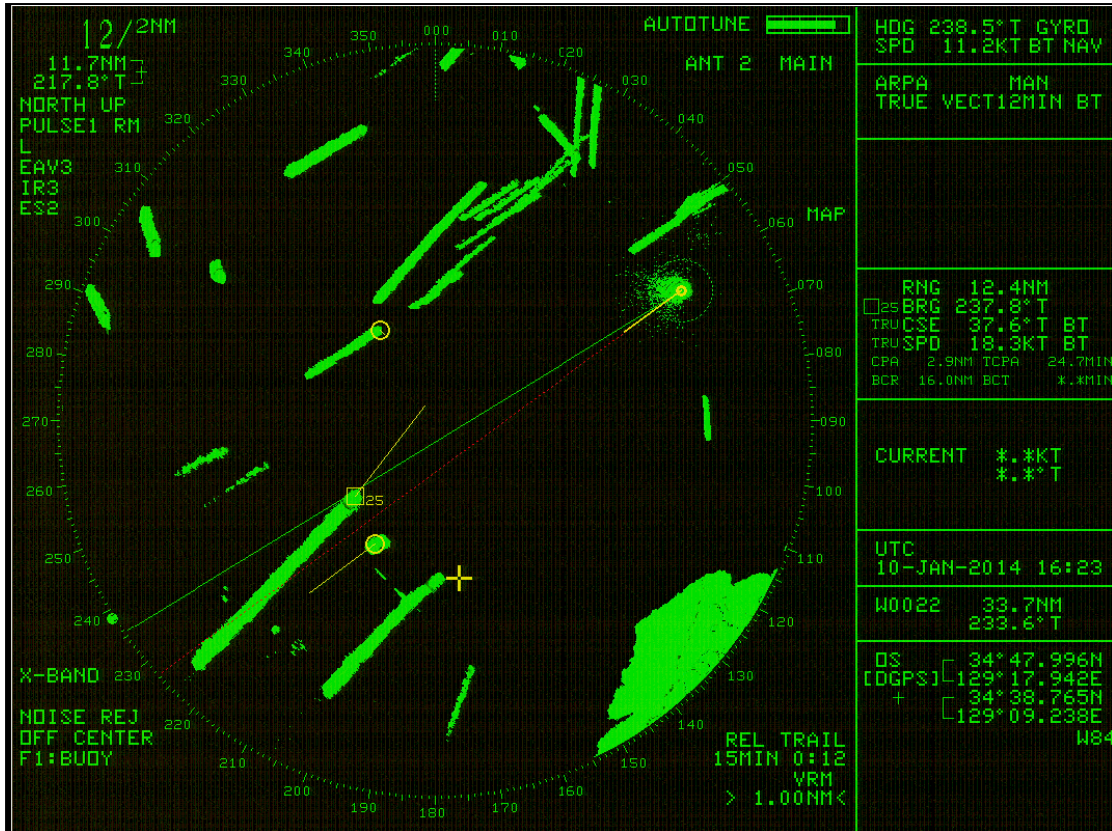
Figure 11: Screen shot at 0123 on 11 January

Still, since the X-band ARPA ‘Relative Target Trail’ function was off for most of the time, the echo of *DL Sunflower* did not attract the attention of the inexperienced eye of the look-out, who was using this ARPA at the time. For instance, at 0123 (LT) and at 0129 (LT) (Figures 11 and 12), when the Relative Trails function of 15 minutes was switched on for a few seconds by the AB, the relative track of *DL Sunflower* was very clearly pointing to the centre, but it still went unnoticed / picked up by the look-out.

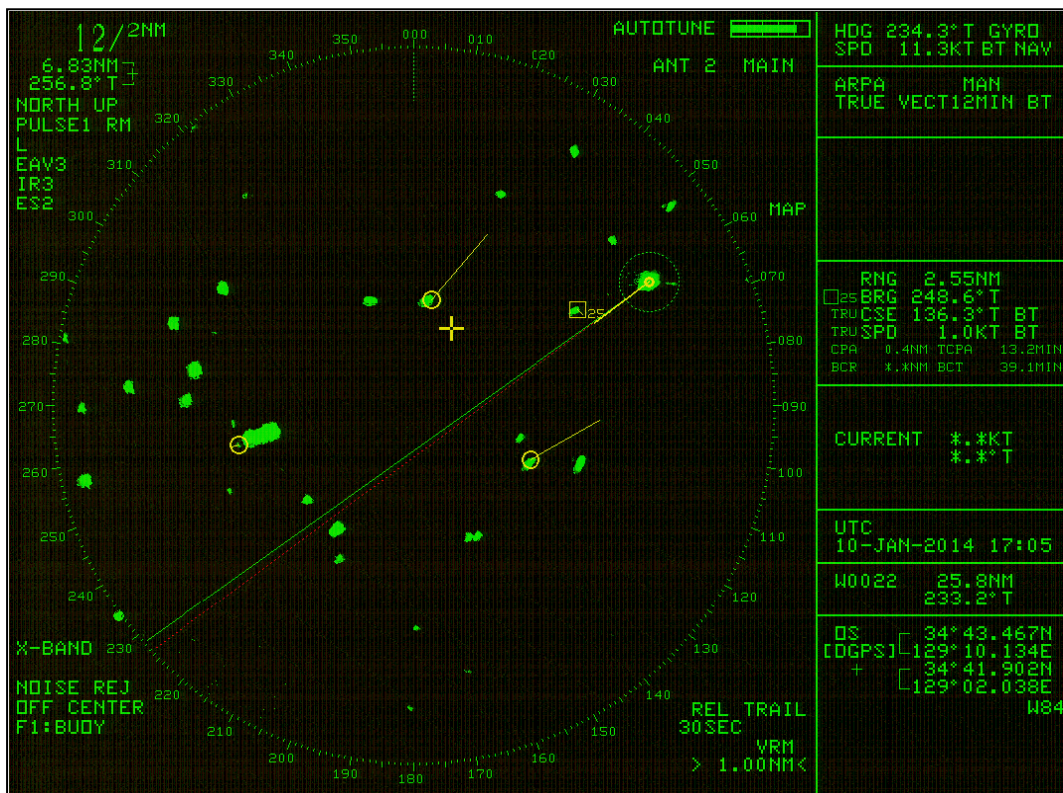
Figure 13: Screen shot at 0205 LT

However, *DL Sunflower* remained unnoticed for over an hour, until it was just 2 nm off the starboard beam when it was first reported by the look-out at around 0200 (Figure 13). This late reporting of *DL Sunflower* can only be attributed to inaccurate situation awareness by both the OOW and the look-out on board *Ligari*.
