## MARINE SAFETY INVESTIGATION REPORT

Safety investigation into the collision  
between the VLCC

***SEEB***

***KOTA TENAGA***

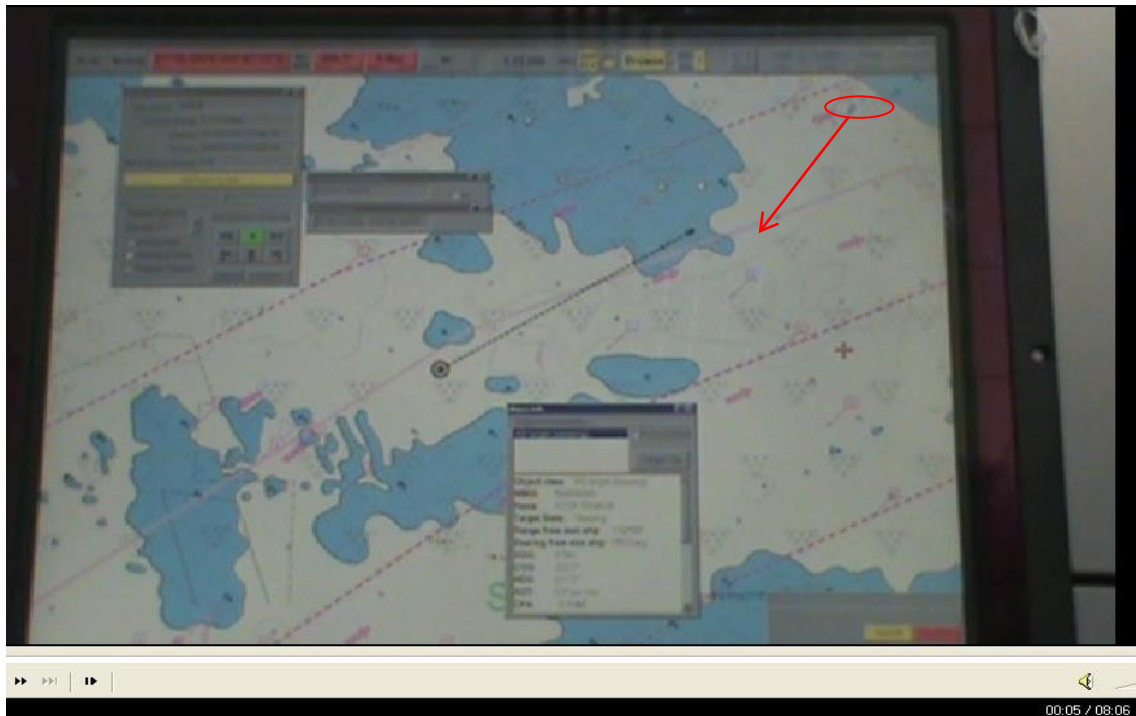
**Figure 3: ECDIS screen shot at 2057**

At 2053, *Seeb*'s main engine was again put on *Slow Ahead* and at 2057, she commenced altering course<sup>5</sup> (Figure 3).

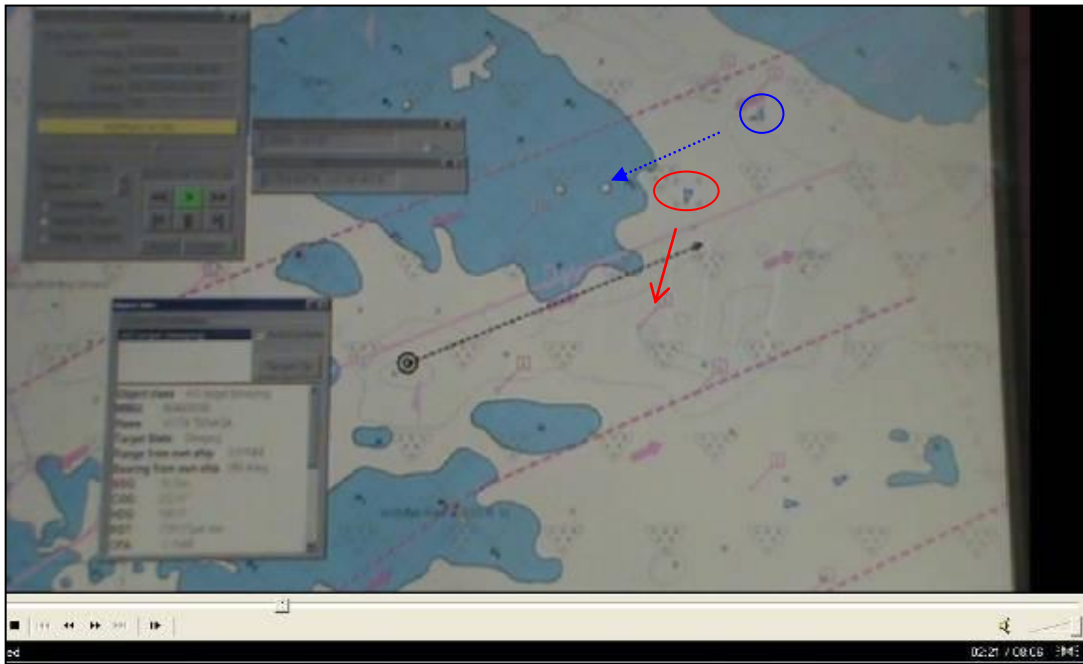
The master assessed the movement of the target vessel visually. Observations were not made on Radar or AIS. ECDIS display showed the target vessel (marked in red circle in Figure 4) one point on the port bow at a distance of 0.8 nm, heading 203°(T) and attempting to cross *Seeb*'s bow from port to starboard.

Figure 4: *Kota Tenaga* about to cross *Seeb*'s bow from port to starboard

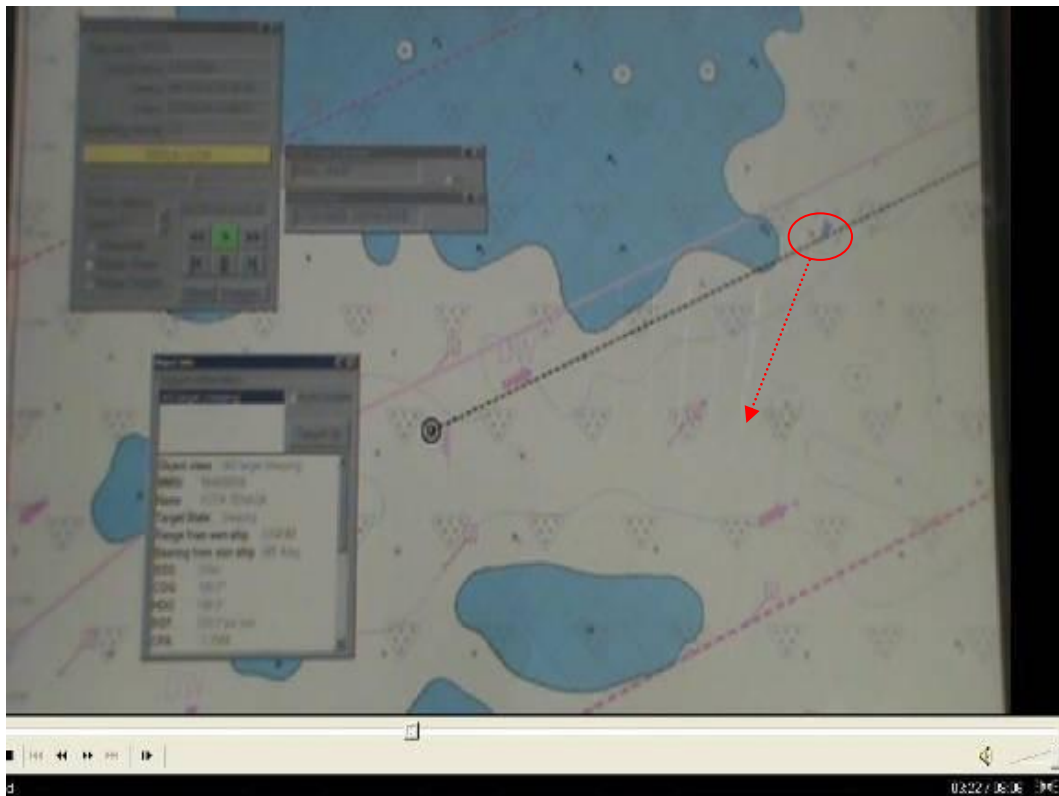
At 2100, *Seeb* was still on a course of 070°(T) at 7.6 knots. The target vessel (marked in red circle in Figure 5) was right ahead at a distance of 0.5 nm, on a course of about 203°(T) and crossing *Seeb*'s bow from port to starboard.

Figure 5: *Kota Tenaga* right ahead of *Seeb* at a distance of 0.5 nm (course 203°) and crossing *Seeb*'s bow from port to starboard

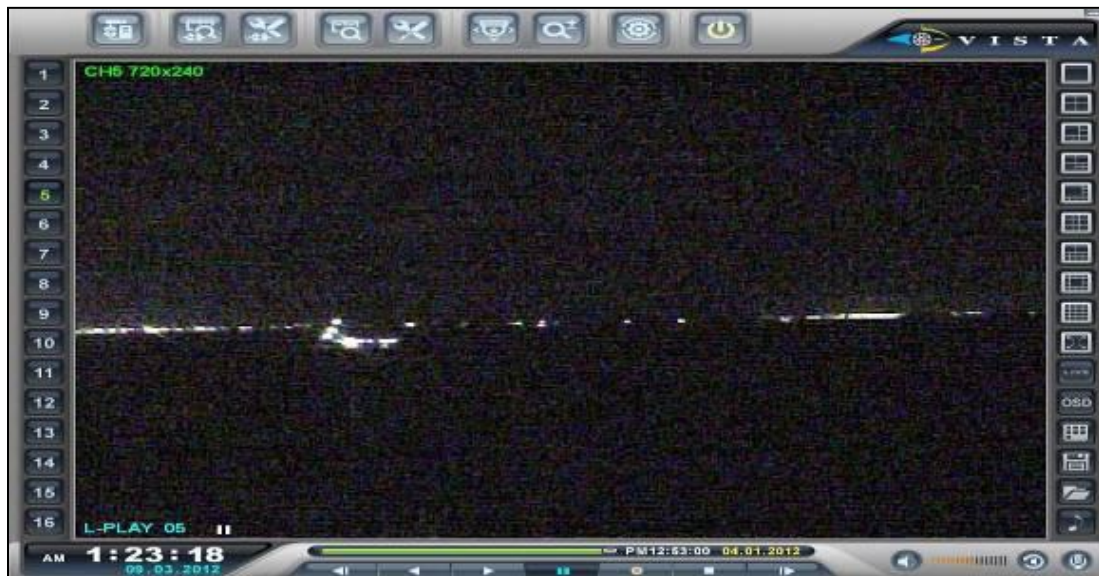
Eventually, the target vessel entered the east-bound lane (Figure 6). Upon coming out from the chartroom, the master of *Kota Tenaga* ordered a hard over helm to starboard. As *Kota Tenaga* started swinging to starboard (to the west), the master saw *Seeb* slowly displaying the starboard (green) sidelight *i.e.* appeared to be altering towards *Kota Tenaga*. The Master ordered the helmsmen to hold onto the hard starboard helm.

**Figure 6: The target vessel showed starboard side light and both mast head lights and was about to start turning to her starboard**

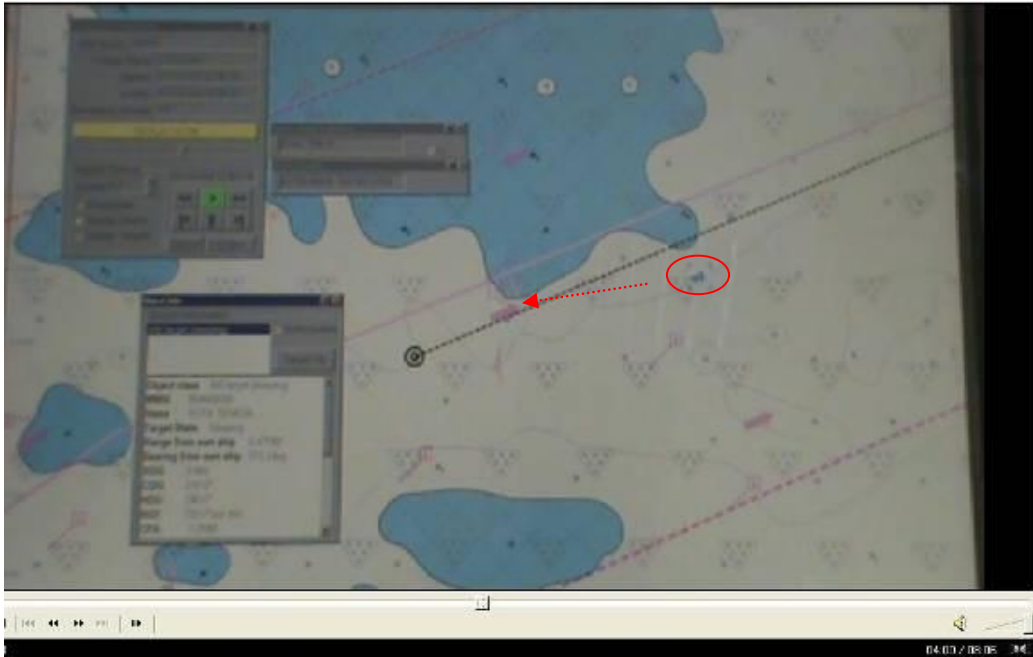
At 2101, the target vessel (marked in red circle in Figure 7) was one point on *Seeb*'s starboard bow at a distance of 3.5 cables, heading about 260°(T) with a speed of 5.2 knots. The target vessel was still not identified on AIS or by VHF communication and she remained in the east-bound lane, heading against the general direction of the traffic flow but swinging to her starboard. Seeing this, the master on *Seeb* ordered a hard to port helm and continued on '*Slow Ahead*'.

Figure 7: The target vessel now one point on *Seeb*'s starboard bow at a distance of 3.5 cables

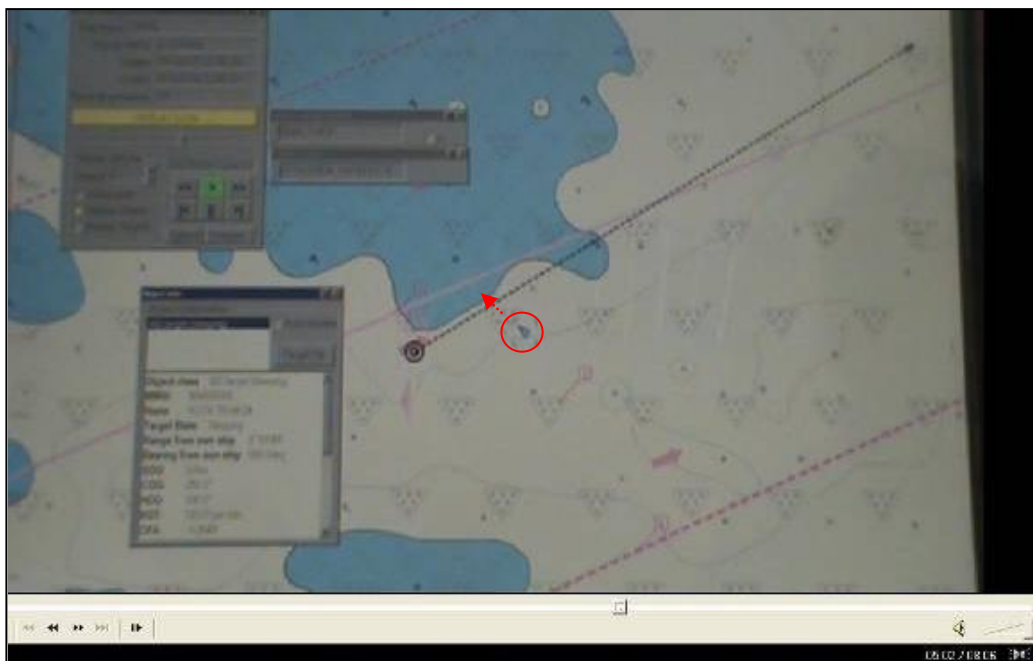
At 2102, *Seeb* was on a course of 055°(T) making 7.5 knots. At this time, the target vessel, which was identified from the AIS as *Kota Tenaga* (marked in red circle in Figures 8 and 9), was two points on *Seeb*'s starboard bow at a distance of 1.3 cables, heading almost north westerly. *Kota Tenaga* was still in the east-bound lane and continued swinging to her starboard in a likely attempt to pass ahead of *Seeb* and come back in the west-bound lane of the TSS.

Figure 8: *Kota Tenaga* at about 1.3 cables from *Seeb*

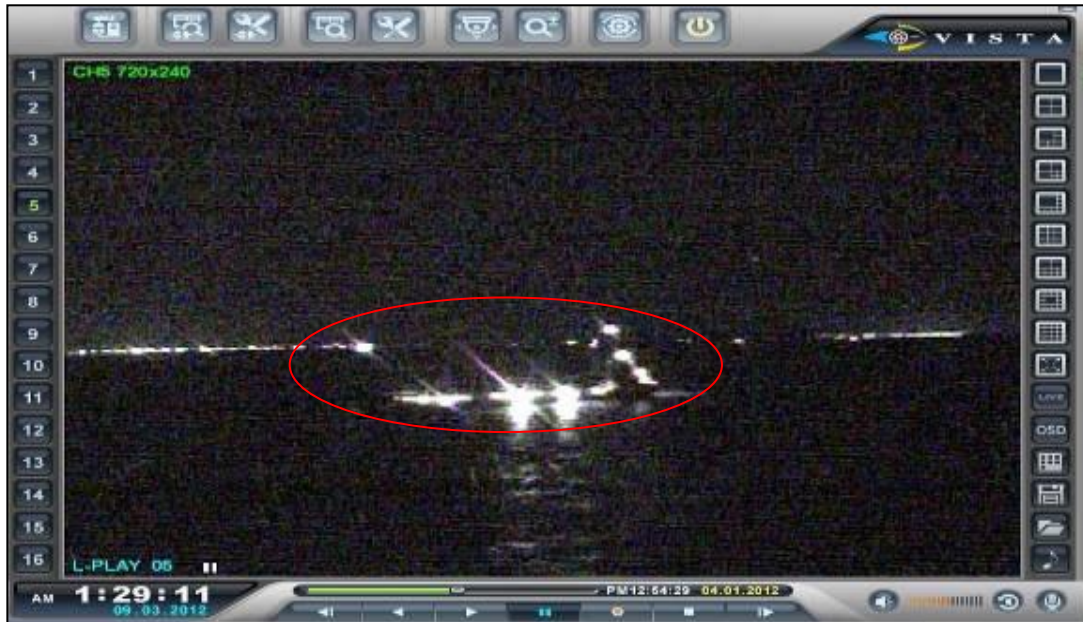
*Kota Tenaga* showed her port side light and both mast head lights and continued swinging to starboard and started crossing *Seeb*'s bow.

Figure 9: *Kota Tenaga* showing her port side light and both mast head lights

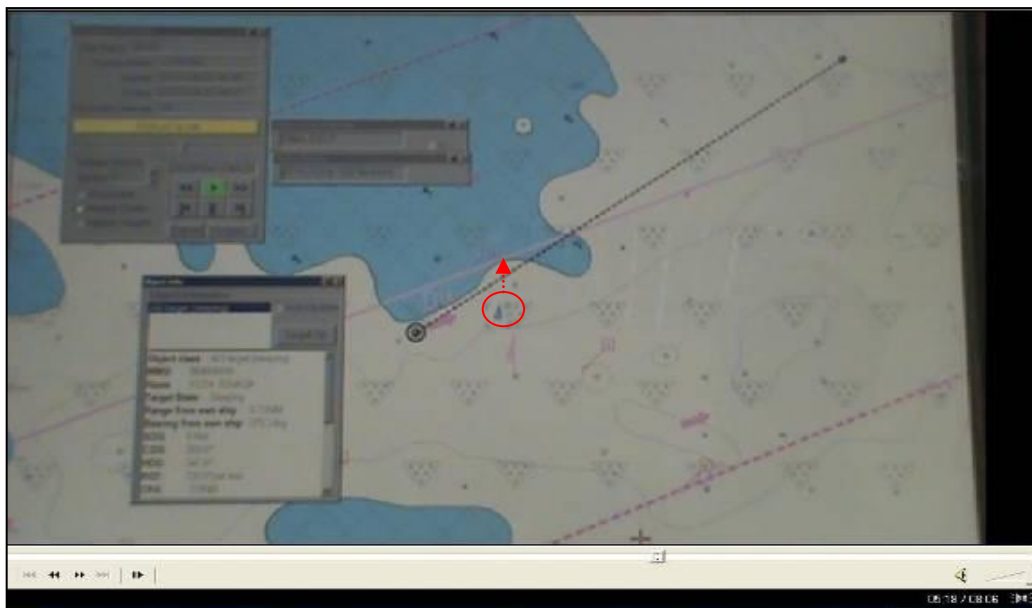
At 2102, *Seeb* was still altering course to port and was now on a course of 050°(T) doing 6.7 knots. The target vessel (marked in red circle in Figure 10) was fine on the starboard bow at a distance of 1.0 cable and was by now heading north in the east-bound lane.

Figure 10: *Kota Tenaga* about 1.0 cable from *Seeb*

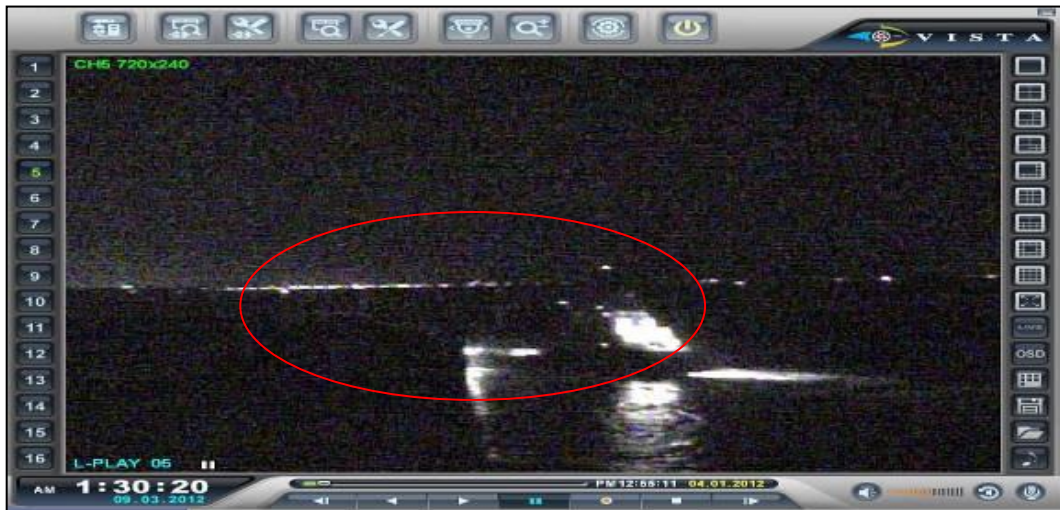
*Kota Tenaga* showed her port side light and both mast head lights (marked in red circle) and continued swinging to starboard. In Figure 11, *Kota Tenaga* is seen right ahead of *Seeb* at a distance of 1.0 cable and attempting to cross the latter's bow. The forward mast head light of *Kota Tenaga* is seen forward of *Seeb*'s stem.

Figure 11: Accommodation of *Kota Tenaga* is seen on starboard side of *Seeb* whilst attempting to cross *Seeb*'s bow

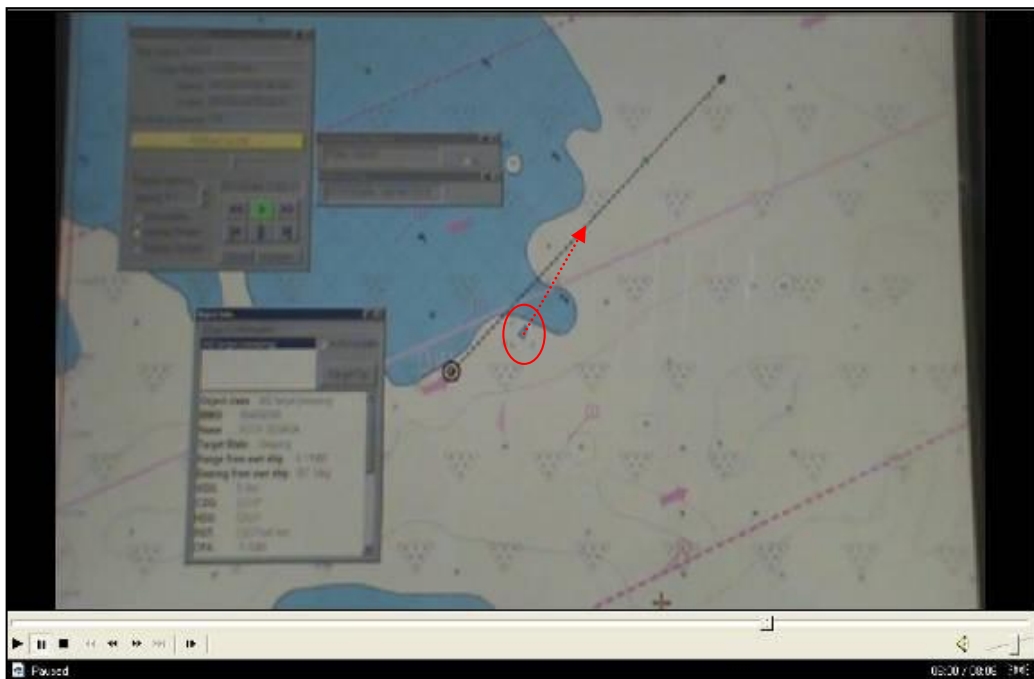
At 2103, *Seeb* continued altering her course to port and was on a course 040°(T) at 5.2 knots. *Kota Tenaga* (marked in red circle in Figure 12) was one and half points on starboard bow at close distance, heading 033°(T) and still attempting to cross *Seeb*'s bow.

Figure 12: *Kota Tenaga* now at a very close distance to *Seeb*

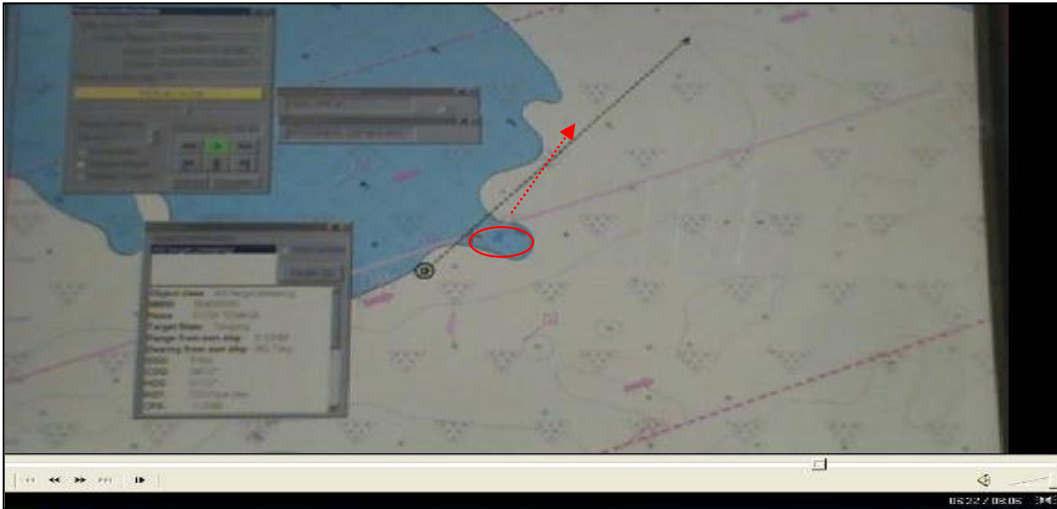
At 2103, *Seeb* was on a course of 038°(T) and doing 5.0 knots. Engine speed was increased to *Half Ahead* a few seconds later. *Kota Tenaga* (marked in red circle in Figure 13) was now on a course of 030°(T), at a very close distance, and still attempting to cross *Seeb*'s bow.

Figure 13: *Kota Tenaga* on a course of 030°(T) and still crossing *Seeb*'s bow

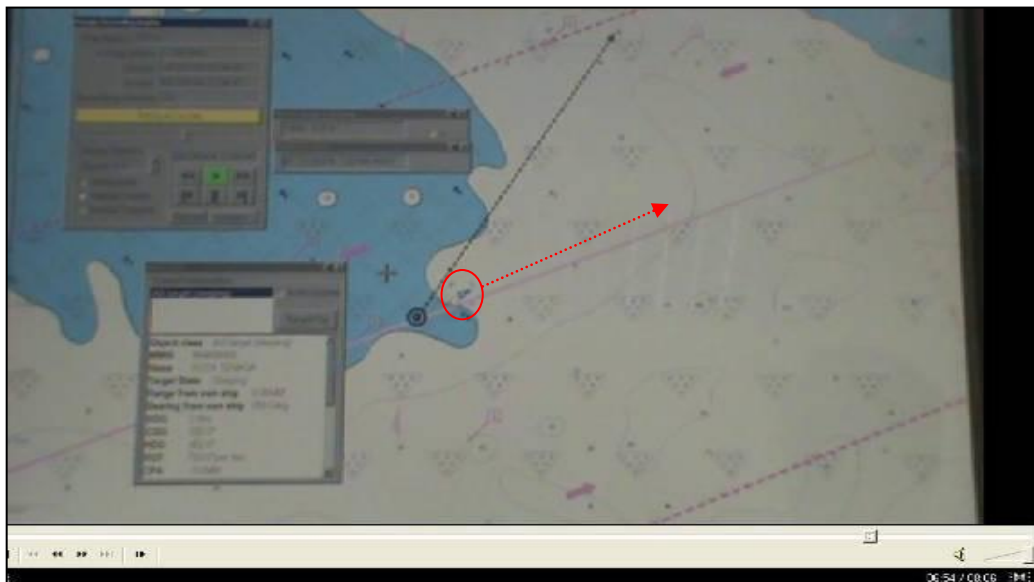
At 2103, *Seeb* further altered to port, eventually coming to a course of 035°(T) at 5.0 knots. *Kota Tenaga* (marked in red circle in Figure 14) was on a course of 030°(T). While attempting to cross bow of *Seeb*, her port shoulder made contact with the stem of *Seeb* in position 01° 10.4'N 103° 48.4'E (Figure 15).

Figure 14: *Kota Tenaga* just before the collision

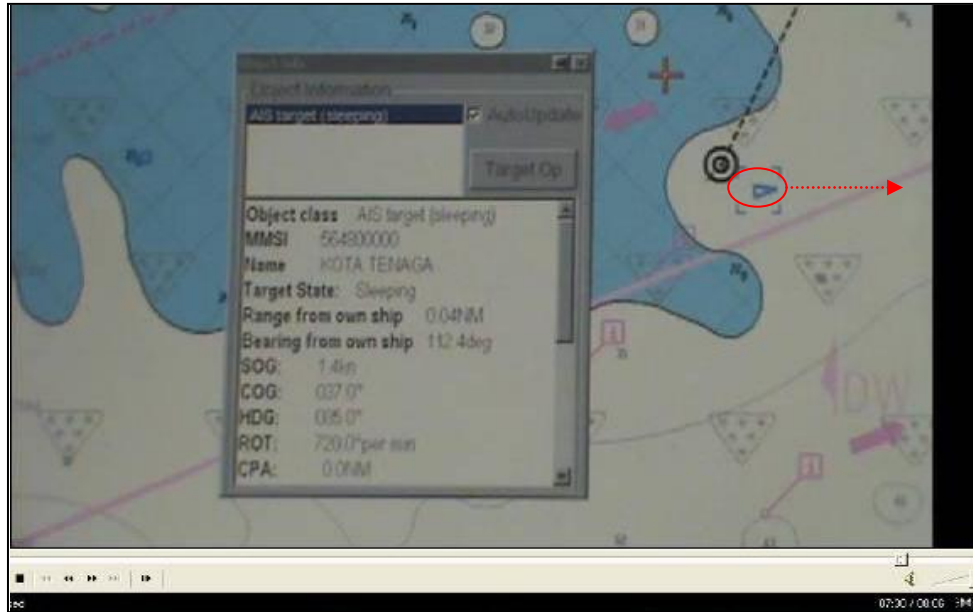
Figure 15: The port shoulder of *Kota Tenaga* collided with stem of *Seeb*. The bow of *Kota Tenaga*, after the collision, swung to starboard and away from *Seeb*

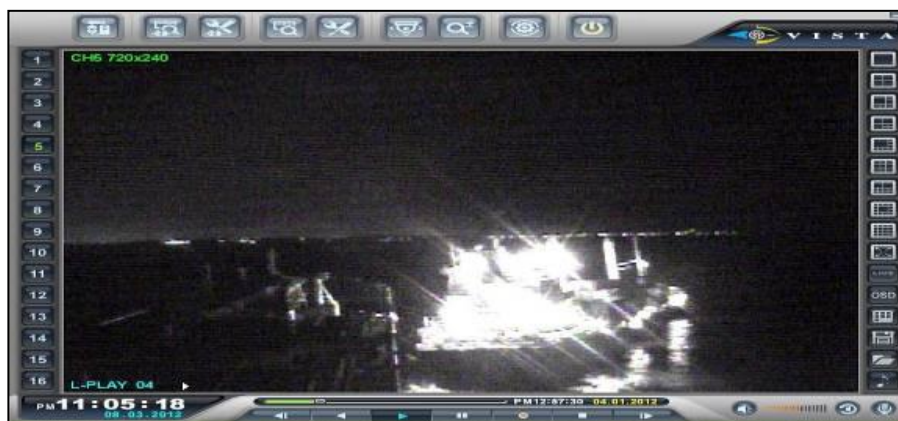
At 2104, *Seeb* was on a course of 022°(T) doing 5.2 knots. *Kota Tenaga* (Figure 16) further swung to starboard to a heading 085°(T) and away from *Seeb*, two points abaft her beam. *Seeb* now altered course to starboard so as to return on the charted course of 070°(T) and in the appropriate east-bound traffic lane. The dynamics of the collision are represented in Figure 17.

Figure 16: The situation for both vessels soon after the collision.

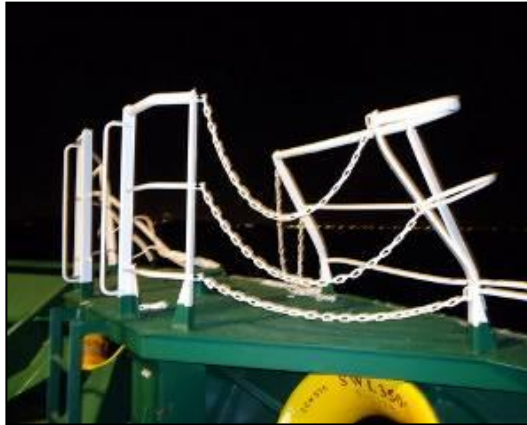
**Figure 18: Forecastle deck railing**

All tanks on *Seeb* were sounded to assess damages or flooding of any of the compartments. There was no reported water ingress in any of the tanks (Figures 18 to 20). The vessel remained afloat with a positive GM. After obtaining the necessary

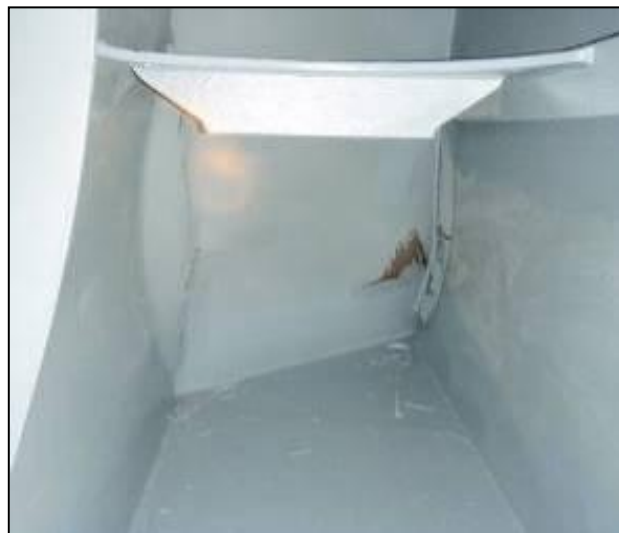
**Figure 20: Stiffeners buckled and side shell indented**

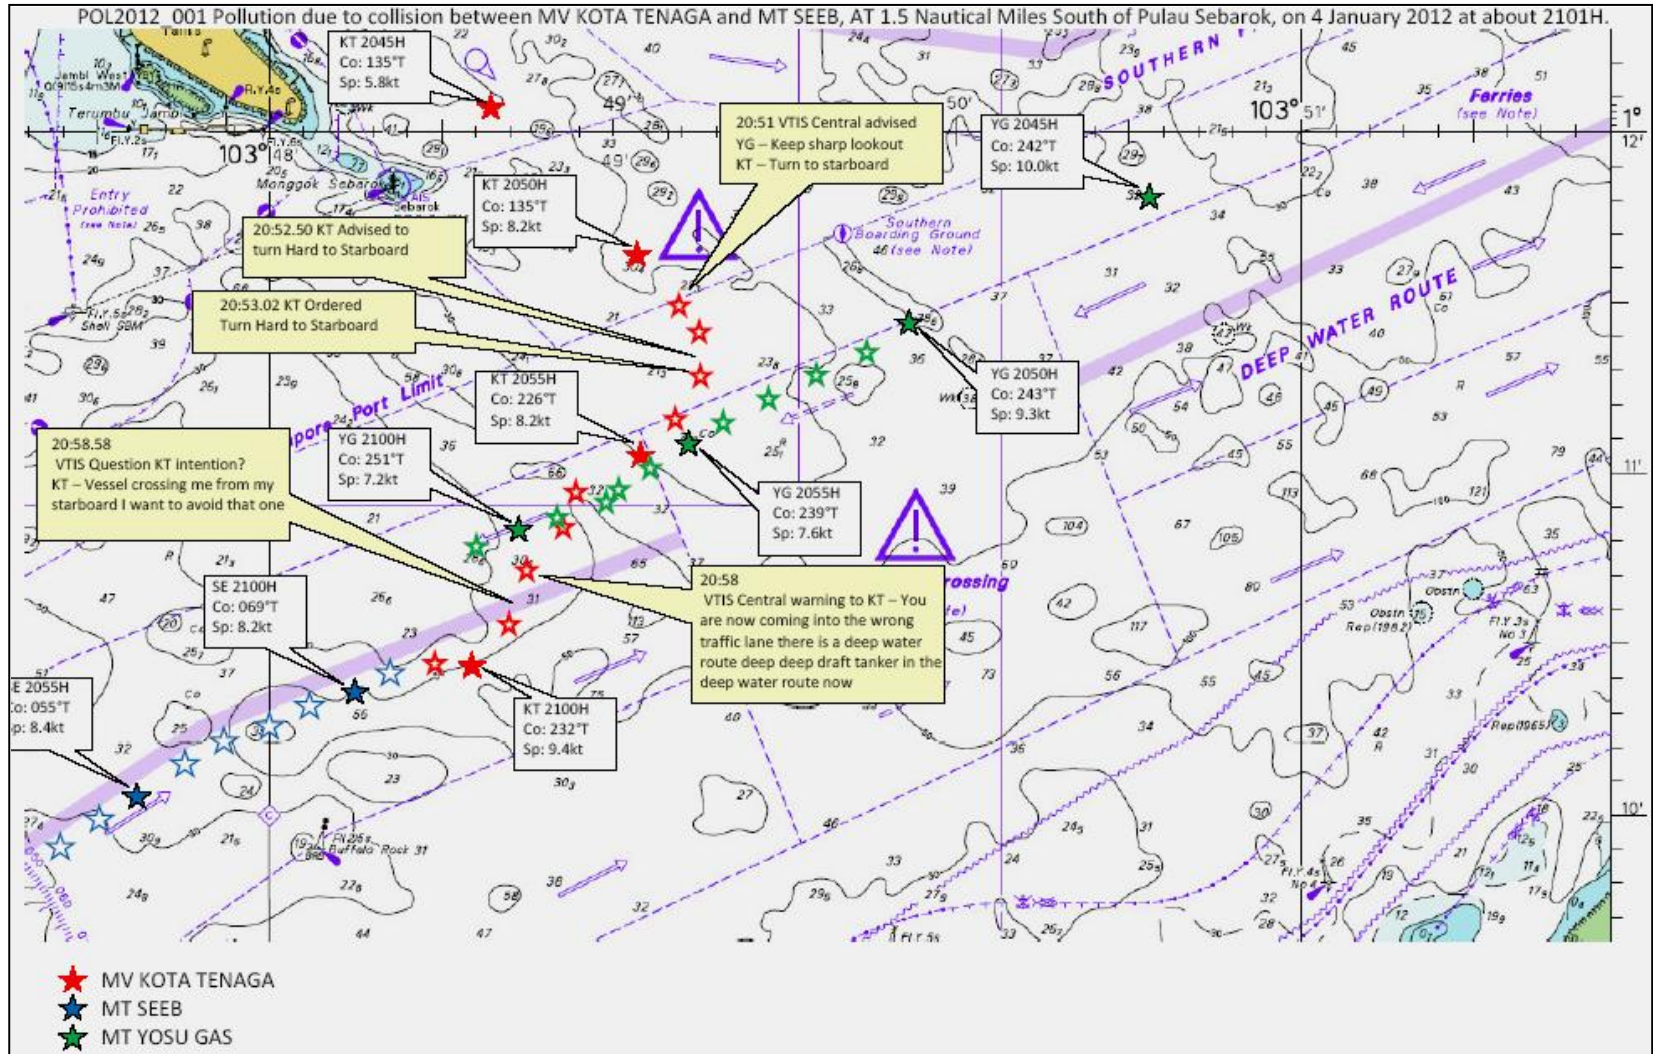
Figure 19: Manoeuvres, collision and subsequent pollution

The alteration of course to port, however, made *Seeb* enter the west bound-lane, and prolonged the suddenly developed close quarter situation. Since the close quarter situation developed at the very last moment, *Seeb* could not make effective collision avoidance actions in ample time, albeit in restricted waters.
