MARINE SAFETY INVESTIGATION REPORT

Safety investigation into the collision between the
Maltese registered vehicle carrier

TONGALA

BO SPRING

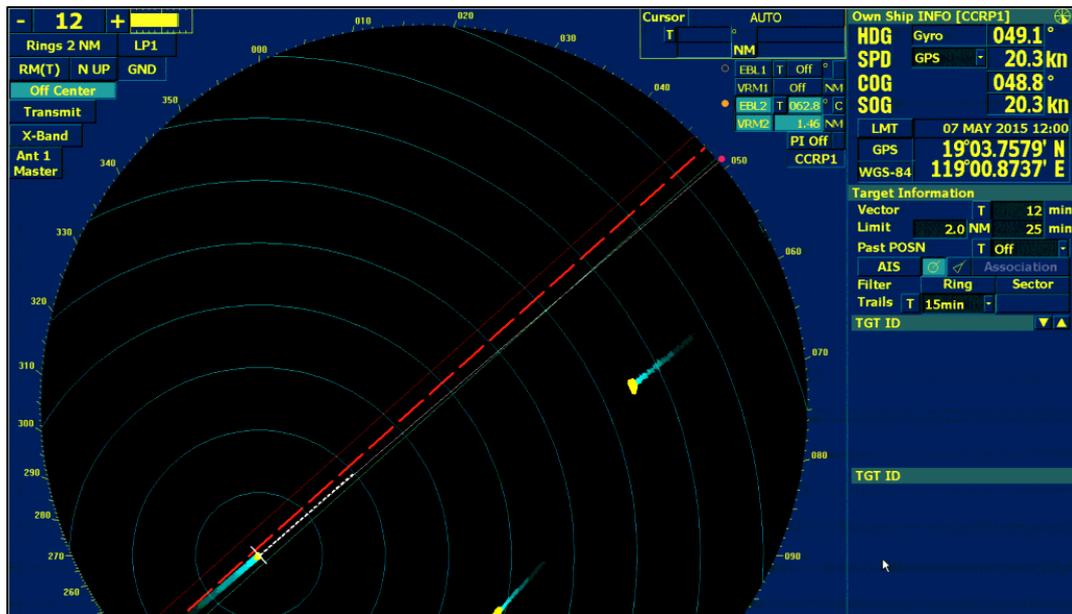
Figure 3: Radar screen shot at 1200 on 07 May 2015

According to the VDR data, a number of vessels were in the vicinity of, or passed close to *Tongala* from 1200 (Figures 3 and 4) to the time of collision at 1535.

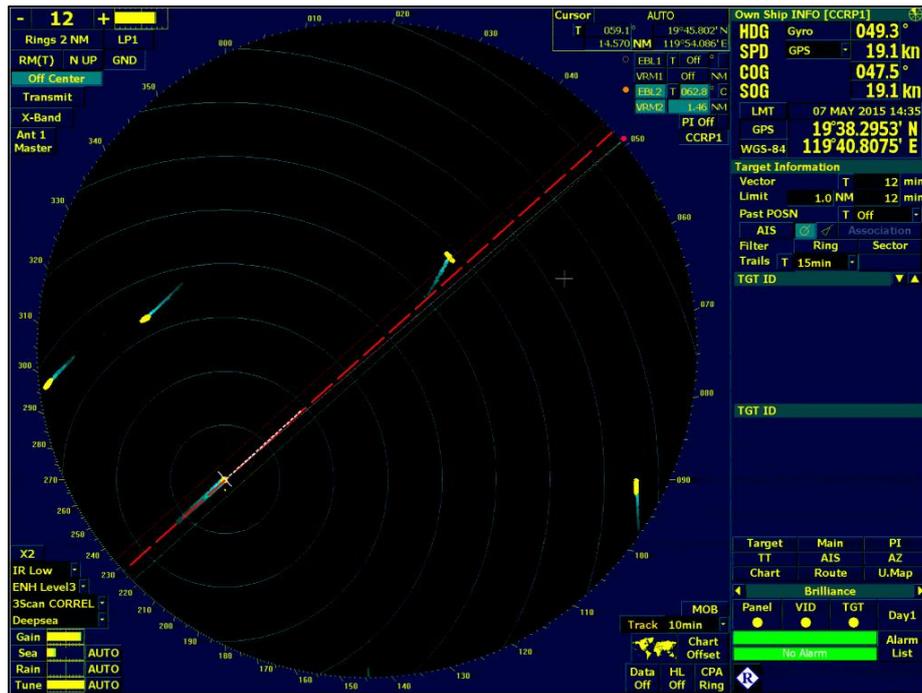
Figure 5: Screen shot at 1435

During the day of the casualty, the weather was fine with very good visibility (over 10 nm). With *Tongala* having an air draft of around 52 m and *Bo Spring* being a vessel of 7656 gt, the 'the combined distance to the horizon' was well over 10 nm. Hence, it was possible that at 1435, when *Bo Spring* was on *Tongala*'s radar for the first time at a distance of around 15 nm, *Bo Spring* was visible to the OOW on *Tongala* (Figure 5). This was about one hour before the collision happened.

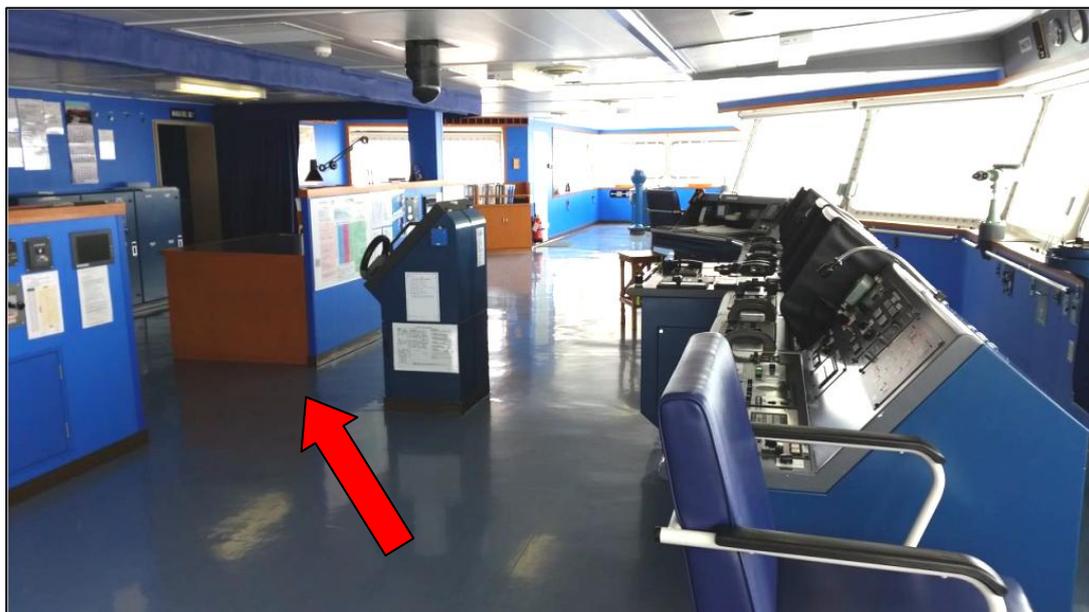
Figure 6: Tongala's chartroom

In the meantime, the OOW had spent long periods of time in the chartroom. Although the chartroom was not a separate room from the bridge, it was located at the after end of the bridge (Figure 6). Even with the night curtains drawn open, the sight from the area was not a clear one especially on the vessel's beams.

Furthermore, it seems that the chartroom's night curtain was normally drawn and stowed on the starboard side of the railing and hence it would have obstructed the view of the OOW on the starboard side. *Bo Spring* was approaching *Tongala* from the starboard side, about four points forward of the starboard beam and it is most likely that the OOW, from his position, would not have visually noticed the approaching vessel.

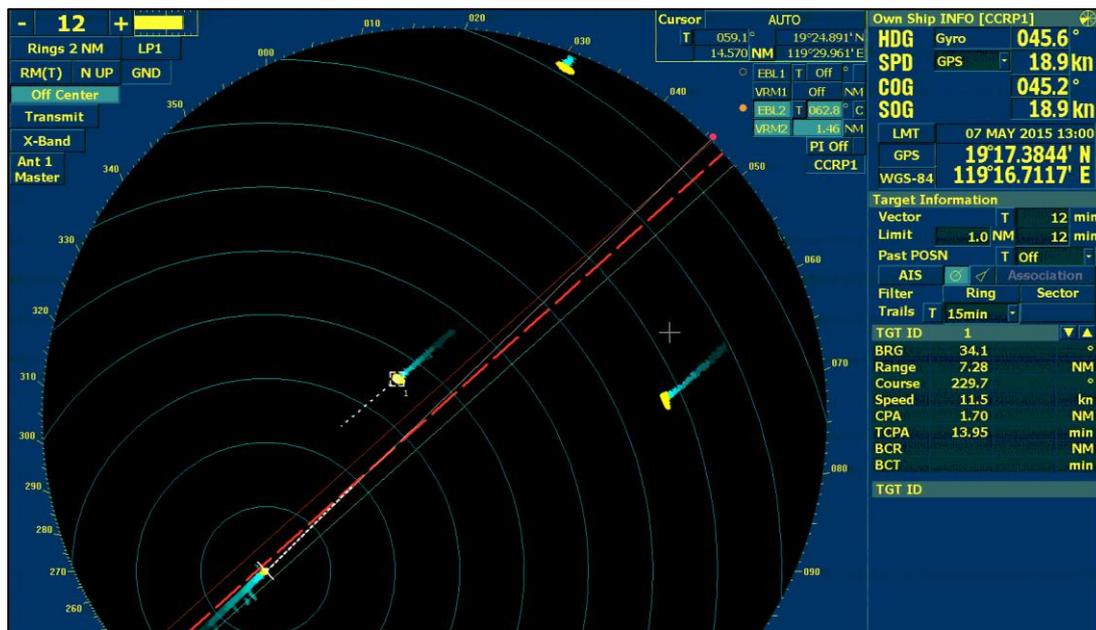
Figure 7: Screen shot at 1300

The VDR data suggested that as from 1314 onwards, the OOW was engaged in the chartroom, preparing for the vessel's next passage plan when at that time there was another vessel on *Tongala*'s port beam at a CPA of 1.5 nm (Figure 7).

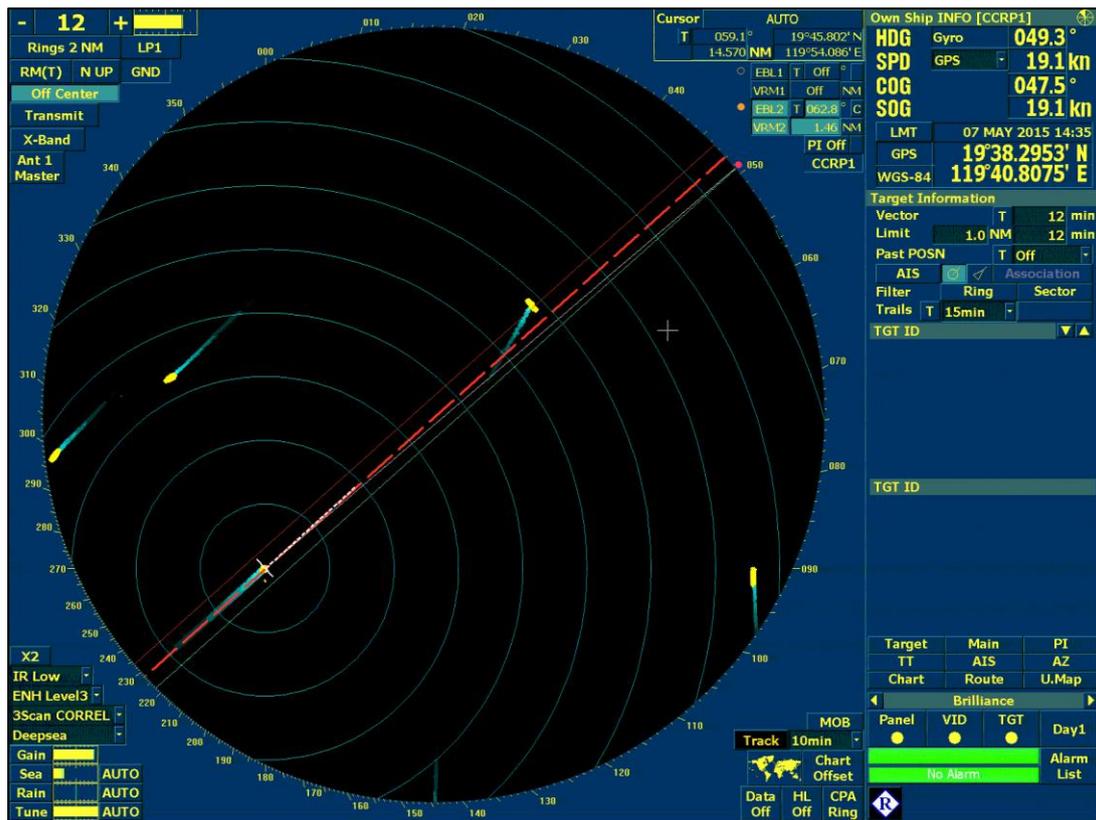
Figure 8: Screen shot at 1435

Given the multiple tasks which had to be carried out, the OOW decided to utilise the time of the navigational watch to work in the chartroom. This was a risky decision, considering that several other ships sailed past *Tongala* although none came relatively close to her. Analysis of the radar data revealed that one of these vessels was being overtaken by *Tongala* and was almost dead ahead at around 1435 (Figure 8). This was approximately the same time when *Bo Spring* first appeared on the radar screen at a distance of about 15 nm, bearing about four points on the starboard bow. At no time were any of these vessels/targets acquired by the OOW, at least not on the X-band radar, which was interphased to the vessel's VDR.

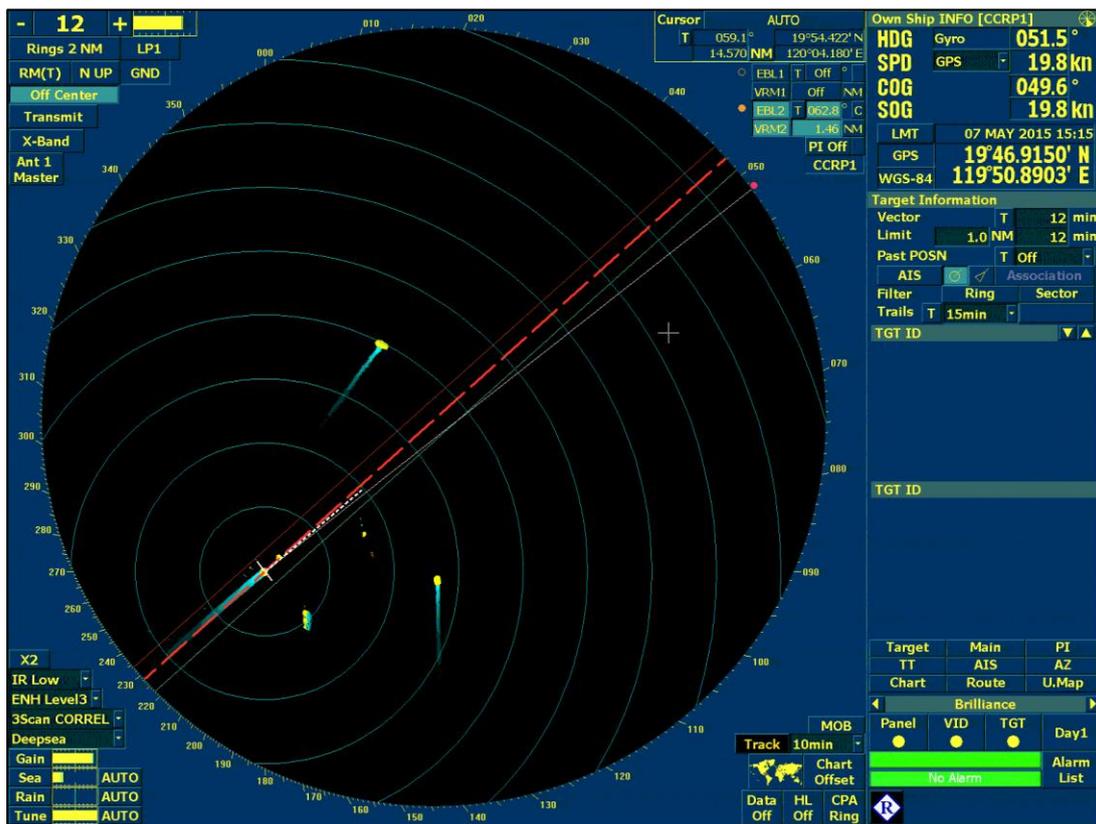
Figure 9: Screen shot at 1515

Further analysis indicated that although the vessel's course steered was claimed to be 048° (G), according to the VDR data, the vessel's heading was varying between 046° (G) and 052° (G). However, from 1500 onwards, the vessel's heading was a steady 052° (G) indicating that the OOW had adjusted the vessel's course to 051° (G)¹⁵ at that time (Figure 9).

Whether this alteration was done at 1500, when *Bo Spring* was eight nm off, or at 1515, when *Bo Spring* was five nm off, it is clear that the OOW was totally unaware of *Bo Spring*, which was approaching *Tongala* on a steady bearing from the starboard side. Moreover, this small alteration of course to starboard made the close-quarters situation with *Bo Spring* more dangerous.

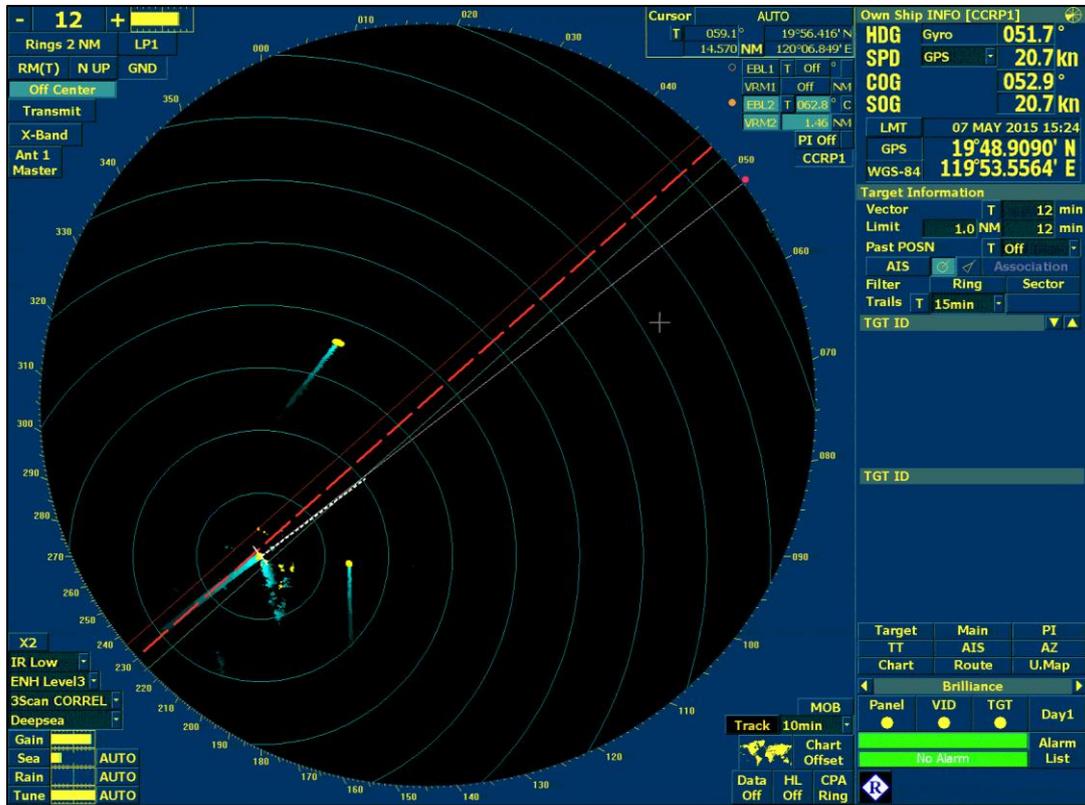
Figure 10: Screen shot at 1524

The issue of inaccurate situation awareness was, however, also evident when the situation was more critical. In fact, at 1524, while the OOW was still in the chartroom working on the next passage plan, *Bo Spring* was just four nm off with a CPA of 0.19 nm (Figure 10). As yet, no acquisition of the target was made.

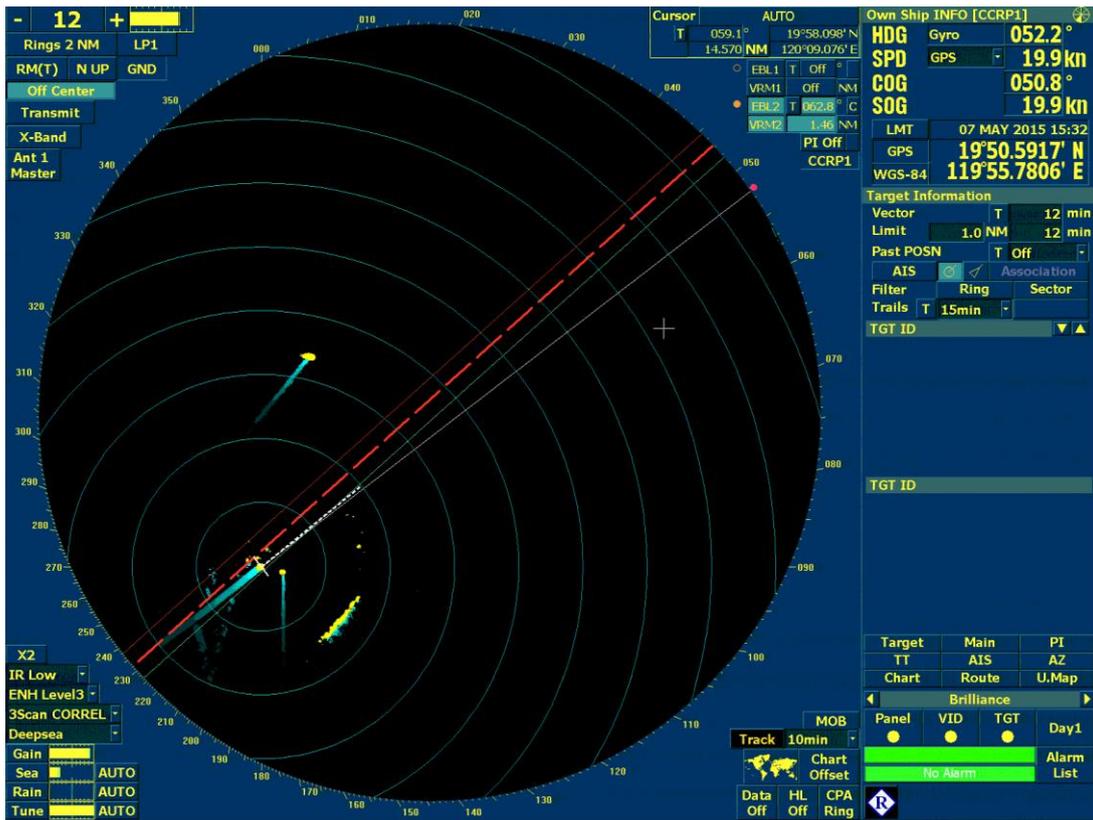
Figure 11: Screen shot at 1532

The matter was also analysed even by taking into consideration the fact that at 1532 (Figure 11), *i.e.*, one minute before the collision and when *Bo Spring* was less than one nm away (CPA was 0.09 nm), no alarms were heard on the bridge.

The absence of alarms was considered to have made the situation more complex. Without any alarms, the OOW in the chartroom had no immediate and perceivable knowledge of the effects on the ship (in terms of the risk of collision).
