Report on the investigation of the collision between

Skagern and Samskip Courier

in the Humber Estuary

Report No 6/2007
April 2007

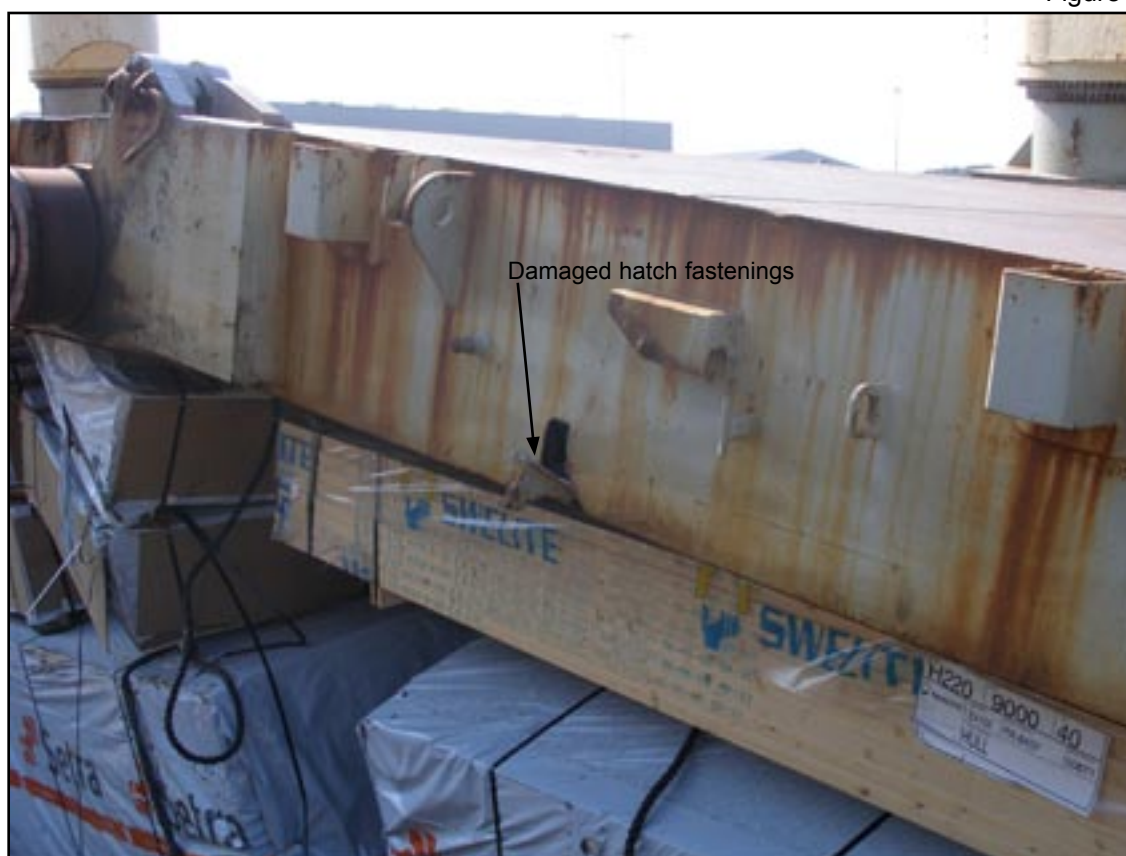
Figure 8

Skagern's hatches forced up by pressure of floating cargo

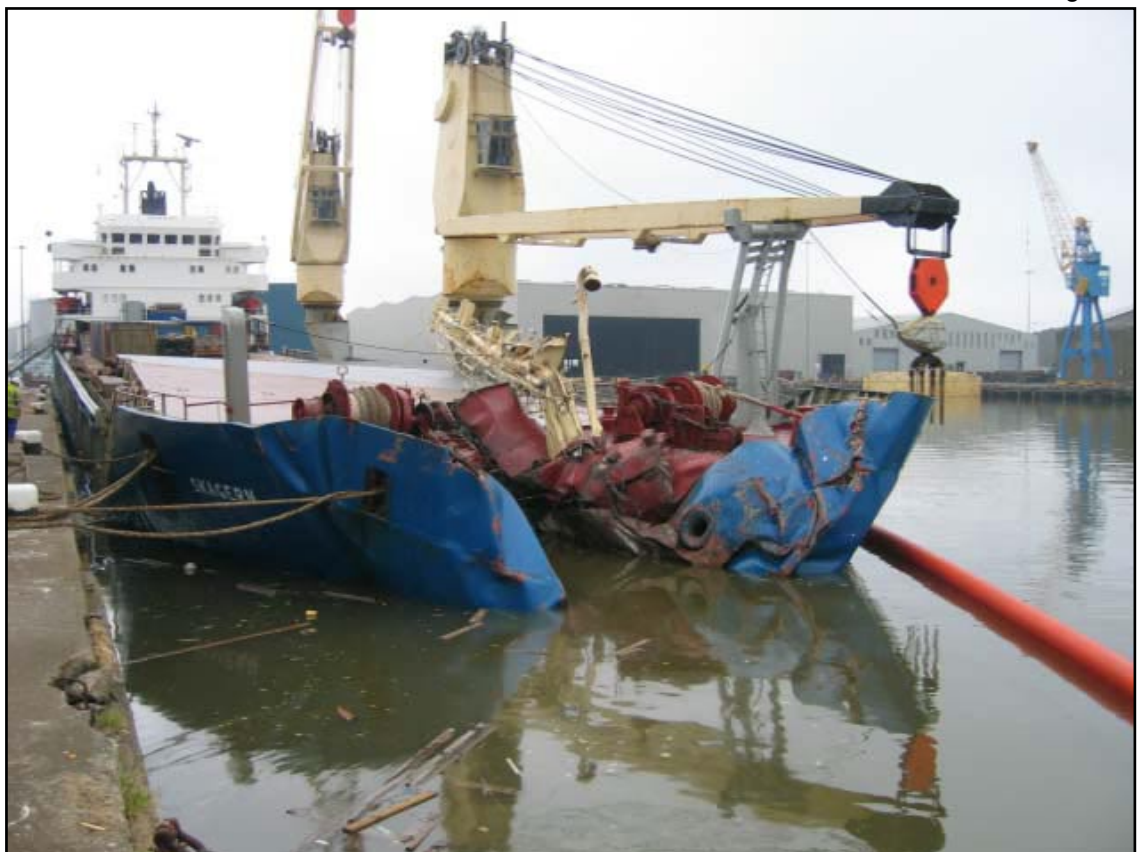
Figure 9

Skagern alongside King George Dock

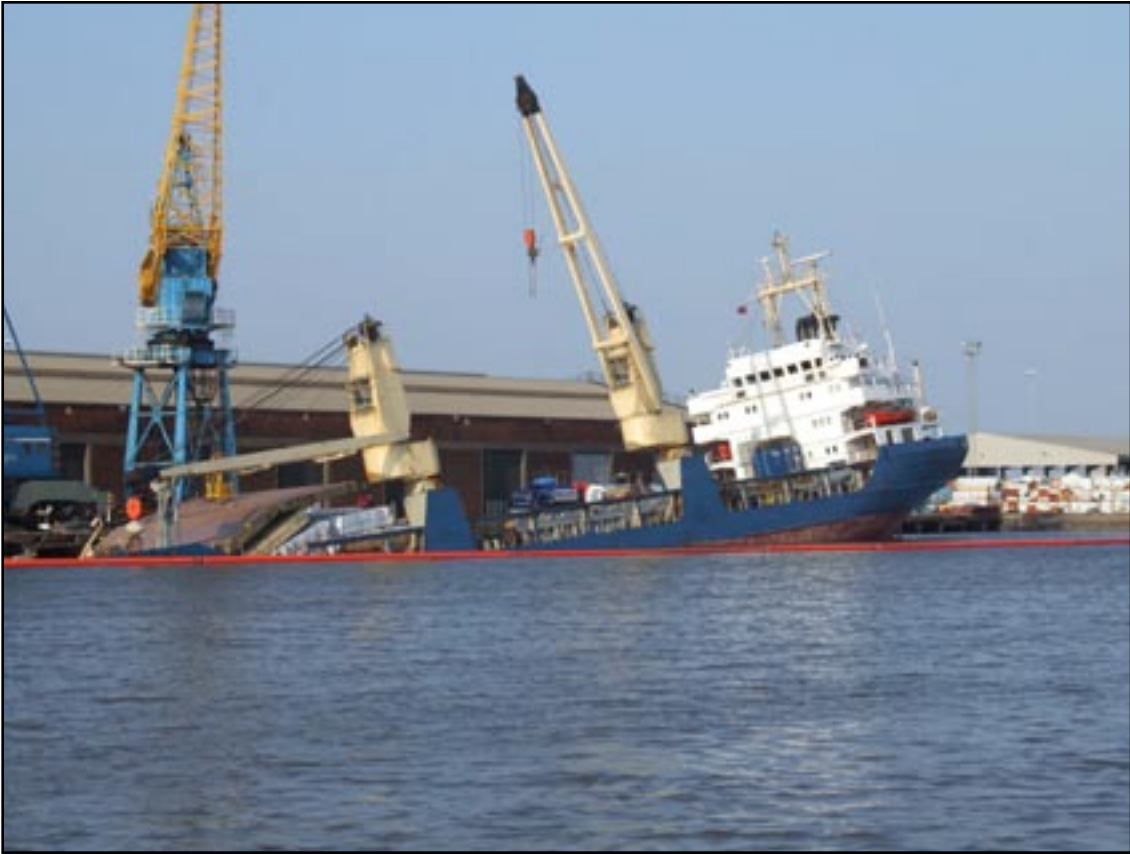
The stern-first tow was completed successfully, and by 04:30 on 8 June, *Skagern* was safely alongside in King George Dock, Hull (**Figure 9**). SOSREP had been previously notified of the accident and the possibility of pollution, and as soon as *Skagern* was moored up, anti-pollution booms were deployed to contain any possible oil spill. Once alongside her berth, progressive flooding through vents and conduits caused the vessel to go down further by the head until, gradually, her bow sank and settled on the dock bottom (**Figure 10**).

Skagern's bow settled on dock bottom

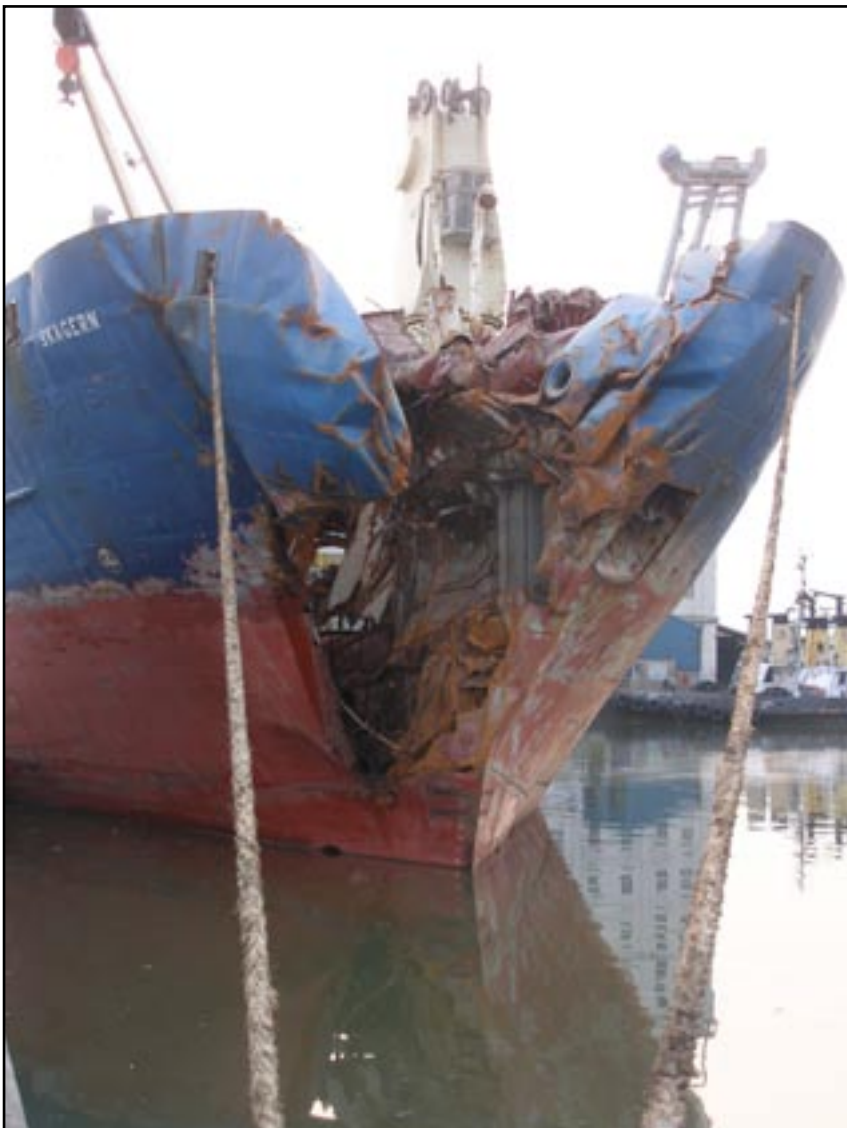
Figure 11a

A full salvage operation took place over the following days and *Skagern* was successfully unloaded and refloated, whereupon the full extent of the damage could be surveyed (**Figures 11a, b and c**).

Skagern after salvage operation

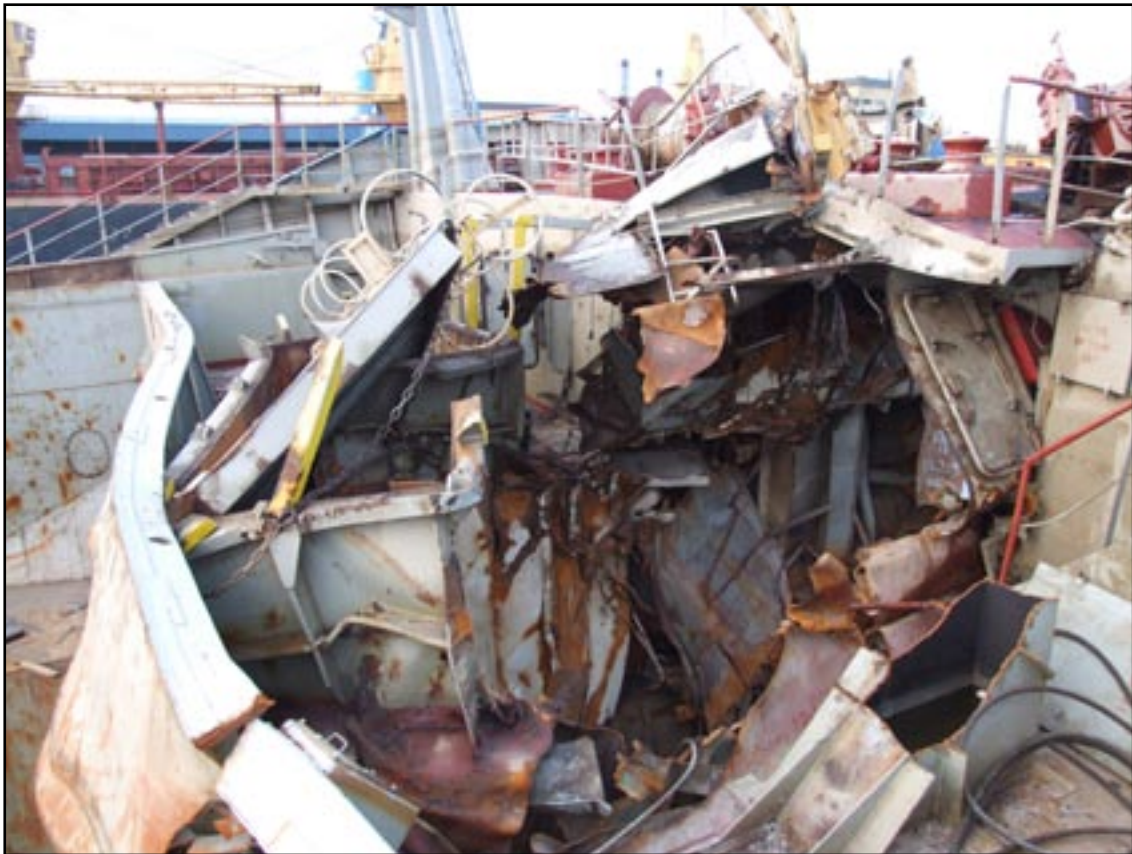
Figure 11b

Damage to fore'sle head

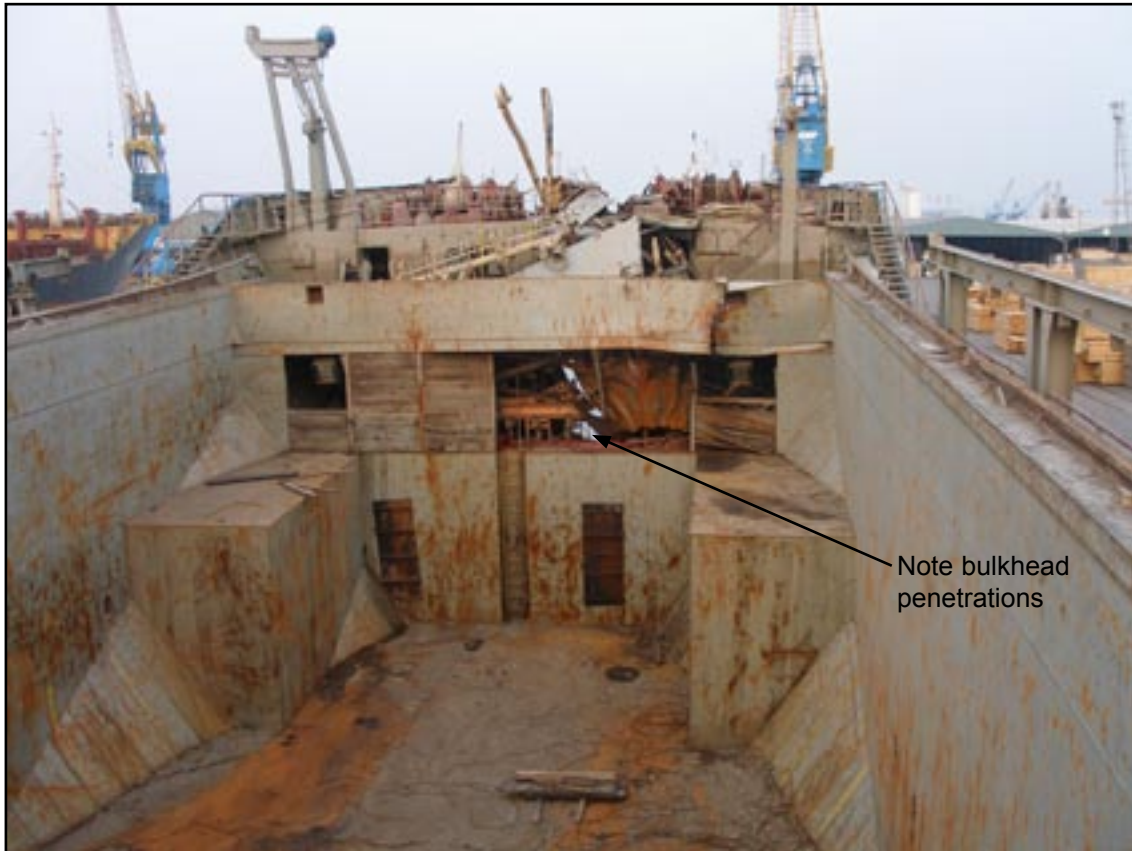
Figure 11c

View from Hold No 1

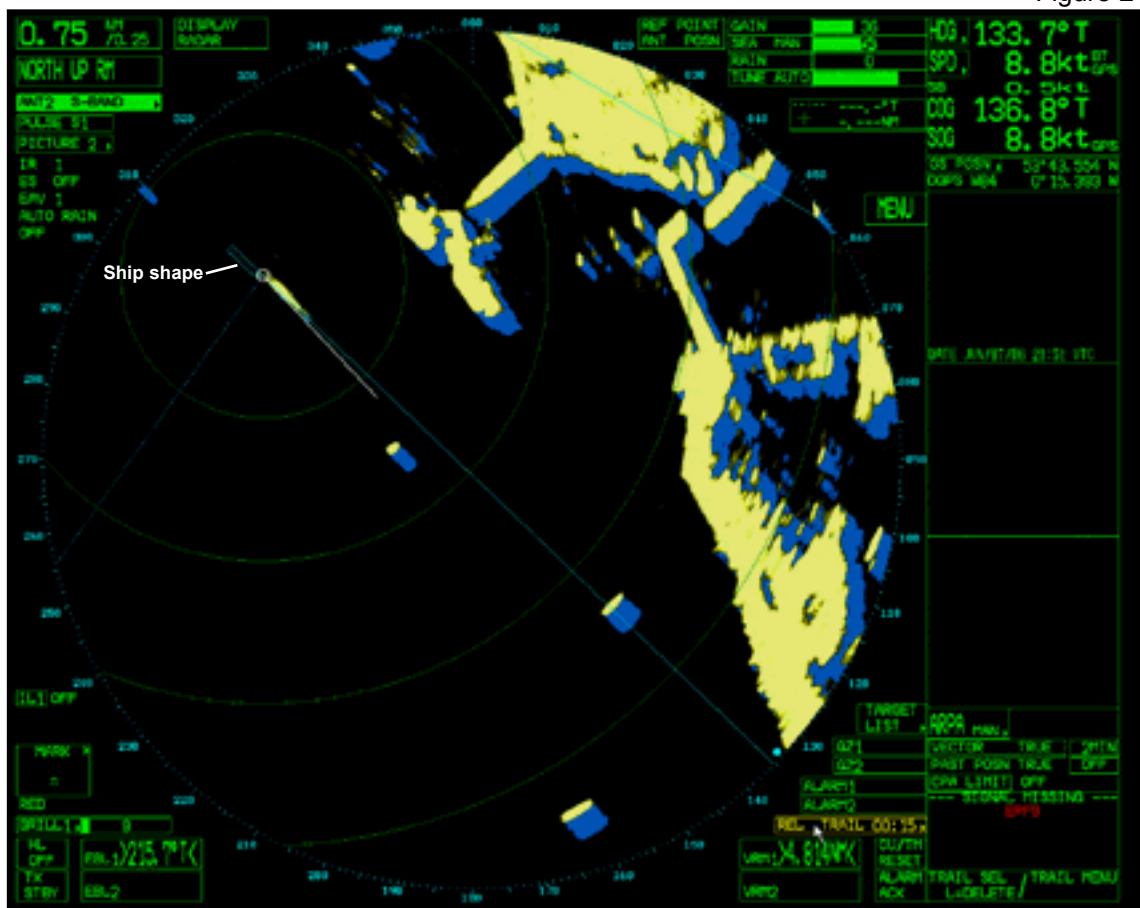
Figure 24

The starboard radar display had a synthetically superimposed "ship shape" symbol showing the radar trace origin as being placed on the bow of the ship when in fact it was near the stern (**Figure 24**). It is considered that this had no bearing on the accident, but that it added an unnecessary complication to the radar picture which could provide an operator with misleading information in other circumstances.

Synthetic ship shape symbol showing radar scanner positioned on bow of *Samskip Courier*
