**Report on the investigation of
the collision between
Wintertide and MSC Sabrina
off Texel Traffic Separation Scheme
13 June 2000**

Report No 7/2001

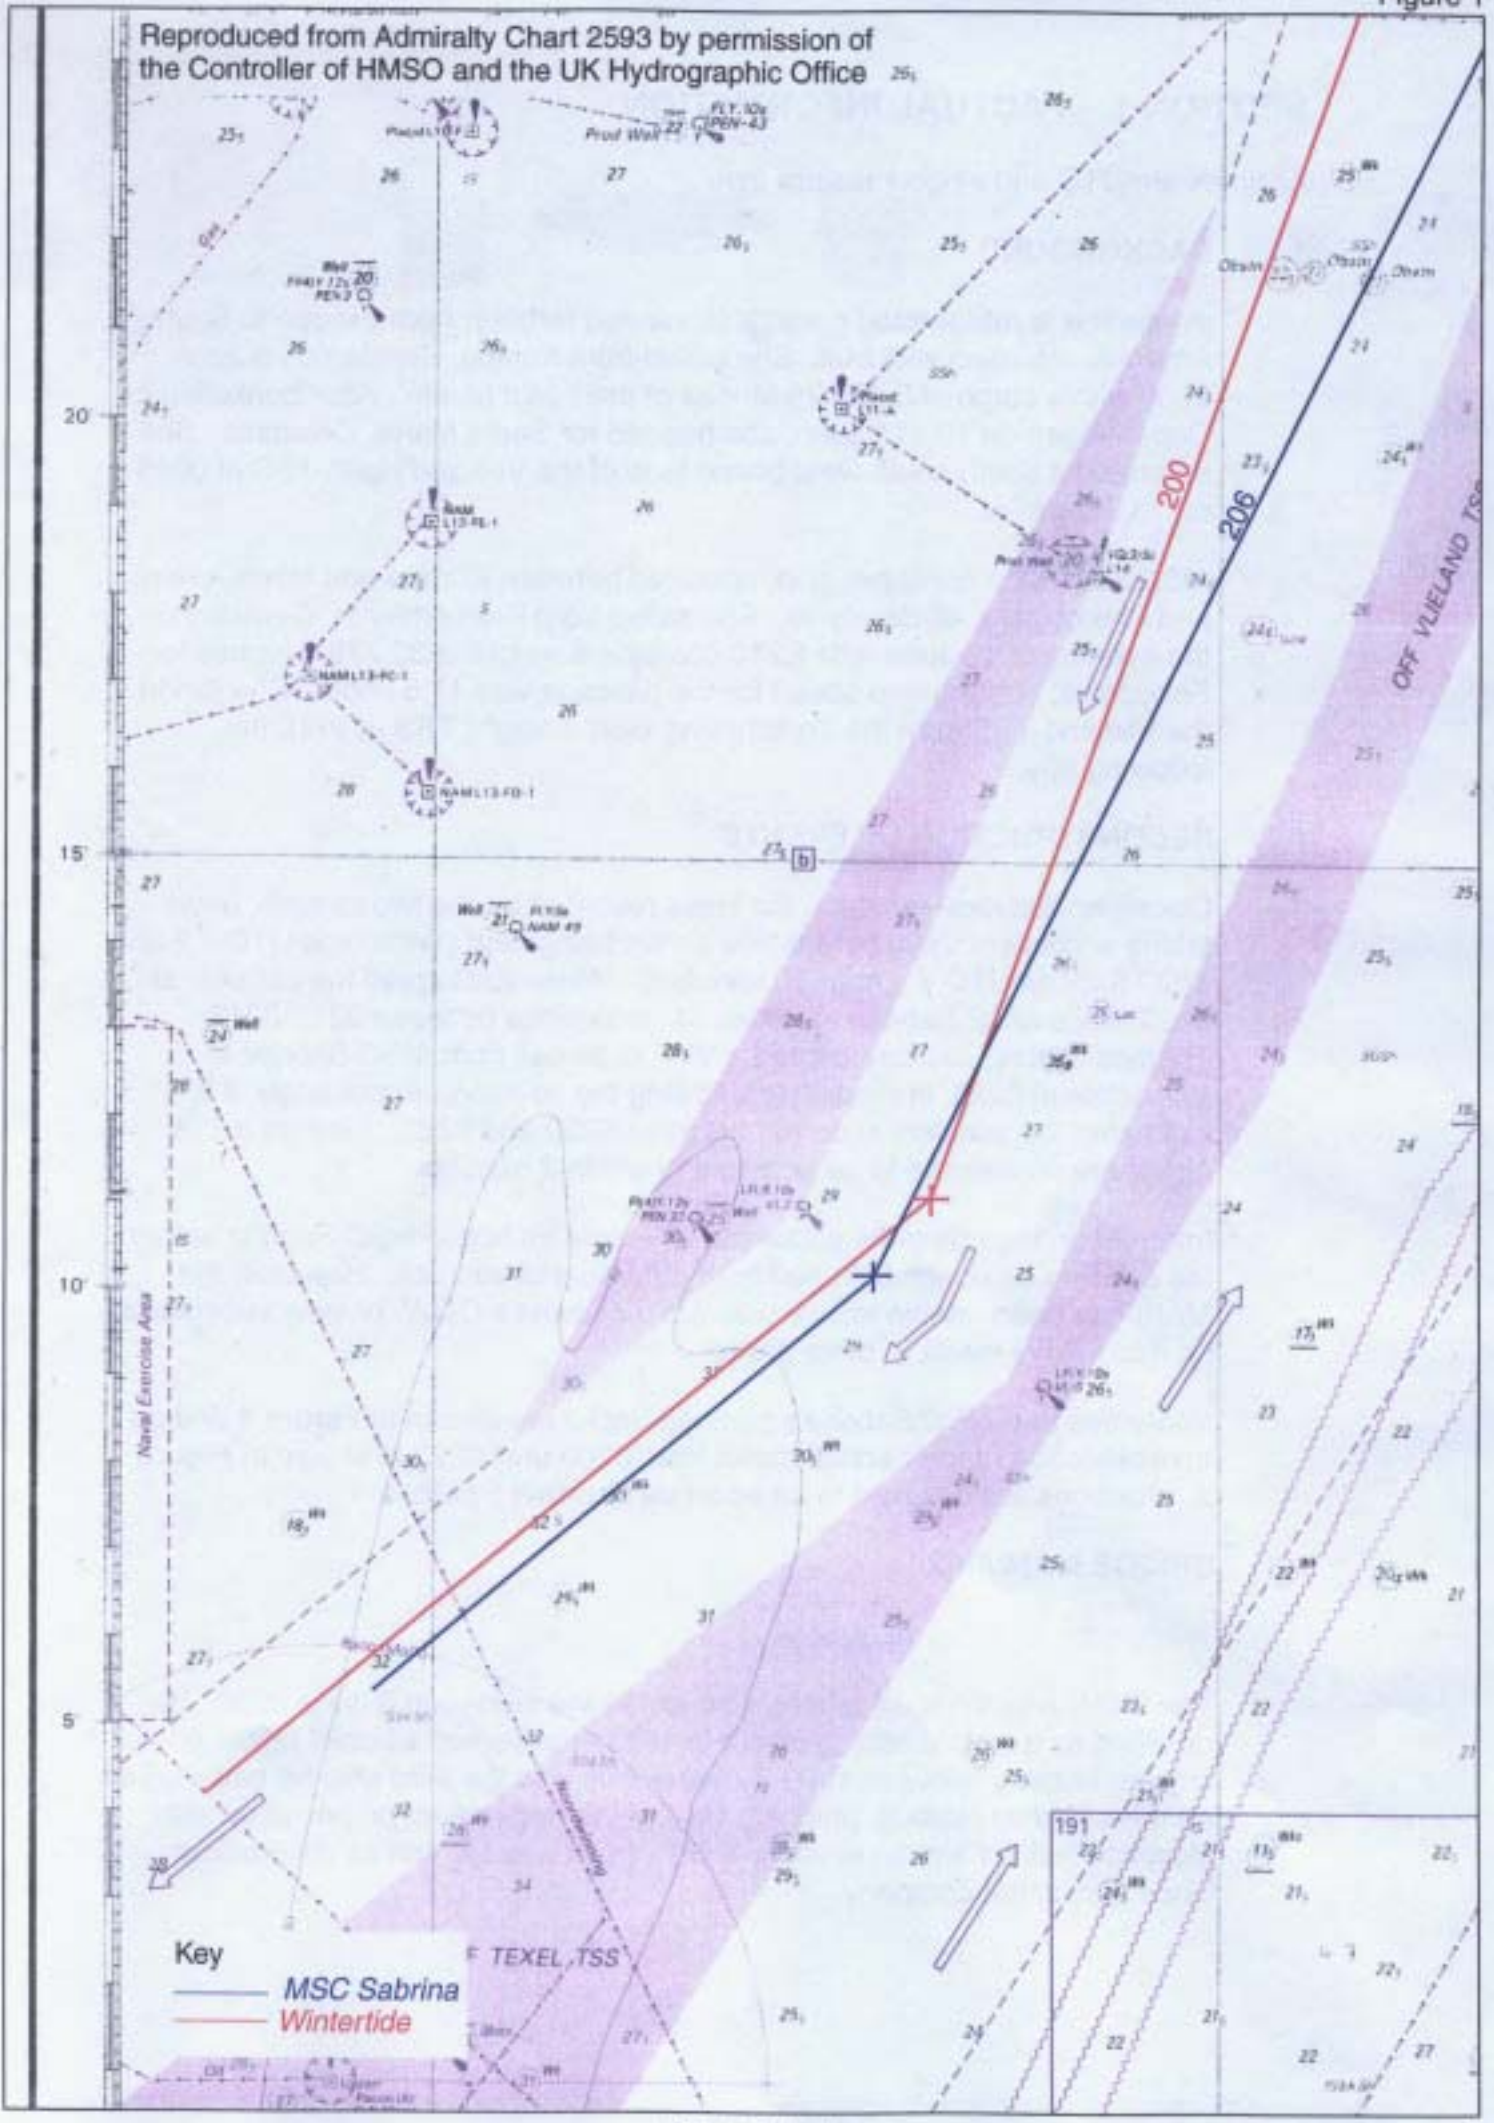
Wintertide and *MSC Sabrina*'s planned tracks are shown at **Figure 1** and an approximation of their actual tracks from 0200 until 0223 is shown at **Figure 2**. Positions are believed to be accurate to within 5 cables.

Planned tracks

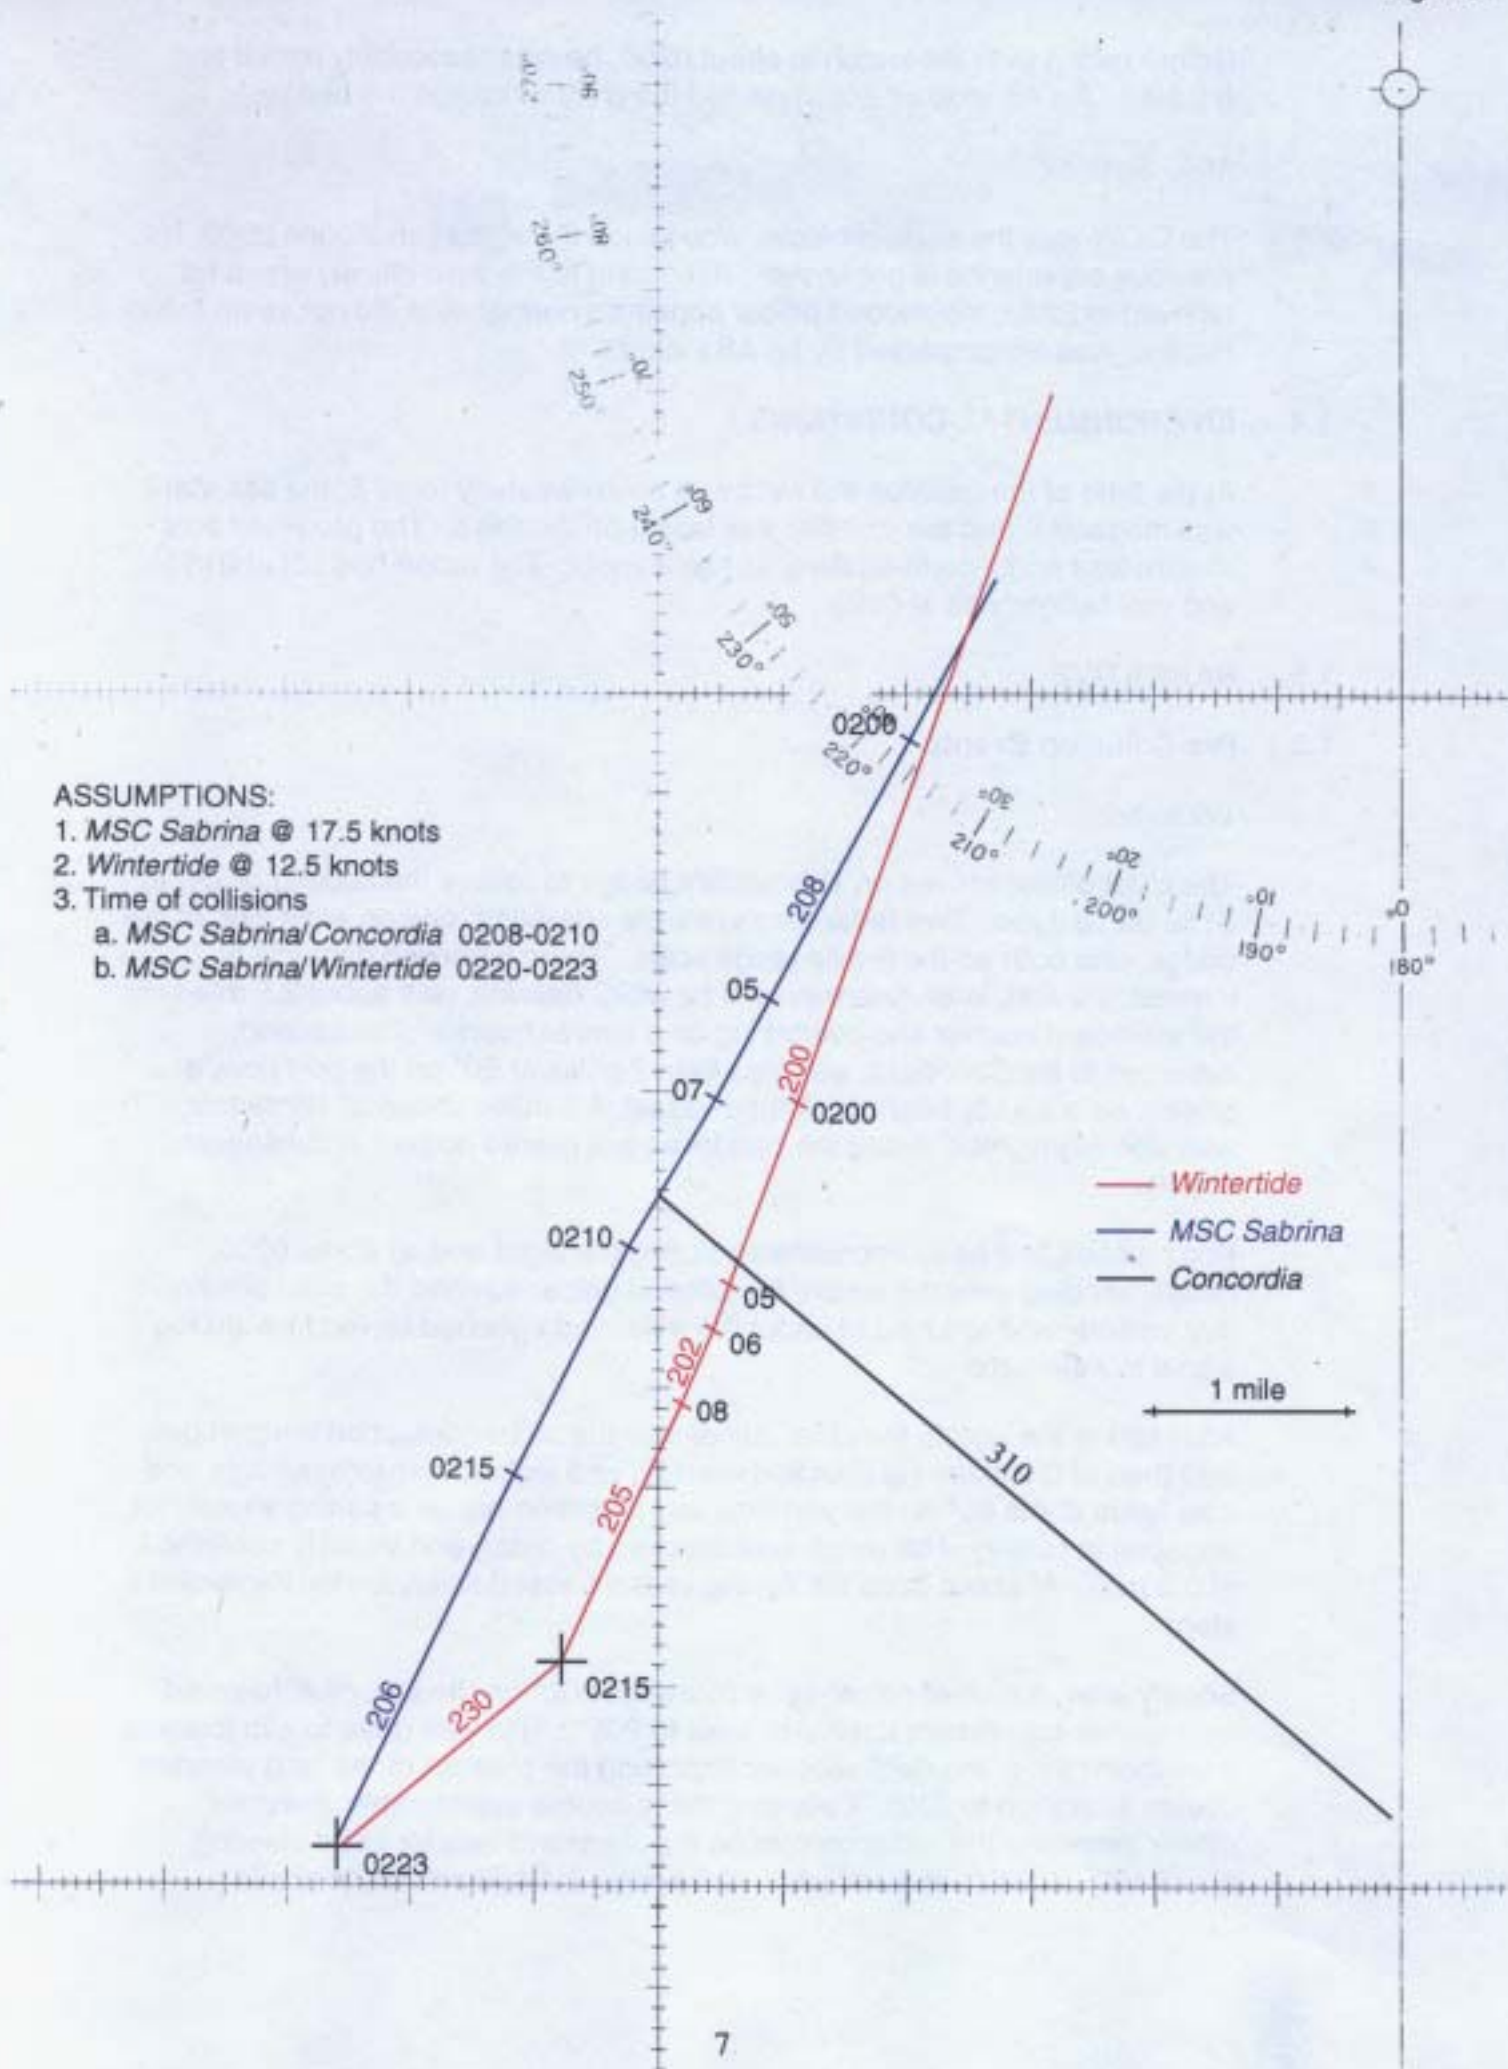
1. MSC Sabrina @ 17.5 knots
2. Wintertide @ 12.5 knots
3. Time of collisions
 - a. MSC Sabrina/Concordia 0208-0210
 - b. MSC Sabrina/Wintertide 0220-0223

Approximation of actual tracks

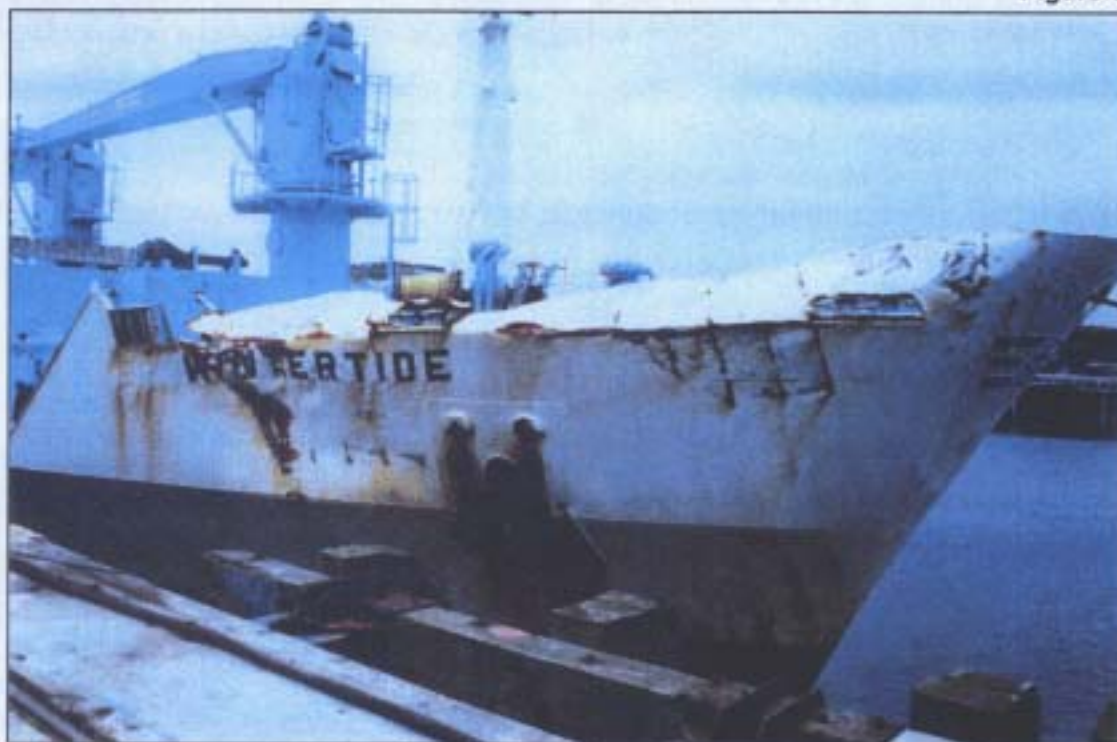
Figure 3

Vessel details	<i>Wintertide</i>
Registered Owner	: Wissel V
Manager(s)	: Norbulk Shipping UK Ltd
Port of registry	: London
Flag	: UK
Type	: Reefer/Cargo
Built	: 1990 – Lervik in Sign, Norway
Classification society	: Det Norske Veritas
Construction	: Steel
Length overall	: 104.85m
Gross tonnage	: 5,084
Engine power	: 4043kW/Diesel
Service speed	: 16 knots
Other relevant info	: Bow thruster, single controllable pitch propeller
Accident details	
Time and date	: 0223 UTC on 13 June 2000
Location of incident	: 53° 10.5' N, 004° 23.5' E (Off Texel TSS)
Persons on board	: 16
Injuries/fatalities	: 0
Damage	: Severely buckled bulwark and internal damage to the starboard bow. Distorted deck fittings and anchor fluke.

After exchanging identities and details of damage with *MSC Sabrina* via VHF radio, *Wintertide*, resumed passage at a reduced speed until visibility improved. She arrived at Falmouth on 14 June for repairs to her damaged bow.

Damage to *Wintertide*

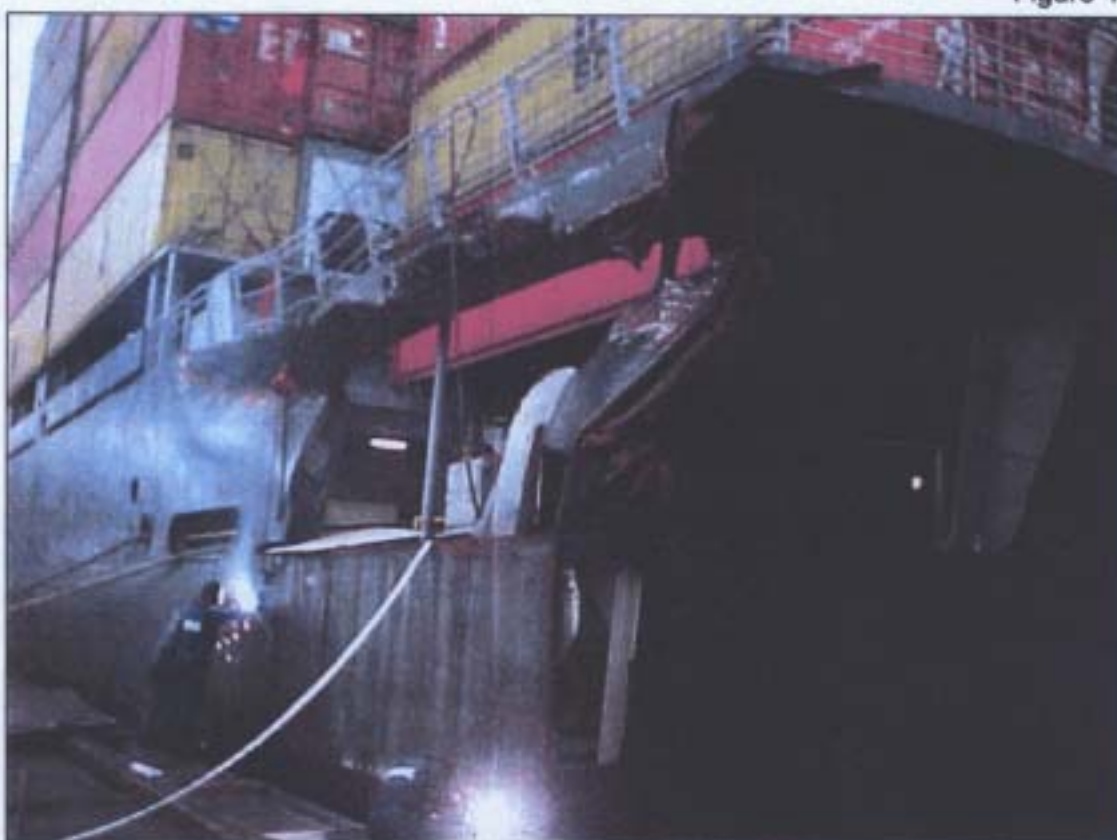
Figure 4

Damage : Loss of watertight integrity above the waterline on the port quarter in vicinity of the steering compartment.

Damage to *MSC Sabrina*
