**HELLENIC REPUBLIC
HELLENIC BUREAU FOR MARINE CASUALTIES INVESTIGATION**

**MARINE CASUALTY SAFETY INVESTIGATION REPORT
06/2013**

**Collision between
M/V Consouth
&
M/V Pirireis**

Foundering of M/V Pirireis

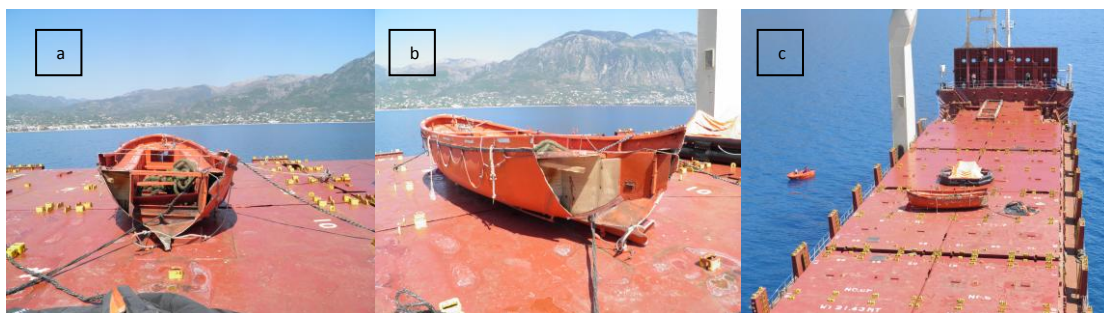
Pirireis' No 2 port life boat placed at boat deck was damaged by Consouth's stem post and her aft section was detached.

Figure 8.a.b.c. Pirireis No 2 life boat on board Consouth

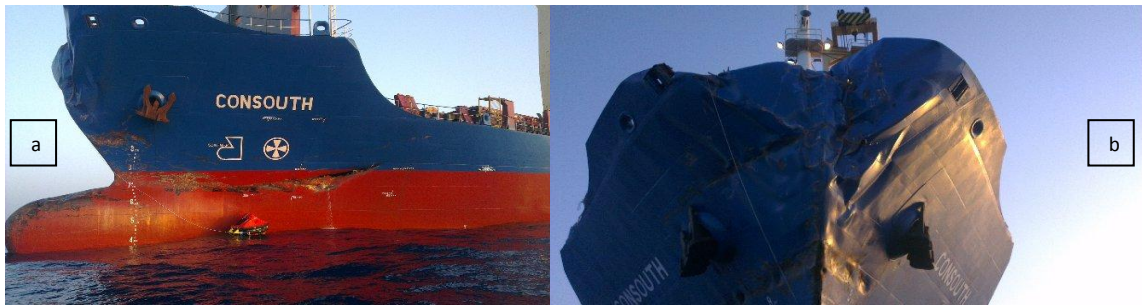
Consouth suffered extended structural damages at her fore section and none of her crew members was injured.

Figure 9.a.b. Consouth damaged morning hours on the day of the collision.

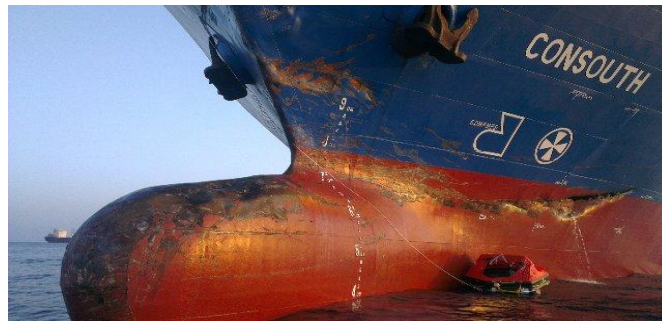
Figure 10. Consouth damaged port bow and her lifeboat used following the collision.

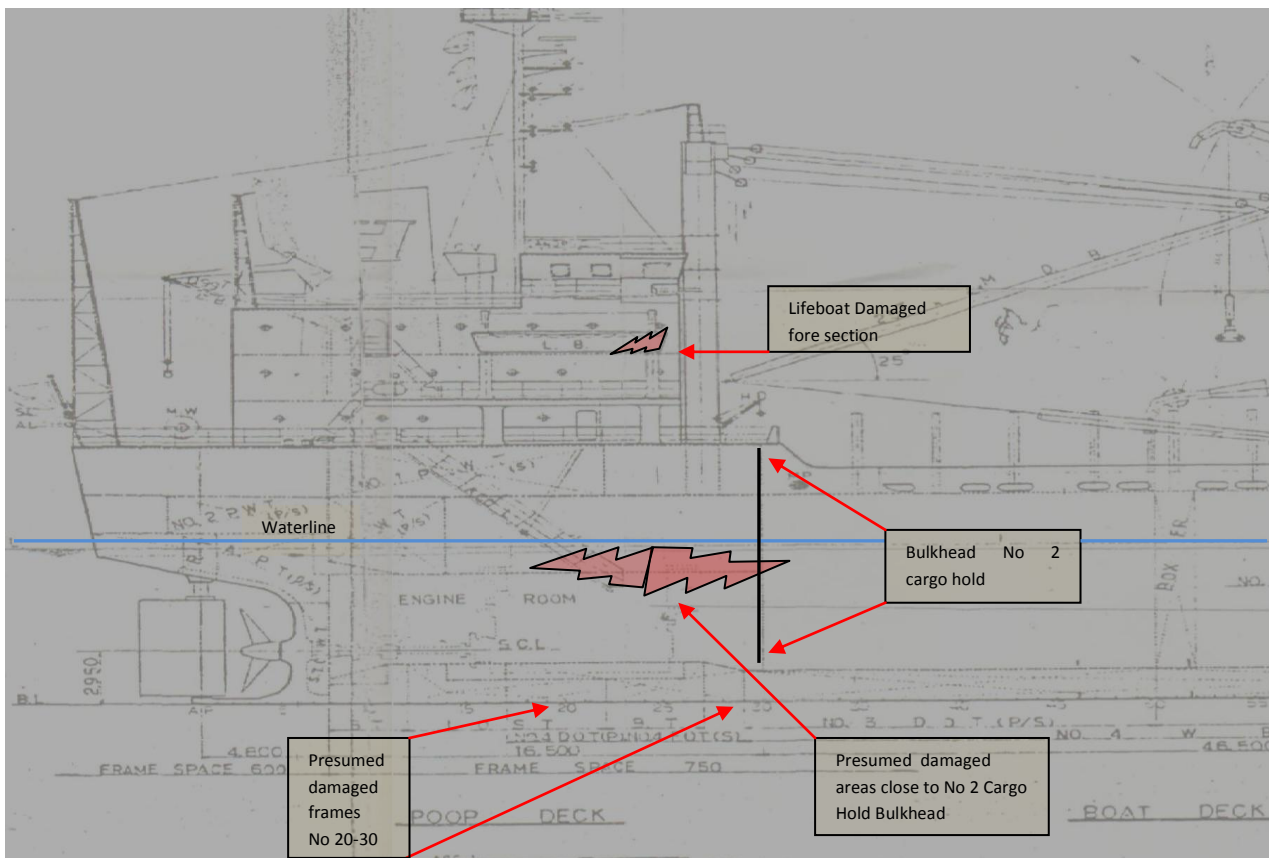
Pirireis was reported to had suffered major structural damages on her port aft quarter shell plating. The exact sections impacted cannot be determined.

it could be concluded that her engine room must had been holed presumably between frames No 20 and 30 close to No 2 cargo hold bulkhead.

- shell plating extended deformations and cracks should had been caused at No 2 cargo hold bulkhead,
- huge quantities of sea water inflowed into No 2 cargo hold loaded with approximately 6000 MT of phosphate fertilizer, leading to her expeditious capsize and foundering.

Figure 9. Pirireis General Arrangement Plan abstract showing vessel's starboard aft quarter. Estimated damaged areas were sustained at Pirireis' port aft quarter.

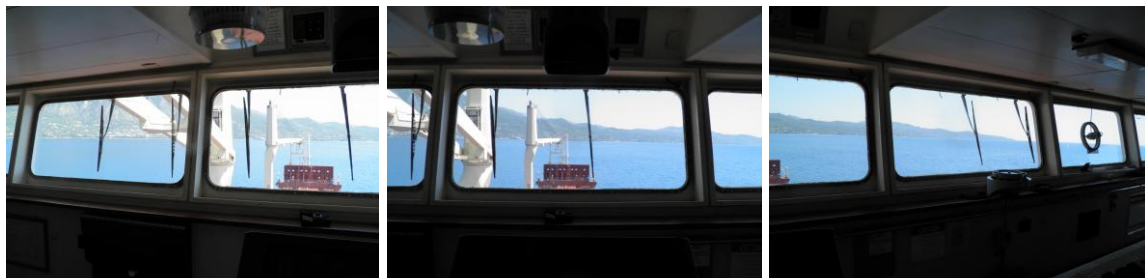
The OOW could maintain a very good visual contact and monitoring of head on vessels with almost reciprocal or nearly reciprocal courses on her starboard bow or abeam yet two cargo cranes located on the her port side were causing minor arcs of blind sectors which could be administered by the continuous movement of the OOW.

Figure 14. Consouth's bridge horizontal field of vision.

In the view of the above the OOW could observe and monitor Pirireis' almost reciprocal course on Consouth's starboard bow at all times before the collision.

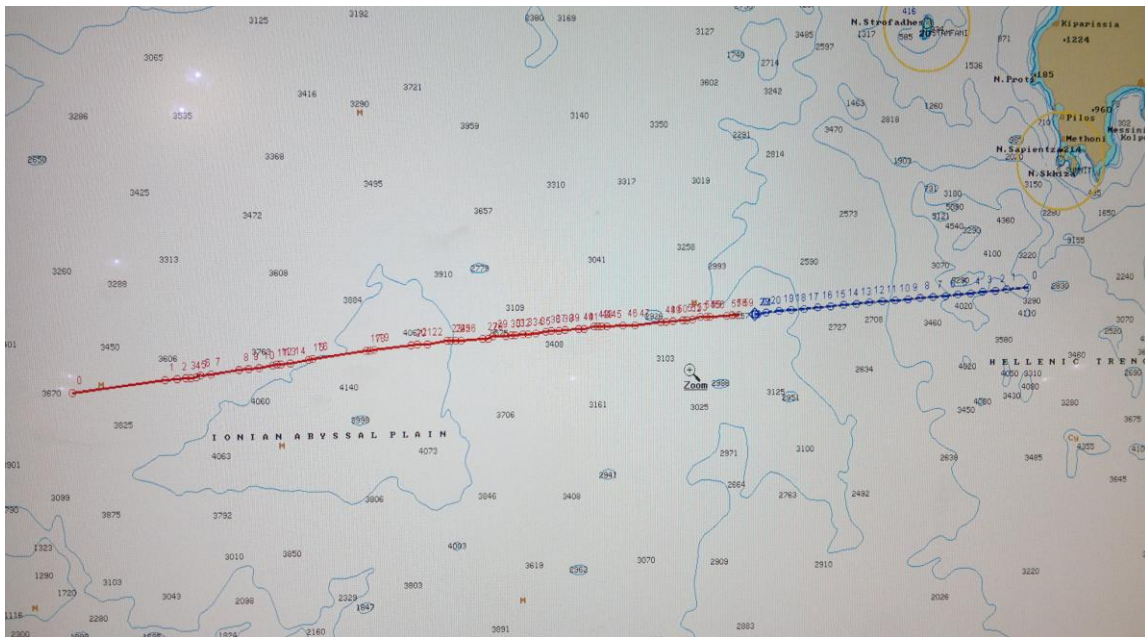
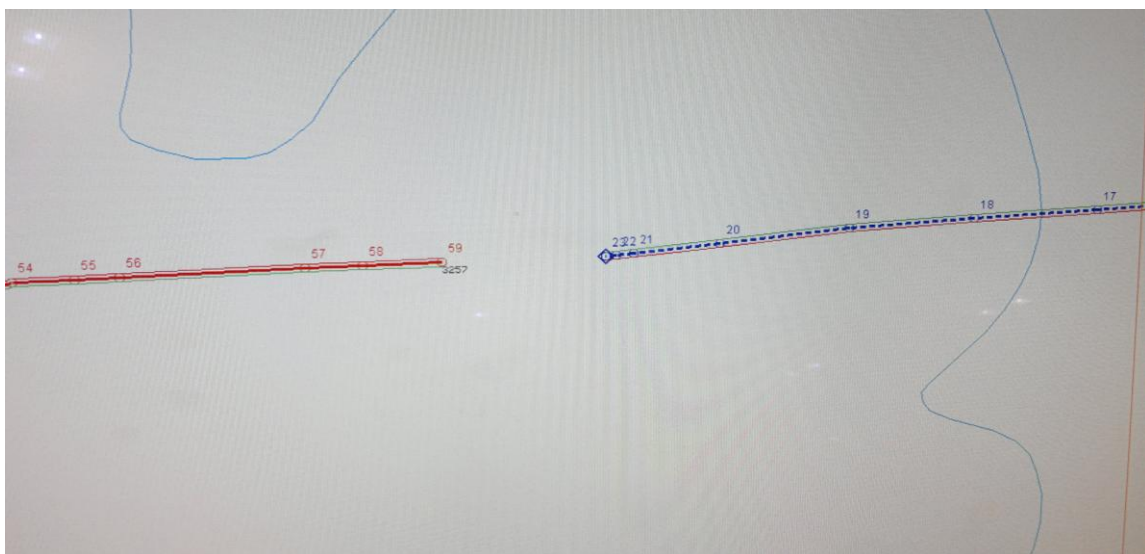
- Pirireis has altered her course to port three times during the specified time window at a range of 3° to 4° maintaining the same speed.
- Pirireis course was not steady although steering, as stated, was in autopilot.
- Consouth was keeping a course very close to 265° while at 0414 her course was altered to 263° maintaining the same speed.
- Consouth course was changed less than half a minute (approximately 20 seconds) before the collision.

Figure 31a. Consouth and Pirireis almost reciprocal courses

Figure 31b. Consouth and Pirireis almost reciprocal courses

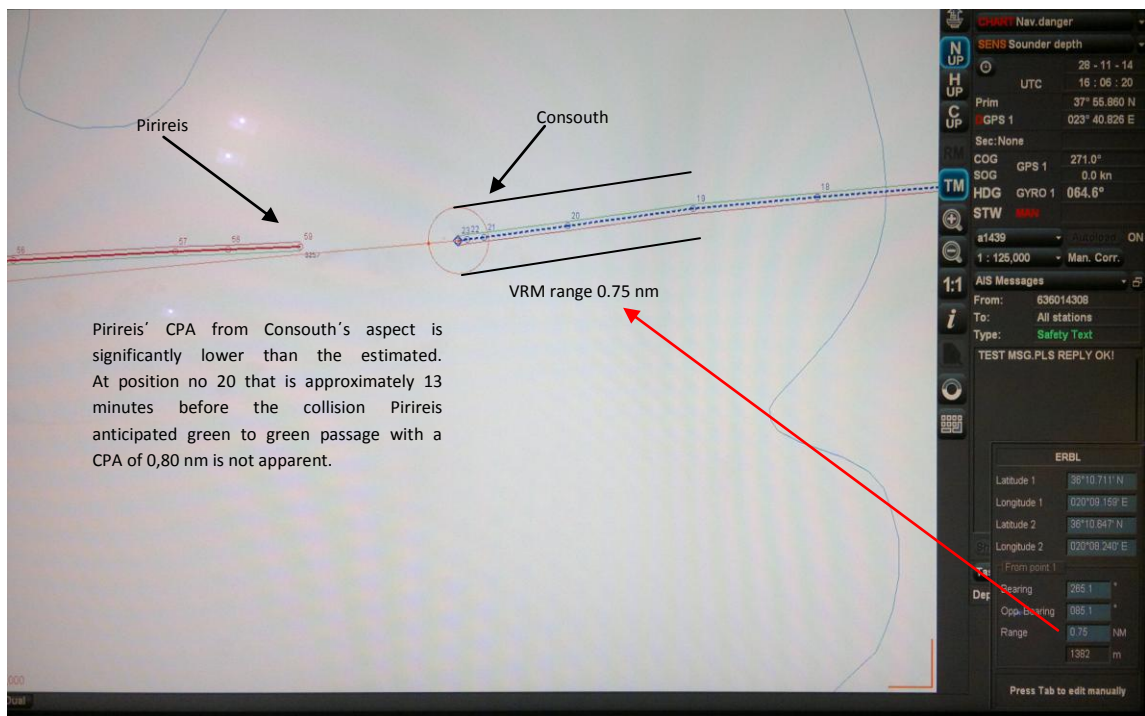
- Consouth and Pirireis maintained extremely practically reciprocal and extremely close courses.
- Vessels’ actual CPA of abeam passage was significantly lower than the CPA alleged by Consouth’s and Pirireis’ OsOW. The exact CPA could not be determined due to lack of technical factual data.
- While Consouth was underway at position no 20, that is approximately 13 minutes before the collision, Pirireis’ anticipated green to green abeam passage with a CPA of 0.80 nm, as alleged by Consouth’s Chief Officer, is not apparent (figure 32).
- While Pirireis was sailing at position no 59, that is approximately 20 minutes prior to the collision, Consouth’s anticipated red to red abeam passage with a CPA of 1 nm, as alleged by Pirireis’ Second Officer, is not resulted (figure 33).

Figure 32. Consouth’s estimated though misguided anticipated green to green passage with CPA 0.80 nm

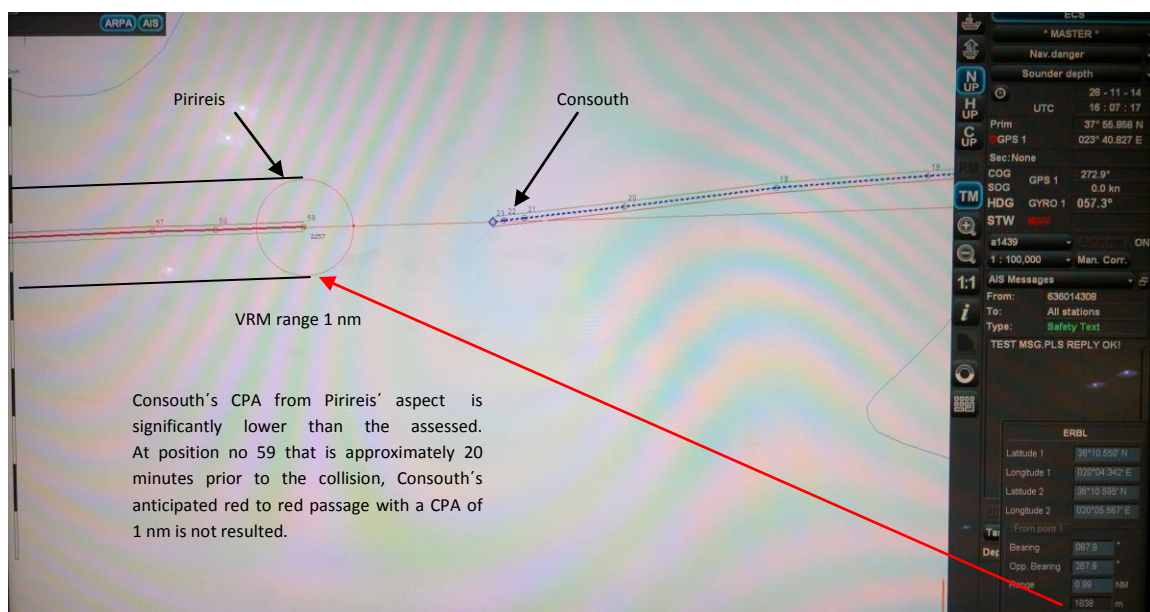
Figure 33. Pirireis’ assessed though misguided anticipated red to red passage with CPA 01nm
