**MARINE ACCIDENT
INVESTIGATION REPORT**

Vessel type and name: Cargo ship YONG SHENG VII

Vessel type and name: Dredger carrier HOKUEI No.18

Accident type: collision

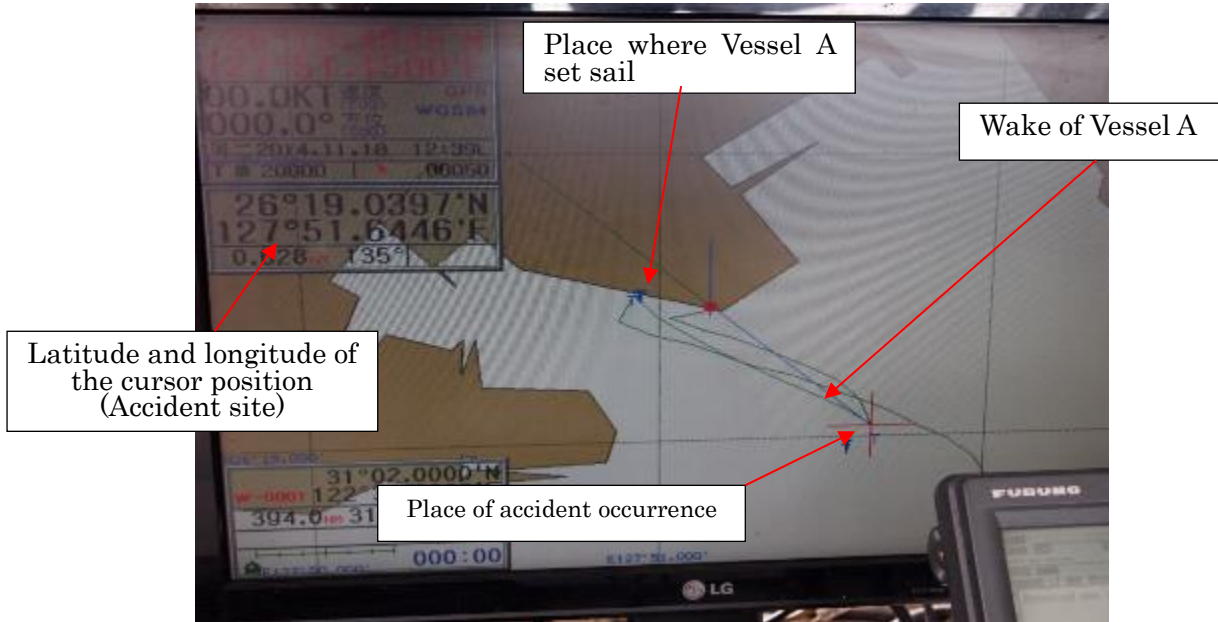
Photo 2.1 Wake of the GPS plotter data of Vessel A

According to the wake of the GPS plotter data of Vessel A, it was navigating in the south-east direction. (See Photo 2.1)

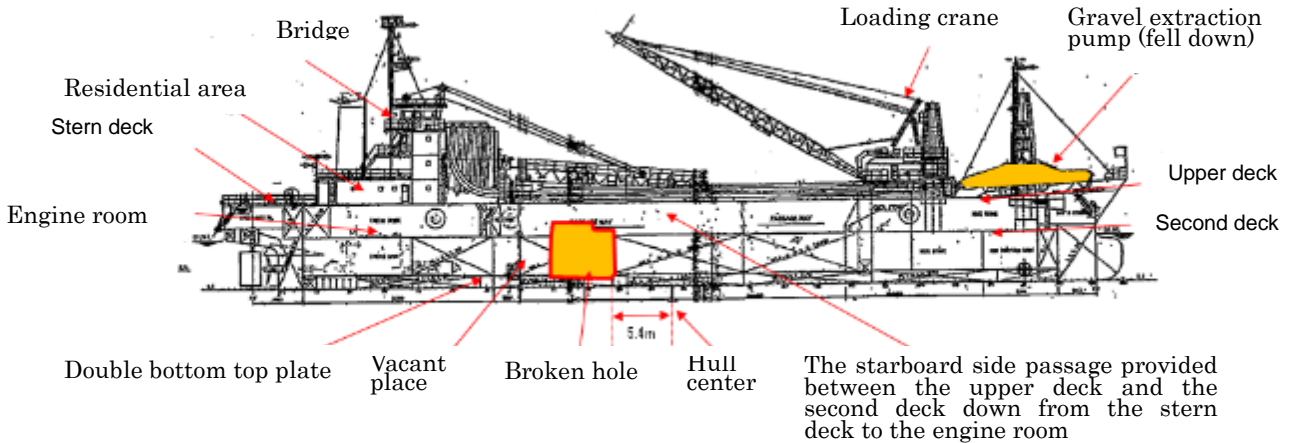
Figure 2.3 Damaged part schematic of vessel B

According to the written reply of the salvage company, a broken hole (length of about 5.6 m width of about 4.4 m) and curve damage were caused from the downward about 2 m of the upper deck and the upper edge of the starboard side shell plate, toward the stern side starting from the position of the stern side about 5.4 m from the hull center, and the occurrence of drop of the gravel extraction pump of the starboard bow section. In addition, Vessel B, after being salvaged at the location was in the vicinity of 302 °

A broken hole (length of about 5.6 m width of about 4.4m) and curve damage were caused from the downward about 2m of the upper deck and the upper edge of the starboard side shell plate, toward the stern side starting from the position of the stern side about 5.4m from the hull center, and the occurrence of drop of the gravel extraction pump of the starboard bow section lead to the total loss.

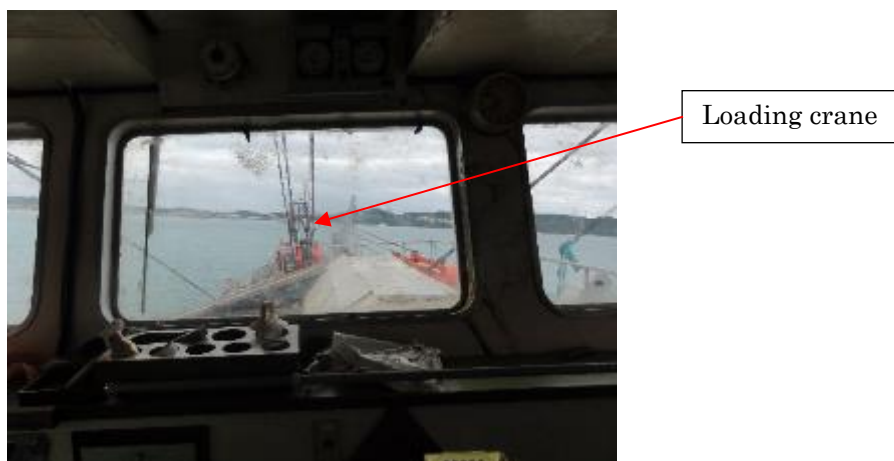
Photo 2.5-6 Forward outlook situation from the bridge center
(repatriation of after lift-up situation)

① When viewed forward from the bridge loading crane which was provided on the bow portion was a blind spot, and it was not possible to see the upper deck bow where chief officer B and able seaman B were performing the preparatory work for the port entry, however, the outlook was good.

② According to the statements of Master B, there was no impact on the lookout by the loading crane (See Photo 2.5-6)

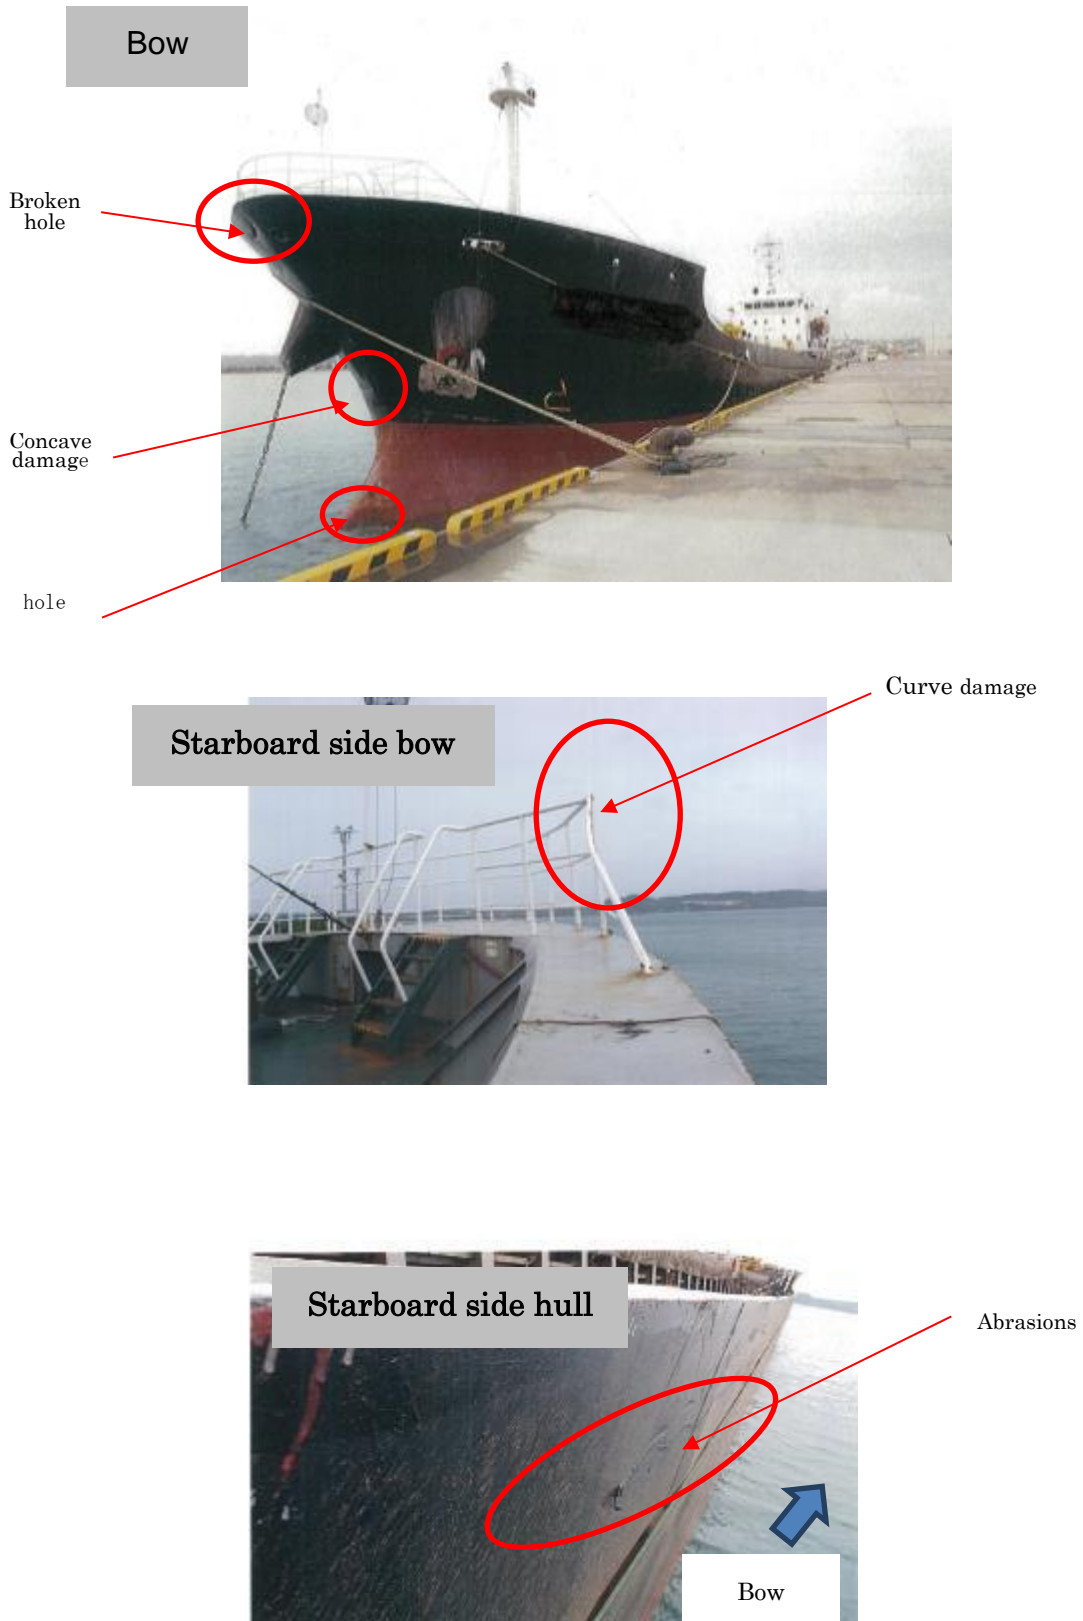
Photo 1 : Damage of Vessel A

Broken hole and damaged recessed part on the bow section, curve damage to the bow handrail, and abrasions arose from the bow section to the side shell of the starboard center. (Refer to Photo 1: Damage of Vessel A)

Broken hole and damaged recessed part on the bow section, curve damage to the bow handrail, and abrasions arose from the bow section of the side shell of the starboard center.

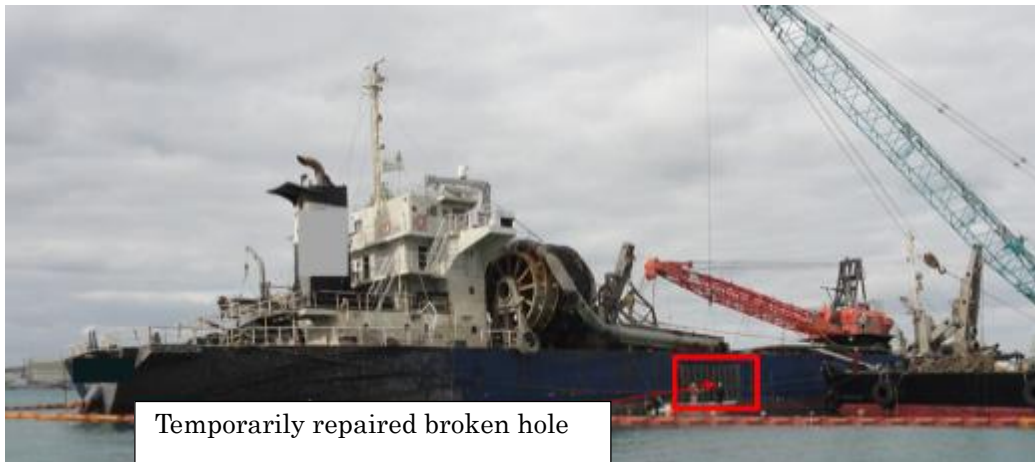
Photo 2 : Damage of Vessel B
(Repatriation of after lift-up situation)

- ⑤ Therefore It is probable that there is a possibility that Vessel B after the broken hole had been generated on the starboard side when the shell plate collides with Vessel A, seawater entered the starboard side passage between the starboard side cavity and the upper deck and the second deck, and the engine room through the front door of the engine room, it laterally inclined to the starboard side, therefore the starboard side was led to the on-grounding.

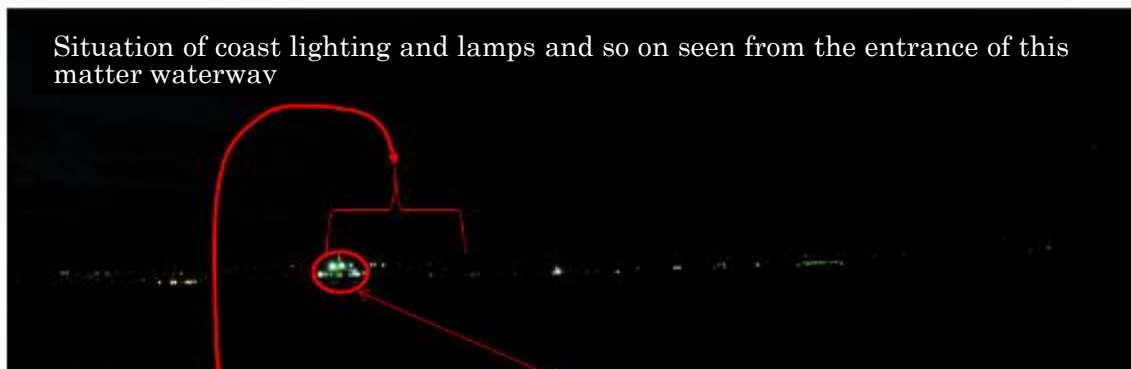
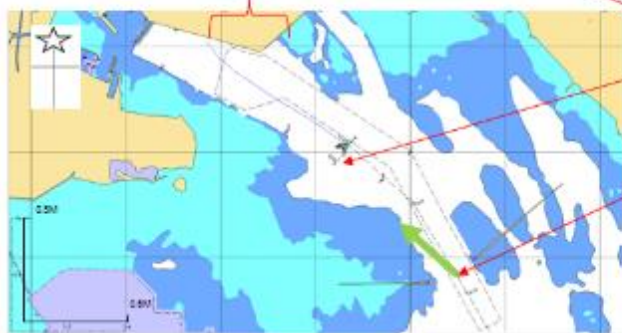
Photo 3 : Situation of coast lighting and lamps

- (1) When looking the coast in the north-west direction from the entrance area of this matter dug waterway in order to know about the condition of lighting and lamps on the coast near this accident waters at 18:40 on January 9, 2015, there was little lighting or lamps in the vicinity of the quay A where Vessel A departed to sail. It should be noted that the weather at the time of the survey was sunny, and the sunset time was at 17:53. (See Photo 3 Situation of coast lighting and lamps)
- (2) According to the statements of chief engineer B who was in the stern arrangement, he had been viewing the lights of Vessel A before Vessel B reached this matter bending portion.
