MA2021-2

**MARINE ACCIDENT
INVESTIGATION REPORT**

Vessel type and name: Container Ship APL GUAM

Accident type: Collision

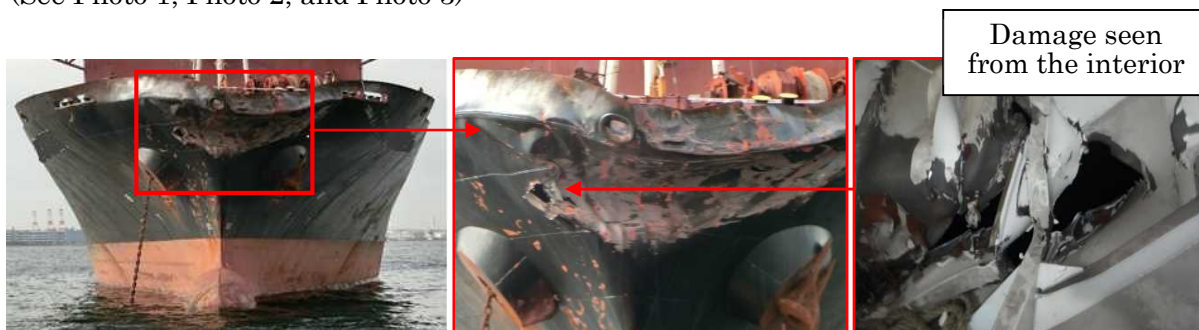
Photo 1 Damage to Vessel A

- (1) Vessel A sustained dents and abrasions with a hole in her bow's plating shell.
- (2) Vessel B sustained dents and abrasions in her bow's plating shell and starboard side bow's plating shell.
- (3) Vessel C sustained dents and abrasions with a hole in her starboard side bow's plating shell.

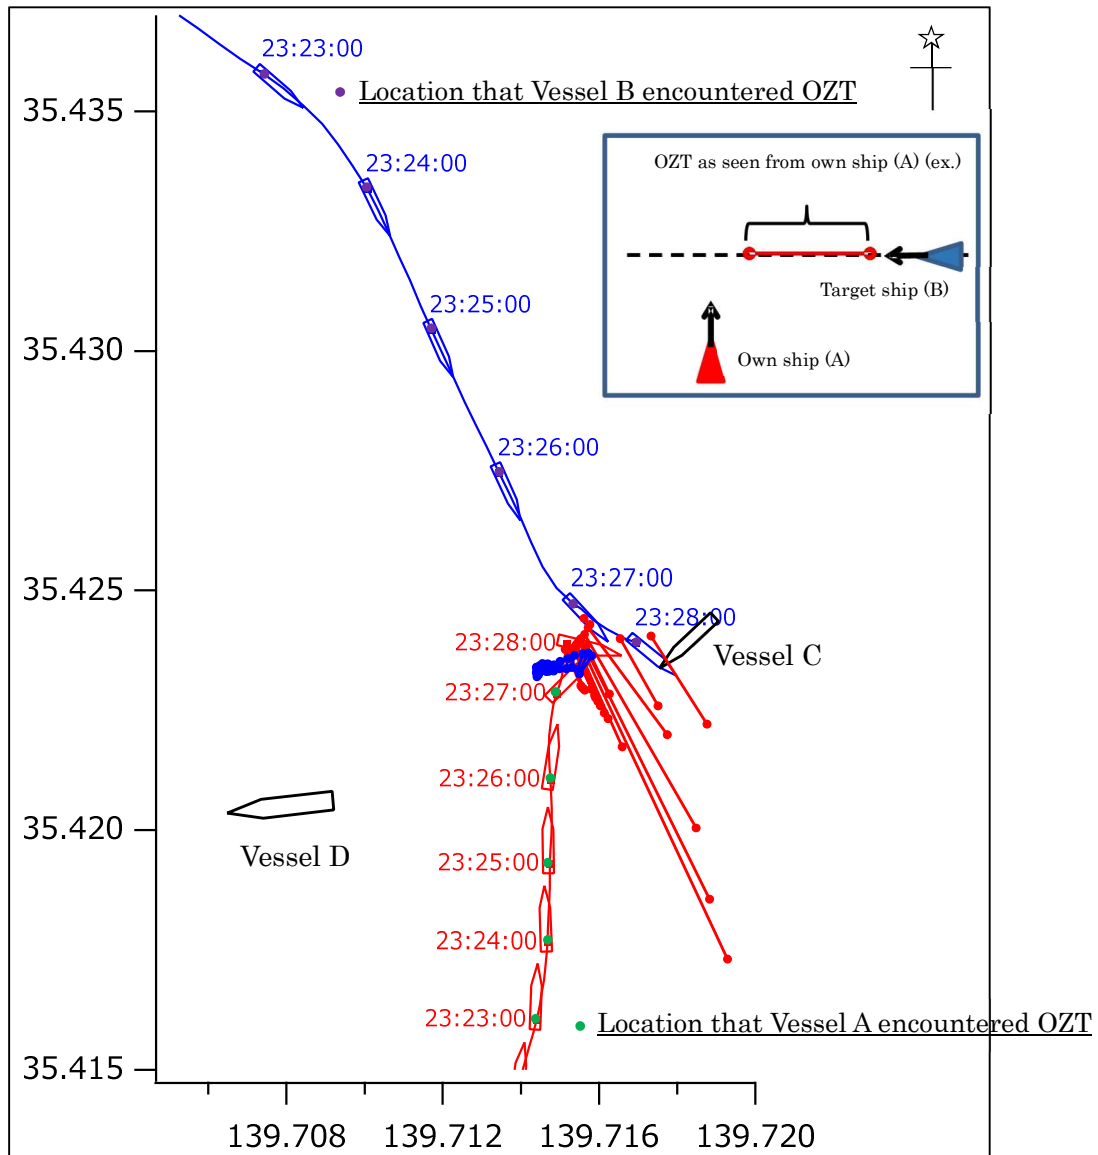
Figure 1 Locations that Vessel A and Vessel B encountered OZT

vessels, and the situation was in a dangerous condition whereby the distance between the two vessels would be 0.1 M or less within five minutes (set as the minimum safe navigating distance in this accident investigation).

The OZT of Vessel A occurred in the sea area on the starboard side of Vessel A's course while the OZT of Vessel B occurred in the sea area on Vessel B's course from around 23:23 to just before the collision.

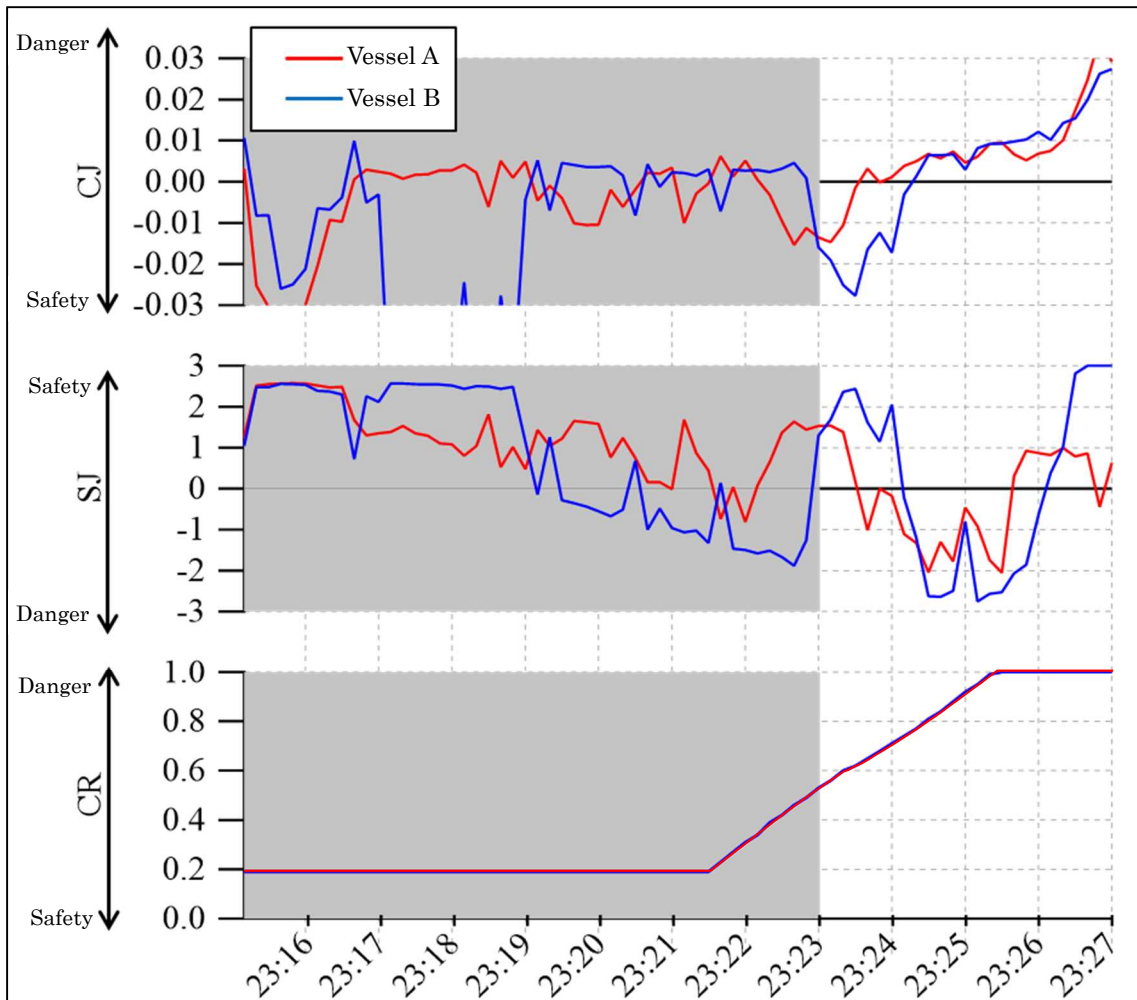
Figure 2 Time-related Changes in Level of Collision Risk (CJ, SJ, CR)

The CR values of Vessel A and Vessel B rise from around 23:22 and reach the maximum value after 23:25.

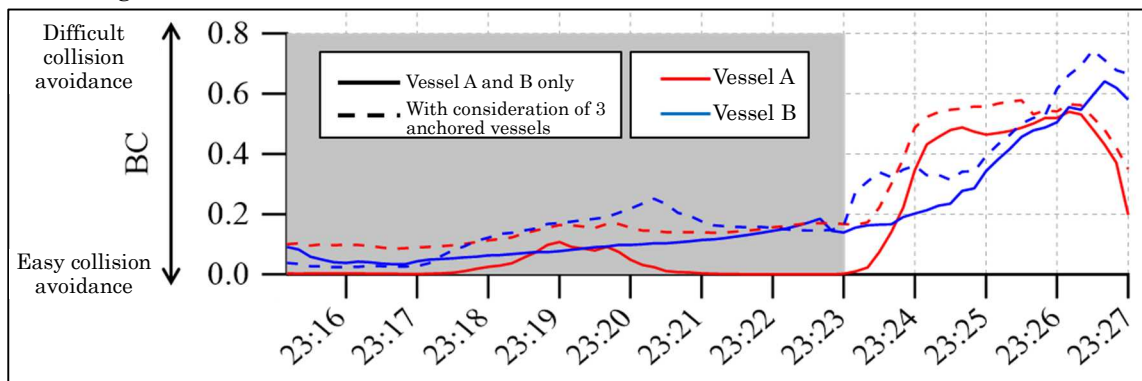
Figure 3 Time-related Changes in Level of Collision Risk (BC)

The BC values that were evaluated with consideration for Vessel A, Vessel B, and nearby anchored vessels are somewhat larger than BC values that do not consider the anchored vessels from 23:23 and rise rapidly after that time. Vessel A's values approach their highest points at around 23:24 and Vessel B's values reach their highest points at around 23:26.

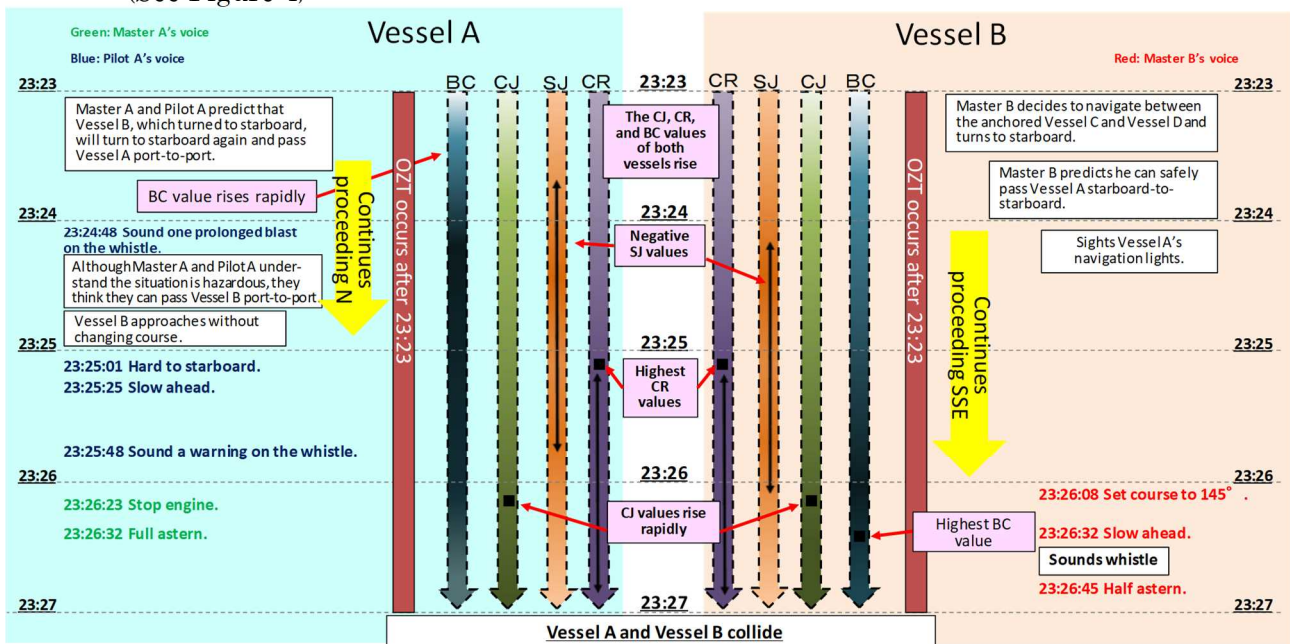
Figure 4 Sequence of Events relating to the Quantitative Assessment of Lookout and Ship Maneuvering Conditions as well as Level of Collision Risk

- 6) From 1) to 5) above, it is probable that, within a confined anchorage with the presence of anchored vessels, in a situation in which sea area available for giving way was restricted by anchored vessels and staying on the present course was likewise restricted by Vessel A, and as freedom of maneuverability decreased and the danger of collision increased after 23:23, Vessel B could have prevented the accident by taking such measures as promptly reducing speed, without attempting to navigate near Vessel A's bow.
