The Bahamas  
Maritime Authority

**Polar Spirit v Zhe Xiang Yu 41020**

**Report on the collision between the LNG tanker Polar Spirit and the fishing vessel Zhe Xiang Yu 41020 on 30 September 2018 resulting in the loss of eight lives**

Date of Issue: 10 August 2020  
Bahamas Maritime Authority  
120 Old Broad Street  
LONDON  
EC2N 1AR  
United Kingdom

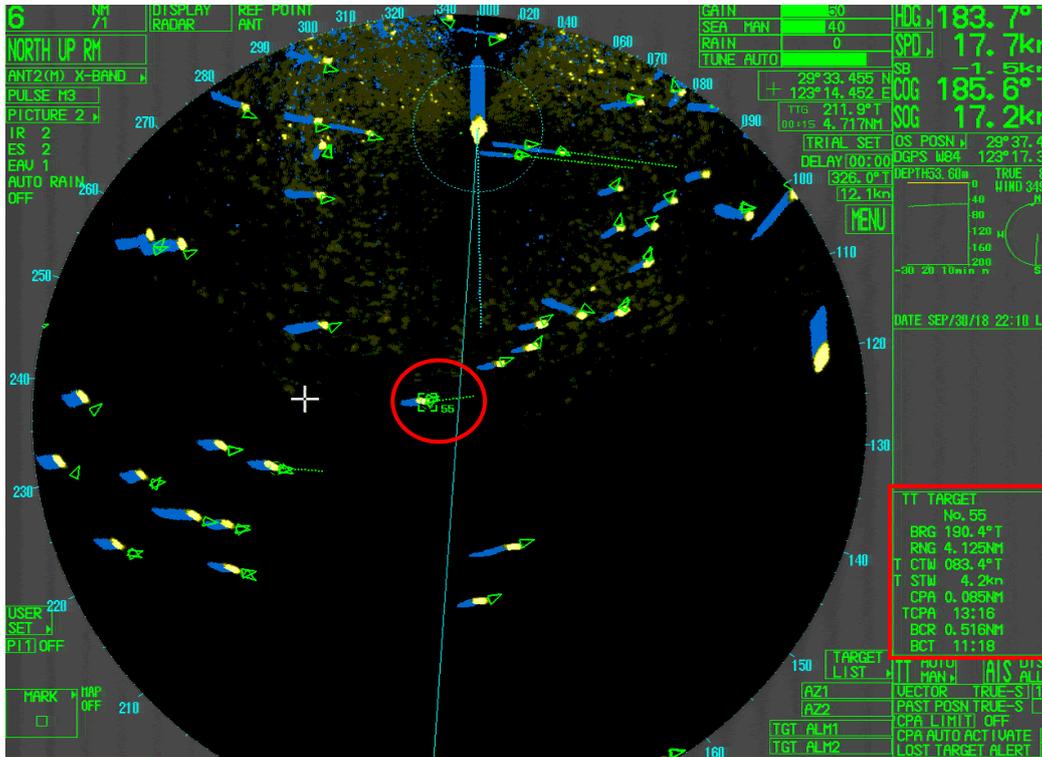
The target was Zhe Xiang Yu at a distance of 4.38NM. The ARPA calculated it was making good a course of 080°T at 4.3 knots. Polar Spirit was on a course of 182°T at 17.6 knots.

Figure 4: Polar Spirit’s X-band radar, 2210. Zhe Xiang Yu (ringed) is target 55

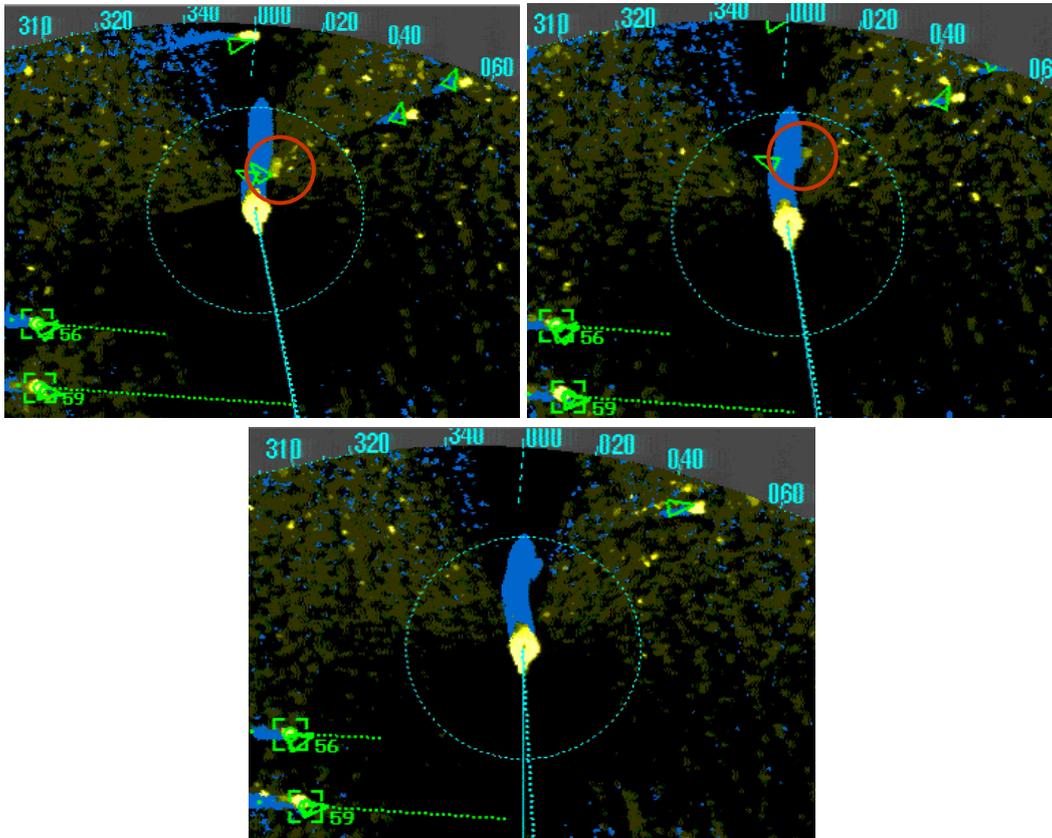
At 22:25, the Third Officer ordered a course of 180°T and Zhe Xiang Yu immediately fell into the radar's blind sector. Approximately 15 seconds later, Zhe Xiang Yu's AIS symbol disappeared from the radar.

**Figure 6: Polar Spirit's X-band radar 22:24-22:25. Zhe Xiang Yu radar paint visible on the port quarter, in blind sector and after AIS target disappears**

After a 17-second discussion, the bridge team concluded that there had been a near-miss with the Zhe Xiang Yu, but there had been no collision. Polar Spirit continued its passage to Bintulu.

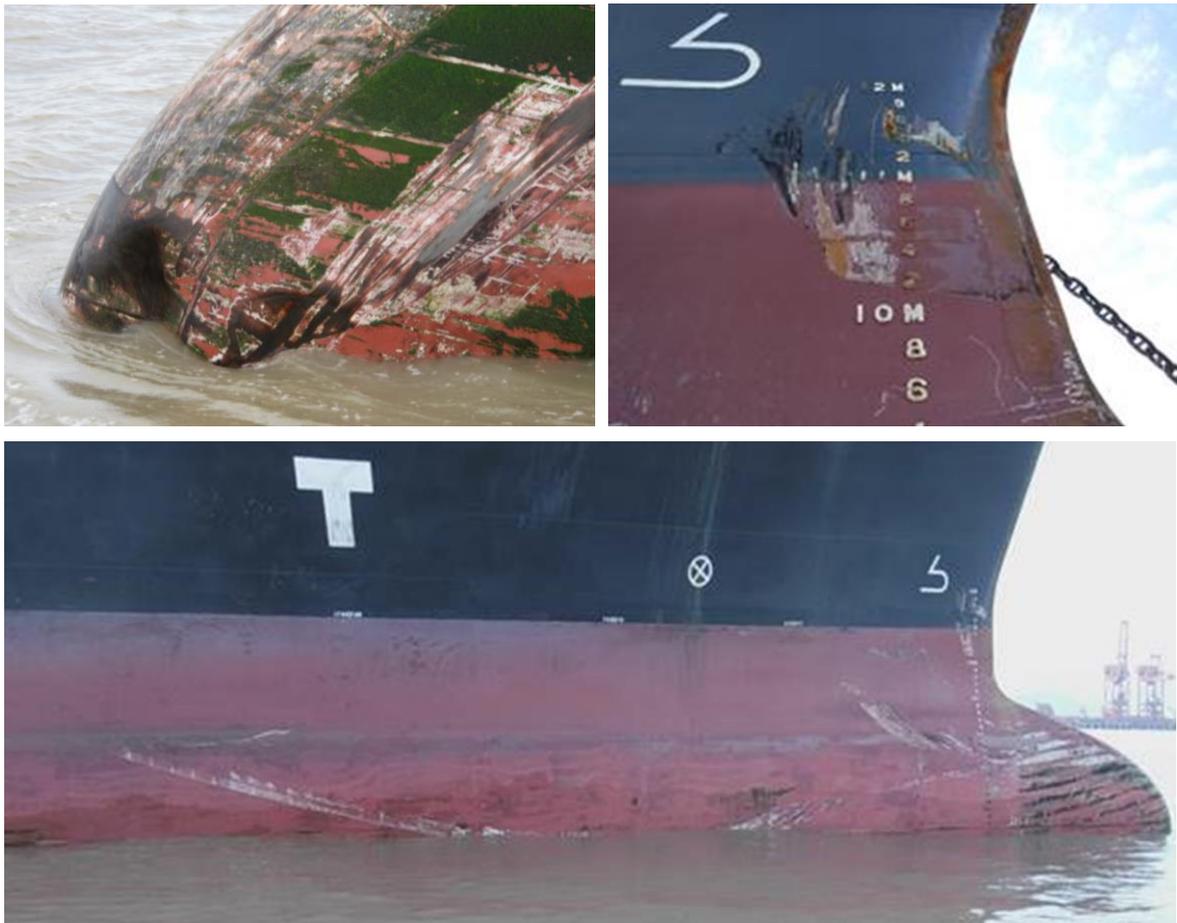
The Polar Spirit sustained superficial hull damage on the bulbous bow and starboard shoulder at the waterline. A survey was conducted on 03 October 2018 by the vessel's classification society (ABS) which found:

- Bulbous bow plating set-in (up to) 100mm over a 800mm x 400mm area.
- No.4 stringer plating deformed.
- Hull paint scratched in way of the forward ballast tank, bow thruster room and forepeak tank.
- Blue paint residue (matching the hull paint of Zhe Xiang Yu) located within and adjacent to the hull damage, extending 24 meters aft from the bulbous bow on the starboard side.

Figure 7: Polar Spirit, indentations on bulbous bow and starboard bow, scratches along the starboard side

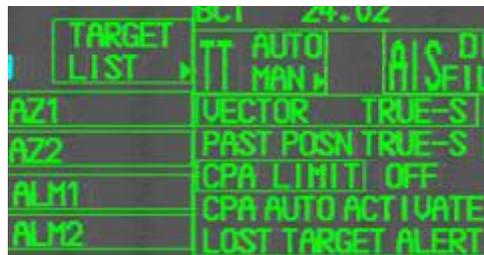
No CPA alarms were set on the radars, but a variable range marker (VRM) was set on the X-band radar, initially at 0.75Nm and then at 1NM.

Figure 10: Radar alarm settings

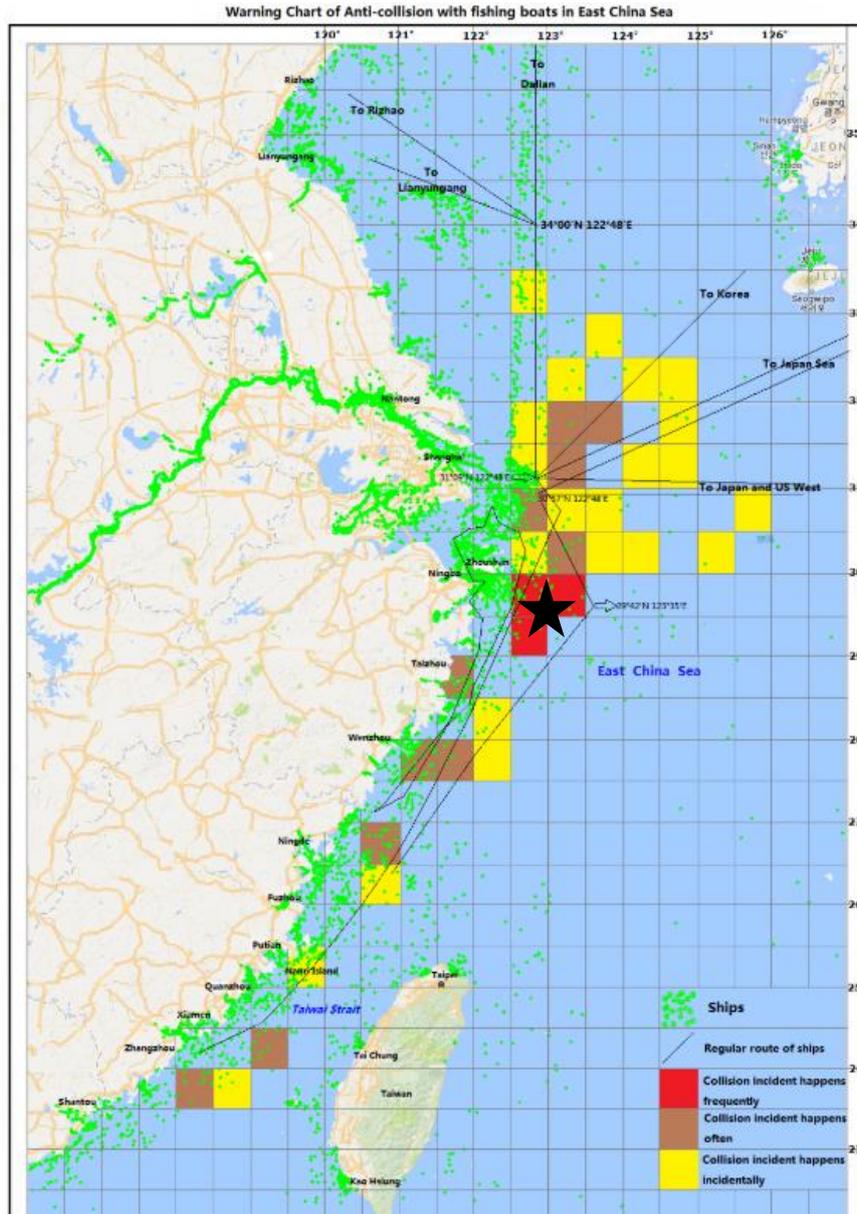
Figure 11: Collision density. Location of the collision marked “★”

Amongst other root causes, common navigational issues in these cases are a failure to adjust passage plans to avoid areas of high density fishing traffic, failure to reduce speed in high density traffic areas and action to avoid collision being inappropriate, taken too late, with too small a margin for error or a combination of the three.
