ICE ROSE & KAZANETS

Marine accident report on collision

**MARINE ACCIDENT REPORT ON COLLISION BETWEEN
ICE ROSE AND KAZANETS ON 23 SEPTEMBER 2020**

The report is issued on 9 April 2021.

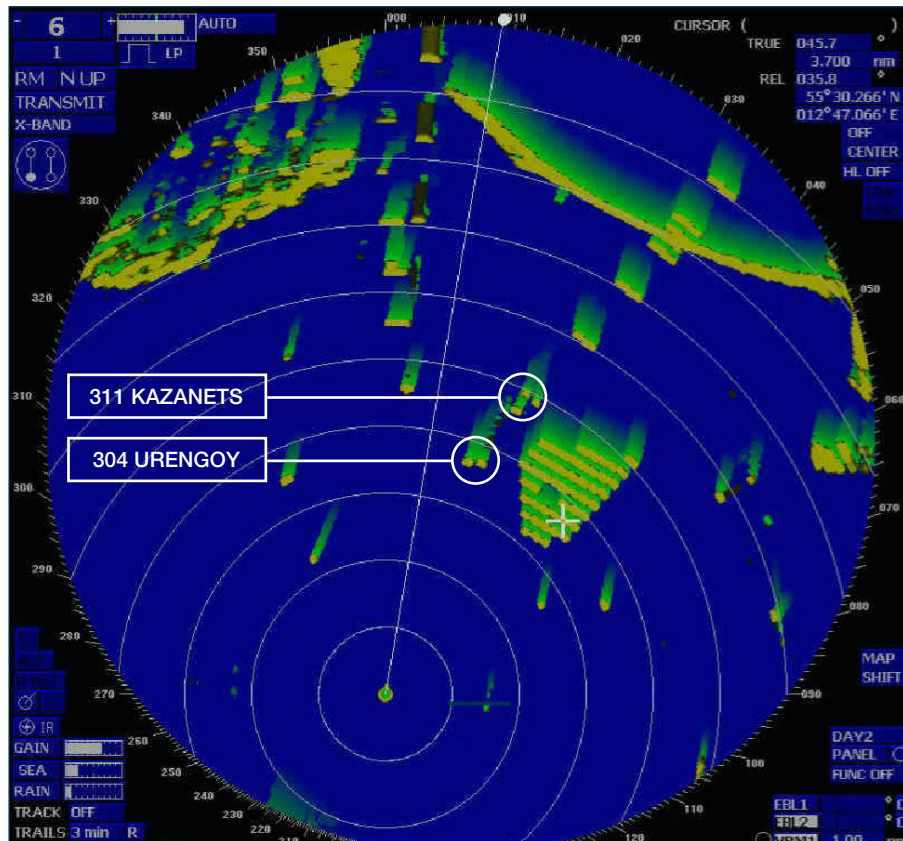
Figure 7: ICE ROSE's radar image at 0935.
Source: ICE ROSE/DMAIB

The X-band radar image from ICE ROSE at 0935 is shown on figure 7. The anti-submarine ships were passing in a fairway marked by buoys and their echoes are displayed close to line of echoes formed by the buoys. The anti-submarine ships did not transmit an AIS signal, so they were not readily identifiable on the ECS and radar display on ICE ROSE.

In figure 7, 304 URENGOY and 311 KAZANETS are marked by DMAIB. From interviews and radar images from ICE ROSE's VDR it was established that neither anti-submarine ship had been observed as a target at this point.

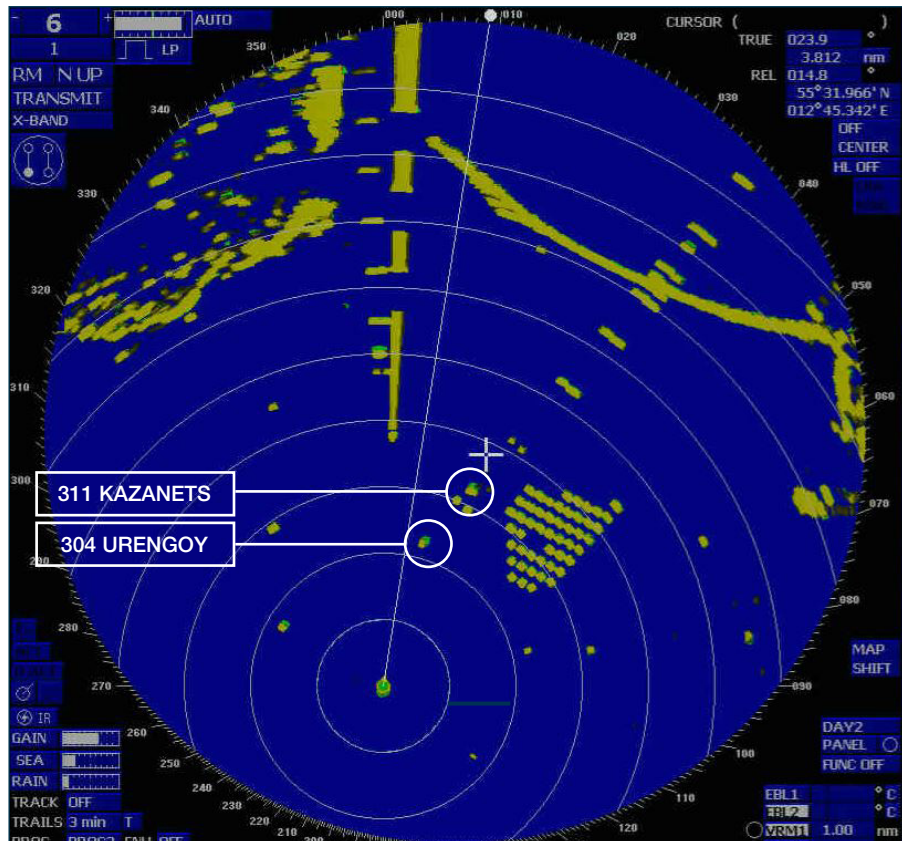
Figure 8: ICE ROSE's radar image at 0938.
Source: ICE ROSE/DMAIB

The third officer on ICE ROSE changed the trails on the X-band radar from relative motion to true motion, which resulted in the trails being reset. It can be observed that the reset of the echo trails made the individual echoes stand out more isolated from the others on the radar image, e.g. the anti-submarine ships from the buoys in the channel (figure 8).

In the radar image in figure 8, 304 URENGOY's echo is displayed outside the channel, while 311 KAZANETS had not yet left the channel. 304 URENGOY's echo was on ICE ROSE's starboard bow at a distance of approximately 2 nm, and 311 KAZANETS' echo was at a distance of approximately 3 nm. Neither of the anti-submarine ships' echoes were acquired on ICE ROSE's radar. Interview data suggests that no crewmember in the bridge team had noticed the echoes at this point.

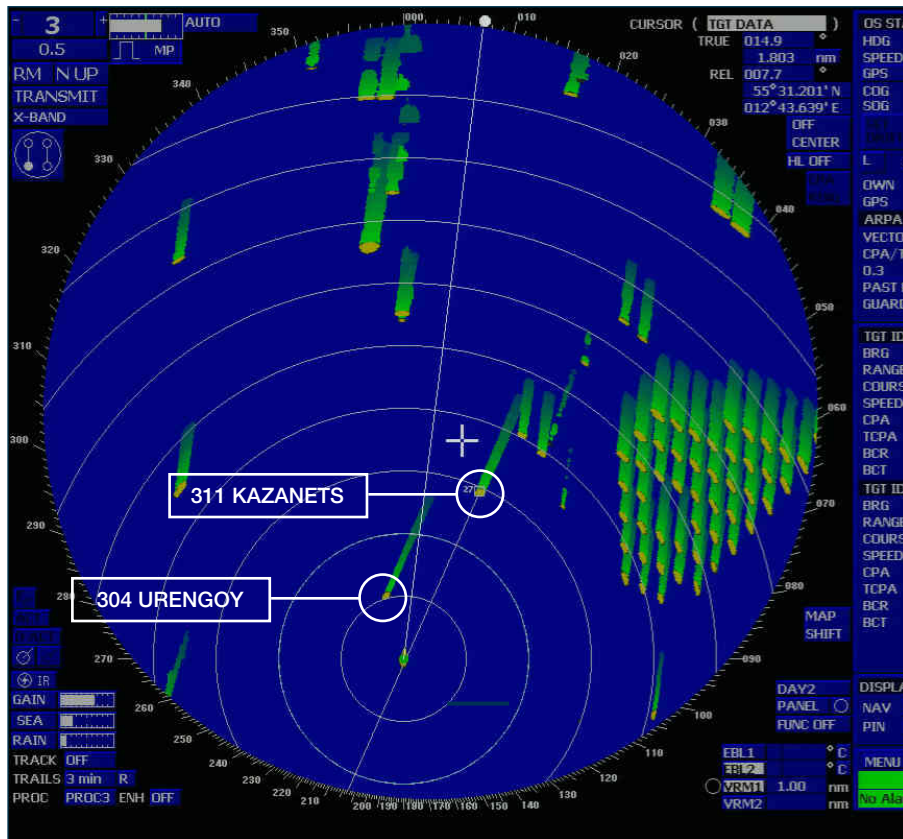
Figure 10: ICE ROSE's radar image at 0942.
Source: ICE ROSE/DMAIB

304 URENGOY's ARPA target was cancelled, and 311 KAZANETS' was acquired and selected showing the closest point of approach (CPA) of 0.02 nm (figure 10).

On the VDR recordings, the third officer calls out to the master standing on the port side of the bridge that "the next ship is coming in three minutes". While walking back to the radar located on the starboard side of the bridge, the master asked to have the message repeated. According to interview data, the master had not seen the 311 KAZANETS's target before this point, but now recognised a risk of collision.

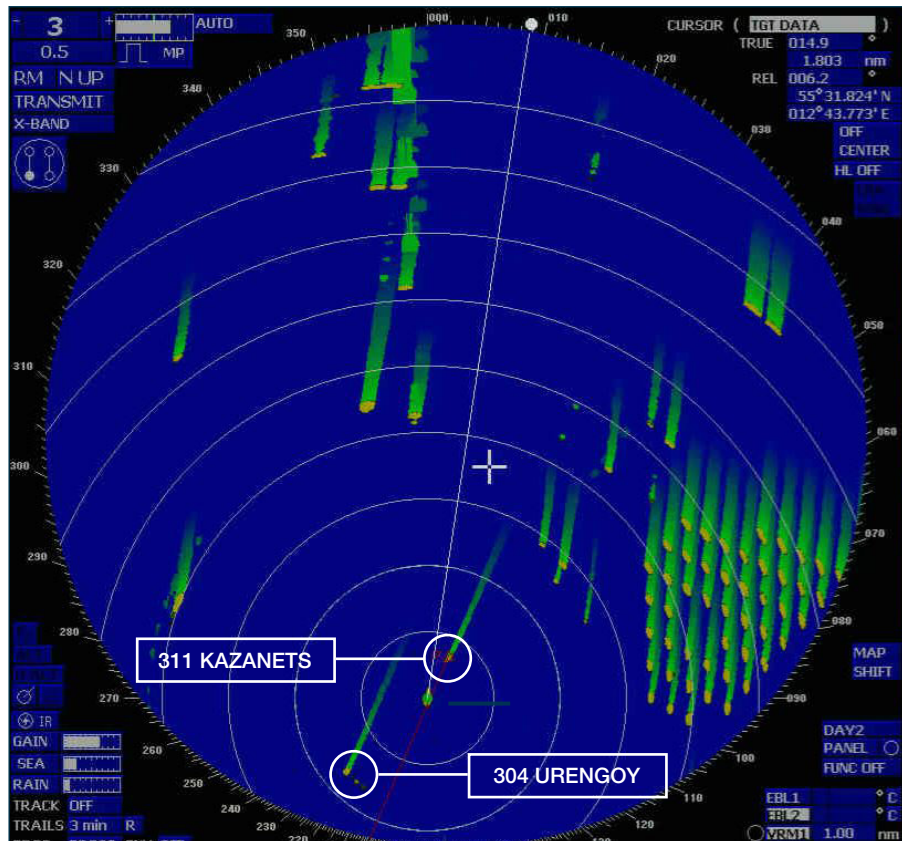
Figure 11: ICE ROSE's radar image at 0942.
Source: ICE ROSE/DMAIB

The CPA alarm activated on the X-band radar on ICE ROSE, and target information indicated that the time for collision was less than one minute. The distance between ICE ROSE and 311 KAZANETS was 0.55 nm (figure 11).

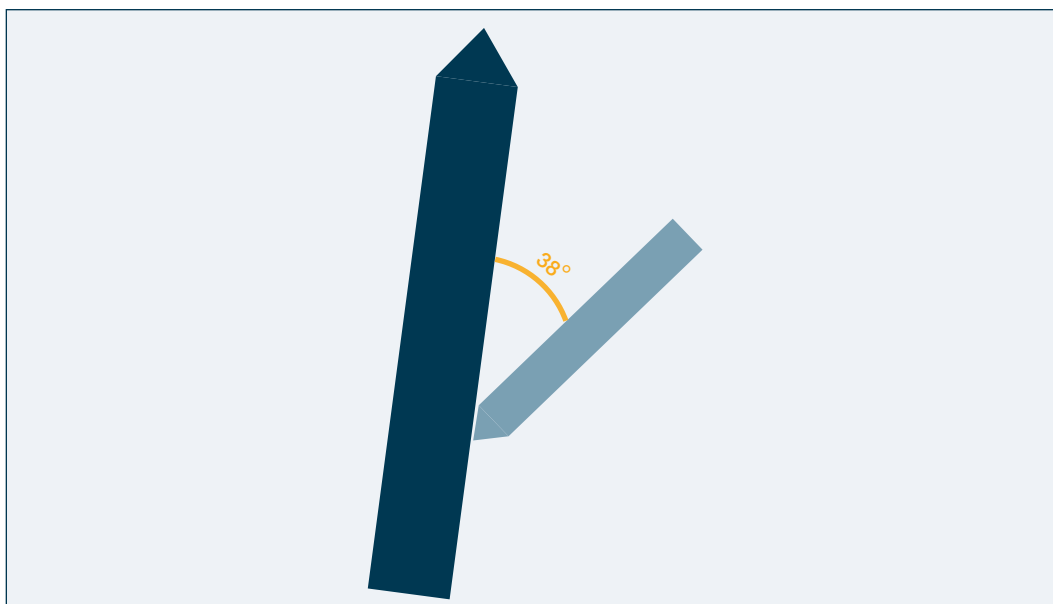
Figure 12: Angle of impact
Source: DMAIB

Based on data from ICE ROSE's VDR and the recording from Sound VTS, the course and speed of 311 KAZANETS and ICE ROSE immediately before the collision could be determined. ICE ROSE's heading was 006° and the speed was 13 knots. 311 KAZANETS' heading was 224° and the speed was 12 knots. The angle of the impact was thus approximately 38° as illustrated on figure 12.

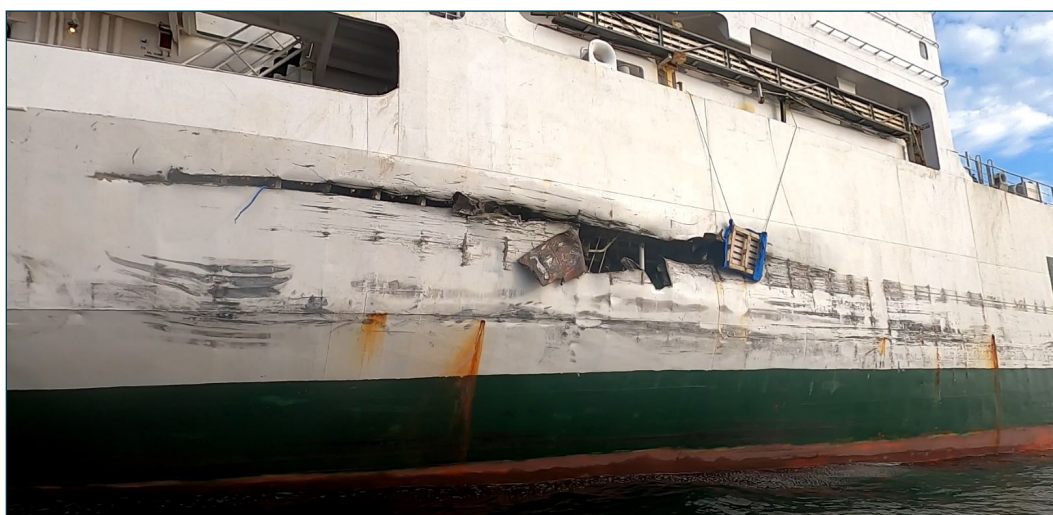
Figure 13: ICE ROSE's damages
Source: DMAIB

The external damages on ICE ROSE can be seen in figure 13. On the starboard side the ship had suffered a hull penetration extending approximately 13 metres longitudinally at 3-4 metres above the waterline. Inside the ship, an oil lubricant tank and various auxiliary systems were damaged. The black longitudinal smudging seen on the hull forward of the indentations did not originate from the collision.

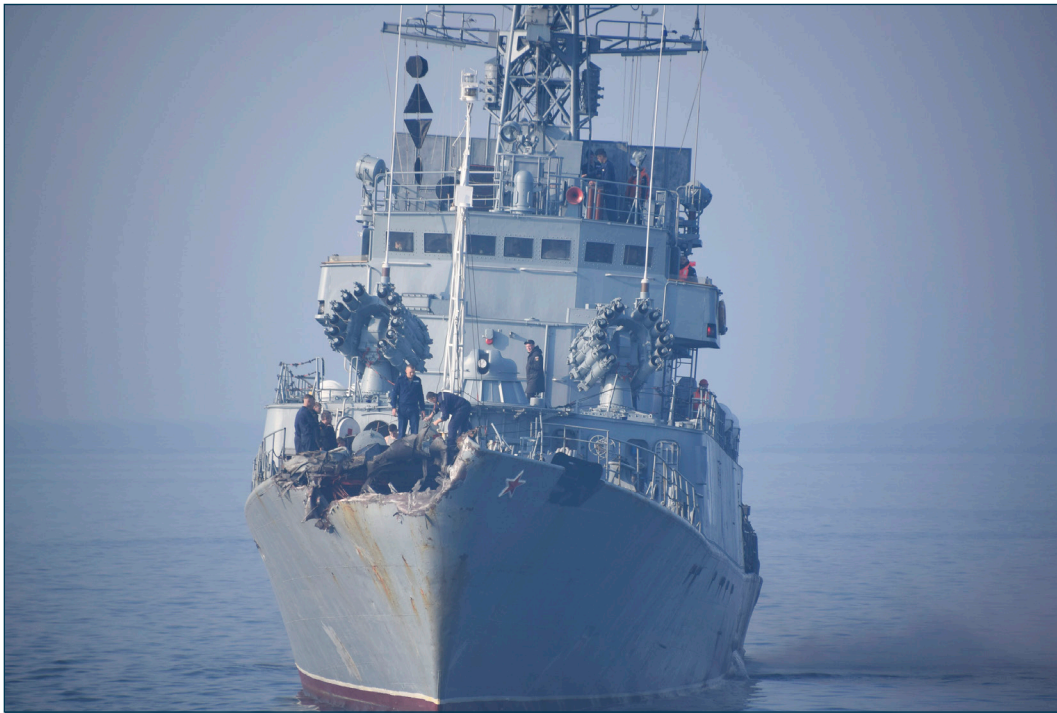
Figure 14: 311 KAZANETS' damages
Source: Private photo

DMAIB was unable to board 311 KAZANETS during the investigation but has reviewed photos taken after the collision (figure 14).

The visible external damage extended from the bow and several metres abaft on the starboard side. Some of the main deck plating had been buckled upwards and inwards indicating that a part of the bow penetrated the hull of ICE ROSE (figure 15). Debris from 311 KAZANETS' bow was found inside ICE ROSE's workshop/refrigerant plant compartment (figure 16). There was no smudging or indentations seen aft of the structural damage which indicates that the impact damages were mainly located on starboard bow.

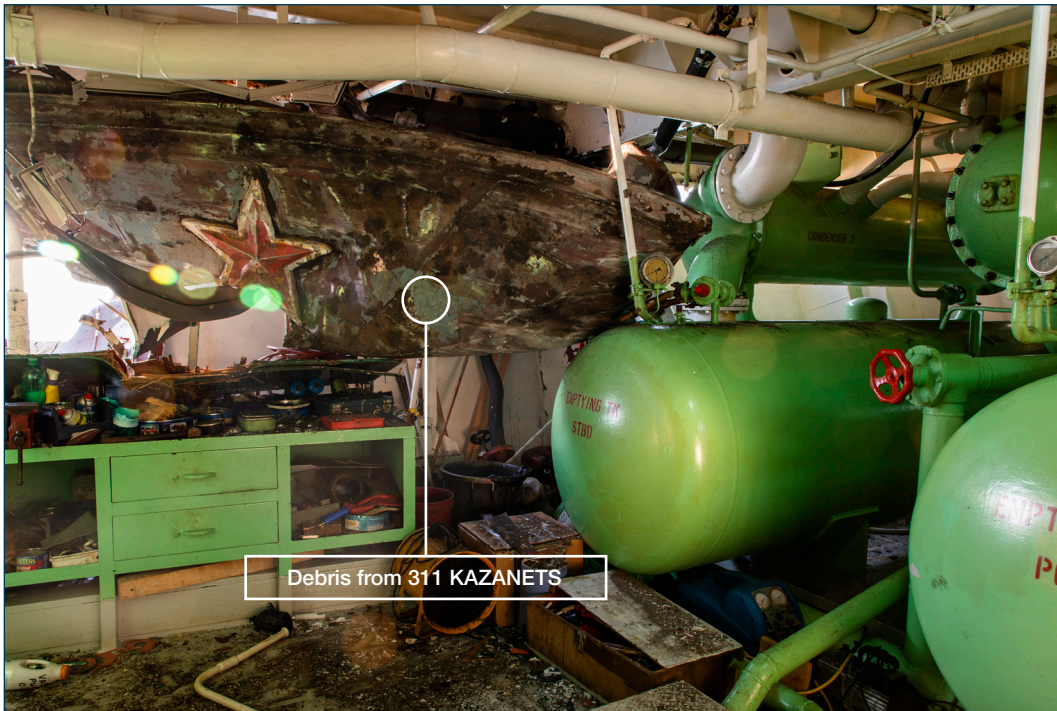
Figure 16: Debris found in ICE ROSE
Source: DMAIB

From 0942 when 311 KAZANETS was acquired as target on ICE ROSE's radar until impact at 0946, no change of course or speed could be observed in 311 KAZANETS' target information. Additionally, from 311 KAZANETS' relative trails there was no visible change of course or speed. This is supported by the recording from Sound VTS. Comparing the ships' headings prior to the collision and the angle of the impact on figure 13 with the damages seen on ICE ROSE and 311 KAZANETS, it is likely that 311 KAZANETS did not make a hard turn to neither port nor starboard before the collision. If 311 KAZANETS had made a significant turn to port, then the damage would be extended further aft. If 311 KAZANETS had made a significant turn to starboard, then the damage would have extended to the port side of the bow.

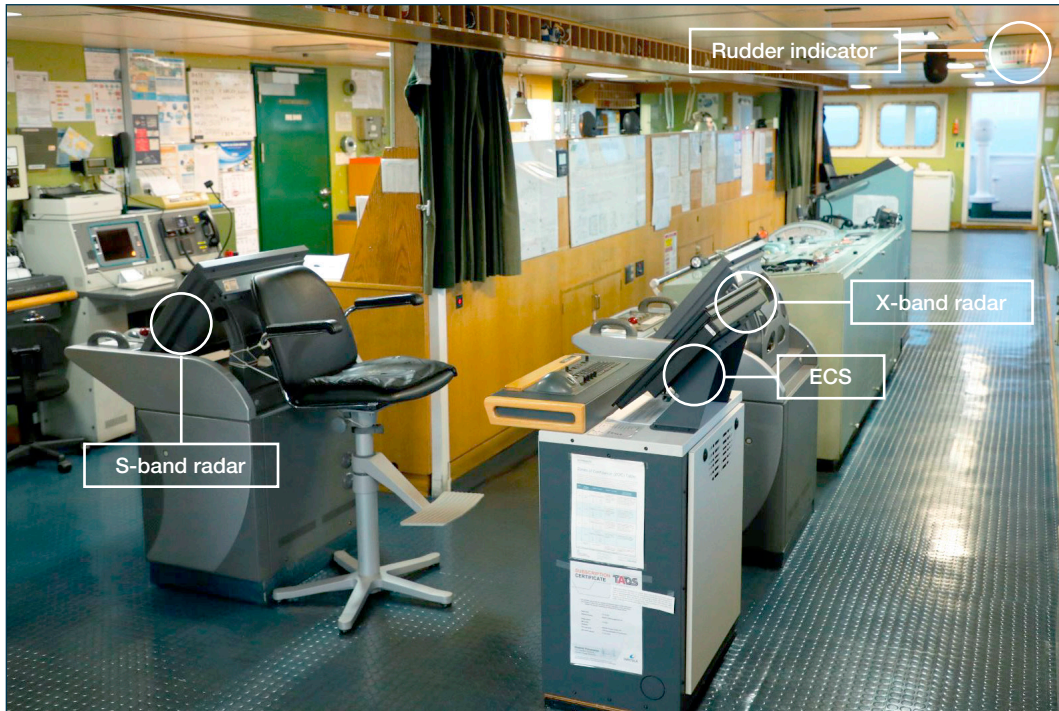
Figure 17: ICE ROSE bridge layout.
Source: DMAIB

ICE ROSE was equipped with two radar control stations located on the starboard side of the bridge, one in front of the other. The forward radar was an X-band radar which was used most by the bridge team. The X-band radar was conveniently located next to the ECS and alongside the engine controls, VHF radio and auto-pilot (figure 17). From this location the watchkeeping officer was in line of sight of the helmsman and the rudder indicator enabling the watchkeeping officer to verify that rudder and course commands were carried out correctly. The S-band radar was located aft of the X-band radar. It was mainly used if there was interference on the X-band radar which made it difficult to detect relevant targets. It was not actively and continuously used, because the paper chart table was located next to the aft radar behind a curtain which blocked the view of the front and port side windows, making it difficult to keep visual lookout. Additionally, when standing by the radar the watchkeeping officer had a poor overview of the bridge, e.g. ECS, helmsman, rudder indicator, etc.

During the interviews and the reconstruction of events it became evident that this layout of the bridge influenced the collaboration and division of work between the master and third officer. The master and third officer shared the X-band radar and ECS, but the location of the X-band radar and ECS did not provide adequate room for the master and third officer to comfortably stand by the same display. Therefore, they rarely monitored the same display simultaneously.

The operator of ICE ROSE has informed DMAIB that the company has issued a fleet circular acknowledging the inexpedient positioning of the radars on some of the company's vessels. However, the company has found that the problems associated with the ergonomics of the bridge can be mitigated by instructing the bridge watchkeepers on specific practices regarding watchkeeping in confined waters, which includes rearranging the division of work among the bridge watchkeepers and how the radars are used.

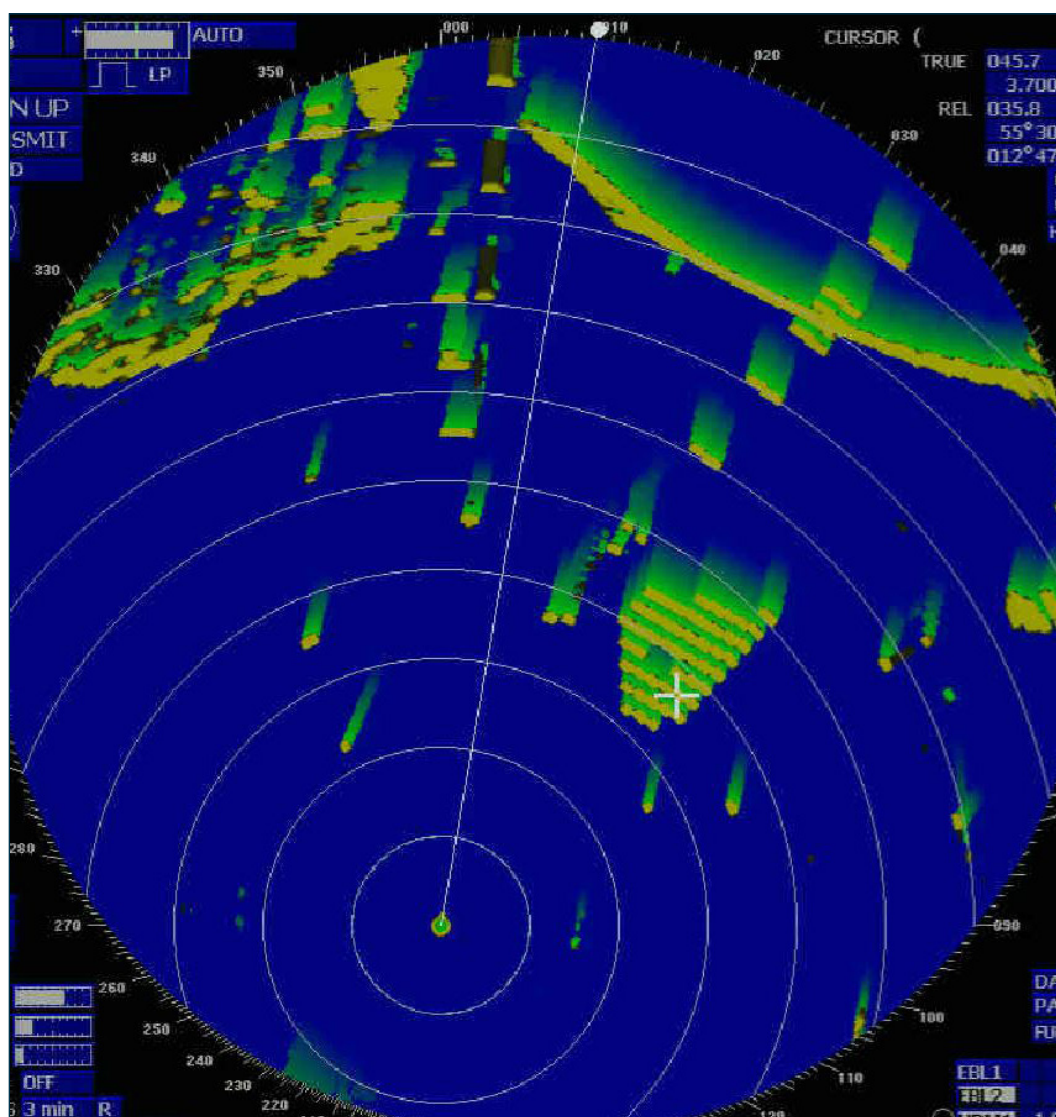
Figure 18: ICE ROSE's radar configuration at 0935.
Source: ICE ROSE/DMAIB

Figure 18 shows the X-band radar's screen at 0935 LT as ICE ROSE is proceeding north-bound towards Drogden Lighthouse. The radar configuration can be seen in the table next page.

This configuration and operation of the radar had both advantages and disadvantages. The advantage of using relative trails and 60 minute relative vectors in conjunction with 1 nm range rings was that the CPA of targets could be assessed at a glance without interrogating the target information in the radar menu. Additionally, by selecting targets based on the relative trails it was not necessary to acquire all potential targets on the screen which could cause a clutter of vectors. The master and third officer were thus mainly relying on visual cues and did have to rely on selecting the various targets and interpreting the values of CPA, TCPA, etc.

There were mainly two disadvantages of this configuration and operation of the radar. Firstly, echoes from approaching ships could be concealed in the clutter from other moving or stationary objects which could delay the target acquisition. Secondly, getting information about potentially dangerous targets could be delayed when considering that the vector may not reach a given level of accuracy until three minutes or more have passed after target acquisition. Even if three minutes or more have passed, the vector may include an error depending on the tracking conditions¹.

From interviews with the third officer and master it was evident that they had not observed the anti-submarine ships at 0935 LT. The third officer might not have detected the anti-submarine ships, because they were hidden in the clutter of the buoys in Flinterenden, even though he was continuously monitoring the radar. The constant monitoring of the radar was verified by observing the VDR recording where a continuous movement of the cursor can be seen. The third officer first became aware of the anti-submarine ships after the trails were reset at 0938, and the ships had exited Flinterenden and were thus distinguishable from the buoys.
