Investigation Report 117/11

Very Serious Marine Casualty

**Collision between the TYUMEN-2  
and OOCL FINLAND  
on 14 April 2011 in the Kiel Canal**

27 June 2014

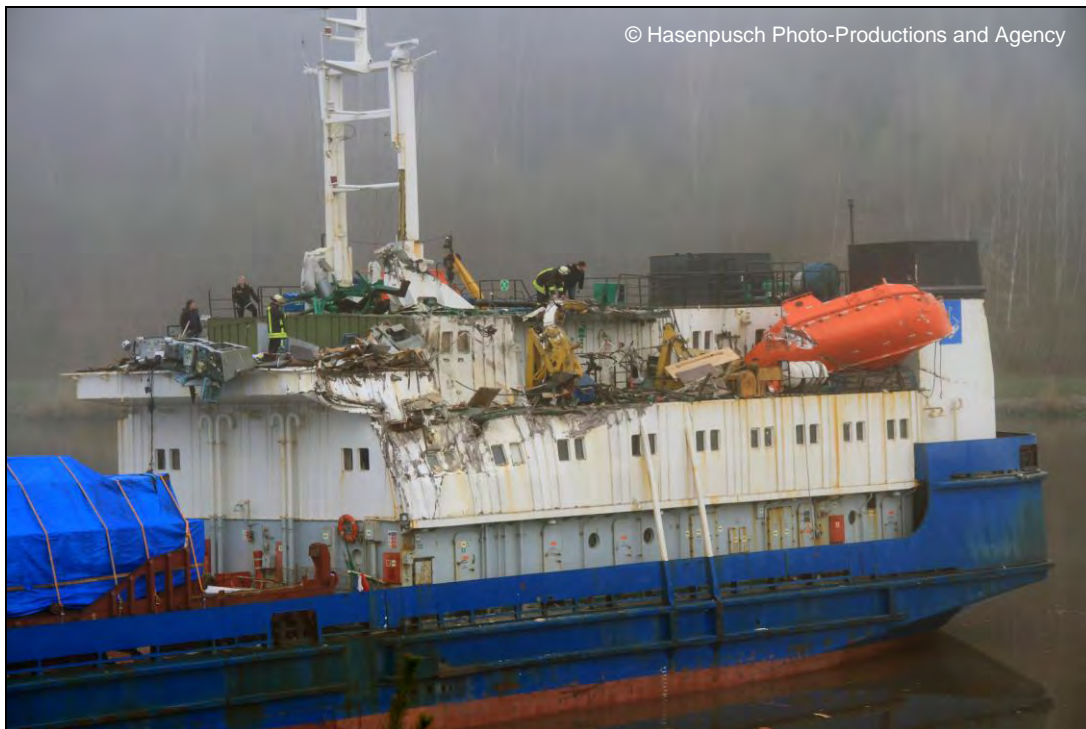
Separated from the rest of the superstructures because of the collision, the wheelhouse of the TYUMEN-2 plunged into the canal. Prior to that, parts of the wheelhouse must also have been situated on the deck of the OOCL FINLAND for a short period as the TYUMEN-2's canal helmsman as well as furnishing and equipment from the bridge were found there later behind the forecastle. The helmsman died there. The TYUMEN-2's pilot was found dead on her deck after the collision. The master and the cadet suffered serious injuries and the chief engineer a minor injury and broke a foot. Following the lack of control, the ship ran into the embankment on the southern side at an angle of approximately 45°. External communication was impossible due to the total destruction of the bridge.

The collision also caused damage to the lifeboat on the port side, its launching device and other parts of the superstructures. A small quantity of hydraulic oil escaped.

Figure 5: TYUMEN-2, damage to the superstructures and lifeboat

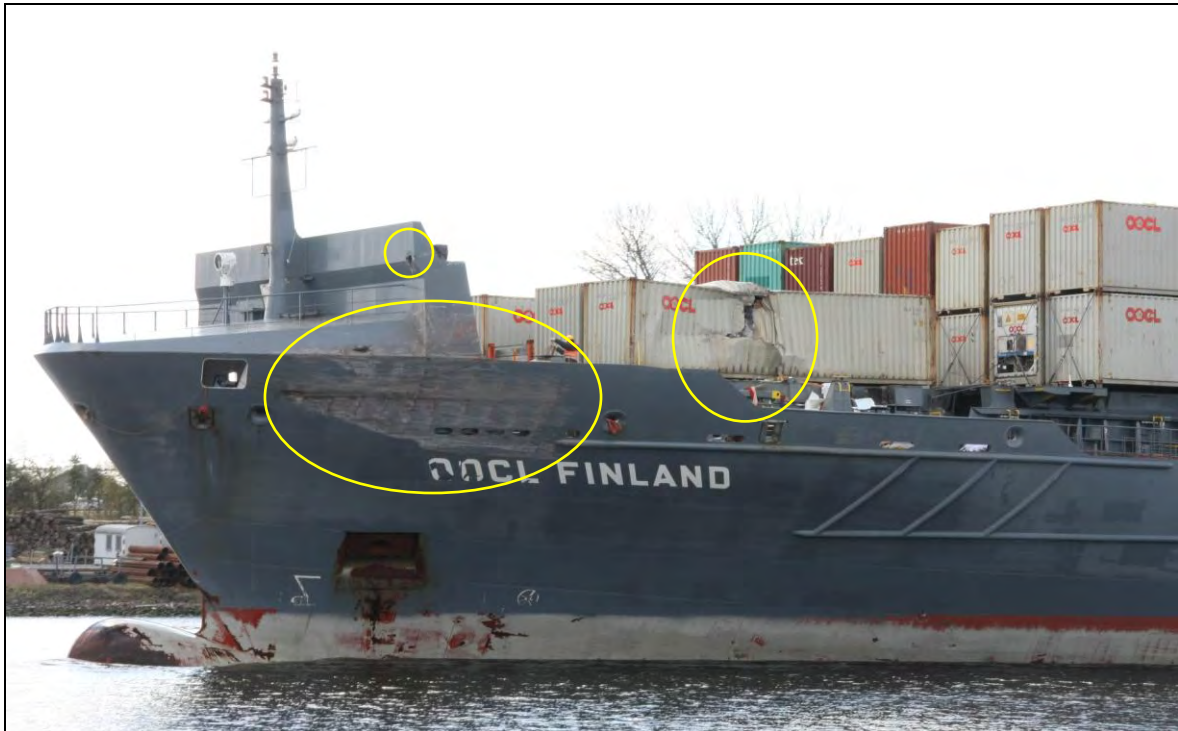
The collision damage on board the OOCL FINLAND was only minor. No members of the crew were injured. There were only small indentations and cracks on the port side of the forecastle and on the upright breakwater. One container was also damaged. There was no damage to the environment.

Figure 6: OOCL FINLAND, damage to the bow and one container

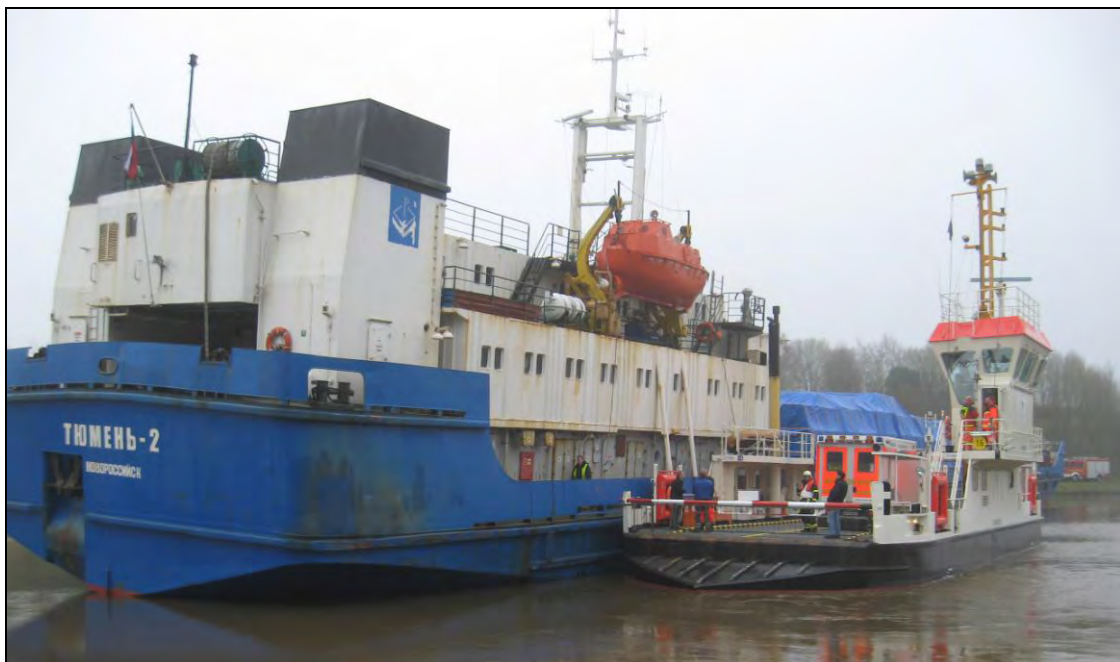
The situation on board the TYUMEN-2 was as follows: “Vessel is in the southern embankment. Bridge largely destroyed, large parts of the bridge walls on starboard side, in the front and on the port side and the navigation deck are missing. Tanks are sounded by the first officer upon request of the head of operations. However, no water ingress could be detected. Slight smoke emission from the destroyed bridge, minor oil leakage (presumably hydraulic oil from a burst pipe) into the Kiel Canal [...]. Two injured persons were recovered by the ferry Fischerhütte and taken to the ferry berth. Another less serious injured crewmember refuses to disembark. Ten other crewmembers are on board, but are obviously in a state of shock. It is only possible to communicate with the vessels crew to a limited extent.”

Figure 9: The SWINEMÜNDE at the TYUMEN-2 during her second call

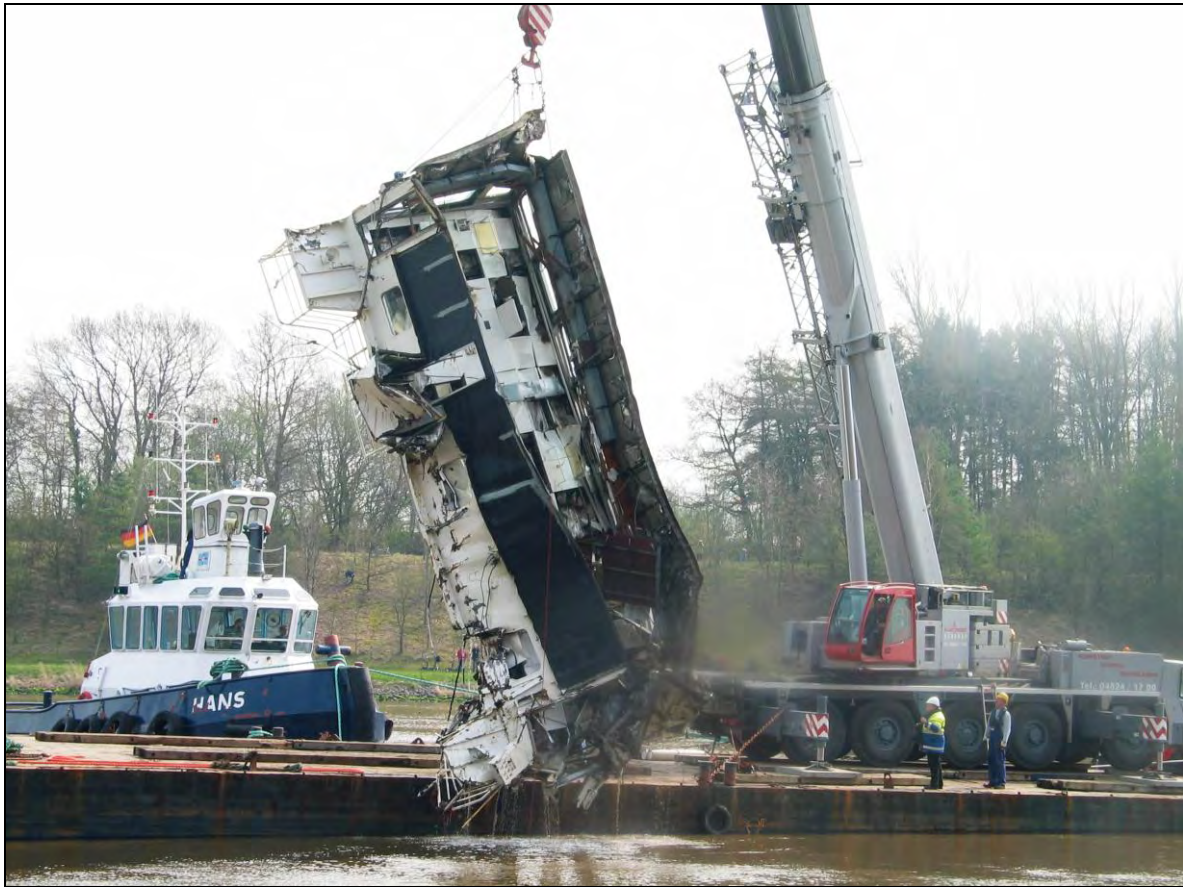
The TYUMEN-2's wheelhouse was recovered by a salvage company on behalf of her operator on 16 April 2011 (see Figure 10). Two tugs and a mobile crane on a pontoon were tasked to do this. After it was recovered, the wheelhouse was also transported to the Nobiskrug shipyard and left there.

Figure 10: Recovery of the TYUMEN-2's wheelhouse

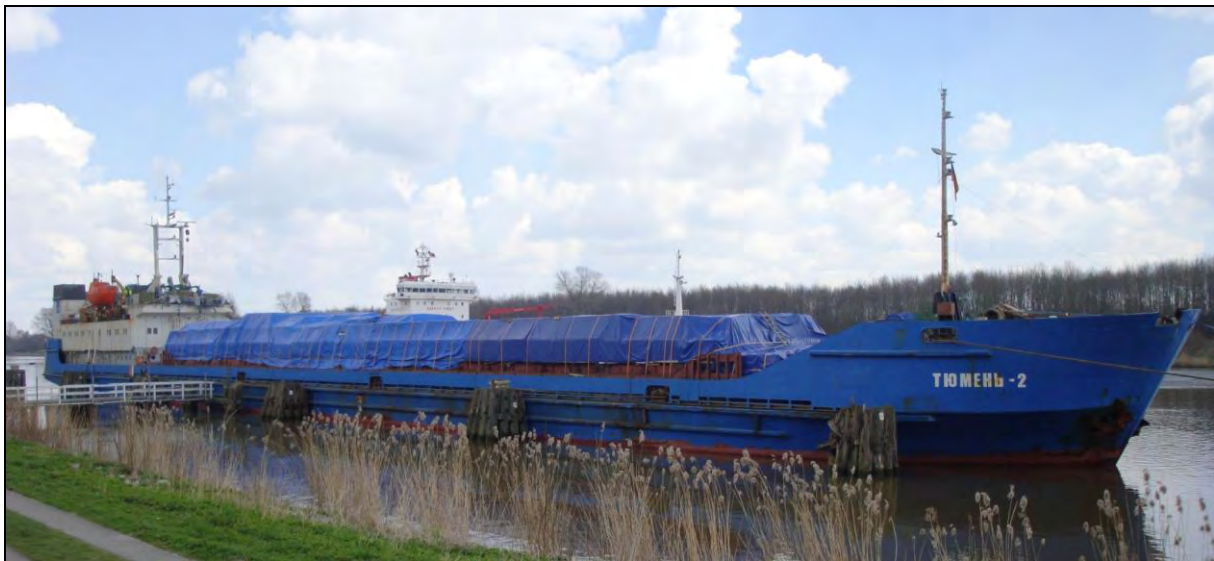
Figure 14: TYUMEN-2 after the collision. Photo taken in the siding at Fischerhütte

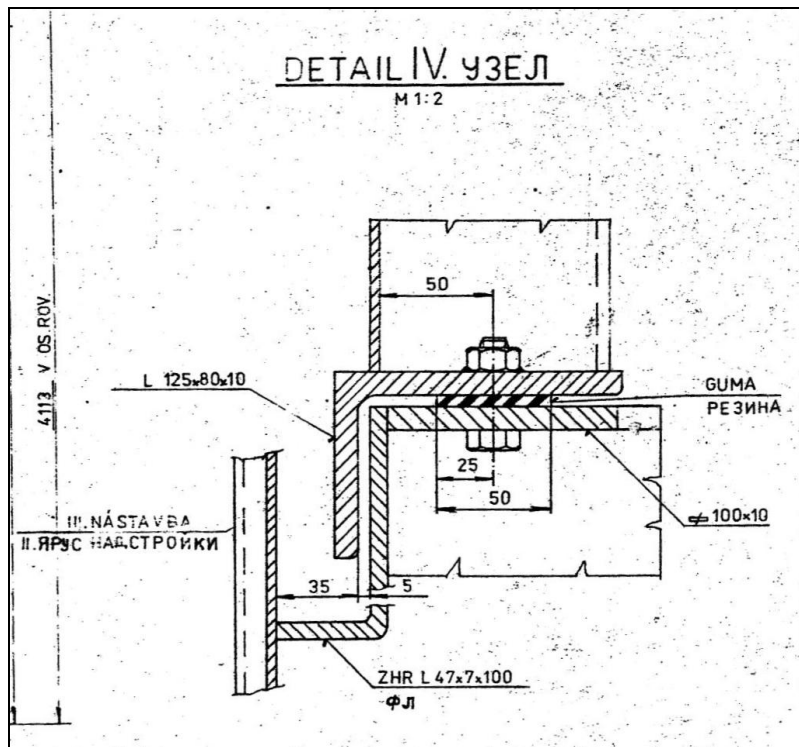
"[...] the helm has been produced separately and bolted onto the foundations and deck superstructures, which are welded to the boat deck.

Figure 16: TYUMEN-2, detail drawing, wheelhouse/deck house connection

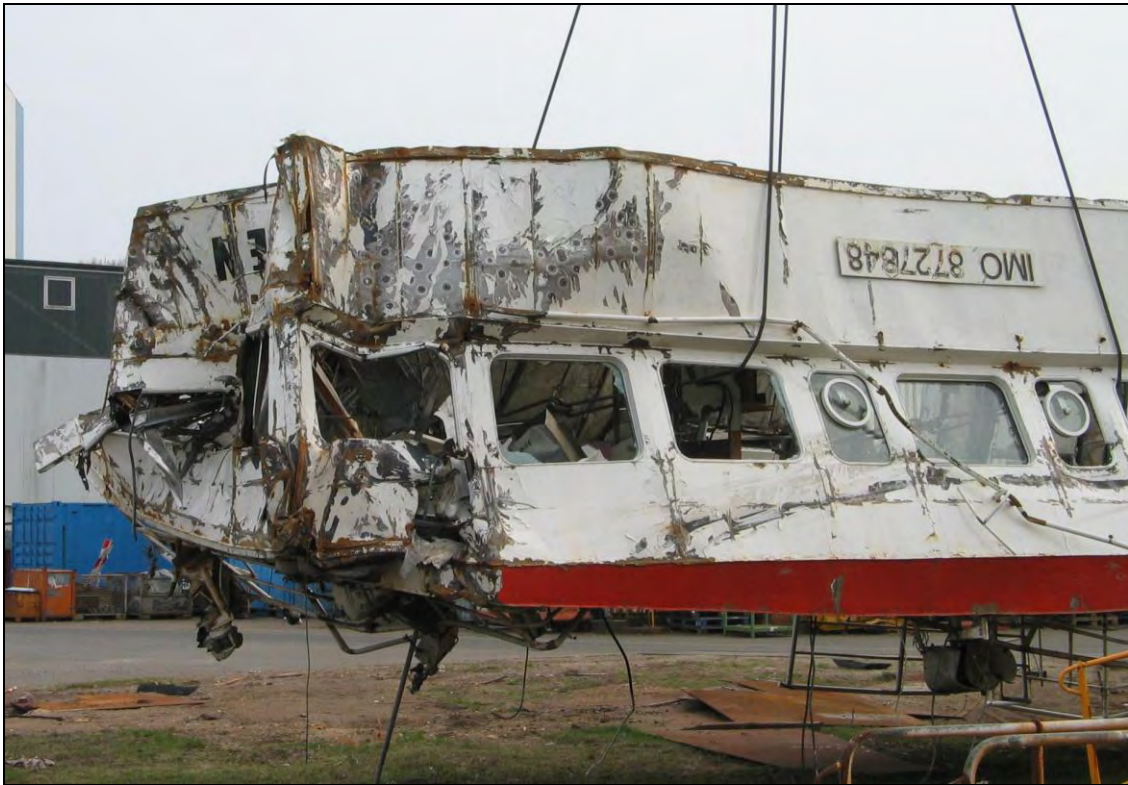
Figure 17: TYUMEN-2, point of impact on the port side front of the wheelhouse

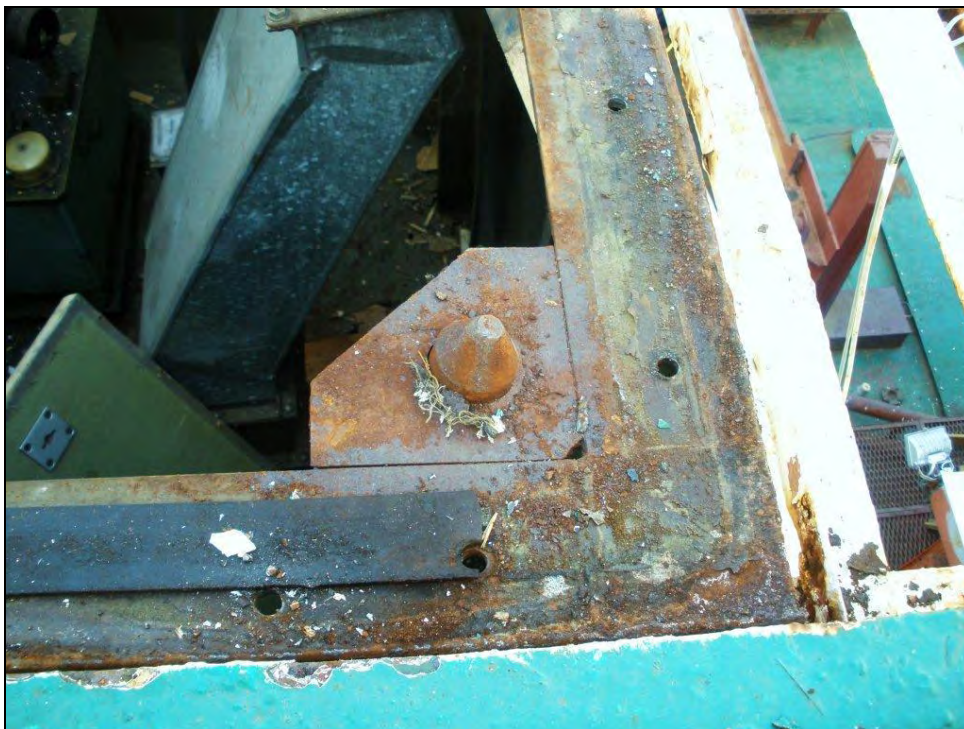
Figure 18: TYUMEN-2, installation cone at the outer corners of the foundation of the wheelhouse, irregular hole spacing of the screw connection and rubber layer

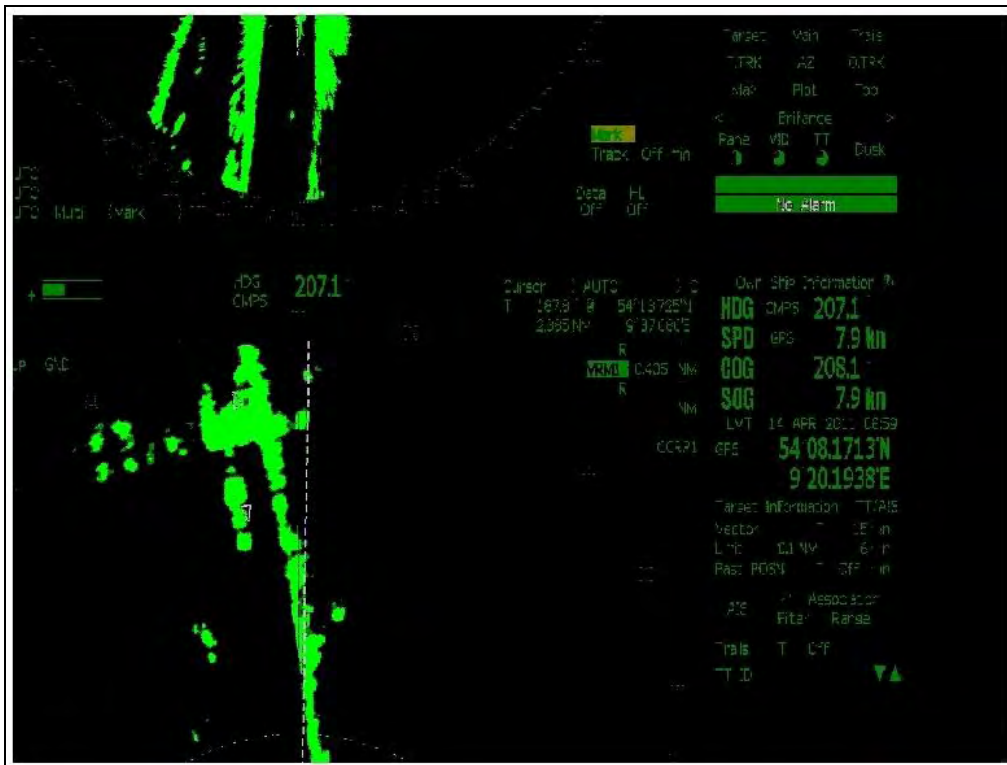
- The replayer's display of the radar is unusable for an analysis because the upper and lower halves of the radar image are composited incorrectly (see Figure 22). Moreover, areas in the centre and on the left border are not shown. This may be caused by an error or a wrong setting while accessing the image data in the radar or saving the radar data.

Figure 22: TYUMEN-2, S-VDR, 'Radar' view at 065947, ahead (distance about 0.7 nm) Passage of the OOCL FINLAND and NORDIC DIANA with corresponding AIS symbols
