# National Transportation Safety Board

## Marine Accident Brief

### Collision between Containerships *Marcliff* and *APL Guam*

<b>Accident type</b>	Collision	<b>No.</b>	DCA19FM028
<b>Vessel names</b>	<i>APL Guam</i> , <i>Marcliff</i> , <i>Hansa Steinburg</i>		
<b>Location</b>	YL-4 Anchorage, Port of Yokohama, Tokyo Bay, Japan 35°25.46' N; 139°42.98' E		
<b>Date</b>	March 21, 2019		
<b>Time</b>	2327 Japan standard time (coordinated universal time + 9 hours)		
<b>Injuries</b>	None		
<b>Property damage</b>	\$1,178,200 est.		
<b>Environmental damage</b>	None reported		
<b>Weather</b>	Visibility clear with passing clouds, winds southwest at 18 knots, seas 1–2 feet, air temperature 64°F, water temperature 64°F		
<b>Waterway information</b>	Yokohama is a busy cargo and passenger port within the heavily congested Tokyo Bay. Two channels, the Yokohama Passage and the Tsurumi Passage, provide shipping access to the piers and terminals within the port. Several anchorage areas are located outside the channels in the bay.

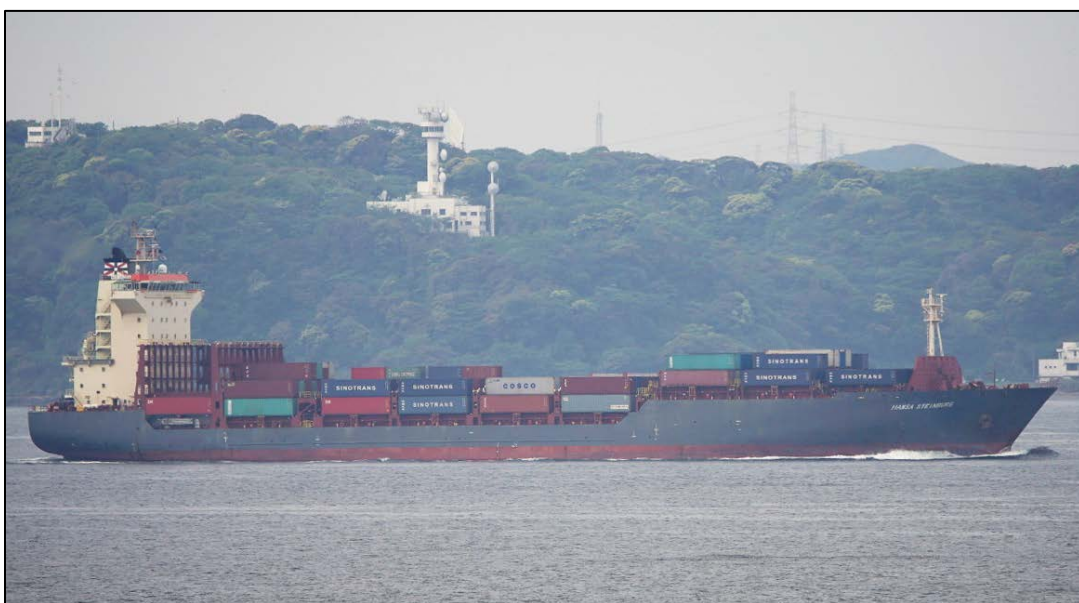
*Hansa Steinburg* postaccident. (Source: D. Nimura)

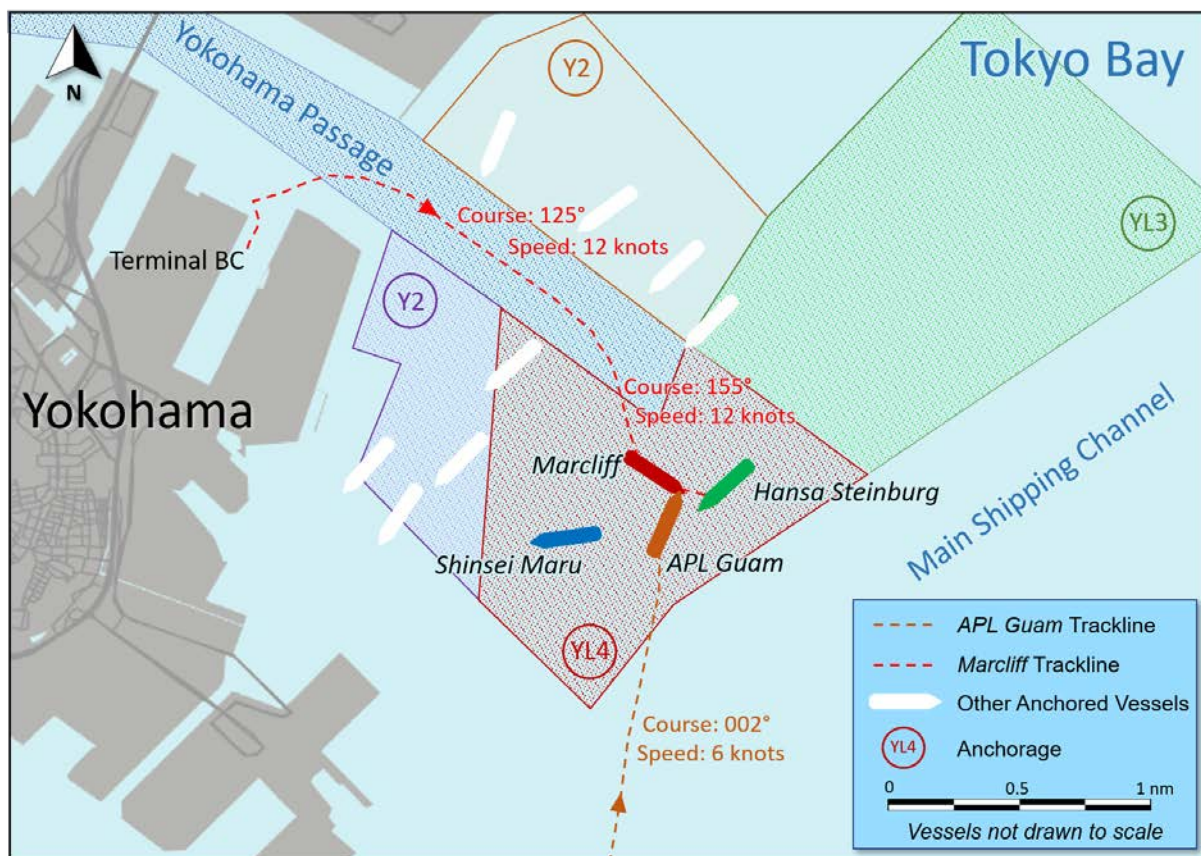
Yokohama harbor with accident vessel tracks. (Background source: Google Maps)

As shown in the illustration on page 4, the Yokohama Passage terminates in anchorage YL-4 and does not extend to the main shipping channel. Ships inbound to or outbound from the passage must pass through the anchorage, navigating between anchored vessels. This arrangement encourages vessel bridge teams to take the most expeditious route through the anchorage, as the *Marcliff* master did when he turned south-southeast, regardless of the risks of navigating in close proximity to anchored vessels. Thus, the arrangement of the Yokohama Passage, terminating in the YL-4 anchorage instead of extending to the main shipping channel, increases the risk of accidents such as this one.

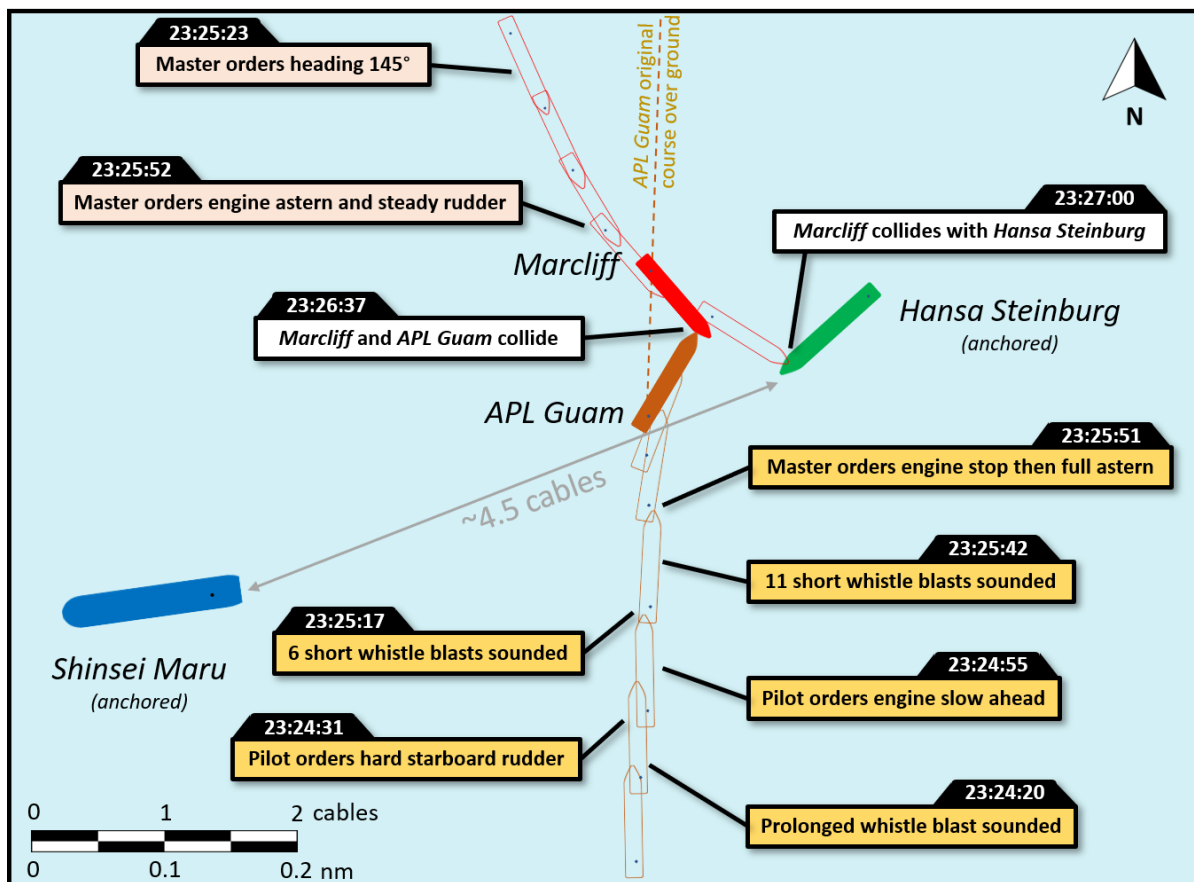
**Accident timeline. Vessels drawn approximately to scale; positions compiled from automatic identification system (AIS) and VDR data.**

The *Marcliff* master stated that his intention was to pass starboard to starboard with the *APL Guam*, and that had the *APL Guam* continued on its original course, the *Marcliff* would have passed safely with 2 cables distance between the *APL Guam* on one side and the *Hansa Steinburg* on the other. However, investigators estimate that the total distance between the *Hansa Steinburg* and the anchored *Shinsei Maru* was about 4.5 cables—wide enough for only one vessel to pass between the two while maintaining more than 2 cables separation on either side. Even if the *APL Guam* had continued on its original course instead of turning hard starboard, the total distance between the *APL Guam* and *Hansa Steinburg*, in which the *Marcliff* intended to pass, was less than 2 cables.

Because the *APL Guam* and the *Marcliff* were in a crossing situation and the *APL Guam* was on the starboard side of the *Marcliff*, by international convention, the *Marcliff* was required to keep out of the way of the *APL Guam* and avoid crossing ahead of it.<sup>6</sup> The master ordered a 10 degree turn to port about 1 minute before the collision, but the *Marcliff* should have altered course to starboard to avoid crossing ahead of the *APL Guam*. A turn to starboard would have been predictable by the *APL Guam* pilot and bridge team and resulted in a port to port meeting between the vessels. Thus, the master's turn to port (and his stated intention to pass starboard to starboard) would have been unexpected by the pilot and bridge team on the *APL Guam*. The *Marcliff* master did not appear to recognize the dangerous situation that was developing until 2325:51—45 seconds before the accident—and at first took no action despite a recommendation from the third mate to use astern propulsion. When the master eventually ordered the engine astern, it was too late to avoid the collision.

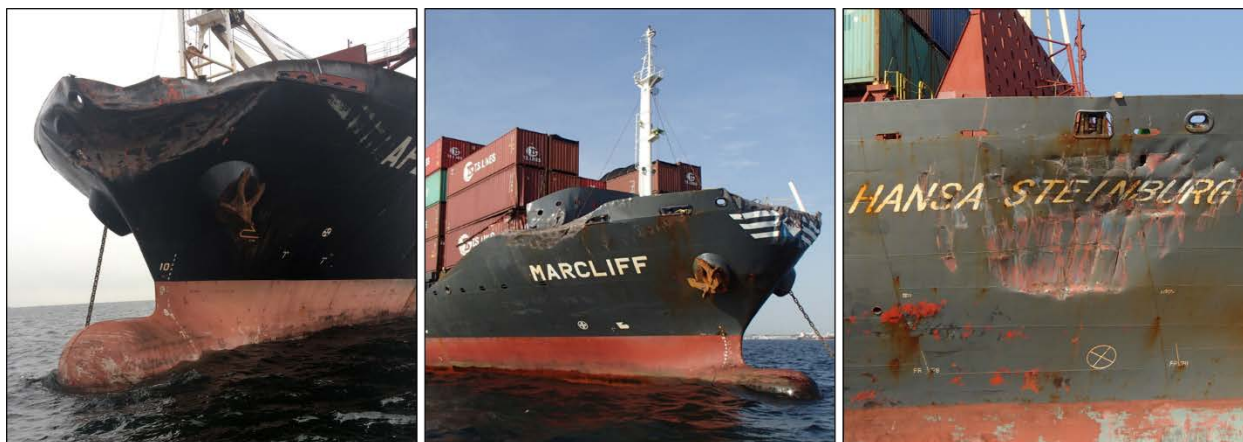
Damage to *APL Guam* bow (left); *Marcliff* bow, starboard side, and container (center); and *Hansa Steinburg* starboard-side bow. (Source: US Coast Guard)

As a result of the collision, the shell plating and bulwarks around the bow and the bow stem near the deckline of the *APL Guam* were stove in, and a hole was opened up in the hull on the starboard bow. The deck plating at the bow was bent downward, and deck and hull framing in the bow area was warped and fractured. On the *Marcliff*, the starboard-side bulwarks on the bow were bent inward and a small crack in the shell plating was opened near the deckline, the starboard-side windbreak was pushed back into the container behind it, and the container suffered a gash nearly three-quarters its length. A container mounting on the starboard-side main deck was also sheared and bent aft. When the *Marcliff* collided with the *Hansa Steinburg*, the *Marcliff*’s bow was pressed inward near the top of the stem, and bulwarks were folded inward. On the *Hansa Steinburg*,

hull plating near the vessel's name plate was inset, and several small cracks were opened. Total damage for all three vessels was estimated at \$1,178,200.
