## MARINE SAFETY INVESTIGATION REPORT

Safety investigation into the collision between the  
Maltese registered bulk carrier

***EVANGELIA PETRAKIS***

***MAYSSAN***

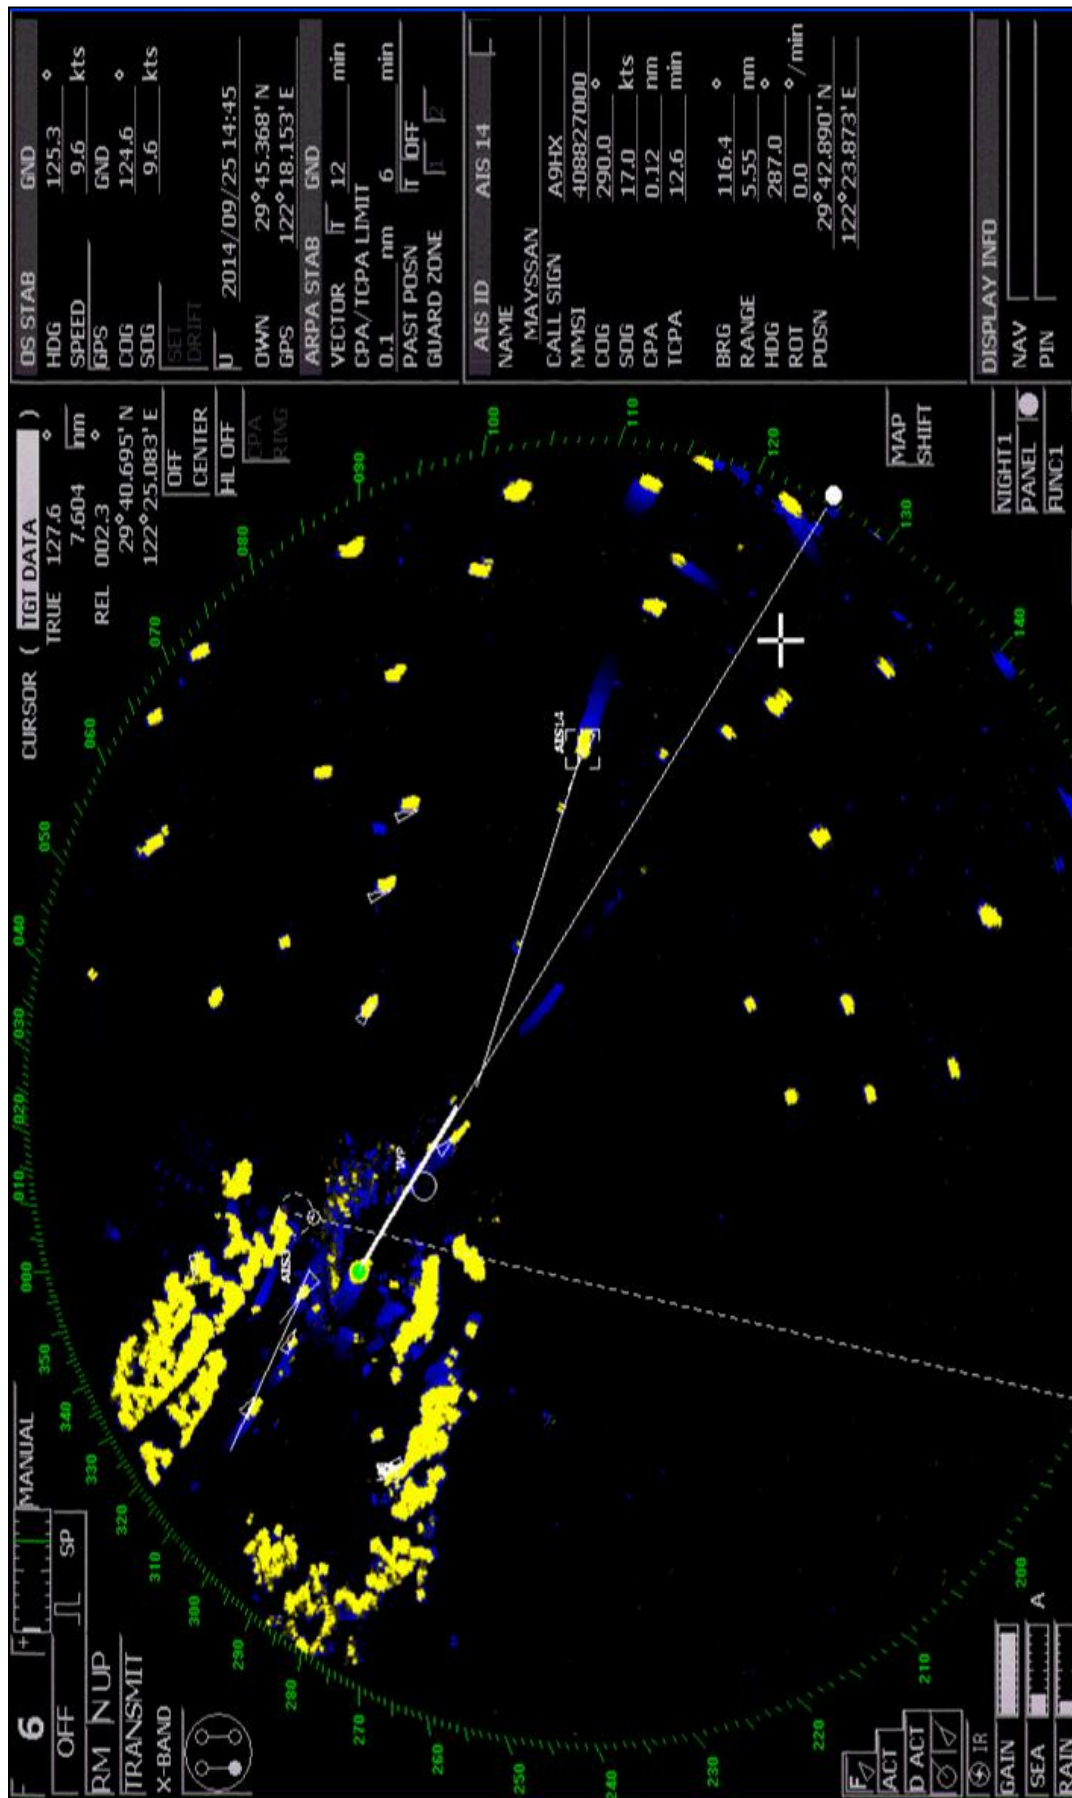
At 2245, a target identified as *Mayssan* was sighted both visually and on the radar. The target was about one point on the port bow of *Evangelia Petrakis*, and at distance of 5.55 nautical miles (nm). *Mayssan* was exhibiting green side light and masthead lights. *Mayssan* was in-bound on a course of 287°, approaching Xiazhimen TSS at 17 knots to pick up the pilot for Ningbo port. Both vessels were in a crossing situation. The CPA and TCPA were reported 0.12 nm and 12.6 minutes respectively. Relative position of both vessels is shown on BA Chart 1126 and the VDR screen shot (Figure 2).

Figure 2: VDR screen shot showing CPA and TCPA

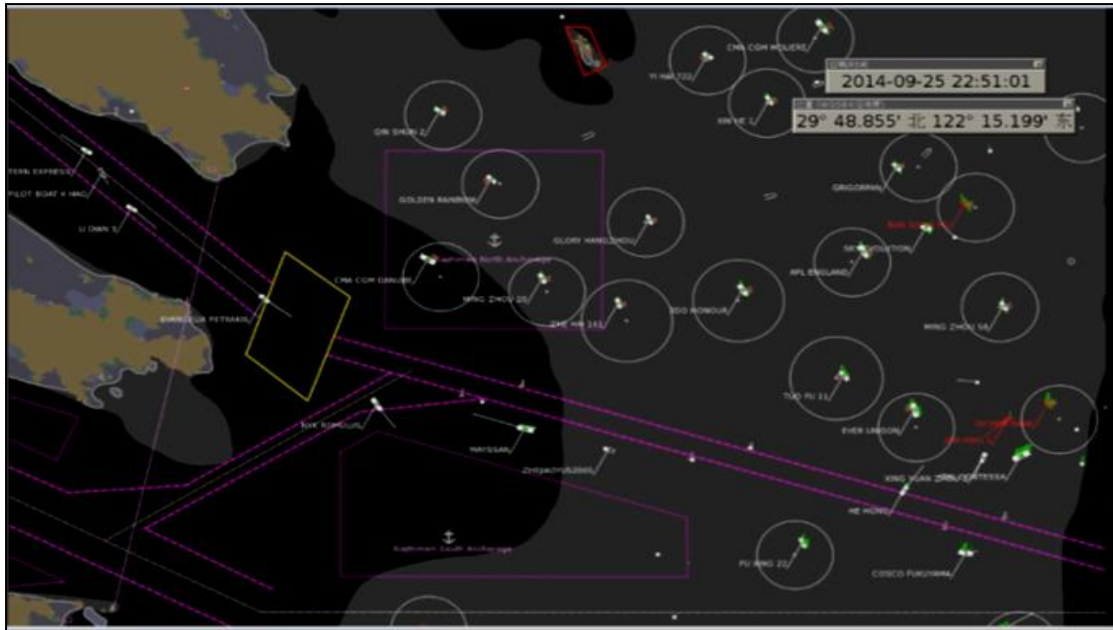
At 2247, *Evangelia Petrakis* reported her position to Ningbo VTS and reached waypoint no. 7 at 2251 (Figures 3 and 4). At the same time, she entered the precautionary area adjoining the Xiazhimen TSS. No course alteration was made for the next planned course 119°(T) at waypoint no. 7. Instead, she continued steering 130° and at which point, the third mate observed no change in *Mayssan's* green side light and masthead lights.

Figure 3: Screen shot from Ningbo VTS video at 2251

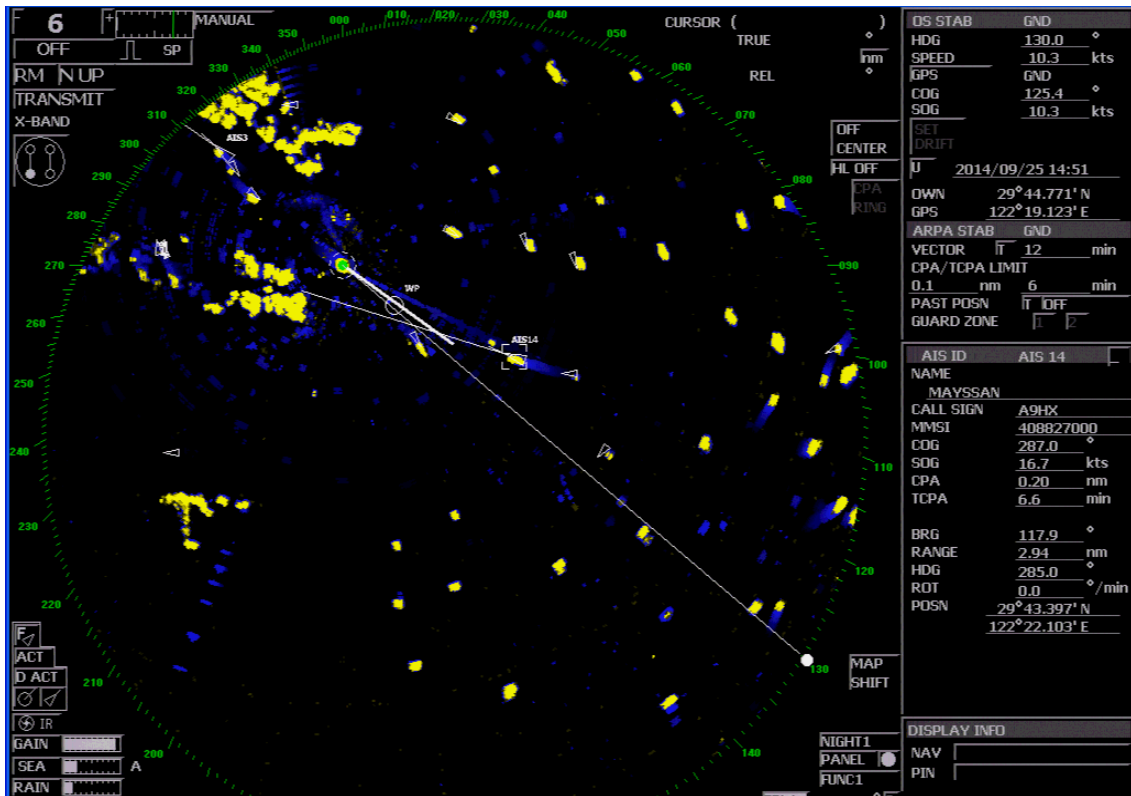
Figure 4: Screen shot from *Evangelia Petrakis* VDR at 2251

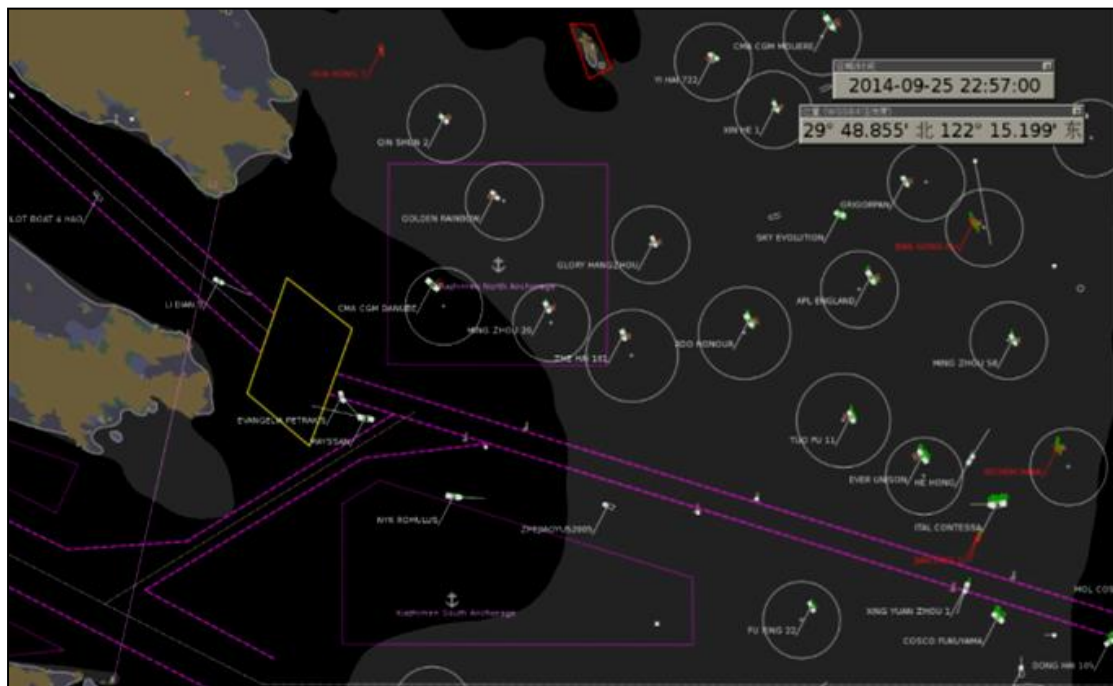
When it became apparent that no action was being taken by *Mayssan*, the master of *Evangelia Petrakis* ordered the wheel hard-over-to starboard while the third mate called *Mayssan*, “motor vessel *Mayssan* starboard to starboard.” As the two vessels advanced towards each other, Ningbo VTS called *Mayssan* to control her speed. The situation at 2257, just before the collision, is shown in Figures 5 and 6.

Figure 5: Screen shot from Ningbo VTS video display at 2257

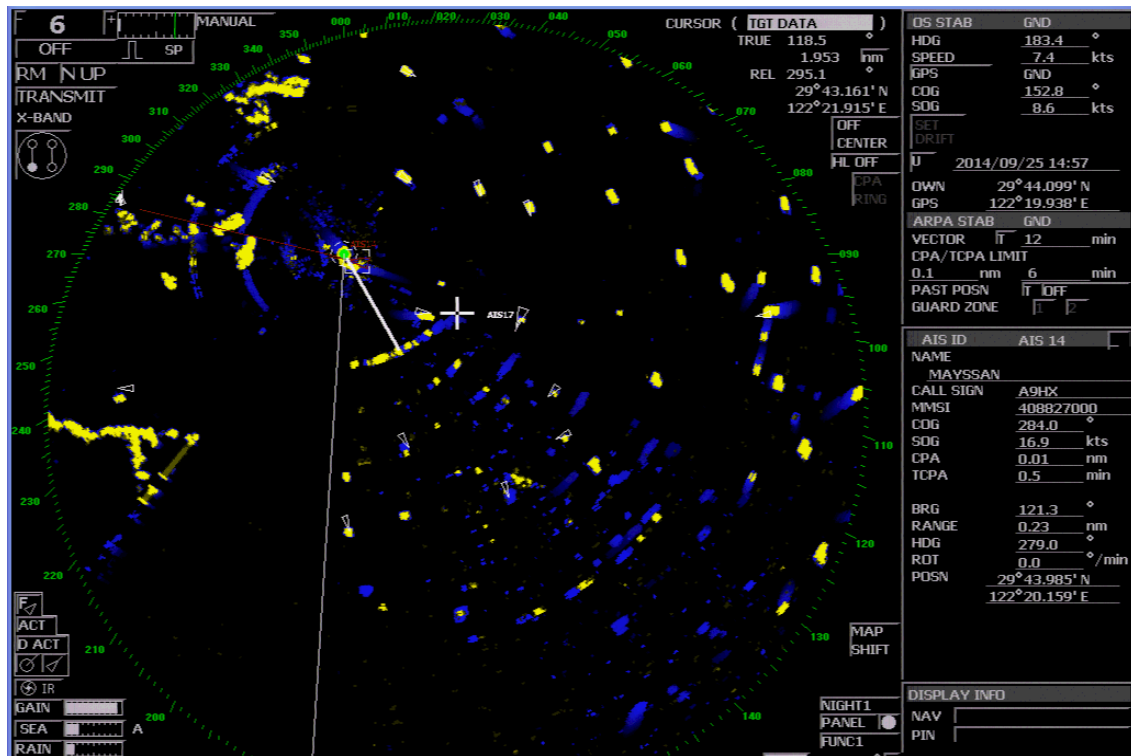
Figure 6: Screen shot from *Evangelia Petrakis* VDR at 2257

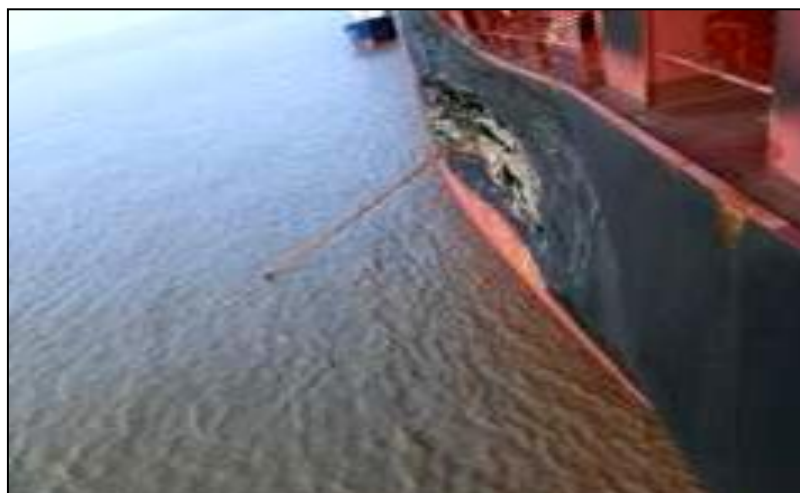
At 2257/30s, the bow of *Evangelia Petrakis* collided with *Mayssan*'s starboard side in way of cargo hold nos. 2 and 3 (Figure 7) just outside the precautionary area in position latitude 22° 44.10'N and longitude 122° 19.70'E.

Figure 7: Side shell plating damage on *Mayssan*

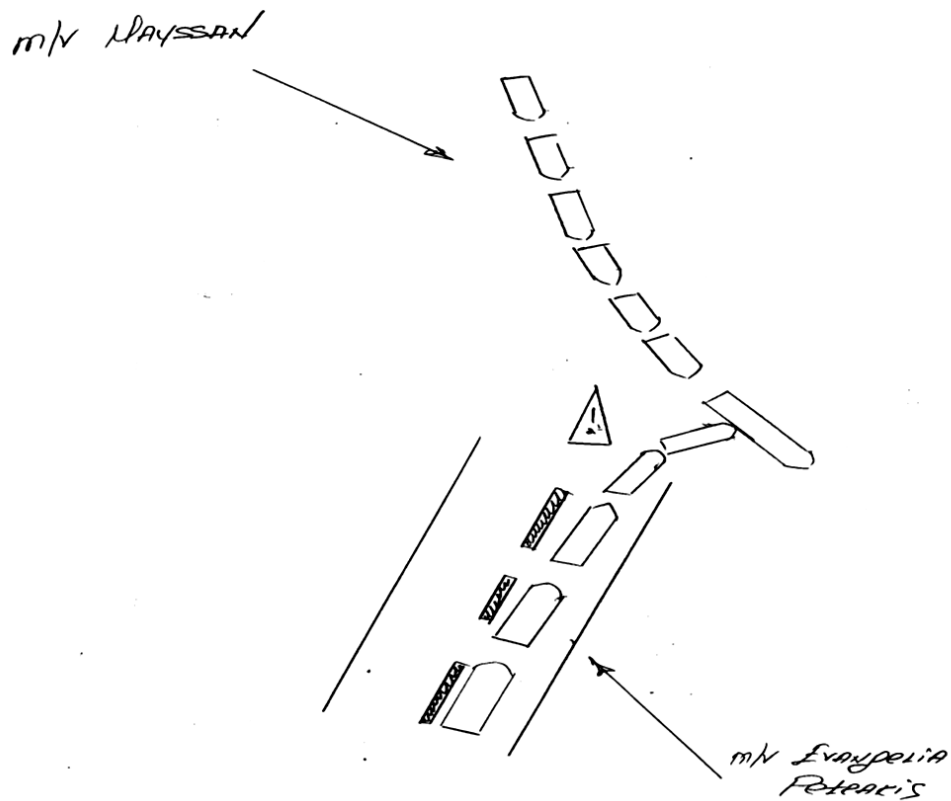
Since the damage on *Evangelia Petrakis* was mostly sustained on the stem and starboard bow relative to the port side, the collision angle was estimated about 40° between the two vessels (Figure 8).

Figure 8: Sketch by *Evangelia Petrakis* showing angle of contact

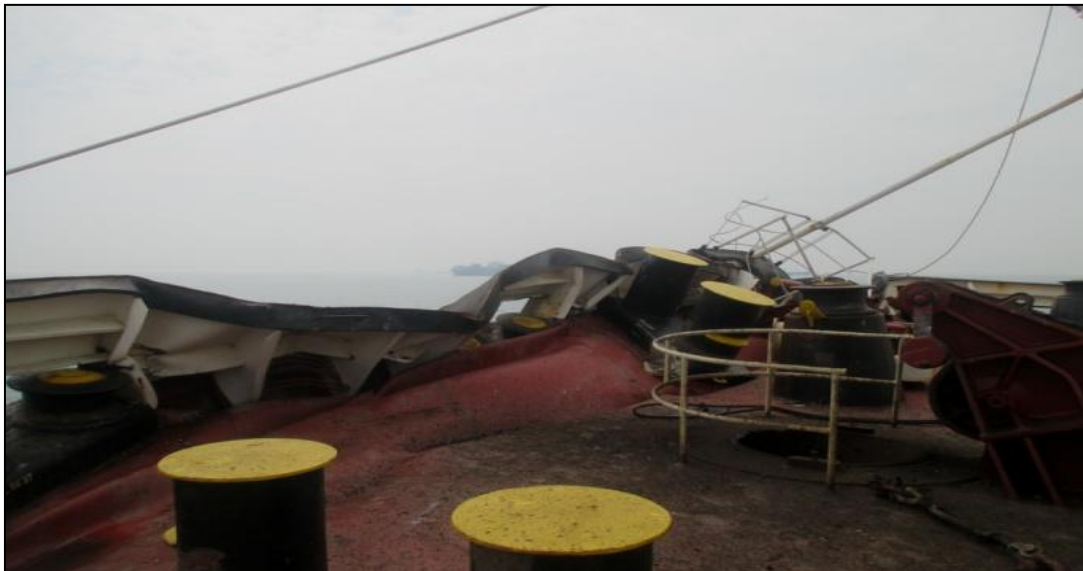
The following damages were identified (Figures 9 and 10):

- Forecastle deck including fairleads, bollards, bulwark, air pipe, port anchor hawse pipe, bosun store *etc.* damaged or deformed;
- Port anchor and anchor chain lost;
- Shell plating with internals in way of forecastle deck were found damaged or deformed; and
- Forward section of bulbous bow severely deformed.

Figure 9: Bulwark and deck plating damage on the forecastle deck

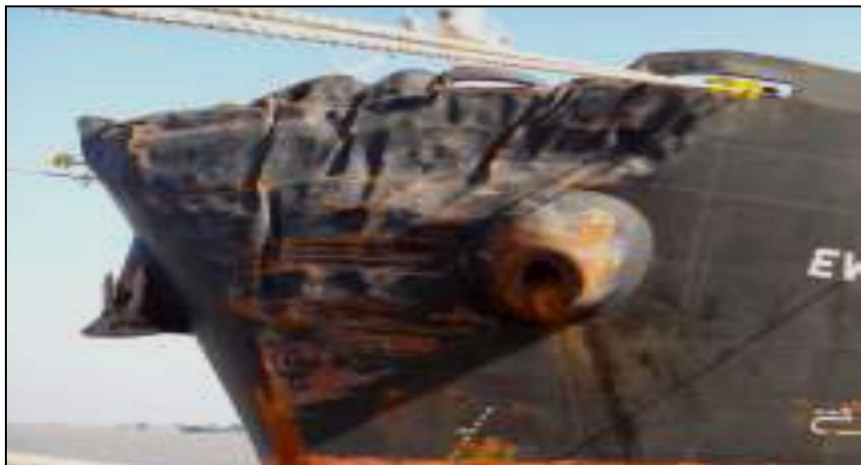
Figure 10: Damages to the bow, anchor and anchor chain
