SAFETY INVESTIGATION REPORT

REPORT NO.: 22/2016

December 2016

MV SHIBUMI **Collision with MV Sam Wolf** **In the Singapore Straits' TSS** **23 December 2015**

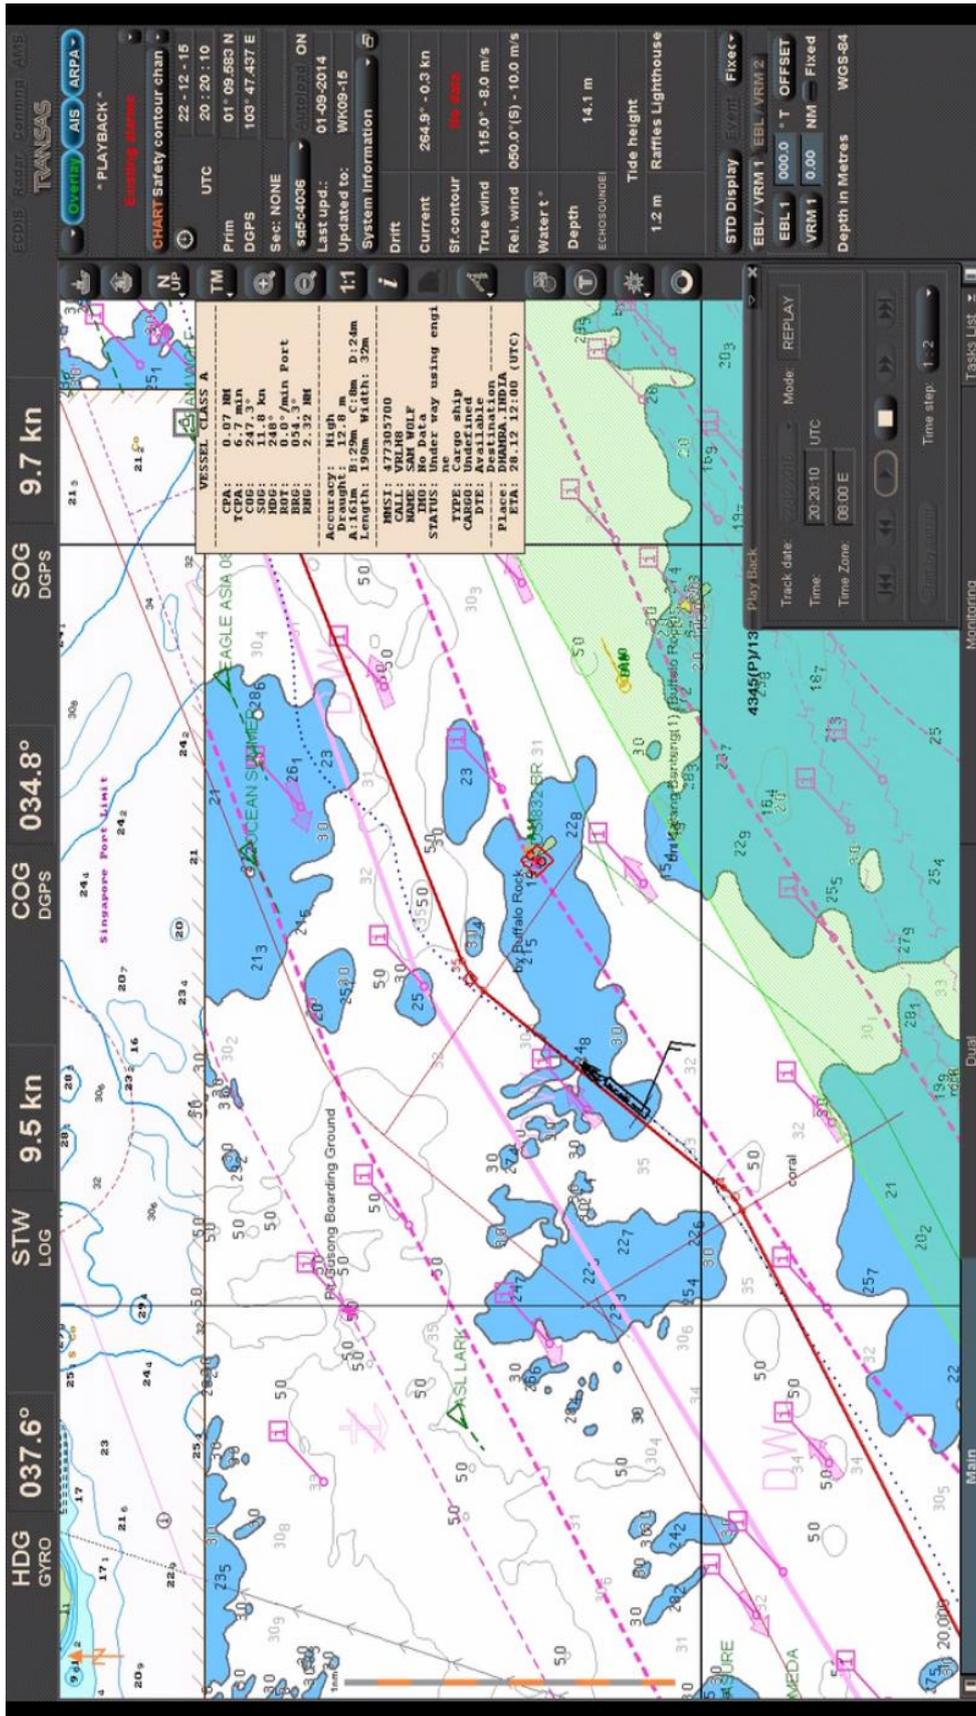
Figure 1: ECDIS image at 0420 showing CPA and TCPA of Sam Wolf

Between 0418 and 0424, *Shibumi* was on a charted course of 037° (T). On *Shibumi*'s ECDIS display, the course 037° appears oblique to the direction of traffic flow. The passing distance (or CPA) to *Sam Wolf* which, on the previous course of 061° was 0.45 nm, had now been reduced to between 0.01 nm and 0.07 nm, with a TCPA of seven minutes² (Figure 2).

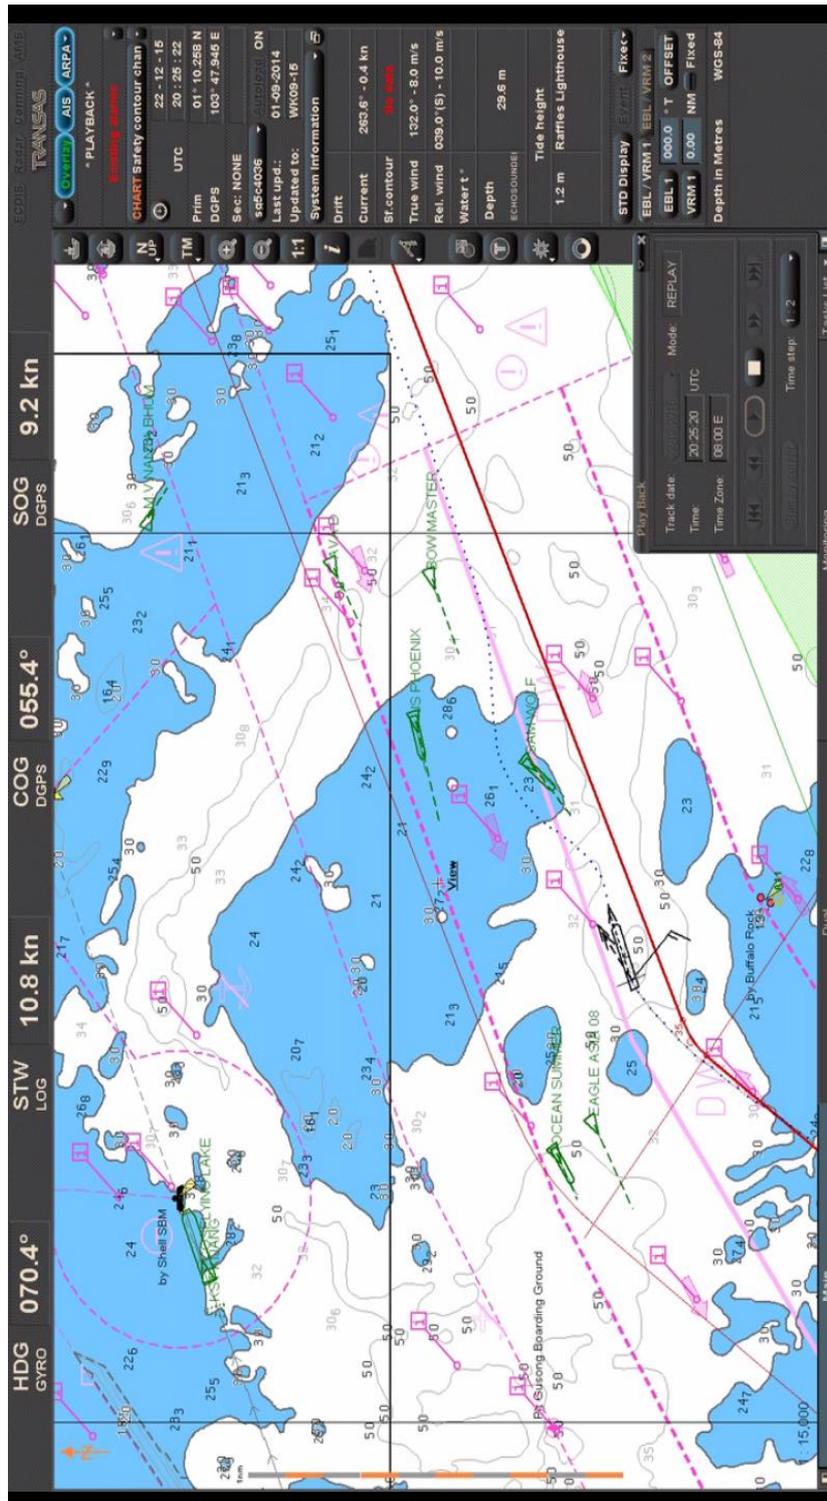
On reaching Buffalo Rock Buoy at 0424, *Shibumi* initiated a starboard turn for her next planned course 067° (T). At about the same time, *Sam Wolf*, which was less than a mile from *Shibumi*, altered her course to port and headed across the path of *Shibumi* in the Eastbound traffic lane (Figure 2).

Figure 2: ECDIS image at 0425 - *Sam Wolf* crossing TSS separation line

Shibumi's master called *Sam Wolf* by VHF radio, however, there was no response. Singapore VTIS responded advising *Sam Wolf* to keep clear and navigate within the Westbound traffic lane. *Sam Wolf*, however, was observed maintaining her course to port and at 0425 crossed the TSS separation line (Figure 2). By then, both vessels were very close and a collision was imminent.

Moreover, the direction and aspect of *Shibumi* appeared to be crossing the TSS and which had (very likely) influenced the decisions made by *Sam Wolf*'s OOW. Less than a mile and closing on a steady bearing, *Sam Wolf* altered her course to port without warning or querying the intention of *Shibumi*; apparently in an attempt avoid colliding with *Shibumi*.

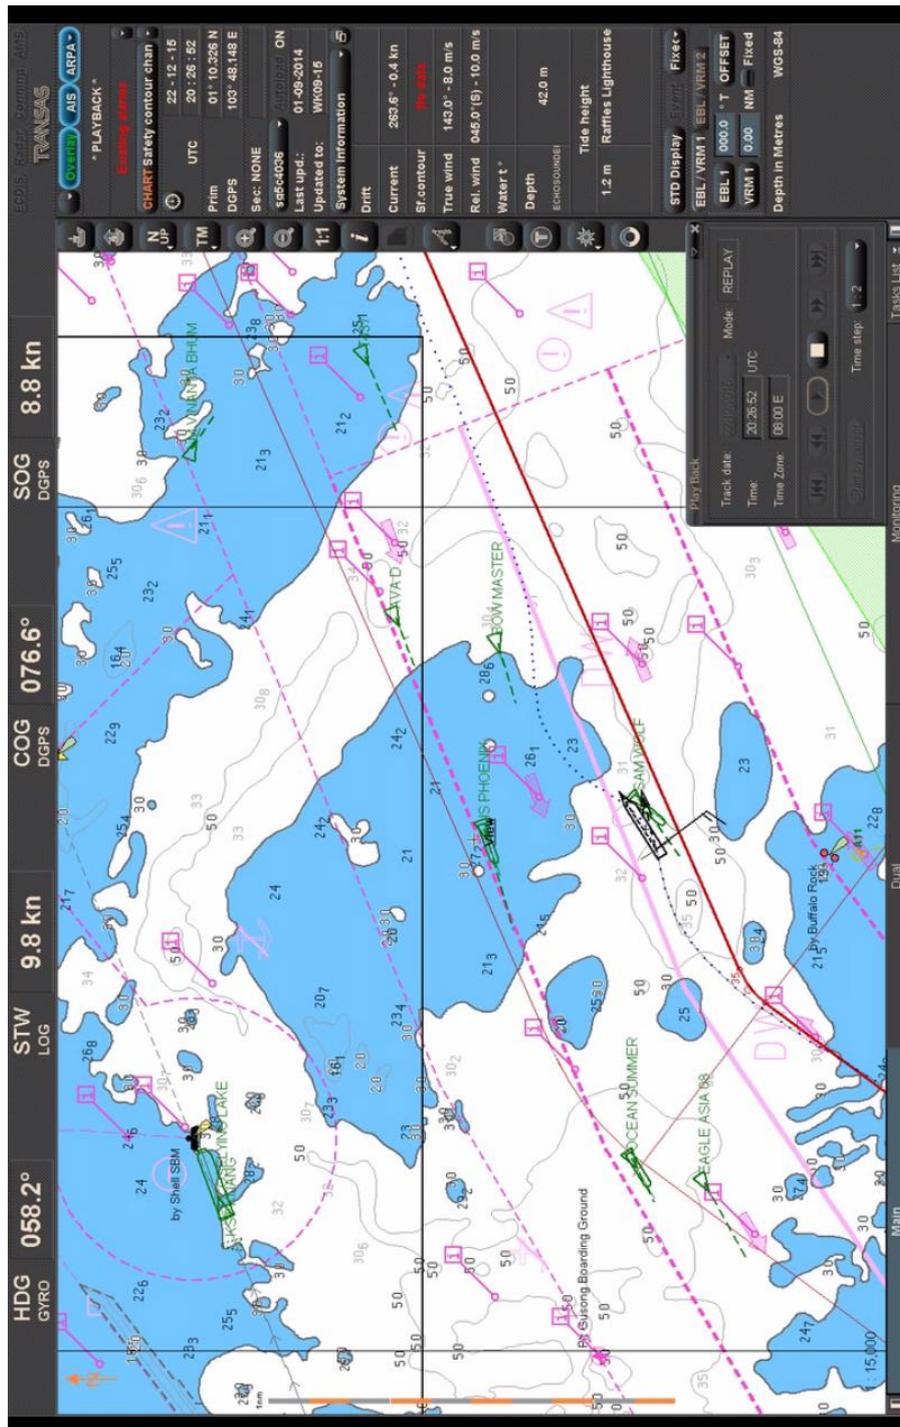
The master on *Shibumi* ordered the wheel hard over to port to minimise the impact of the collision. At 0426/50s *Shibumi's* starboard bow scraped *Sam Wolf's* starboard quarter. The collision occurred in position 01° 10.32' N 103° 48.14' E, in the Eastbound Deep Water Route of TSS Singapore Straits (Figure 3).

Figure 3: ECDIS image at 0426/50s, showing position of collision
