Final report RS 2016:05e

STENA JUTLANDICA/TERNVIND – collision in Gothenburg’s archipelago on 19 July 2015

File no. S-127/15

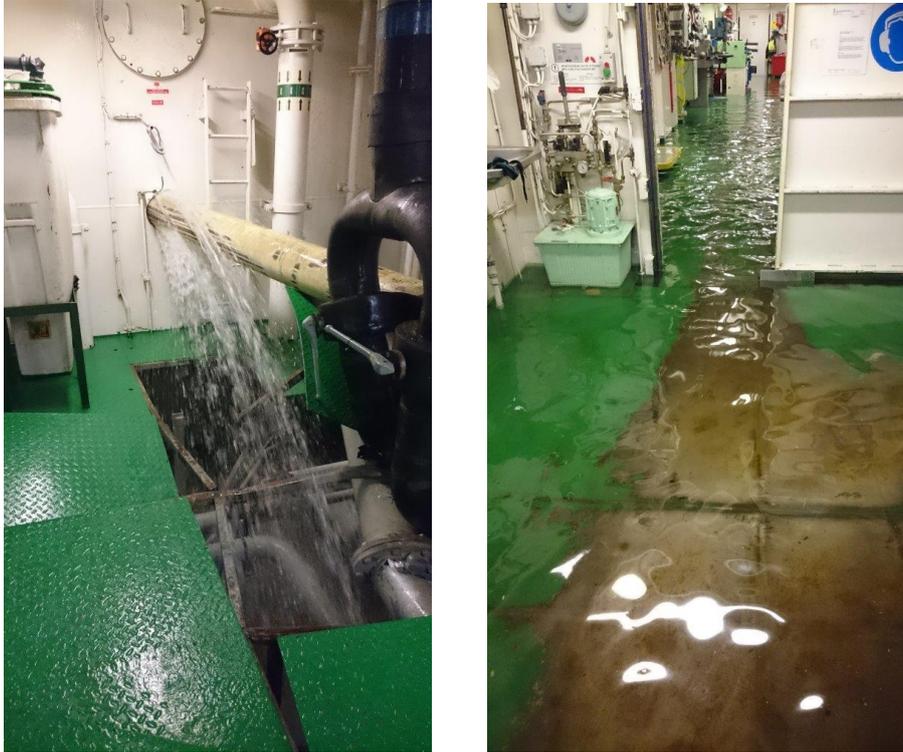
Fig. 4a and 4b. Water leak in the pump room on STENA JUTLANDICA. Image: Stena Line.

The port fin stabiliser, that was out during the collision, was damaged and in turn damaged some pipes, which also led to a pump room taking in water. It was not possible to pump out the pump room because of this damage. This space also contained electronic equipment for the vessel's engine control system. In order to protect this equipment and also make it possible to pump out, a manhole was opened into an empty tank under the pump room. The water thus ran into the tank and could be pumped out. STENA JUTLANDICA was able to proceed to the quay under her own steam.

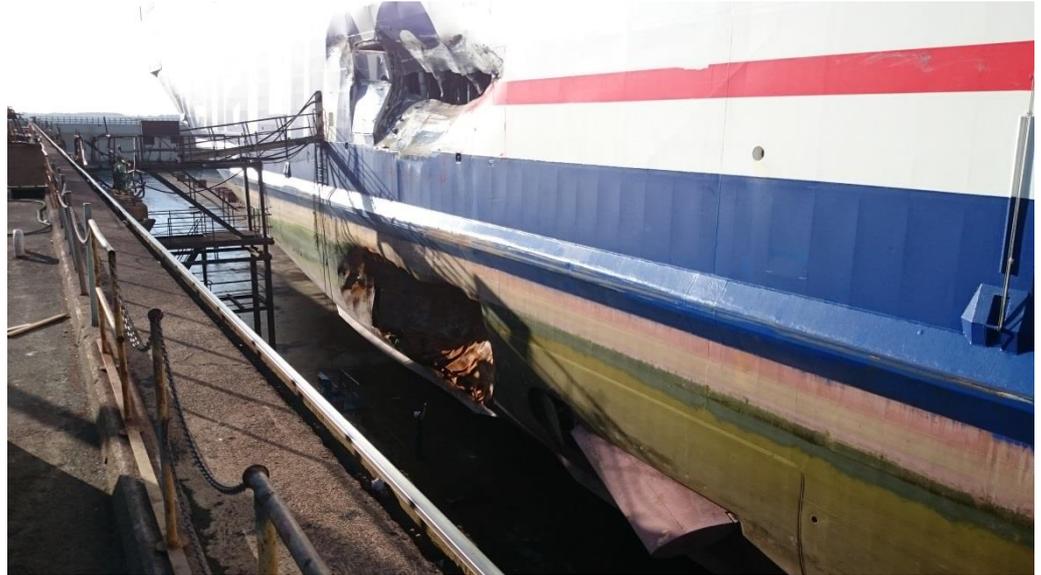
In the collision, STENA JUTLANDICA suffered hull damage both above and below the waterline, the former being caused by the bow and the latter by the bulbous bow of TERNVIND.

Above the waterline, damage occurred on the main deck between frames 100–106. No water entered there, but the supply hatch and supply lift were damaged. However, under the waterline, 1,220 m³ of water entered immediately and filled watertight sections 9 and 10 as a result of damage between frames 101–118 (see Fig. 5). This resulted in a levelled submergence of the vessel. A total of 43 tonnes of steel had to be replaced.

Fig. 5. Damage to STENA JUTLANDICA. The photograph is taken in dry dock. Image: Termtank.

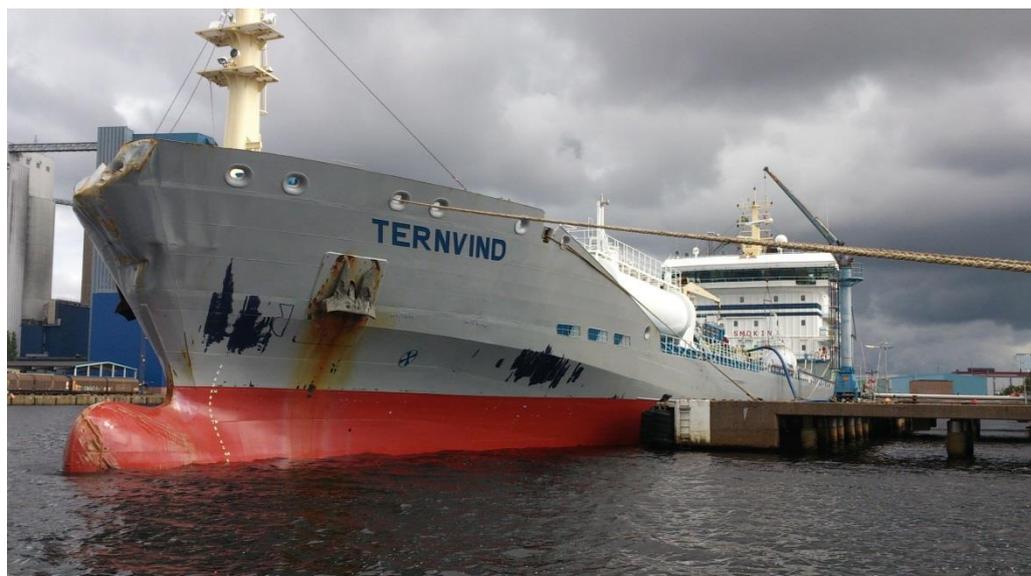
TERNVIND suffered only minor damage to her forward bulwark¹⁴ and bulbous bow (see Fig. 6).

Fig. 6. Damage to TERNVIND.

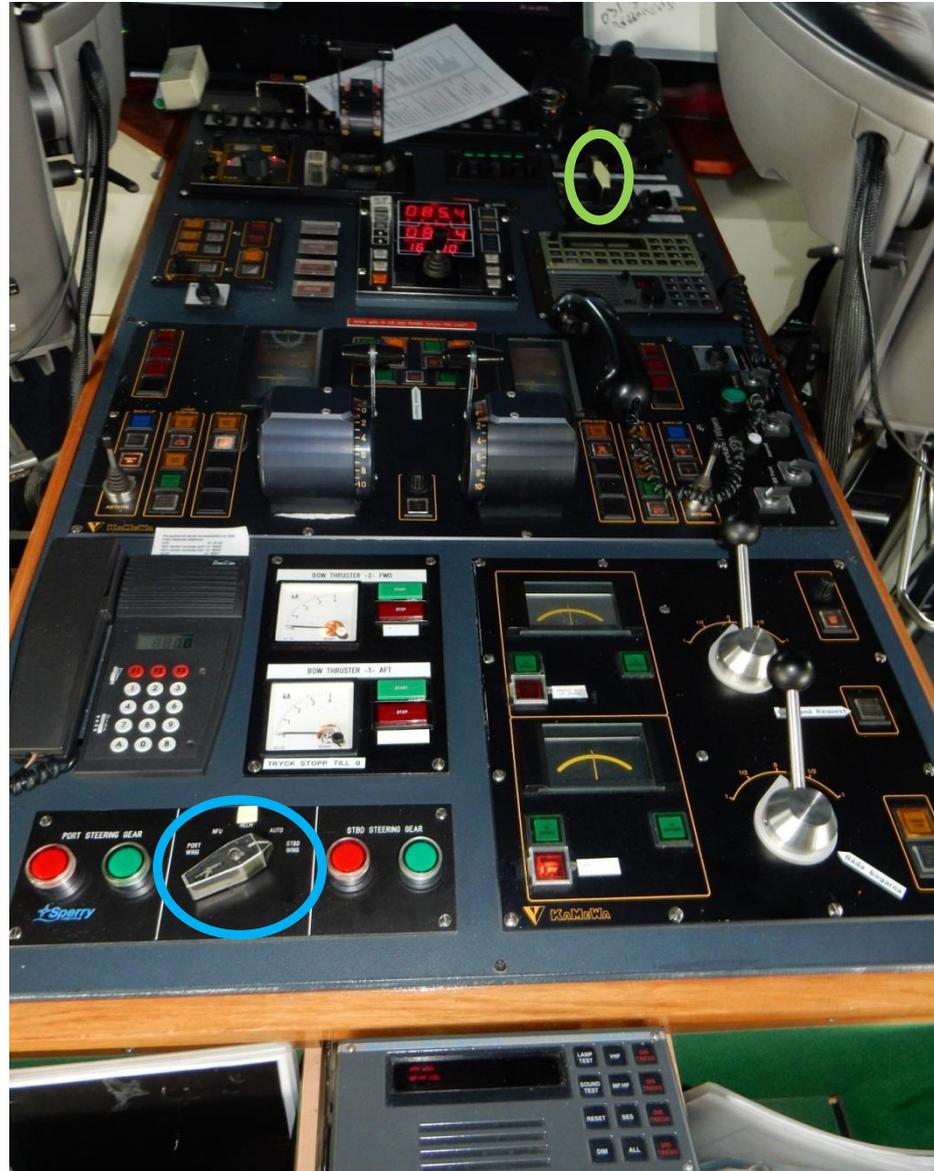
Fig. 10. The desk between the navigators' chairs on STENA JUTLANDICA. The override knob is located close to the officer's chair, circled in green (top right of the image). The knob to switch between different methods of steering the vessel is on the aft part of the panel, circled in blue (bottom left of the image).

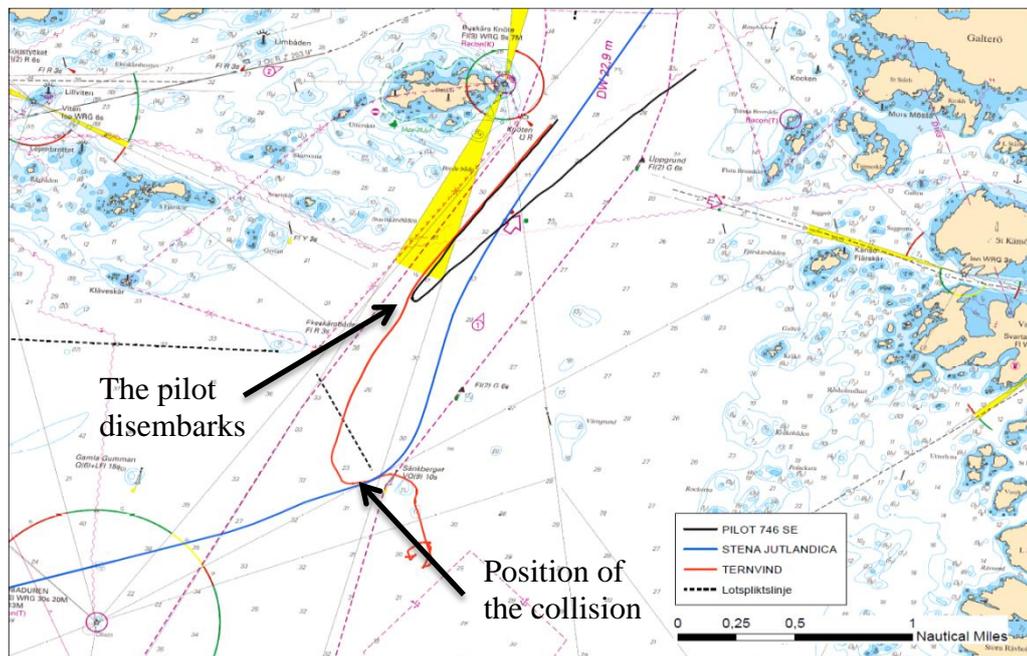
Fig. 14. Nautical chart of the area that contains the AIS tracks of the vessels in question. STENA JUTLANDICA's AIS track is blue, TERNVIND's is red and the pilot boat's is black. The pilotage line is marked with a dashed black line. Image: Swedish Maritime Administration no.: 10-01518.

With the help of data from STENA JUTLANDICA's VDR, it can be established that a turn to port with a radius of 1.4 M was initiated just before the VHF call from TERNVIND (see Fig. 15 and 18). Furthermore, it has been possible to create a reconstruction of the rudder movements. In addition, the VDR shows that all the watertight doors were closed at the moment of collision, apart from door no. 2, which was closed just after the collision.

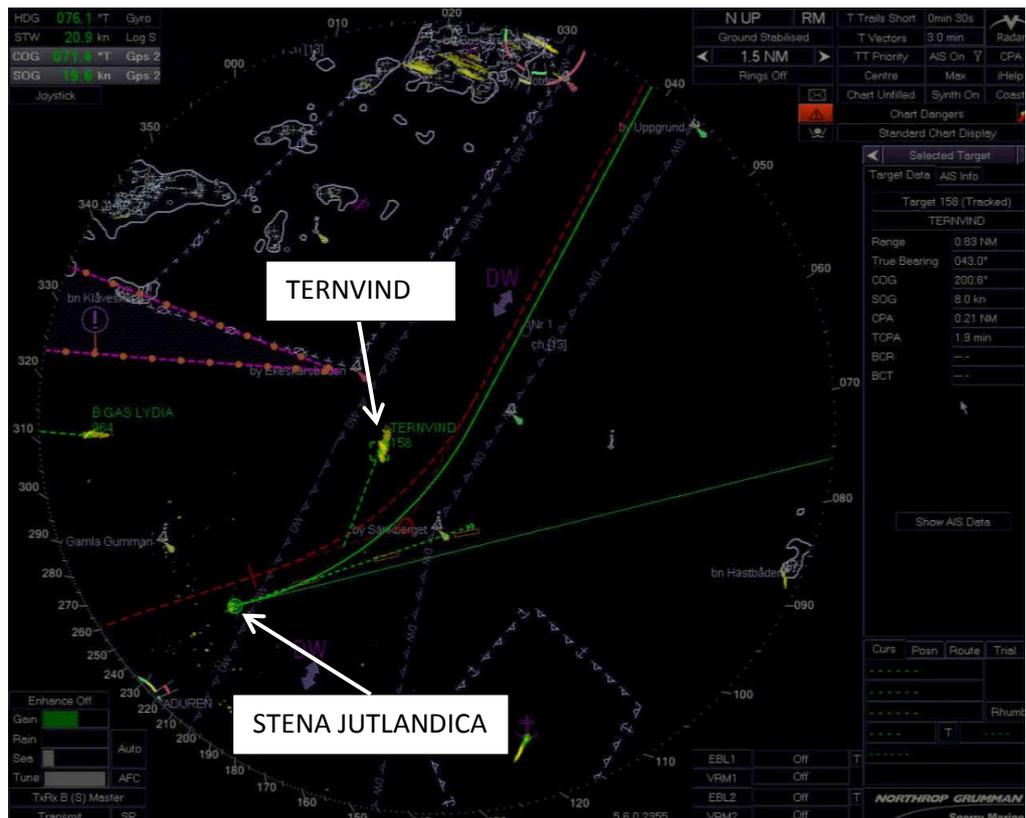
Fig. 15. Radar image (appears with north up) from STENA JUTLANDICA at the moment the turn to port with a radius of 1.4 M begins. The CPA to TERNVIND is seen on the right and, according to the ARPA, is 0.21 M. The green dashed lines in front of each vessel is that vessel's estimated route unless the conditions change. The unbroken, curved green line in front of STENA JUTLANDICA is the course that she will follow when the turn begins. The time at this point is 02:14:44.

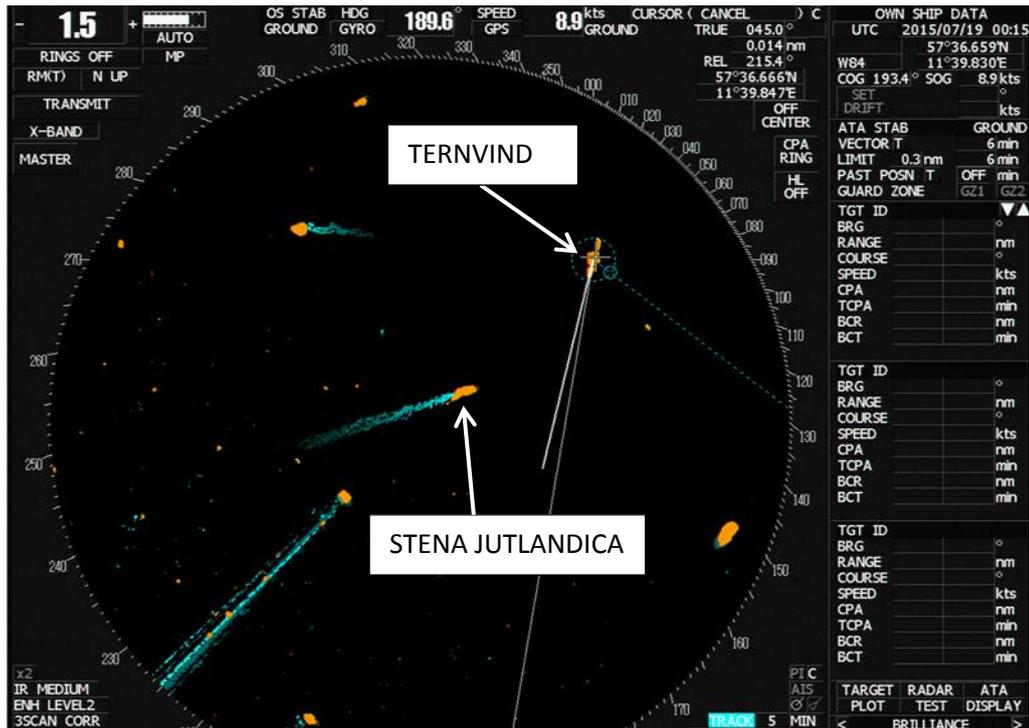
Fig. 16. Radar image (appears with north up) from TERNVIND's X-band radar when the master calls STENA JUTLANDICA at 02:15:12. TERNVIND is in the small circle at the top right, with white course indicator of approx. 190°. STENA JUTLANDICA is the yellow echo at the centre of the image. The distance between the vessels is now just over 0.7 M.

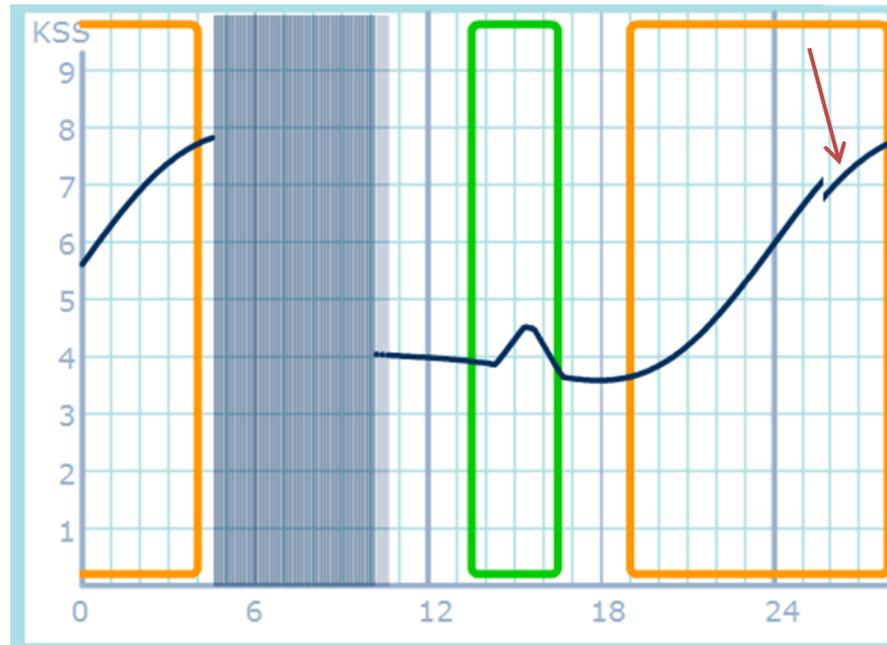
Fig. 17. An example of a wave pattern for level of tiredness/alertness according to the Karolinska Sleepiness Scale.³⁹ The Y-axis shows the KSS value, while the X-axis shows the time. The basis used is the work schedule for the officer on board STENA JUTLANDICA. The example shows a curve with a starting time at midnight between 17 and 18 July, approx. 26 hours before the collision. The collision took place at around 02:17, which is indicated by the red arrow.

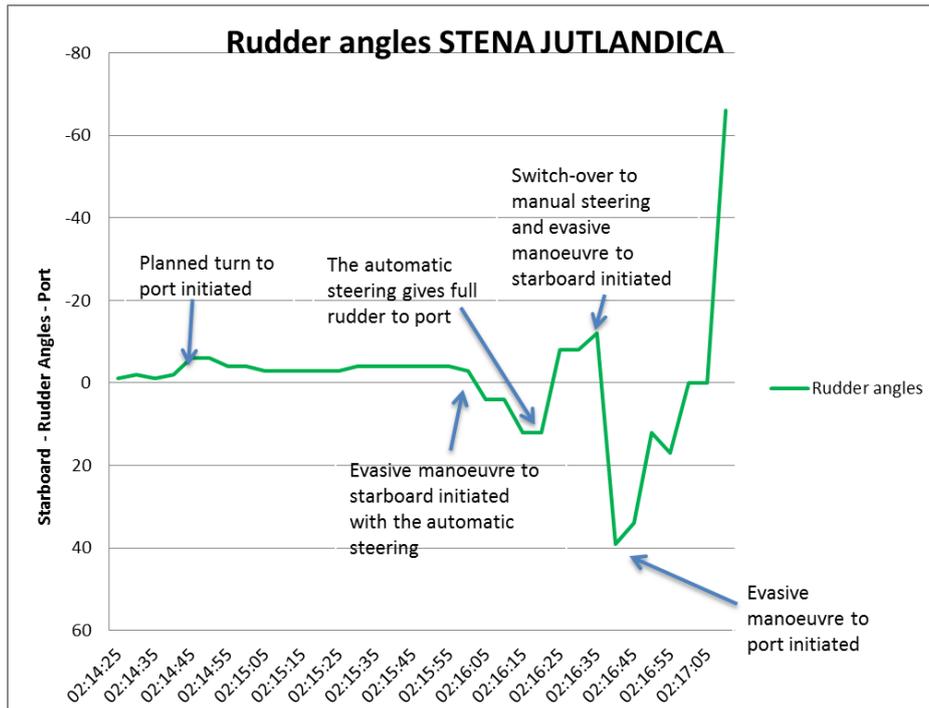
Fig. 18. STENA JUTLANDICA's rudder angles during the sequence of events. The arrow on the left shows the turn to port with a radius of 1.4 M, after which it is possible to divine from the curve that the radius increases as the rudder angle decreases. The second arrow shows the evasive manoeuvre to starboard that was made using the automatic steering and the third arrow points to when the rudder braced in order to hold the new course. The fourth arrow indicates when the manual steering was confirmed on the steering desk and the rudder was set hard to starboard. However, it is not possible to see when the switch-over took place on the desk by the navigators' chairs. The fifth arrow indicates when the rudder was set hard to port.

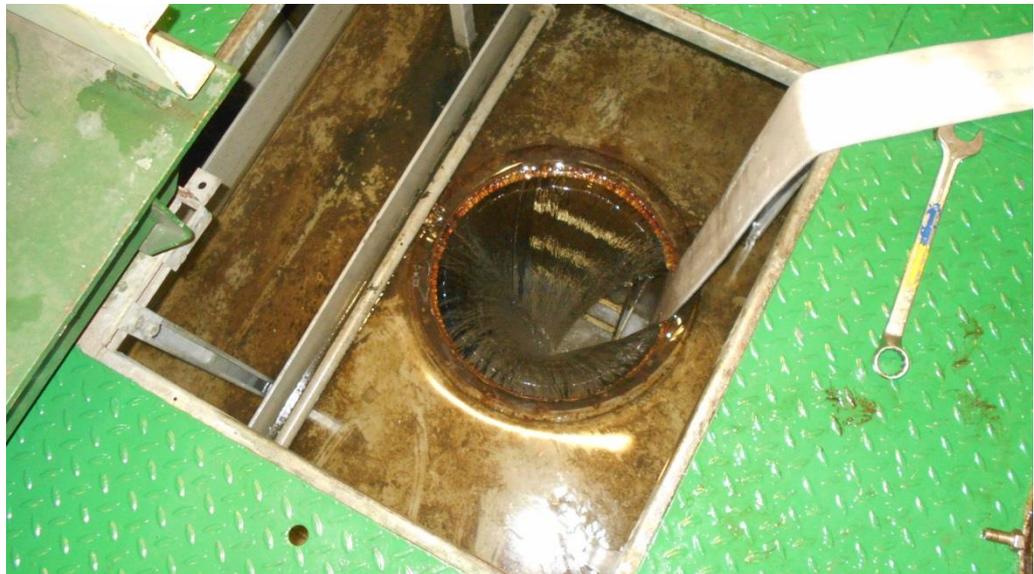
Nevertheless, the stabiliser fin was damaged, which in turn damaged piping in another of the vessel's compartments that is used as a pump room. As a result, there was also water intrusion there, which risked damaging the electronic equipment in the compartment. This damage resulted in some risk to the vessel. If this equipment, which included the vessel's engine control system, had been damaged, it could have made the onward voyage into the city more difficult. While it is possible to control the engines without the control system, when all is said and done, this is not a normal form of operations, which means that complications are to be expected. However, the engine crew was able to keep down the water level by opening a man hole to the ballast tank under the pump room (the only empty ballast tank on this occasion), making it possible to get the water out of the way.

Fig. 19. By opening this man hole, in spite of the water level in the room rising, it was possible to lead the water away from the pump room. Image: Stena Line.
