## *Final Report RS 2017:04e*

PHOENIX II/TERNVAG – Near collision in  
Gothenburg's archipelago on 14 July 2016

Reference no. S-116/16

5 July 2017

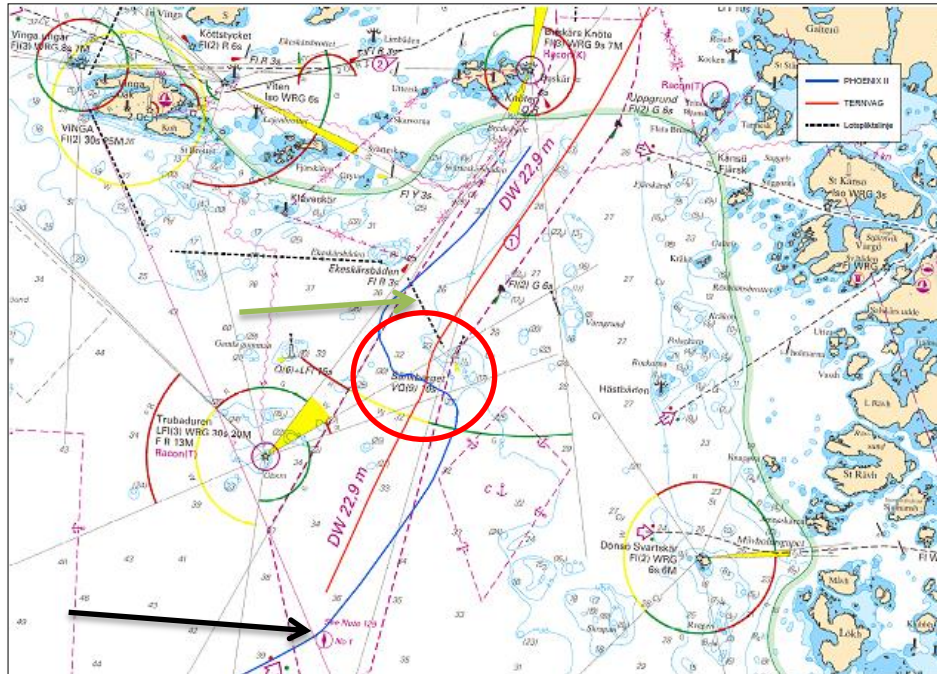
Figure 3. Excerpt from the chart showing AIS tracks, the blue track is PHOENIX II, the red TERNVAG. The location of the occurrence is circled. Compulsory pilotage lines (green arrow), boarding position (black arrow) south Trubaduren and anchorages area also shown. Image: Swedish Maritime Administration no.: 10-01518.

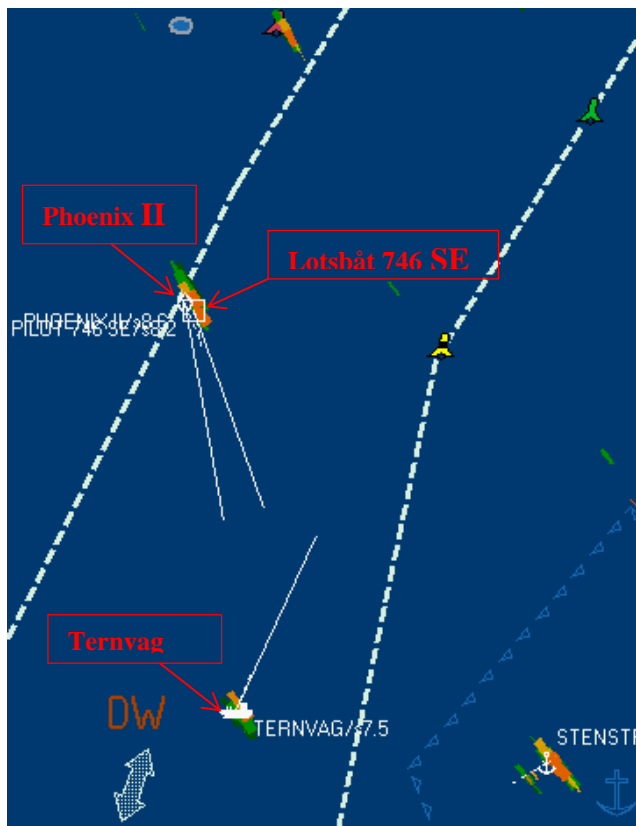
Figure 4. The position of the vessels and pilot boat with 3-minute vectors at 02:08, when the pilot disembarks.

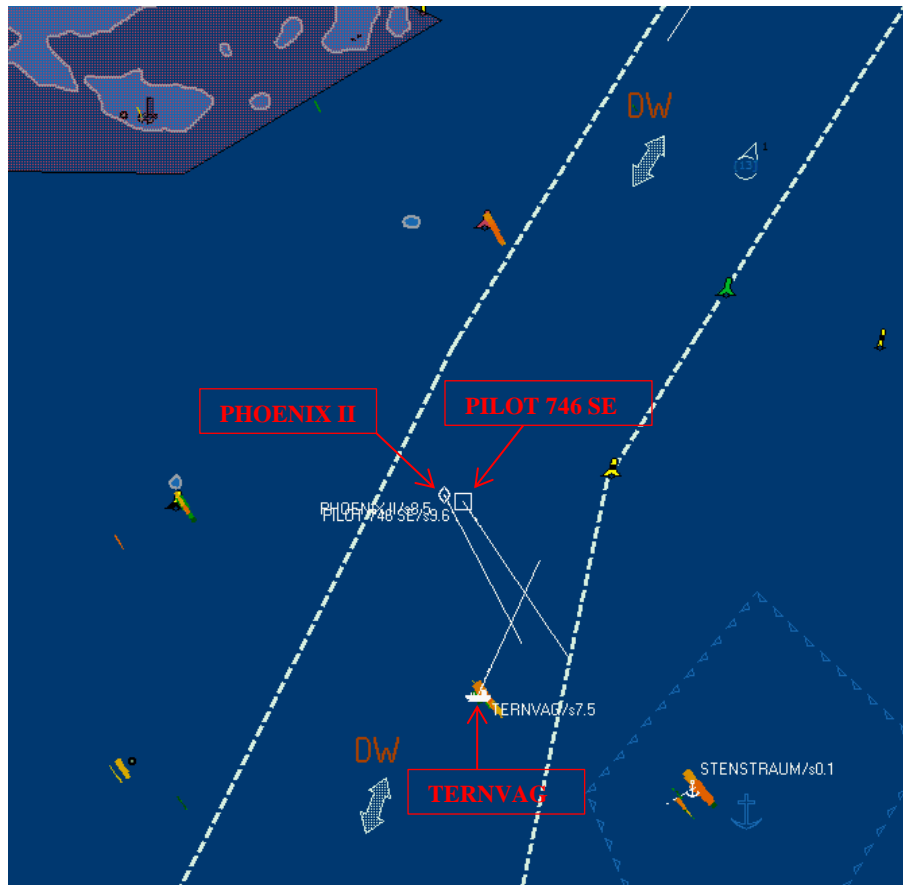
When the pilot had disembarked and came on board the pilot boat (Figure 5), PHOENIX II's heading was 150° and the distance between the vessels was 0.5 M, which is equivalent to ca. 925 m. The master has stated that he returned to the conning position<sup>5</sup> on the centre line and changed heading to starboard, but that the turn was slow.

Figure 5. The vessels position, heading and speed at 02:09 when the pilot has disembarked. PHOENIX II is making 8.5 knots and is the left-hand vector. The vector to the right of PHOENIX II is that of the pilot boat. TERNVAG is making a speed of 7.5 knots. The length of the vectors is equivalent to 3 minutes running time for each vessel.

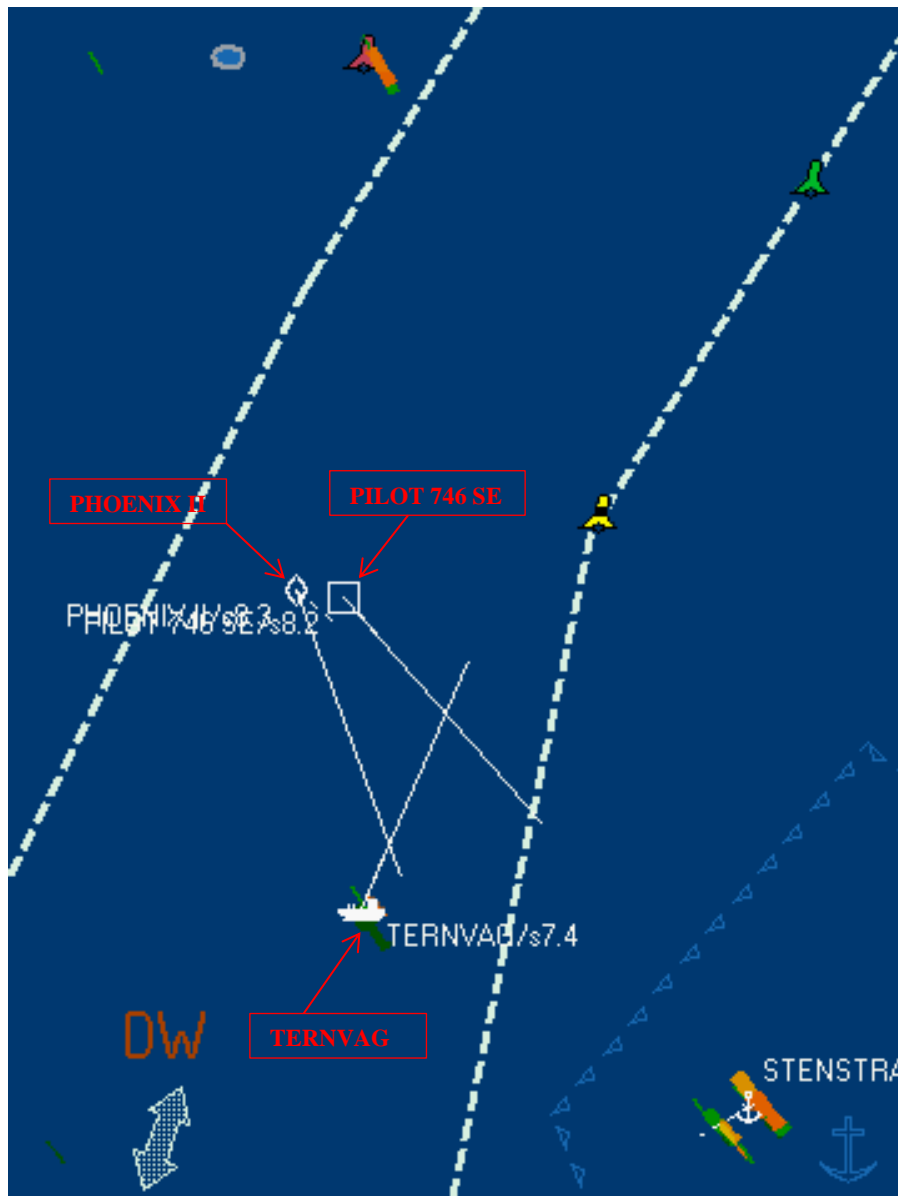
Figure 6. The vessels' positions, headings and speed at 02:11, when the pilot calls PHOENIX II from the pilot boat.

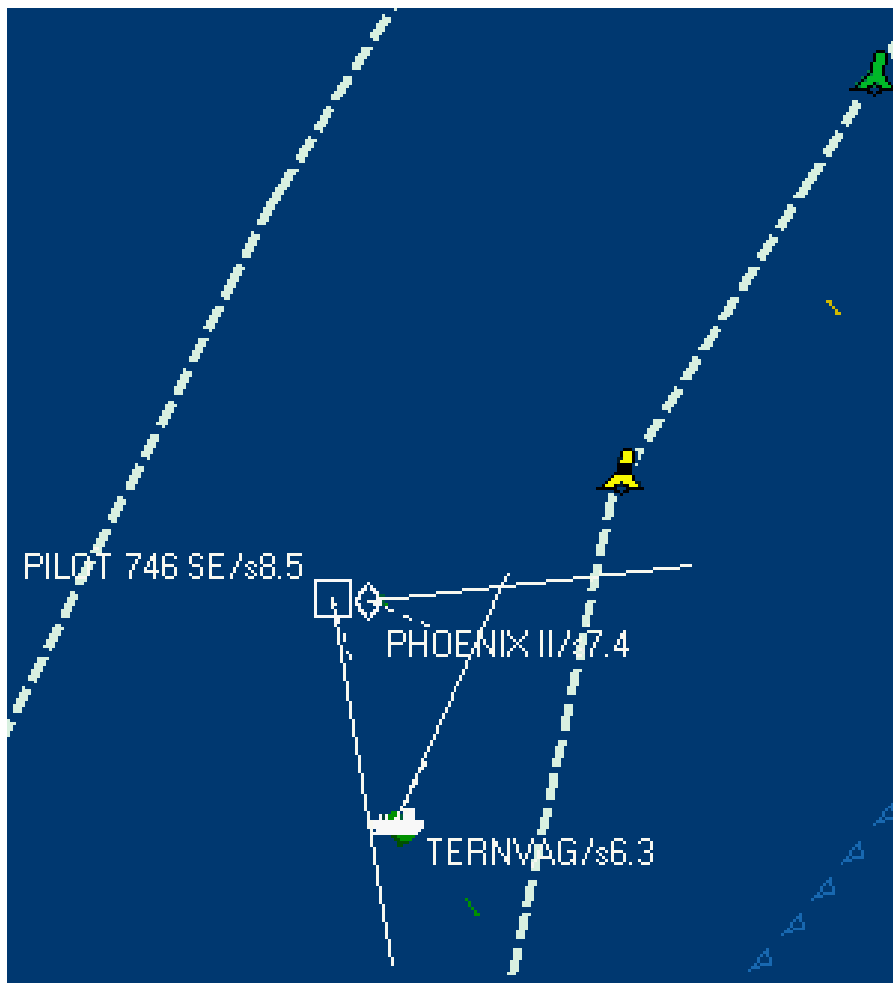
Figure 7. The vessels' positions, headings and speed at 02:12:30, when the pilot calls PHOENIX II from the pilot boat. TERNVAG has its engine set to full astern and PHOENIX II has turned heavy to port.

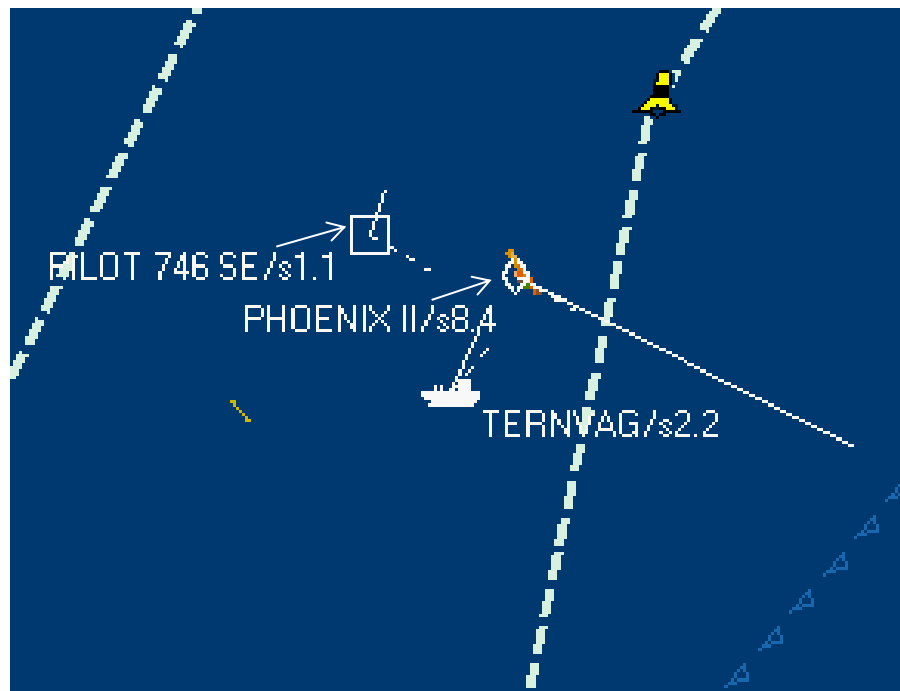
TERNVAG continued running its engine full astern and the bow propeller full to port at the same time as PHOENIX II increased speed somewhat and passed just ahead of TERNVAG. Several of those involved thought that the vessels would collide and the minimum distance between the vessels was estimated at ca. 100 m. The master on board PHOENIX II subsequently ordered the second officer to turn hard to starboard and the vessel then turned south and continued its voyage towards Gdansk.

Figure 8. The vessels' position, heading and speed at 02:14.
