## MV *SPRING BOK* and MV *GAS ARCTIC* Collision 6nm south of Dungeness, UK 24 March 2012

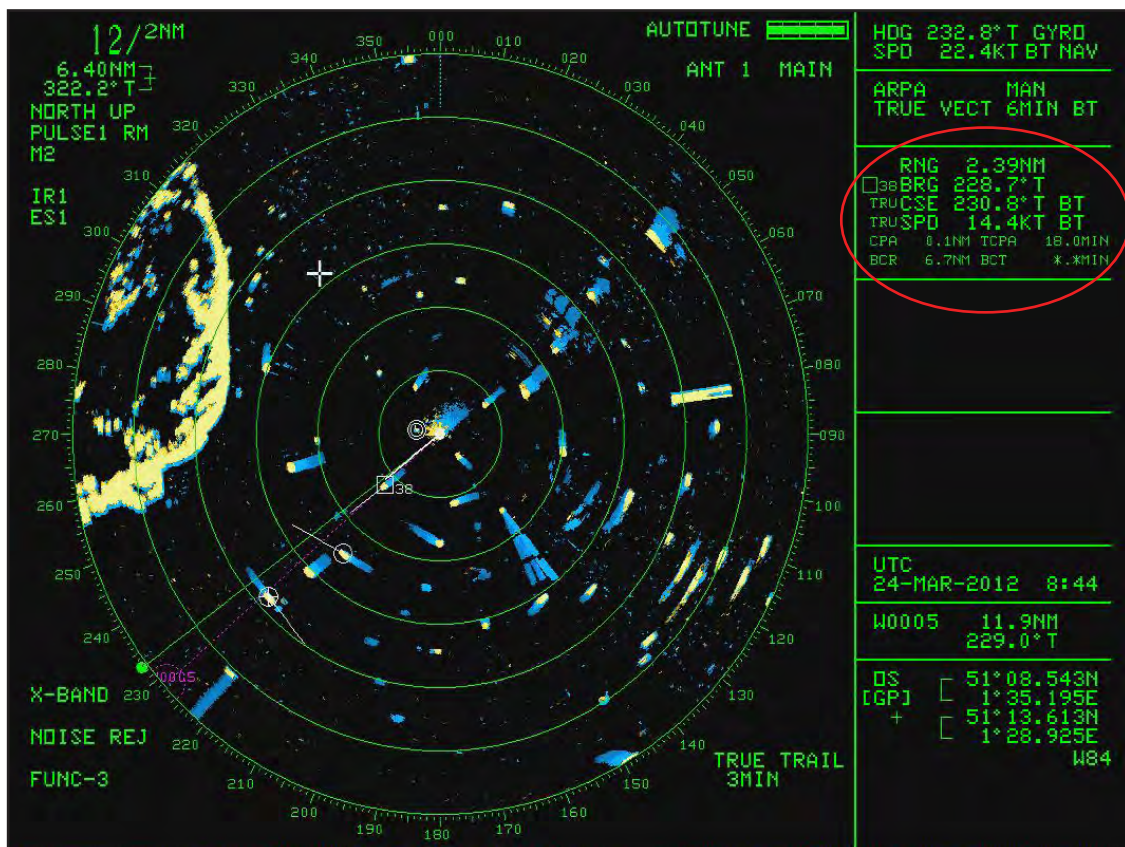
Figure 4: 0844 X-Band radar display showing data selected for one target

At 0810 the master reported the vessel's details to Dover coastguard on entry to the mandatory reporting area for vessels using the Dover TSS. The visibility then reduced and a lookout was posted. At 0844, as the vessel was approaching Dover, the master called the coastguard on VHF radio to report that visibility was 200 metres, the vessel's speed was 22.4 knots and no fog signal was being sounded. There were numerous other vessels in the vicinity, and the master manually acquired one of the closest radar targets and displayed the target data on the radar set (Figure 4).

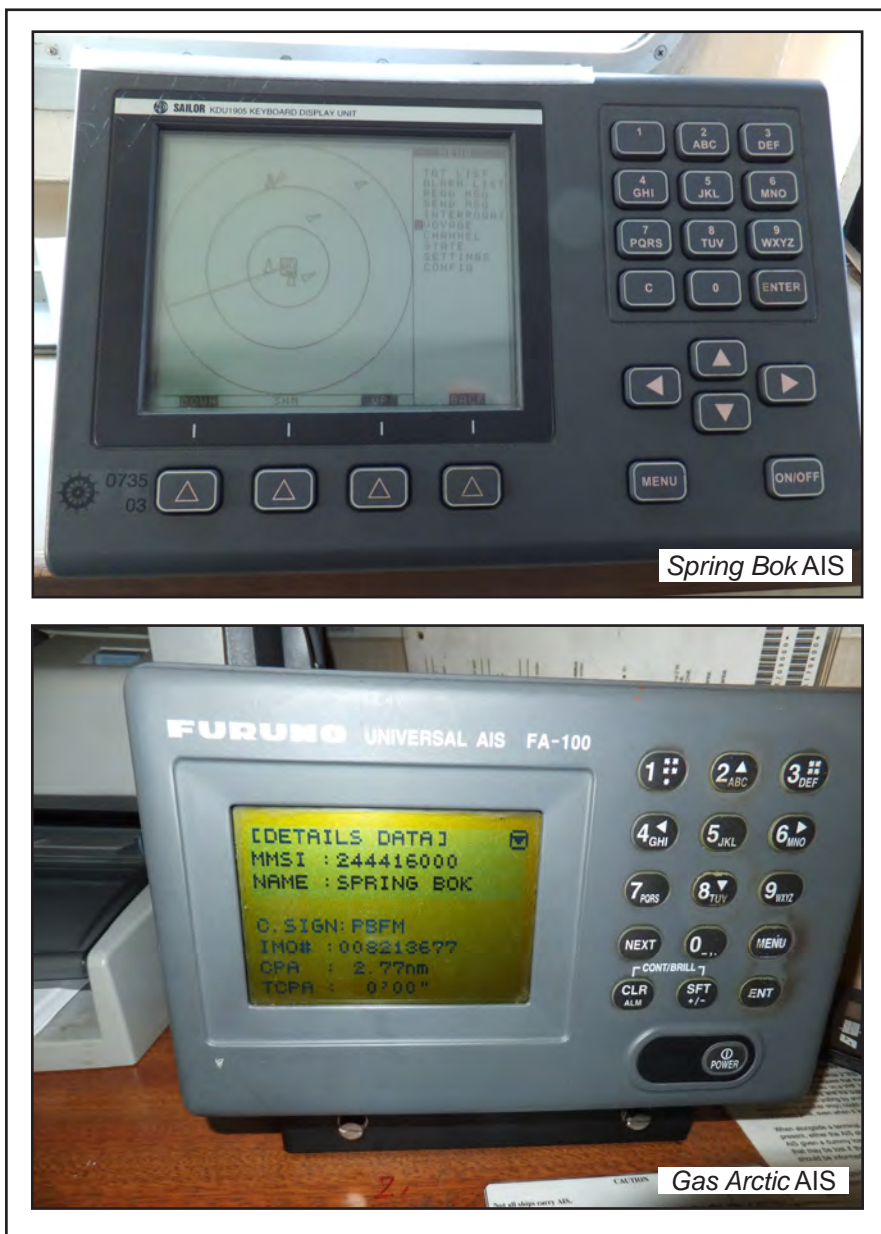
Figure 5: *Spring Bok* and *Gas Arctic's* AIS

*Bok. Gas Arctic's* AIS display had a feature which (Figure 5) allowed the 3/O to observe that the closest point of approach (CPA) of *Spring Bok* was 0.3nm.

At 1000 the 3/O again observed *Spring Bok* on AIS when she was about 3nm astern with a CPA of zero; he could not see the vessel visually at that time. He took no action to contact the other vessel because he expected it, as the overtaking vessel, to keep clear. He was also plotting the *Gas Arctic's* position onto the paper chart at frequent intervals during this period.

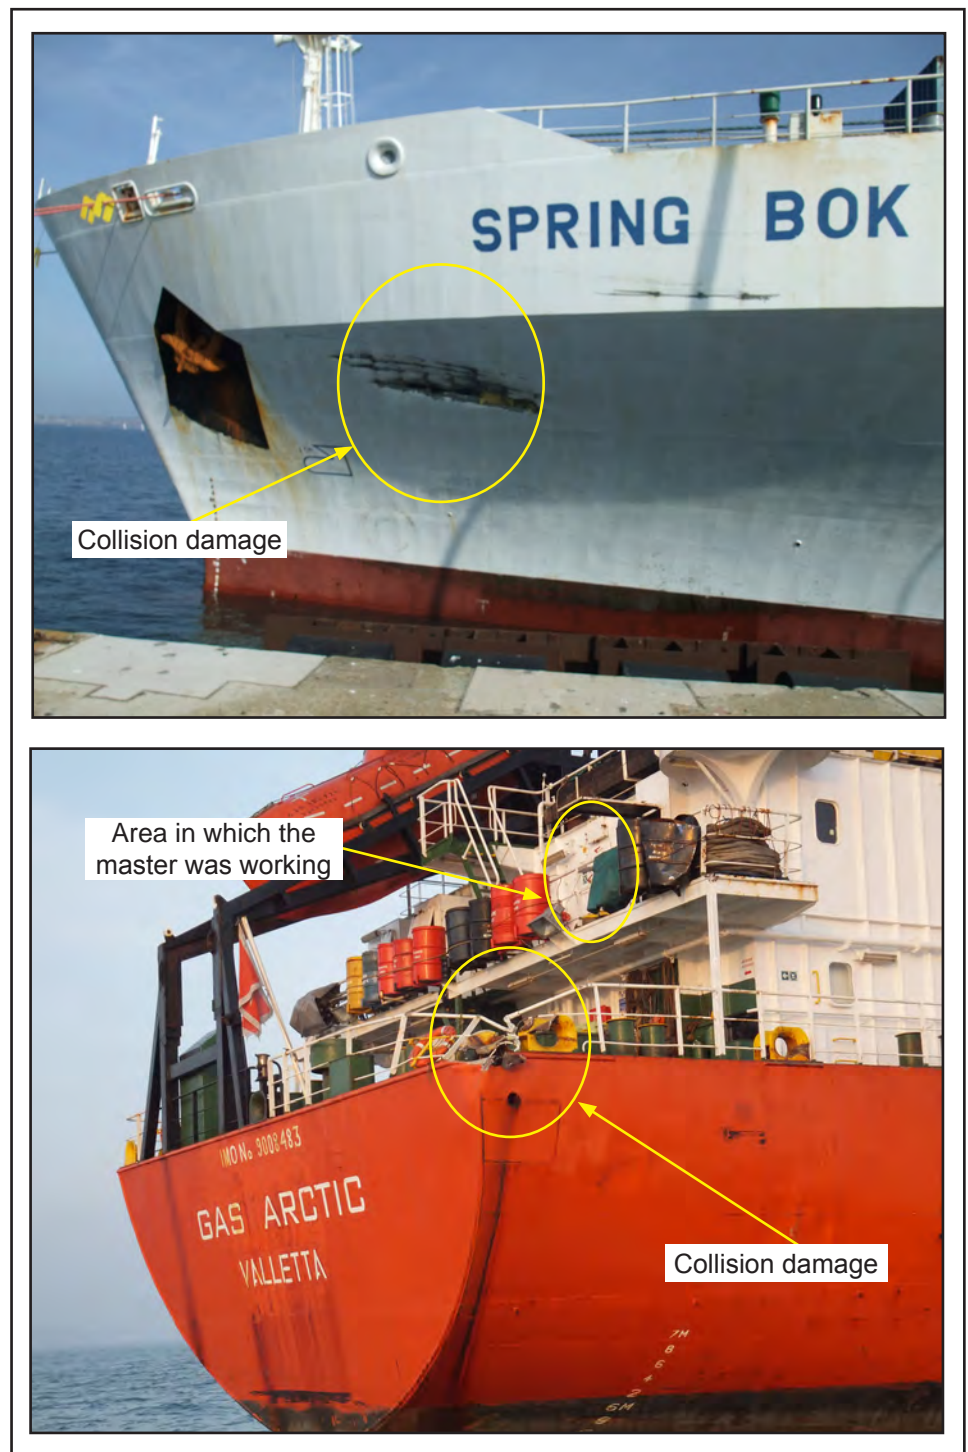
**Figure 6:** Damage to both vessels

The point of collision was between the port bow of *Spring Bok*, which had maintained her heading, and the starboard quarter of *Gas Arctic* (**Figure 6**).

*Gas Arctic* suffered a breach of her hull, shell indentation and damage to fairleads and railings on her starboard quarter. *Spring Bok* was holed on the port bow and her collision bulkhead was penetrated.

*Spring Bok* was detained pending repair of her steelwork, which was carried out in Portland. She was released from detention and resumed her passage to the Caribbean on 31 March.

*Gas Arctic* was given a condition of class<sup>6</sup> and a single voyage dispensation to proceed to the nearest suitable repair port. She was subsequently dry docked and repaired in Poland, and resumed service on 21 April.

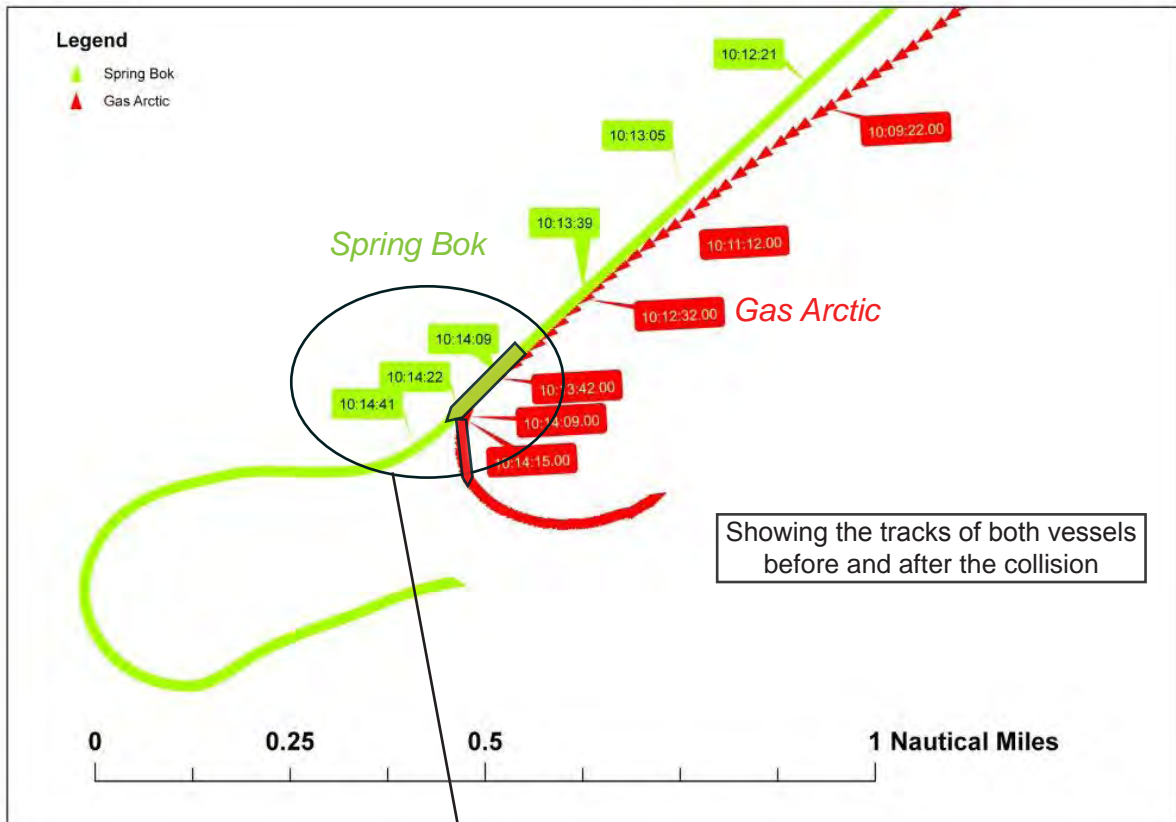
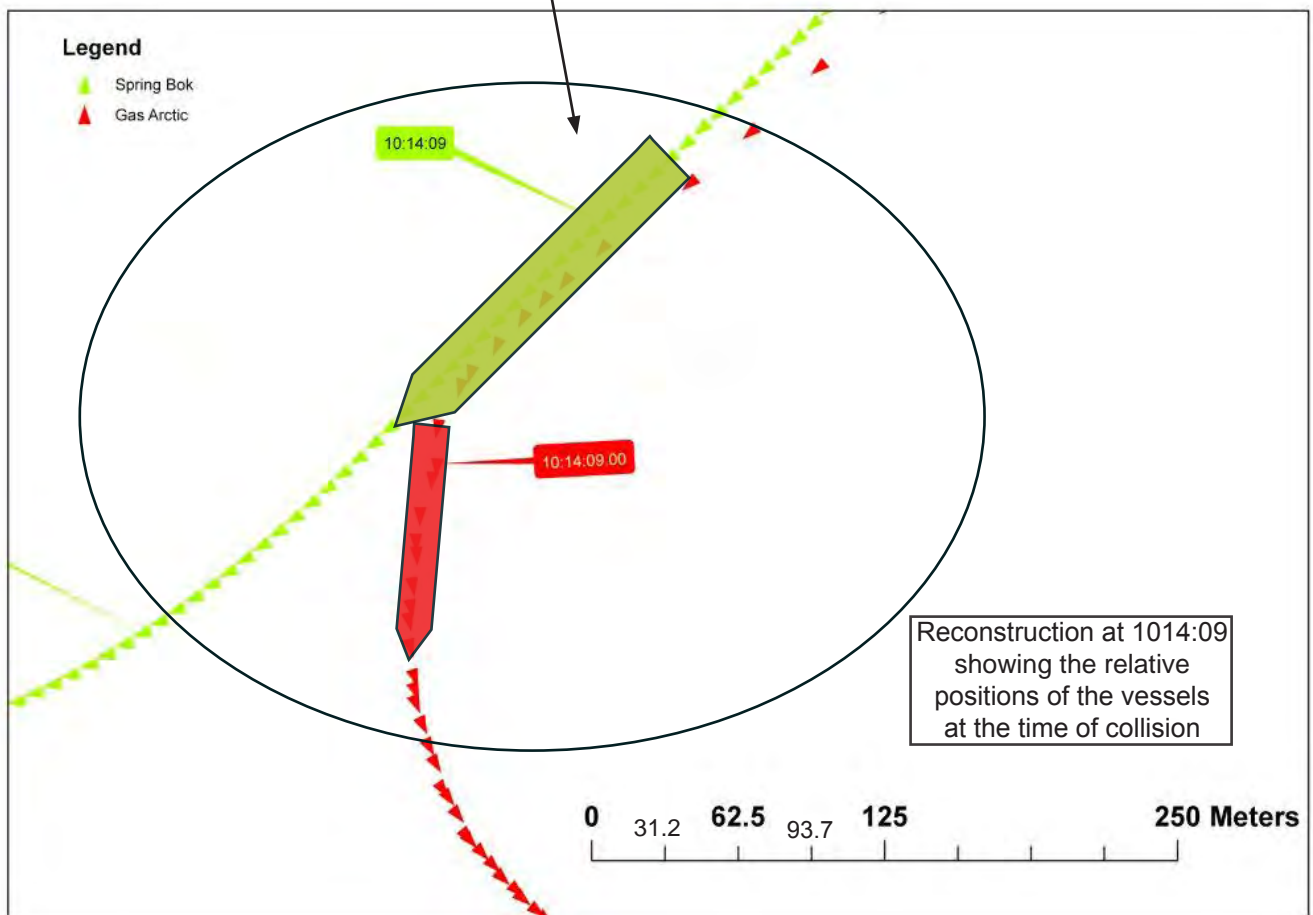
Figure 7: Reconstruction

The reconstruction of the ground tracks of *Spring Bok* and *Gas Arctic*, based on GPS information (**Figure 7**), confirms that *Spring Bok* was overtaking *Gas Arctic* and made no alteration of course before the collision.

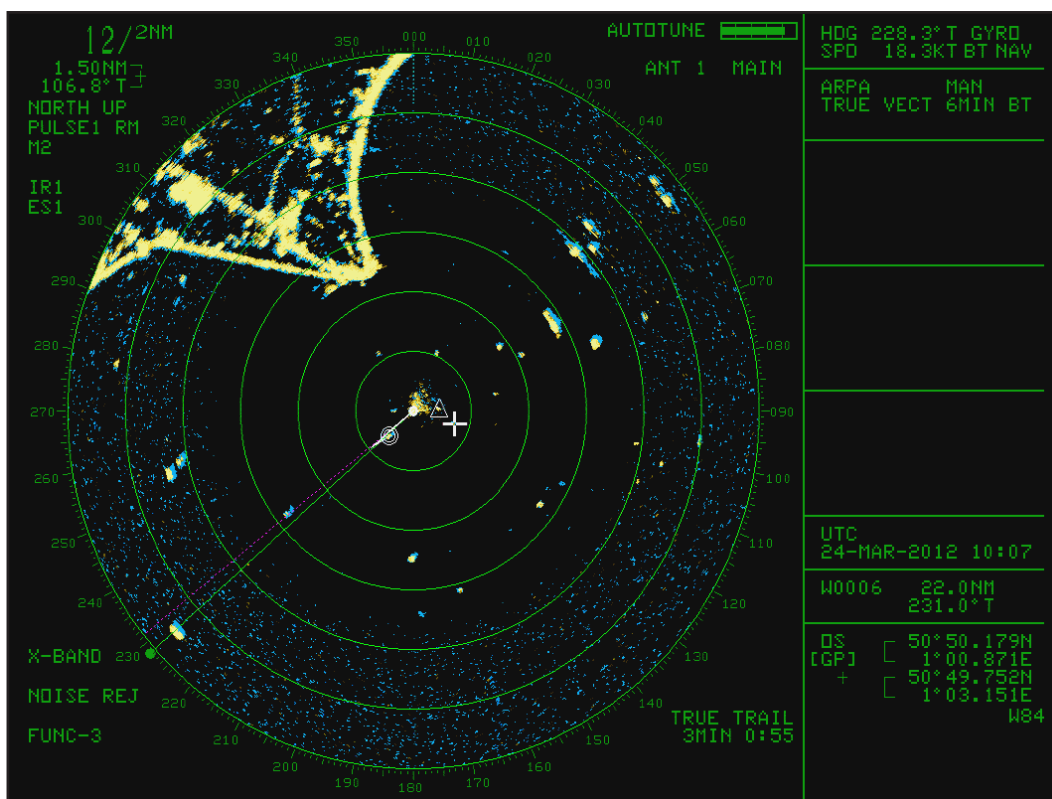
Figure 8: *Spring Bok* - ARPA radar display at 1007

The master selected true vectors and true trails for targets on the ARPA radar. This selection had the disadvantage of giving no relative information of a target, unless it was selected for display, which the master did not do. With *Gas Arctic* directly ahead, the radar heading line and *Spring Bok's* own vector might have combined to obscure the radar target's vector unless the heading line was occasionally switched off; and there is no evidence to suggest the master was doing this. Further, as *Spring Bok's* radar was on the 12 mile range scale, *Gas Arctic's* radar echo became less distinct as its range decreased (**Figure 8**).

The fact that the target data of *Gas Arctic* was not displayed meant that there was no stimulus to the master once the target had merged with the vessel's own heading line and vector as the likelihood of collision increased.

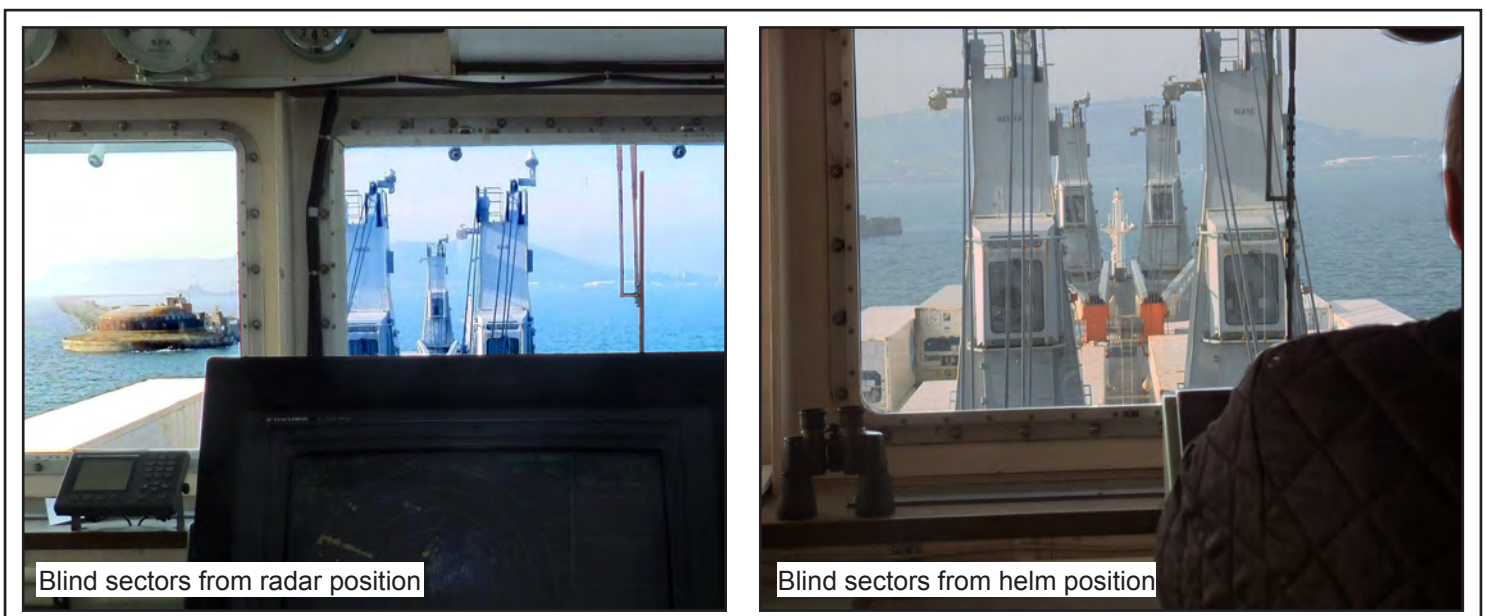
**Figure 9:** *Spring Bok* bridge showing blind sectors from radar and helm positions

to see *Gas Arctic* from that location due to a blind sector caused by a combination of the wheelhouse window frame and the cargo cranes (**Figure 9**), and he first became aware of her presence after she altered course to port and appeared to the left of the blind sector.

SOLAS<sup>8</sup> Chapter V, Regulation 22 sets maximum permissible blind sectors from the conning position on vessels built after 1 July 1998. Although these regulations do not apply to *Spring Bok* as she was built in 1984, the visibility from the bridge did comply with the new regulations.

On vessels with wheelhouse blind sectors, it is important that the OOW/lookout moves around the bridge frequently to ensure that a proper lookout is maintained at all times. This was not the case at the time of the collision as the master had stationed himself at the radar display, a not unreasonable course of action in restricted visibility, and the lookout that should have been available to back him up had been stood down.
