**MARINE ACCIDENT
INVESTIGATION REPORT**

Vessel type and name: Chemical Tanker "SULPHUR GARLAND"
IMO number: 9209013
Gross tonnage: 3,498 tons

Vessel type and name: Oil Tanker "WAKOMARU NO. 2"
IMO number: 141721
Gross tonnage: 2,018 tons

Accident/Incident type: Collision
Date and time: Around 03:26:39, October 17, 2015
Location: East off Mutureshima Island, Shimonoseki City, Yamaguchi Prefecture
(Kanmon Passage, Kanmon Port)
Around 071° true bearing, 1,360 meters from the Mutureshima Lighthouse
(approximately 33°58.9'N, 130°52.9'E)

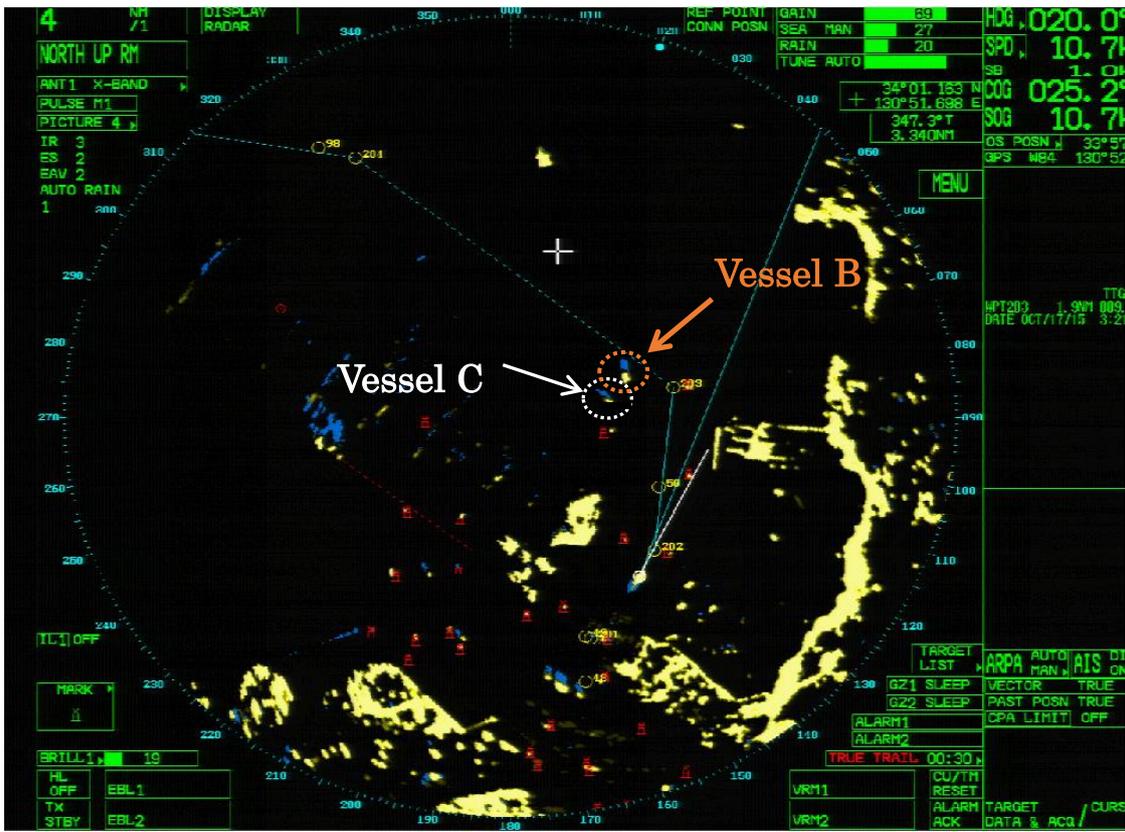
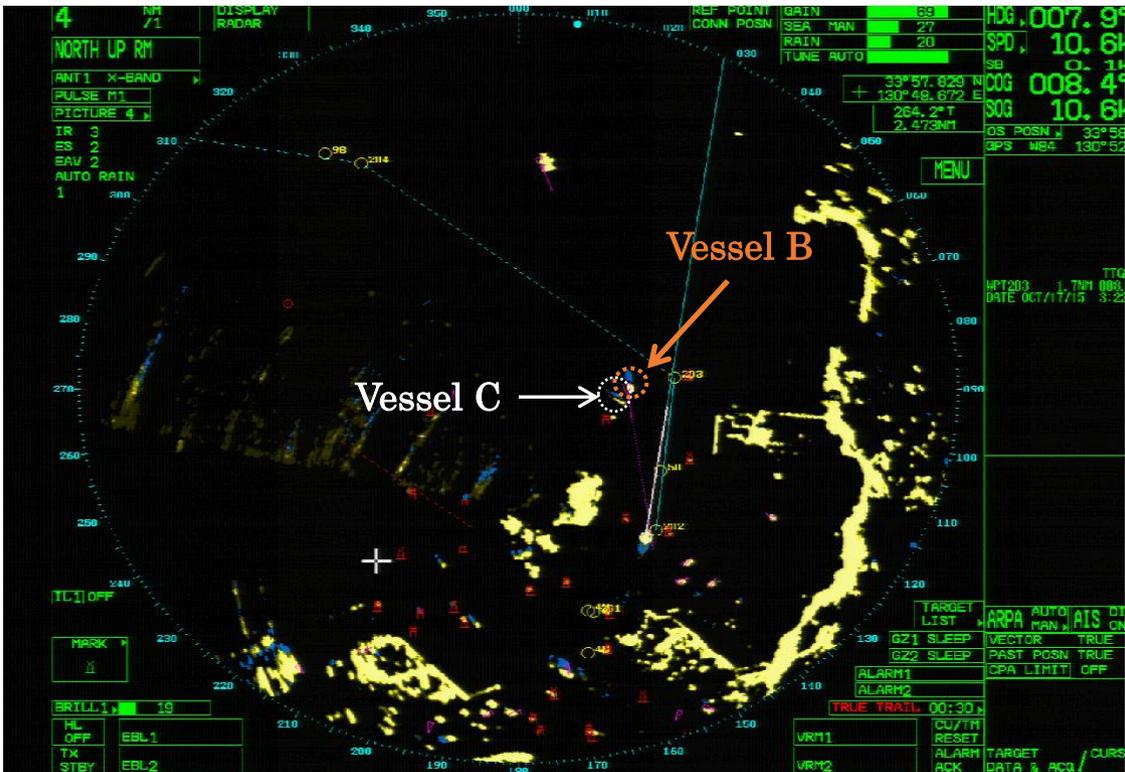
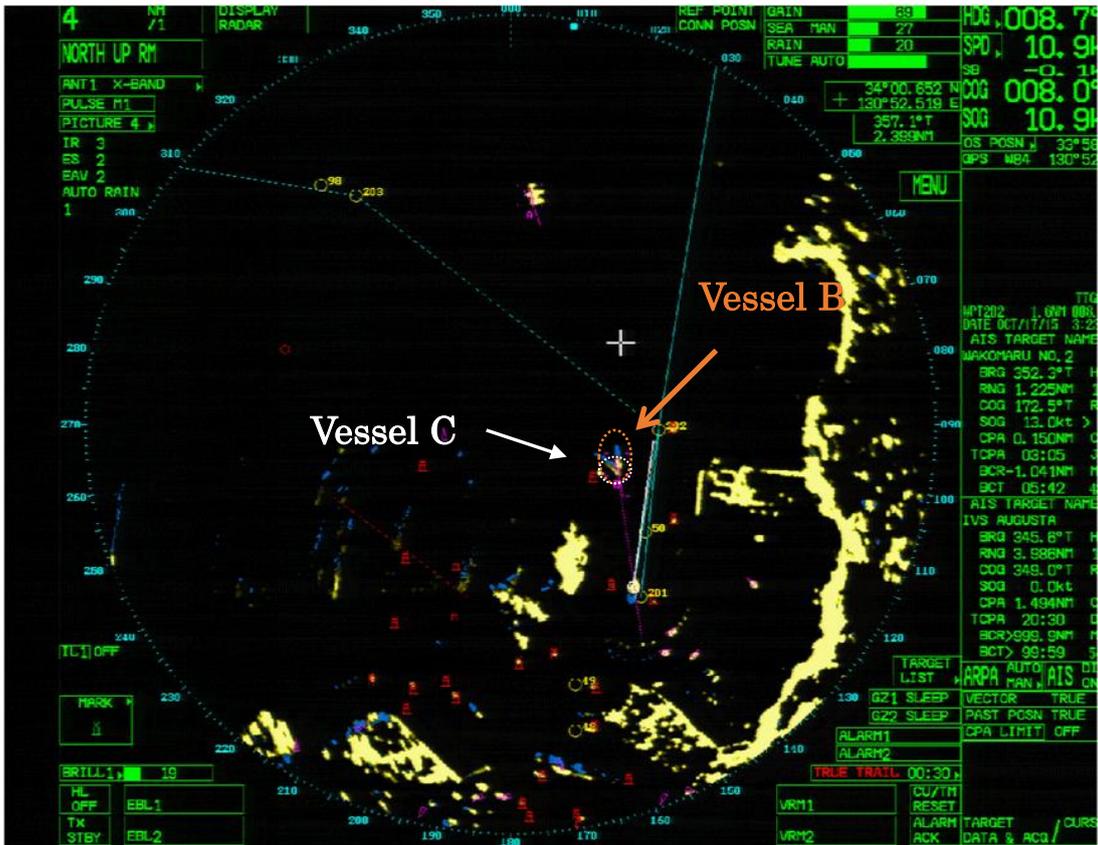
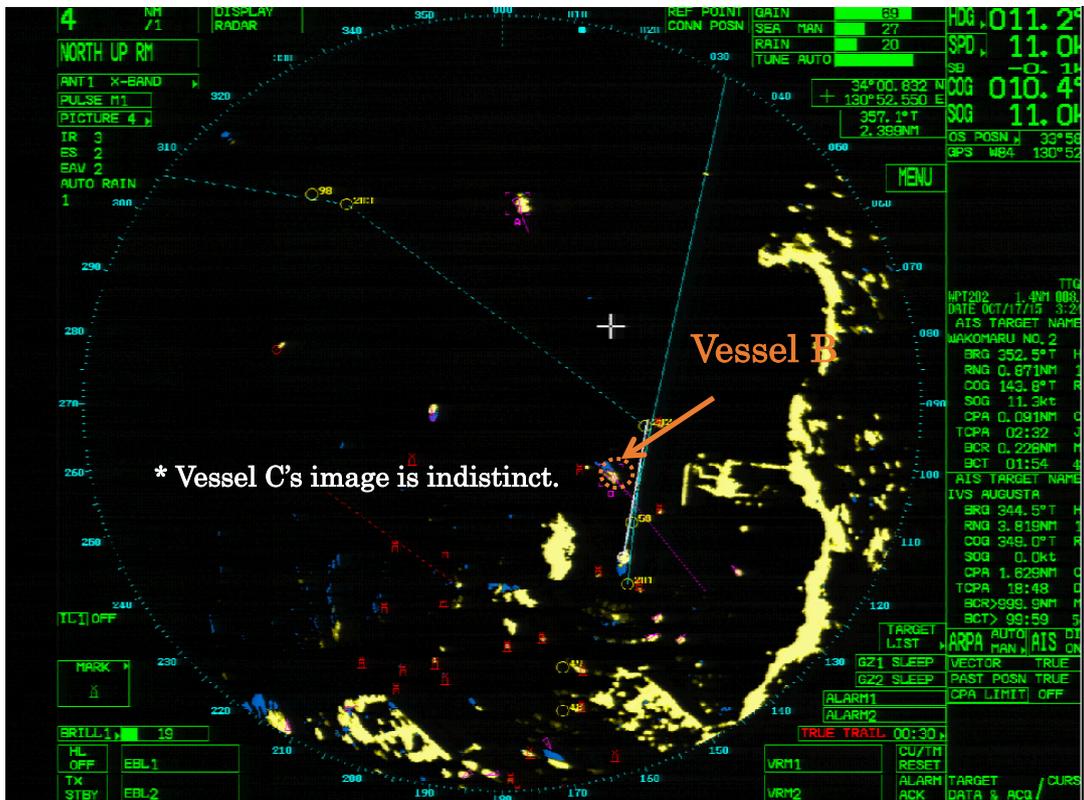
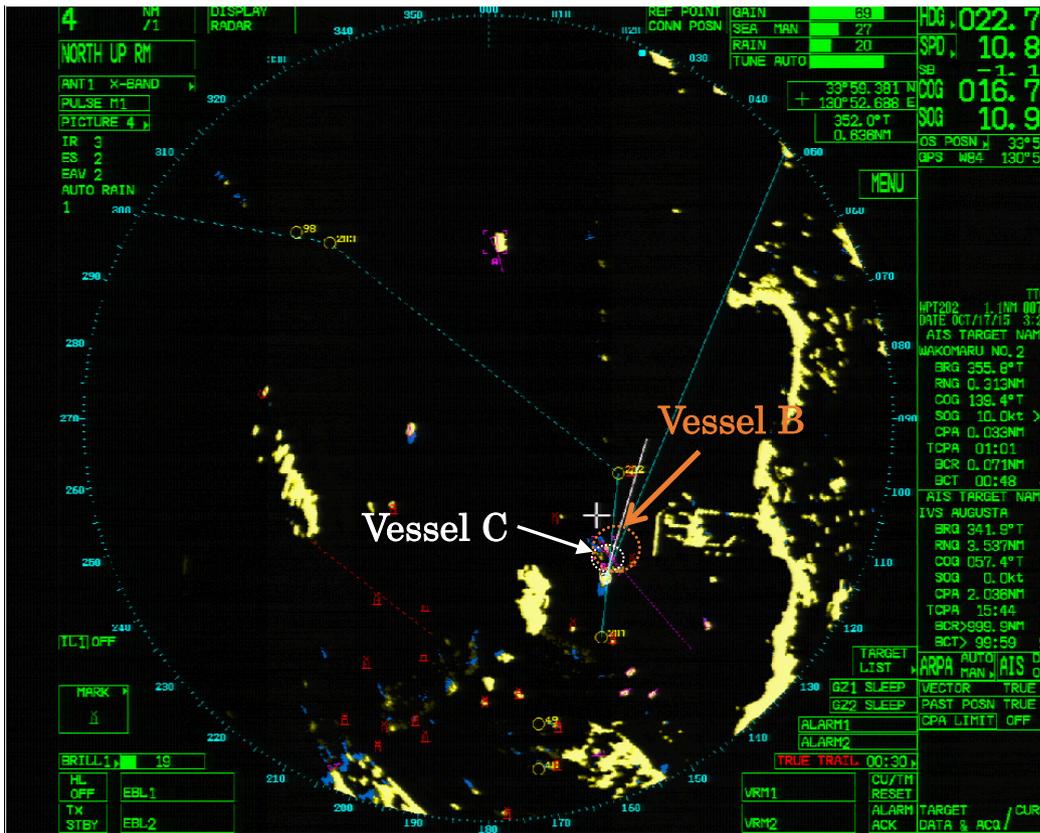
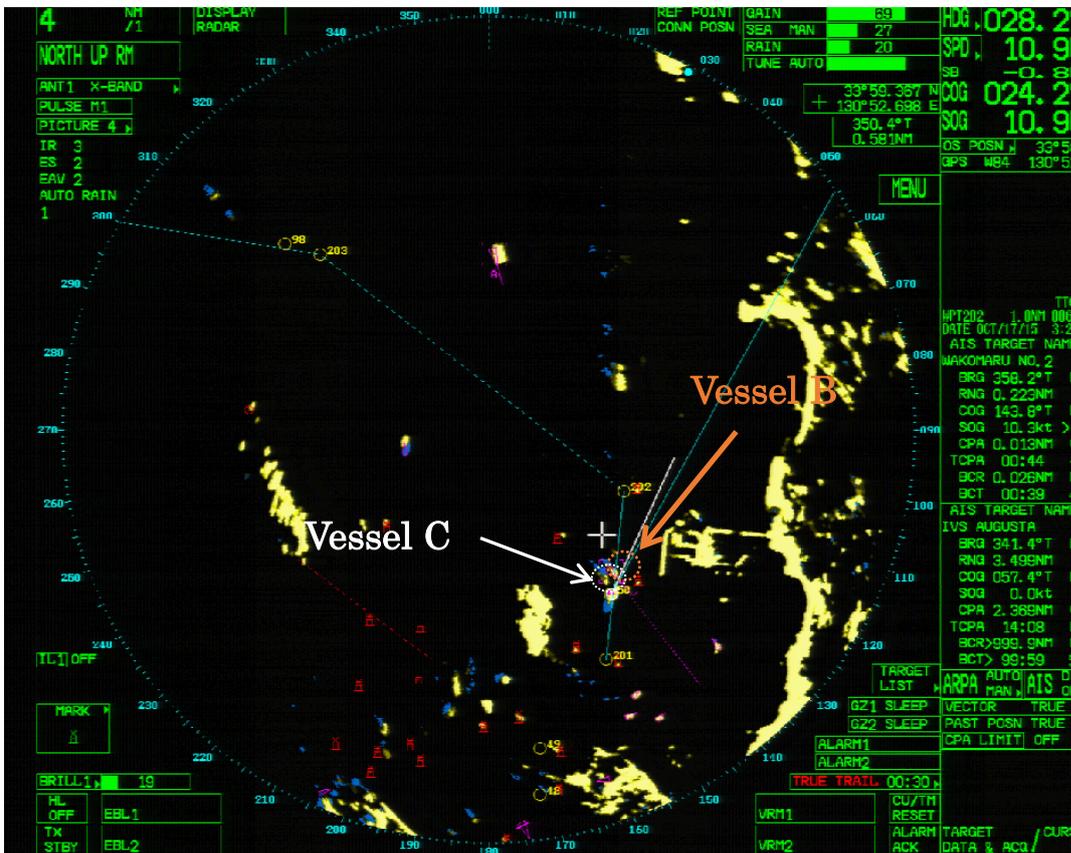
Figure 1 Radar Images from Vessel A

- 9) Given that Vessel C appeared on Vessel A's radar screen at about 03:21, it is somewhat likely that if Master A had been on the bridge, Navigation Officer A would have been monitoring the radar and noticed Vessel C. (See Figure 1 Radar Images from Vessel A)

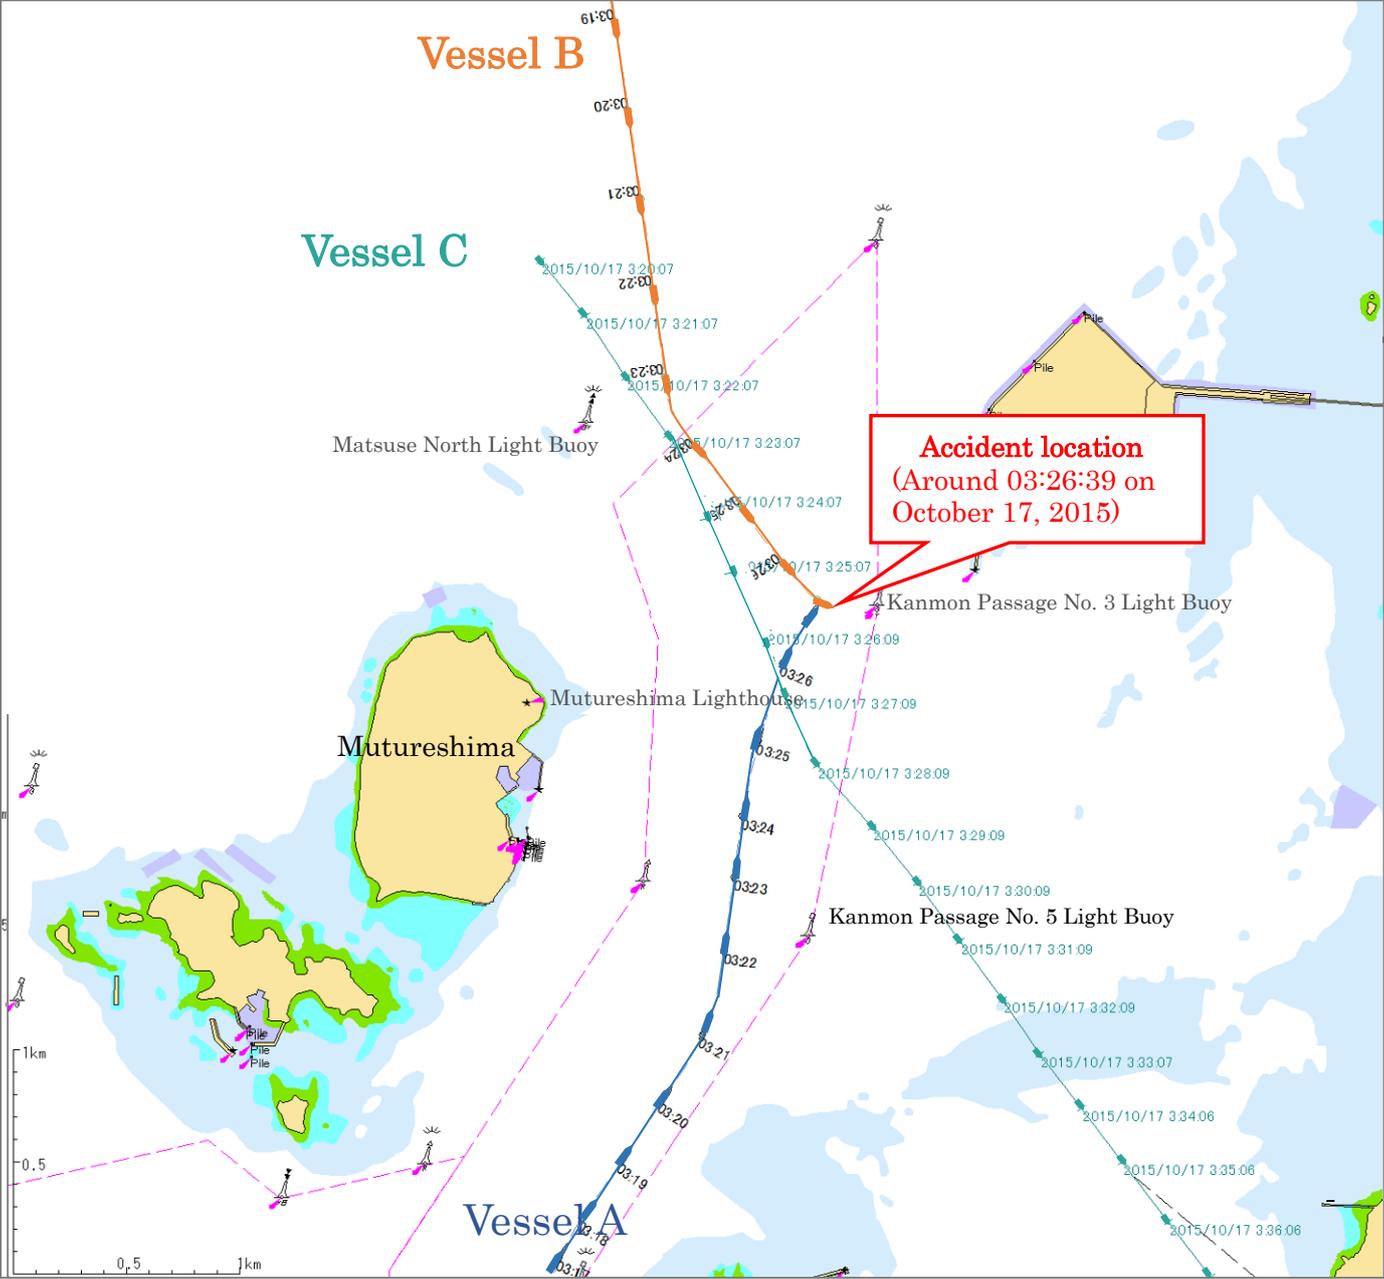
The date and time of occurrence of the accident were at about 03:26:39 on October 17, 2015, and the location was at about 1,360 meters at 071° true bearing from the Mutureshima Lighthouse. (See Figure 2 Navigation Paths and Figure 3 Navigation Paths [Enlarged])
