# BAHAMAS MARITIME AUTHORITY

Report of the investigation into the collision between the passenger vessel "Norwegian Dream" and the container vessel "Ever Decent" in the approaches to the Dover Strait at 0055 on 24 August, 1999

12 April, 2000

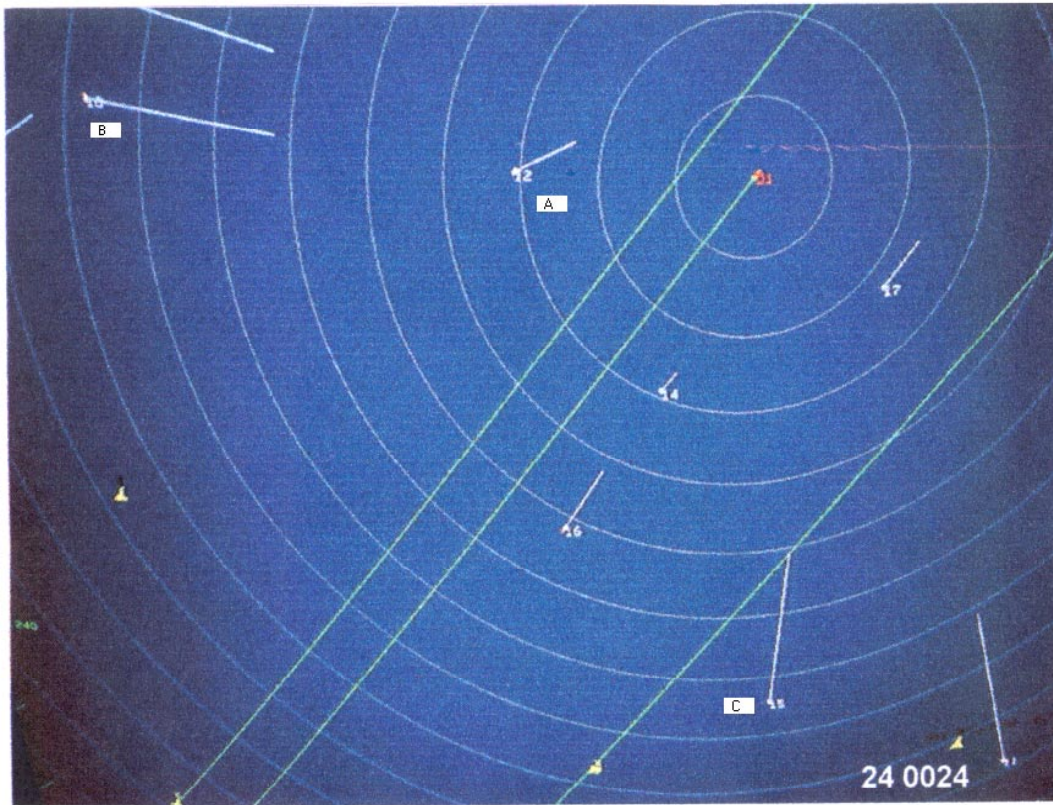
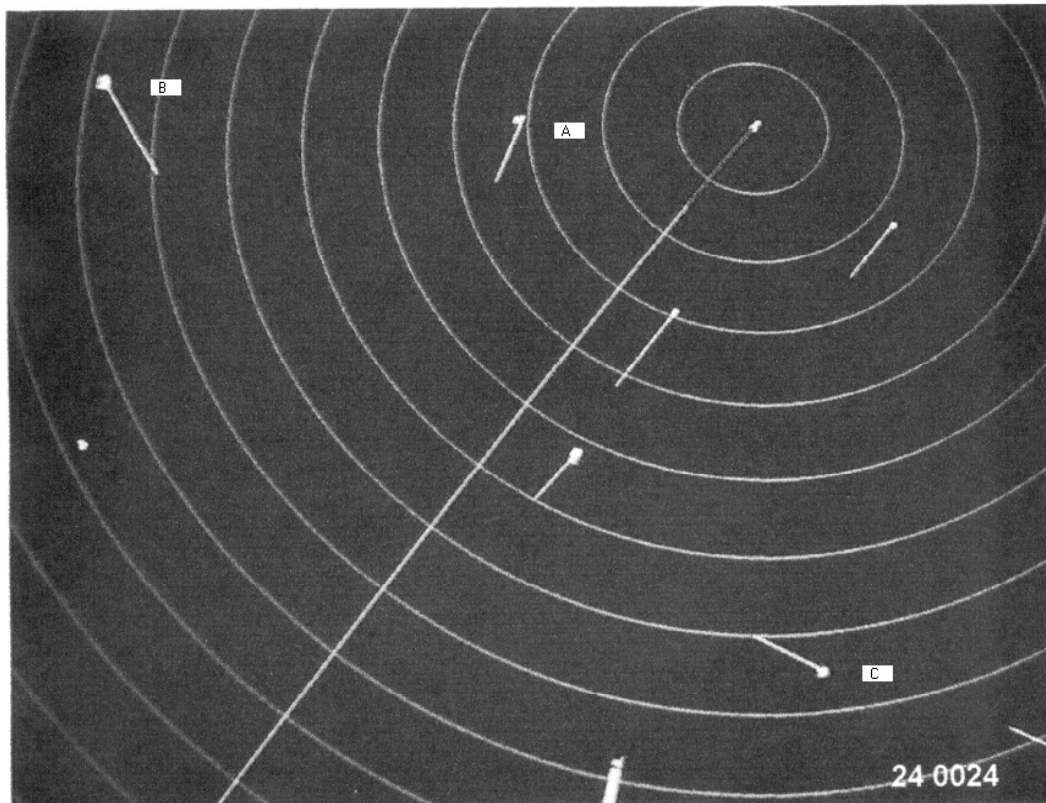
**Time: 0030**  
(see opposite)

At 0026, course was altered to 212 °(T) and (G) to bring the Norwegian Dream nearer to the centre of the traffic lane. This had the effect of bringing the CPA of the ship (B) being overtaken by the Ever Decent down to about 0.3 miles. It also brought the ship about three points to port some 7 miles away (C) onto a collision course.

The Ever Decent (ED) came into radar view about one mile on the port quarter of the ship which she was overtaking (B). She was on a collision course with the Norwegian Dream and about 6.6 miles away. The ship being overtaken by the Norwegian Dream to starboard (A) was almost in transit with the Ever Decent and was about 2.7 miles away. The ship on a collision course to port (C) was about 5.8 miles away holding a steady course. The Norwegian Dream was under an obligation under Rule 13 of the Convention on the International Regulations for Preventing Collisions at Sea 1972 (COLREGS Rule 13) to keep out of the way of the ship being overtaken (A) and to maintain her course and speed for the ship (C) on a collision course to port. The Ever Decent was under an obligation (COLREGS Rule 13) to keep out of the way of the ship (B) which she was overtaking.

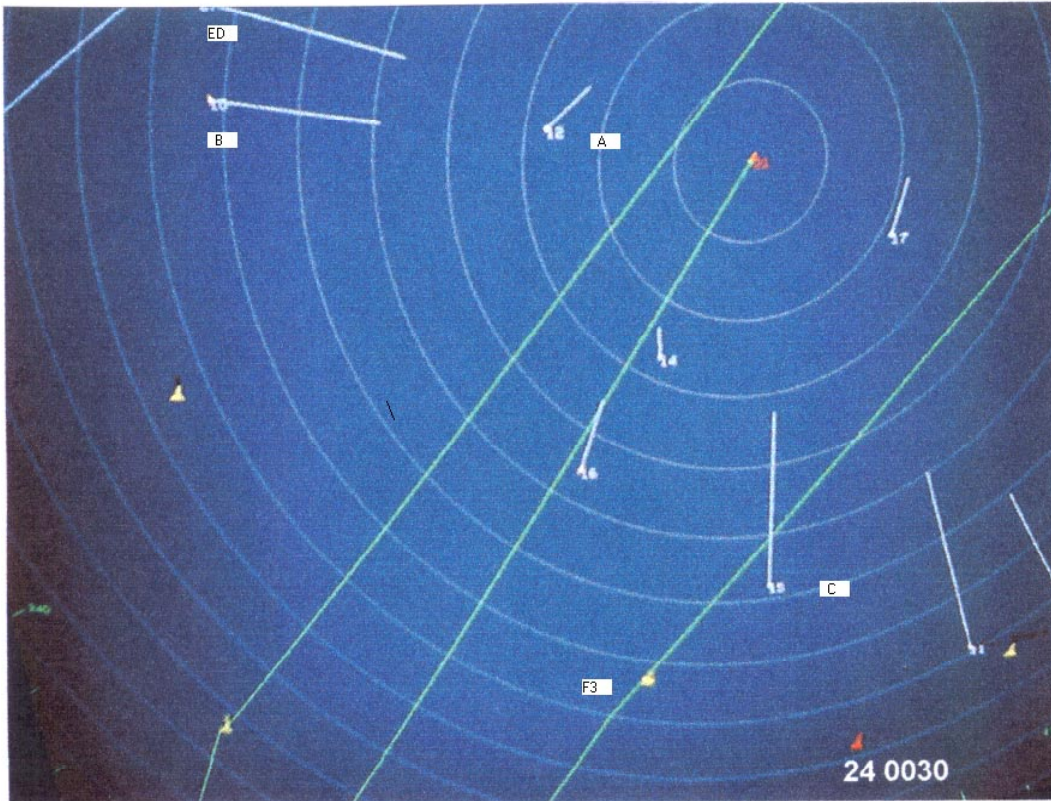
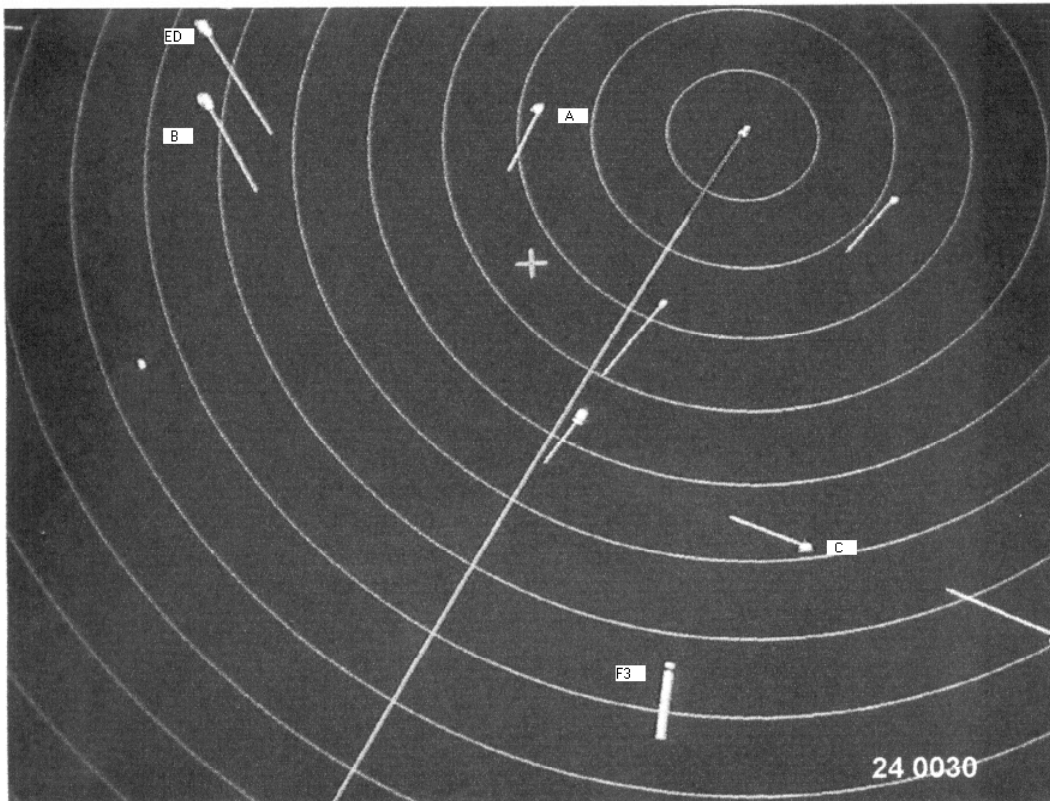
**Time: 0036**  
(see opposite)

The racon of the F3 buoy can be seen about two points to port, six miles distant. The OOW of the Norwegian Dream was conscious that as his ship passed that point it would be necessary, in accordance with company instructions to report to the CNIS station at Dover. The ship to port (C) remained on a collision course at a distance of 4.0 miles. The ship being overtaken to starboard (A) was still forward of the beam at 2.3 miles. The Ever Decent (ED) remained on a collision course at a distance of 5.5 miles, while continuing to overtake the ship on her starboard side (B). The Ever Decent (ED) and the ship being overtaken by the Norwegian Dream to starboard (A) were in transit at about this time and the Ever Decent may not have been visible to the Norwegian Dream or the lights of the two ships in transit may have been confusing from Norwegian Dream's bridge.

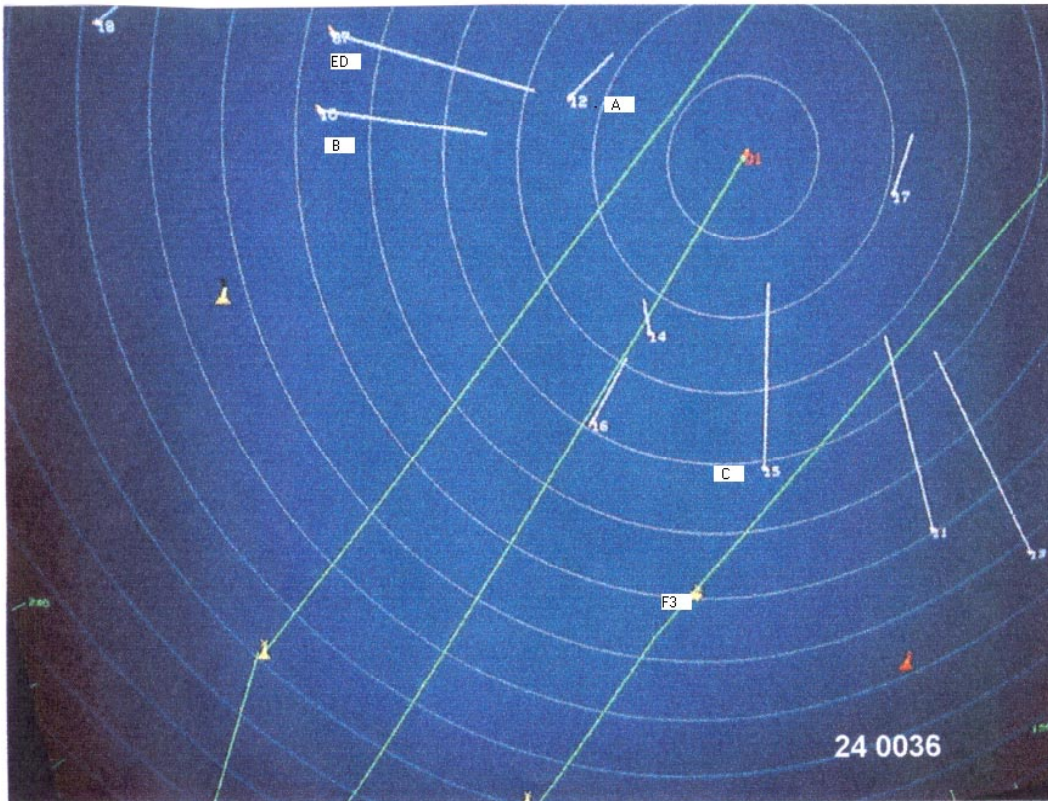
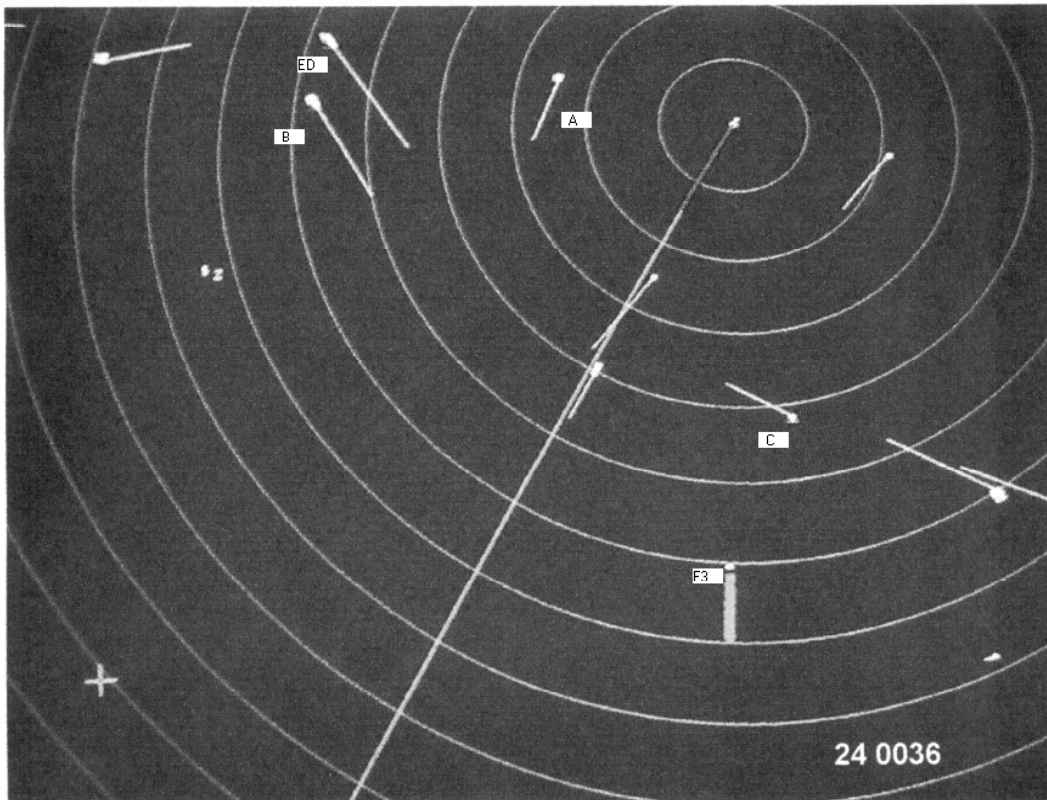
**Time: 0042**  
(see opposite)

Just before this time, a crew member came to the bridge to have the garbage record book signed. The entrance door to the bridge was locked, as was usual for security reasons, but the OOW let him on to the bridge and signed the book. The time against the signature was 0040 and the OOW estimates that the complete operation took about three minutes. This was a distraction for the OOW at a time when the traffic situation was becoming very busy.

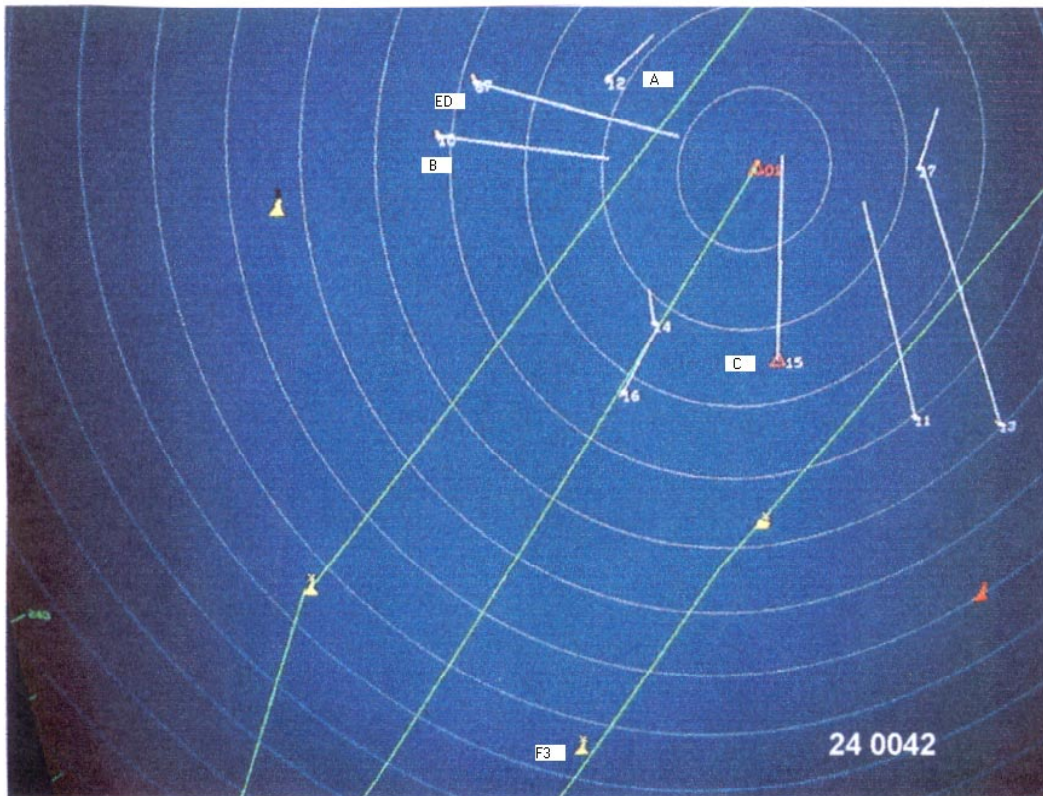
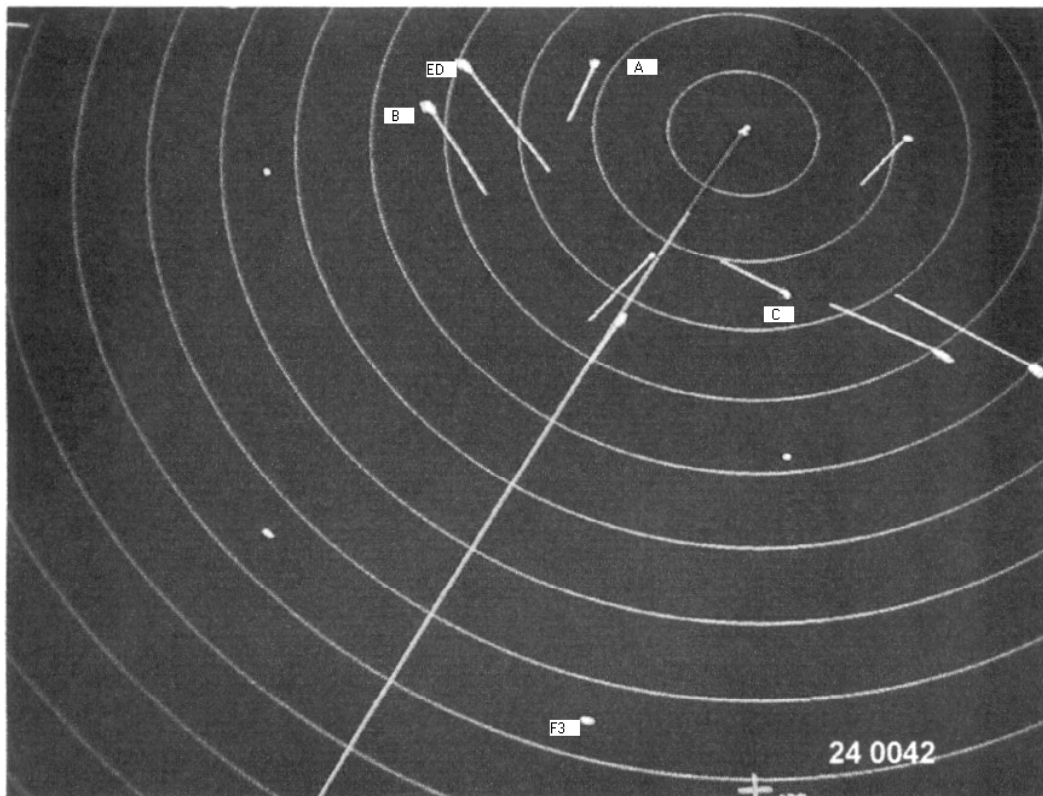
**Time: 0043**  
(see opposite)

The alteration of course by the ship to port (C) is now clear.

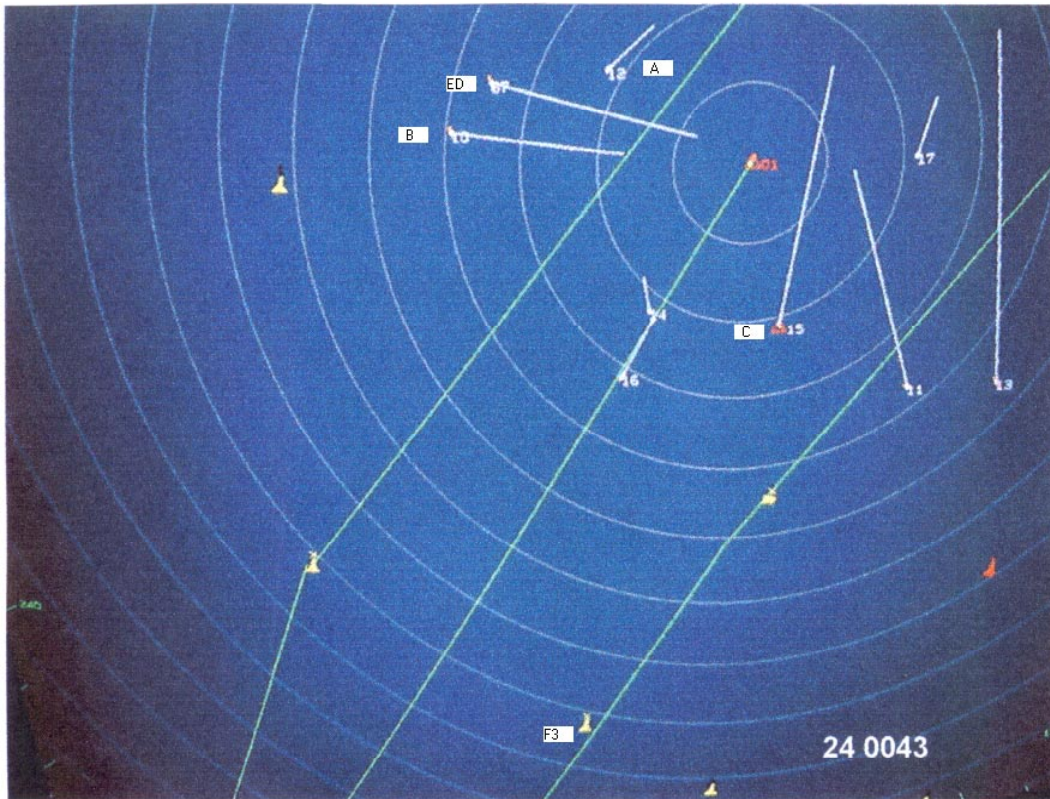
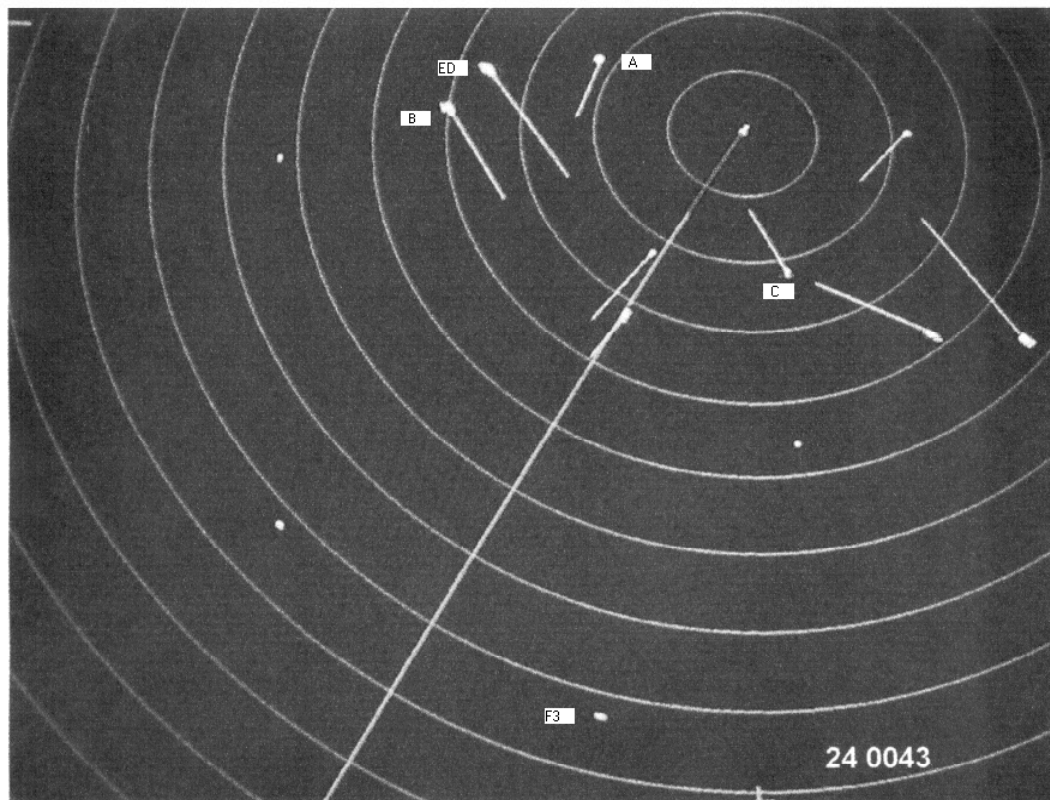
**Time: 0048**  
(see opposite)

Ever Decent (ED) was now clear of the ship which she was overtaking (B). The overtaken ship (B) altered course to port to pass around Ever Decent's stern, but at about this time the ship was in transit with the Ever Decent (ED) and probably not visible from the Norwegian Dream. The Ever Decent (ED) was 2.0 miles away and a point forward of the beam. The ship (A) to starboard being overtaken by the Norwegian Dream was now abaft the beam and no longer a direct problem, but if the Norwegian Dream had made a large alteration of course to starboard it may have brought her into a close quarters situation with this ship.

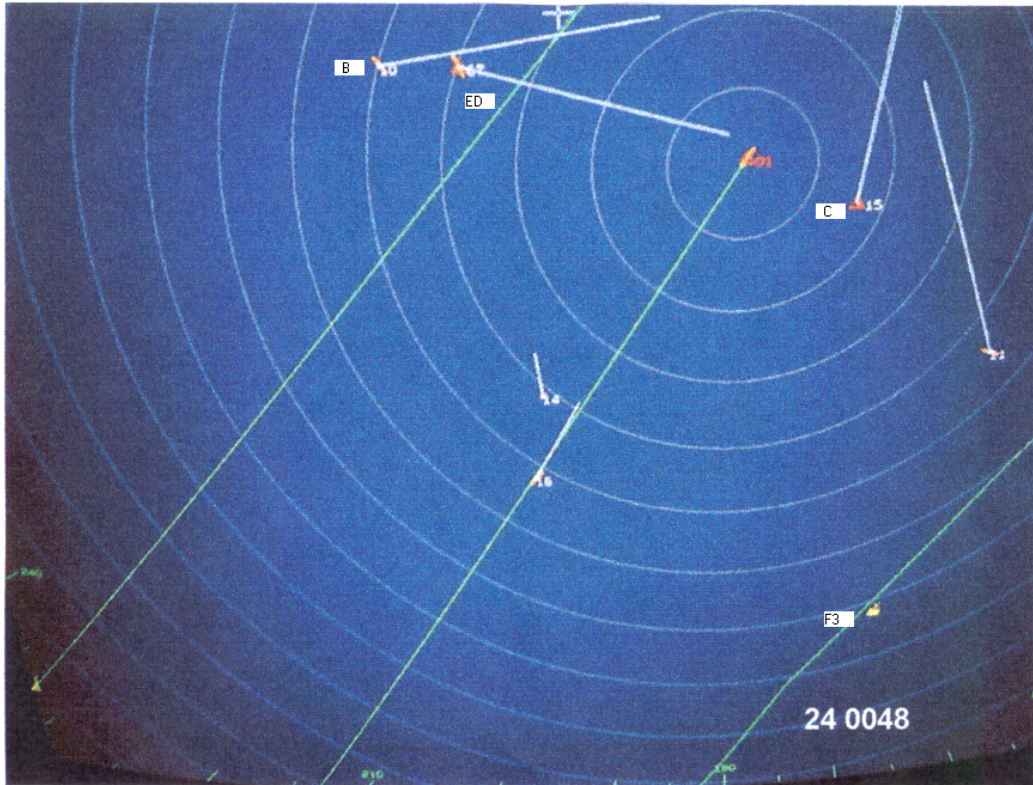
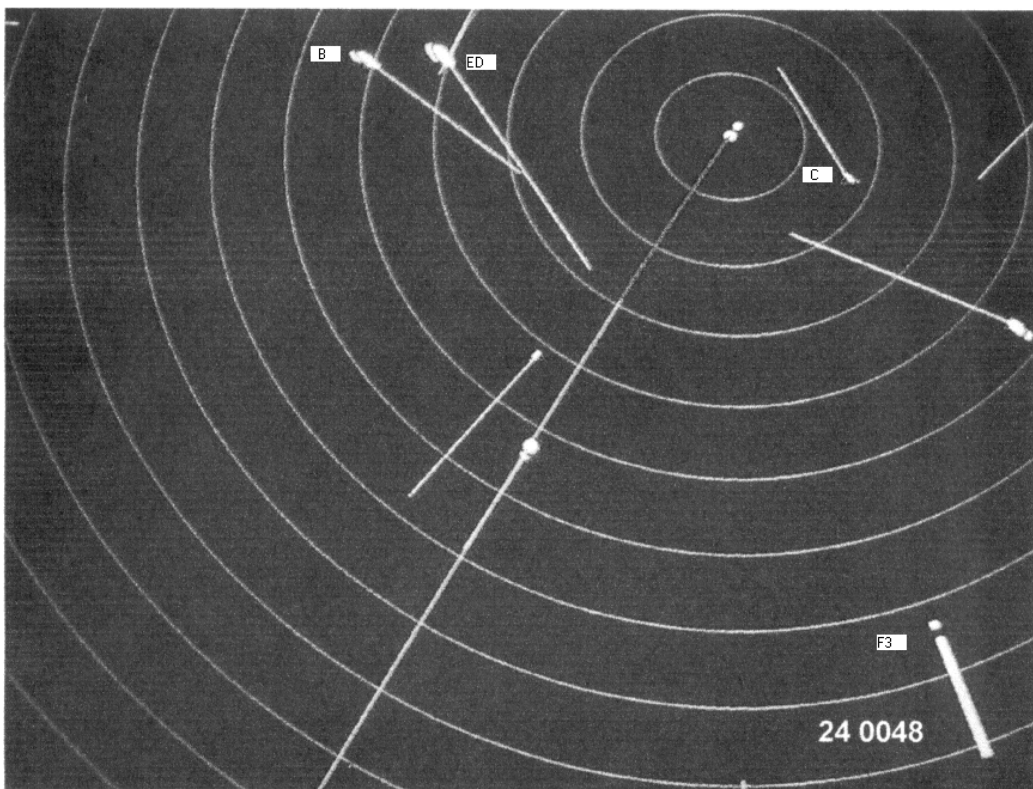
**Time: 0049**  
(see opposite)

A message was heard on VHF, Channel 16, saying "Passenger ship approaching Foxtrot Freeboy [i.e. F3 Buoy] course 215, please". The VHF transcript from CNIS notes the first Channel 16 VHF exchange without any time but the follow up on Channel 10 was noted as 00 hours 49 minutes 40 seconds. This was about 4 - 5 minutes before the collision. The ships identified themselves and, while replying, the OOW looked to starboard and saw a ship flashing a light forward of his starboard beam. The Ever Decent asked the Norwegian Dream to come to starboard to pass around her stern. The OOW seems at this point to have become confused with the ARPA plot. He stated that he thought the Ever Decent would pass about 0.6 miles ahead of him. This probably resulted from confusing the true vector with the relative vector. As can be seen on the 0051 lower plot the true vector of the Ever Decent passes about 0.7 miles ahead of the Norwegian Dream. He therefore agreed to the Ever Decent's request. Accordingly at about 0051 he altered course about 7 degrees to starboard to 220° (T) and (G) to increase the apparent passing distance.

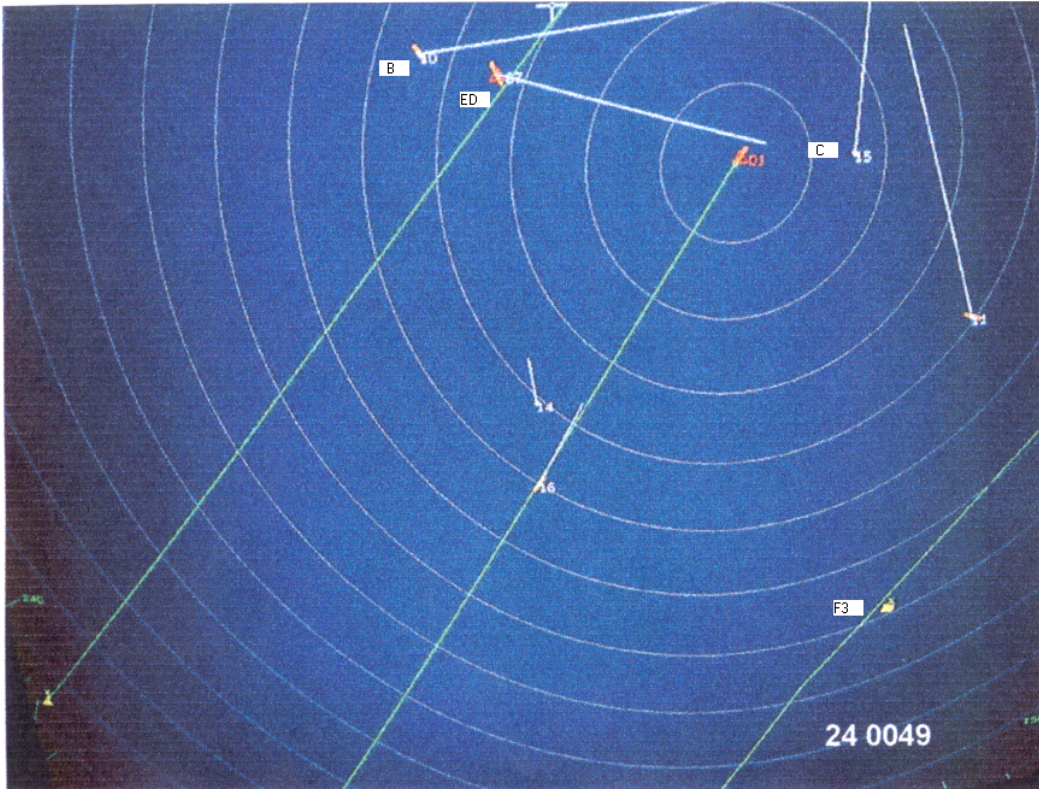
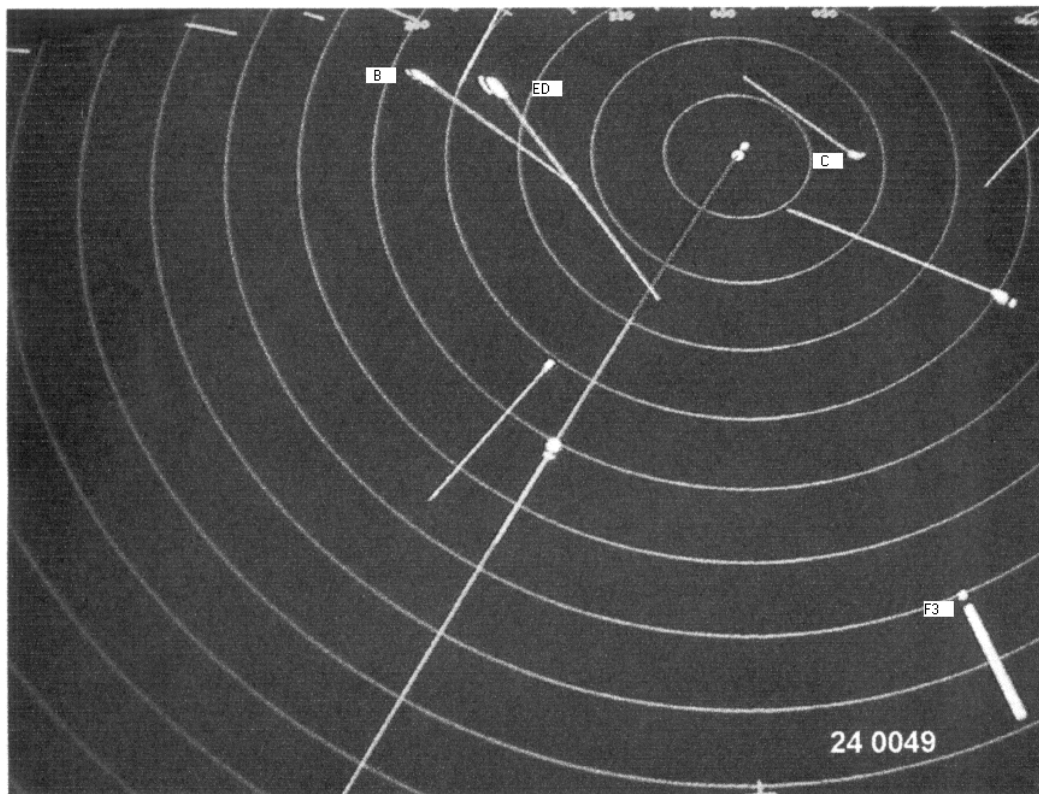
**Time: 0051 (see opposite)**

The Ever Decent (ED) appears to have maintained her course and speed throughout. The plot of her track shows no deviation. If any action was taken, it was too late to affect the outcome.

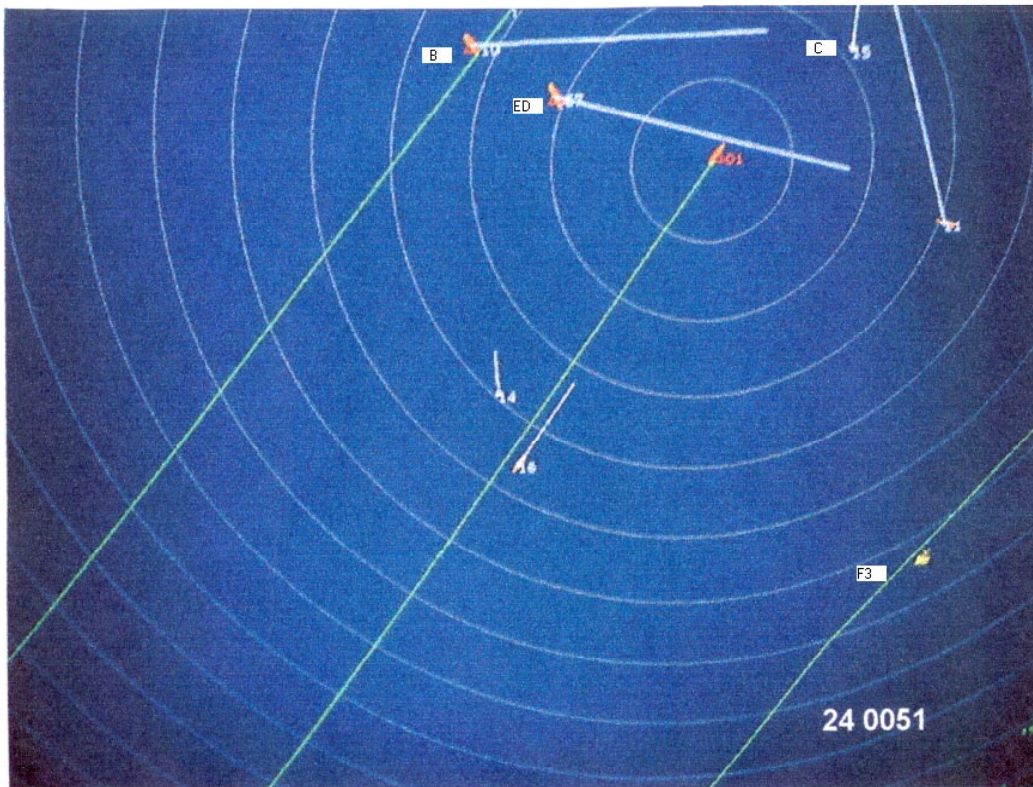
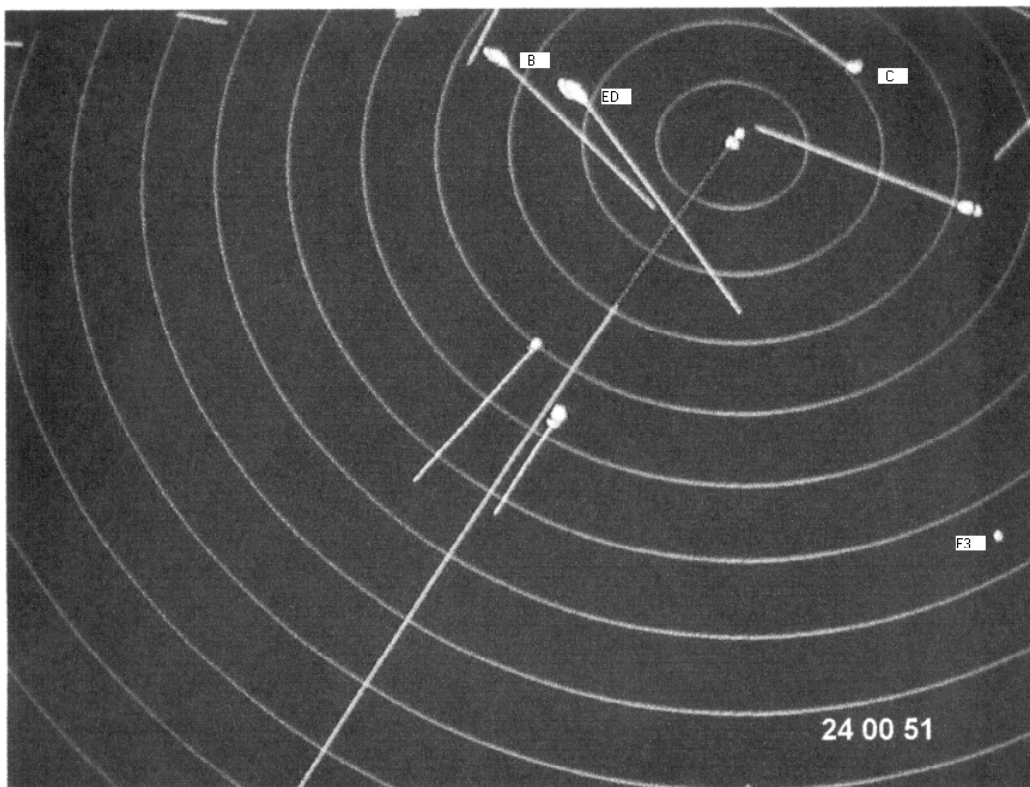
**Time: 0052 to 0053**  
(see opposite and on pages 26 and 27)

The Norwegian Dream was swinging to starboard, but the engine movement was ineffective in reducing the vessel's speed.

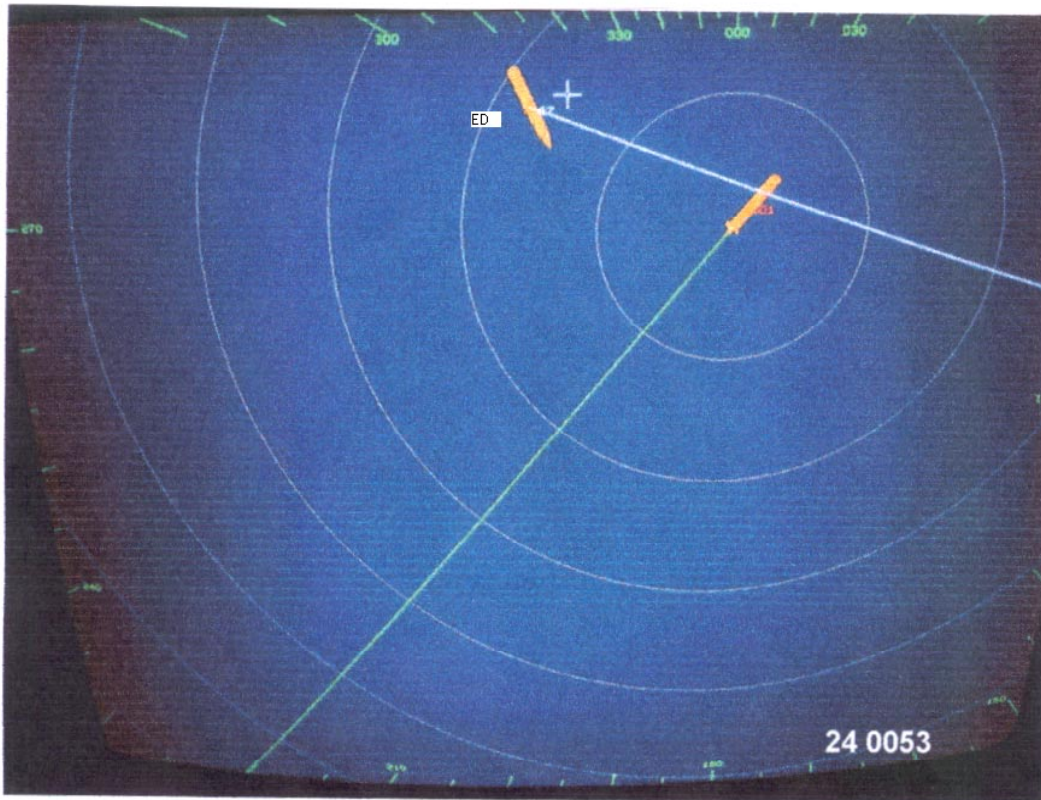
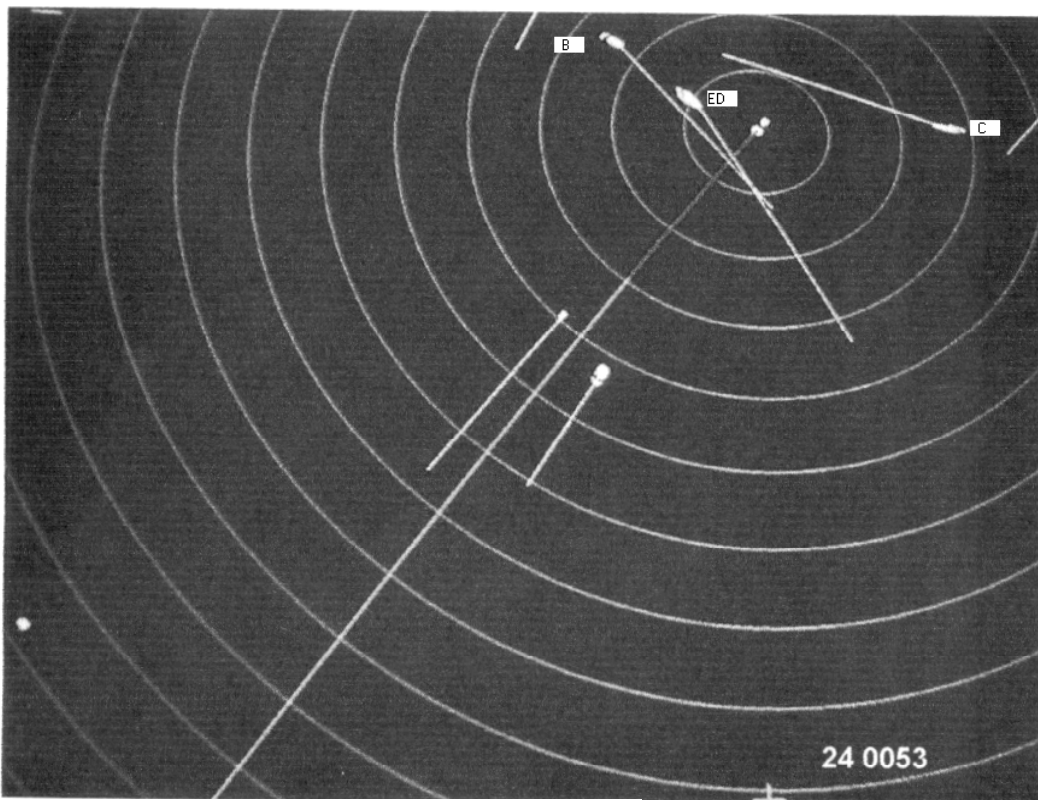
**Time: 0054**  
(see opposite)

The Norwegian Dream hit the port side of the Ever Decent (ED) approximately at right angles. The pitch and revolutions of both Norwegian Dream propellers tripped to zero on impact. The momentum of the two ships swung the Norwegian Dream to port and as the ships separated the stern of the Ever Decent hit the starboard side of the Norwegian Dream causing some further damage.
