Bundesstelle für Seeunfalluntersuchung
Federal Bureau of Maritime Casualty Investigation
Federal Higher Authority subordinated to the Ministry of Transport
and Digital Infrastructure

Investigation Report 58/14

Less Serious Marine Casualty

**Collision between the JADE and
MV WILSON FEDJE on 5 March 2014 in the
port of Hamburg**

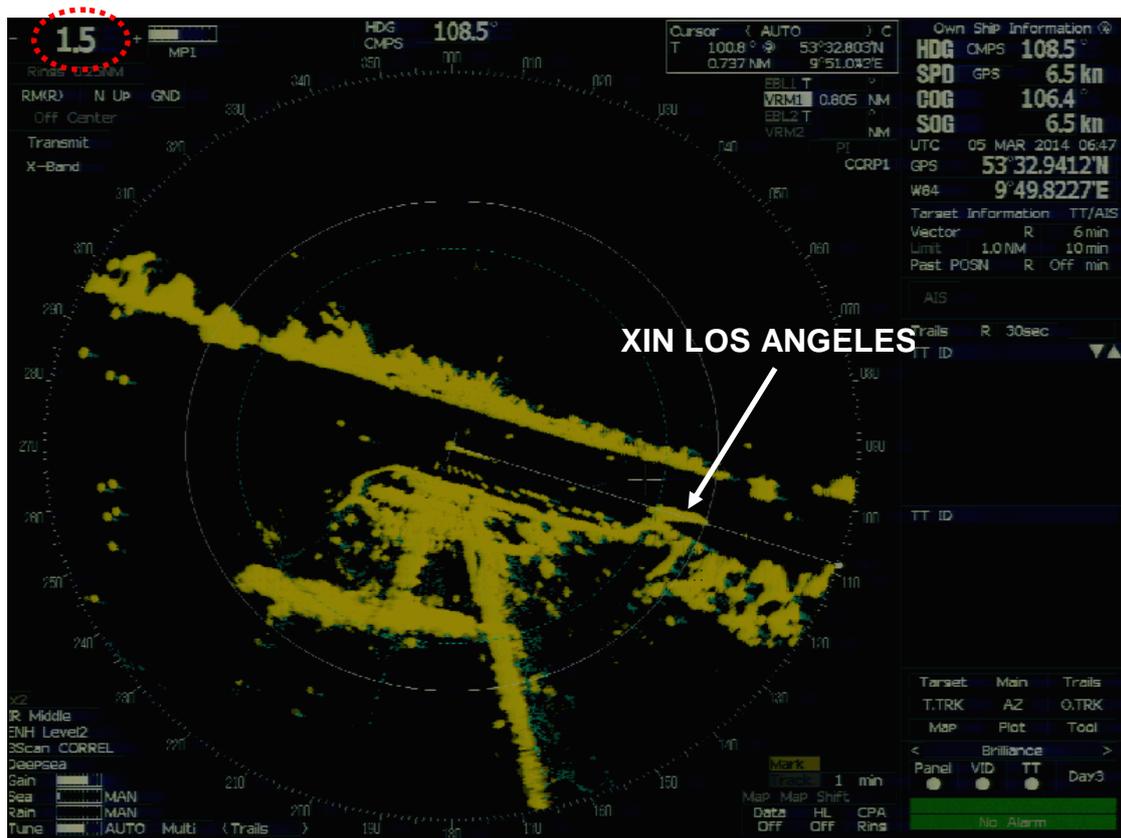
Figure 4: WILSON FEDJE's radar image (X-band) at 0747 (1)¹²

On **Fig. 4**, which shows the traffic situation from the radar perspective of the WILSON FEDJE at **0747**, i.e. just before the pilot transfer, the radar echo of the large container ship XIN LOS ANGELES is visible ahead at a distance of about 0.8 nm.¹¹ This vessel was also sailing upstream on the River Elbe to her berth in the port of Hamburg with tug assistance at a speed of about 6 kts. The echo of the XIN LOS ANGELES inevitably disappeared from the radar image initially after the radar unit's range was switched to 0.75 nm (see **Fig. 5**).

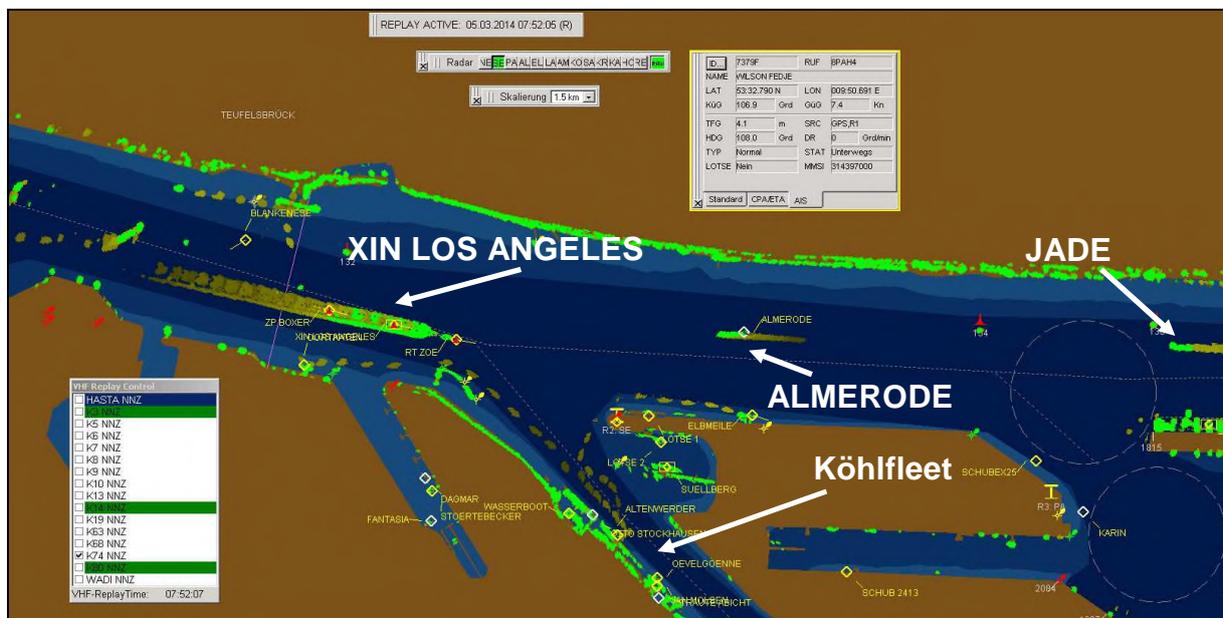
Figure 6: Radar/AIS recording from Hamburg Port Traffic (0752)

Fig. 6 below was extracted from Hamburg Port Traffic's radar/AIS¹⁶ recording and shows the positions of the ALMERODE, heading for Köhlfleet, and the XIN LOS ANGELES, sailing toward Köhlbrand, shortly before the WILSON FEDJE and ALMERODE liaised with each other, as already discussed above. The JADE's radar echo can now be seen on the right edge of the recorded image. The WILSON FEDJE was still outside and to the left of the section shown about 1.4 nm west of the ALMERODE and about 0.8 nm west of XIN LOS ANGELES at the time in question.

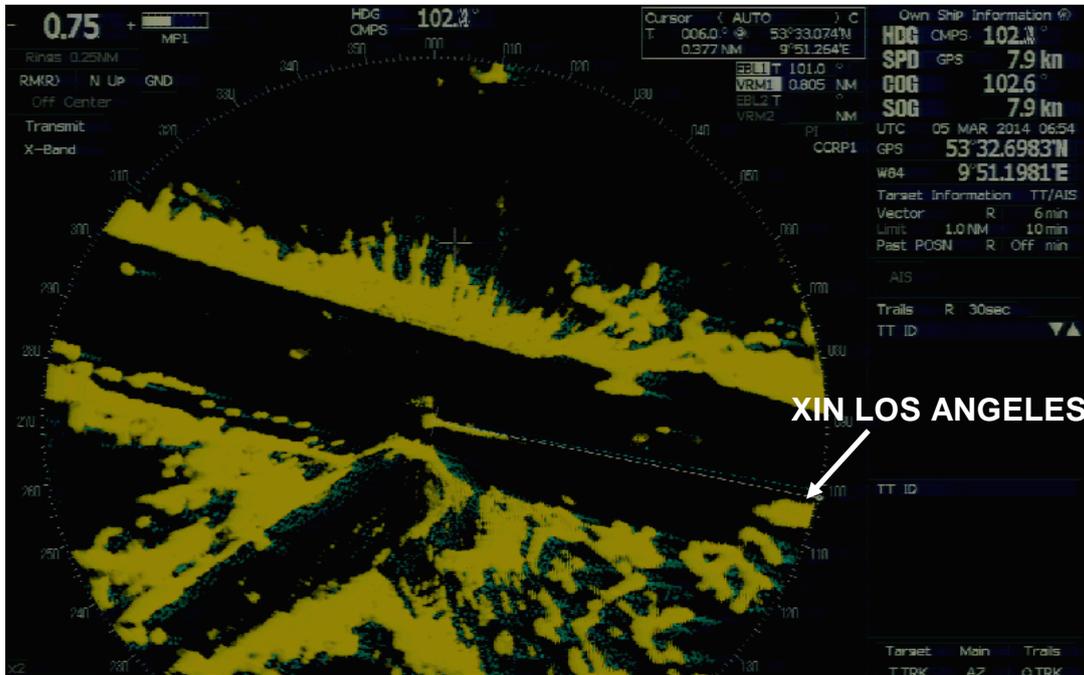
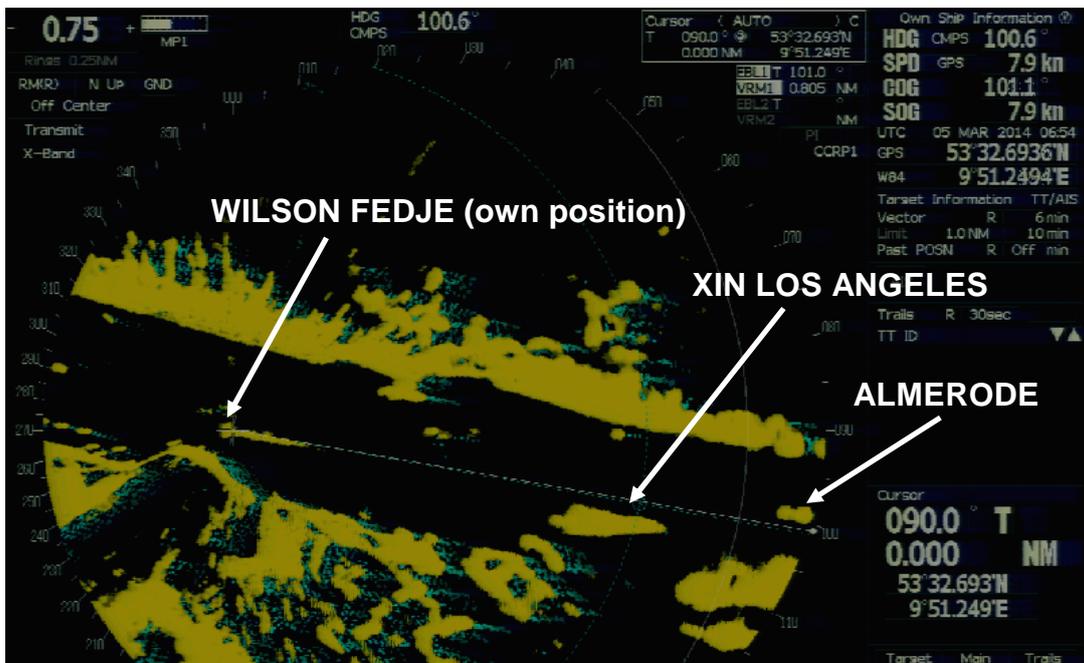
the pilot was able to see about 1.2 nm ahead without changing the 0.75-nm range setting on the radar. Consequently, the echo of the large container ship XIN LOS ANGELES, sailing ahead, was now completely visible on the radar screen and that of the ALMERODE, in a waiting position, had appeared on it for the first time (see Figs. 7 f.).

Figure 7: Extract from the WILSON FEDJE's radar image (X-band) at 0754 (1)

Figure 8: Extract from the WILSON FEDJE's radar image (X-band) at 0754 (2) (after her position was shifted to the left)

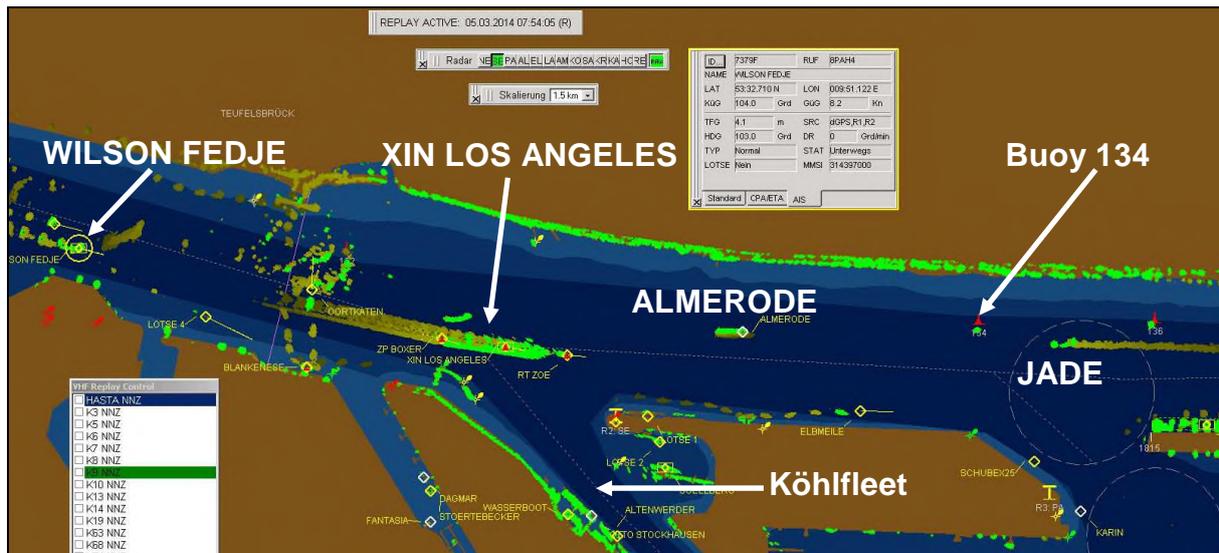
Figure 9: Radar/AIS recording from Hamburg Port Traffic (0754)

Owing to the distance between the two vessels being too great, the echo of the JADE is still not visible on the radar screen even after the position of the WILSON FEDJE was shifted. When the individual reference points are plotted in a nautical chart, the following representation of the traffic situation, also at **0754**, which was taken from the radar/AIS recording of Hamburg Port Traffic, shows that at the time referred to the distance between the WILSON FEDJE and the JADE, which is only displayed as a radar echo for lack of AIS ID (not a carriage requirement), stood at about 1.8 nm (see Fig. 9).

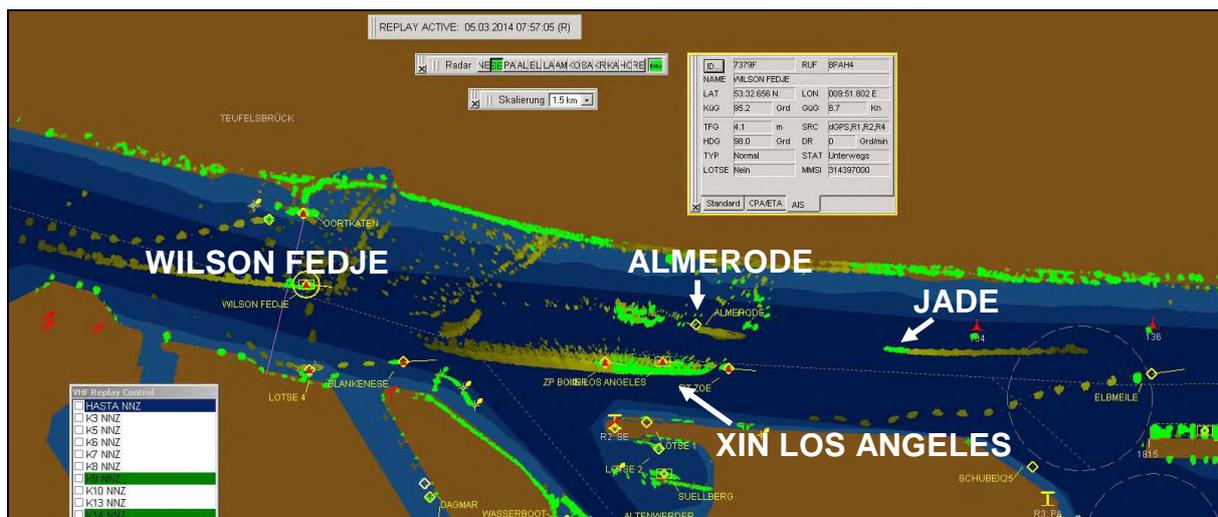
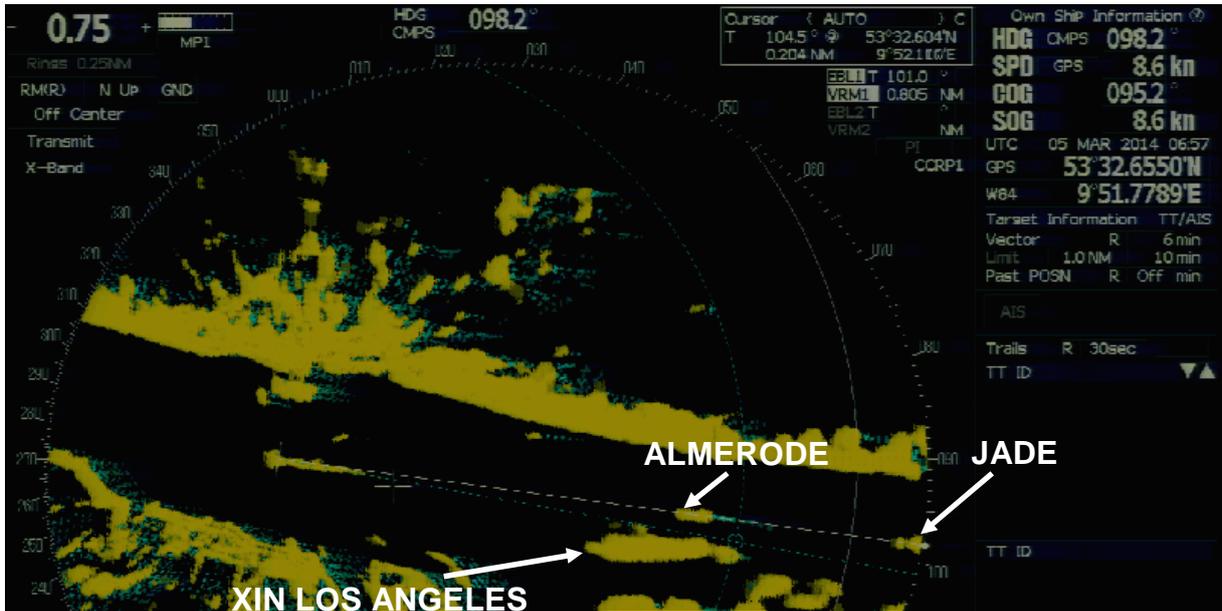
The two following **Figs. 10 f.** show the traffic situation at **0757** from the shore-based perspective of Hamburg Port Traffic and correspondingly from the perspective of the WILSON FEDJE's X-band radar. It is clear that the JADE, still anonymous to all stations, moves into the range of the radar unit used by the WILSON FEDJE's pilot at precisely this moment.

Figure 10: Radar/AIS recording from Hamburg Port Traffic (0757)

Figure 11: Extract from the WILSON FEDJE's radar image (X-band) at 0757

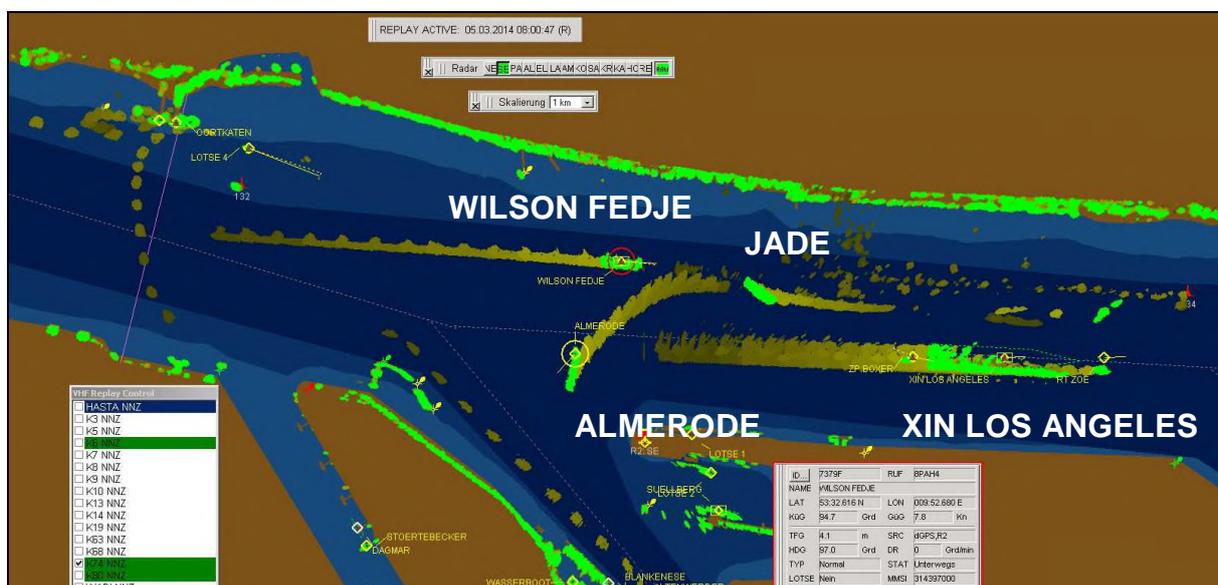
Figure 13: Radar/AIS recording from Hamburg Port Traffic (0801)

The turn to starboard of the still anonymous JADE coupled with the almost consistent course of the WILSON FEDJE is clearly visible on the following screenshot of Hamburg Port Traffic's recording of the traffic situation (see **Fig. 13**).

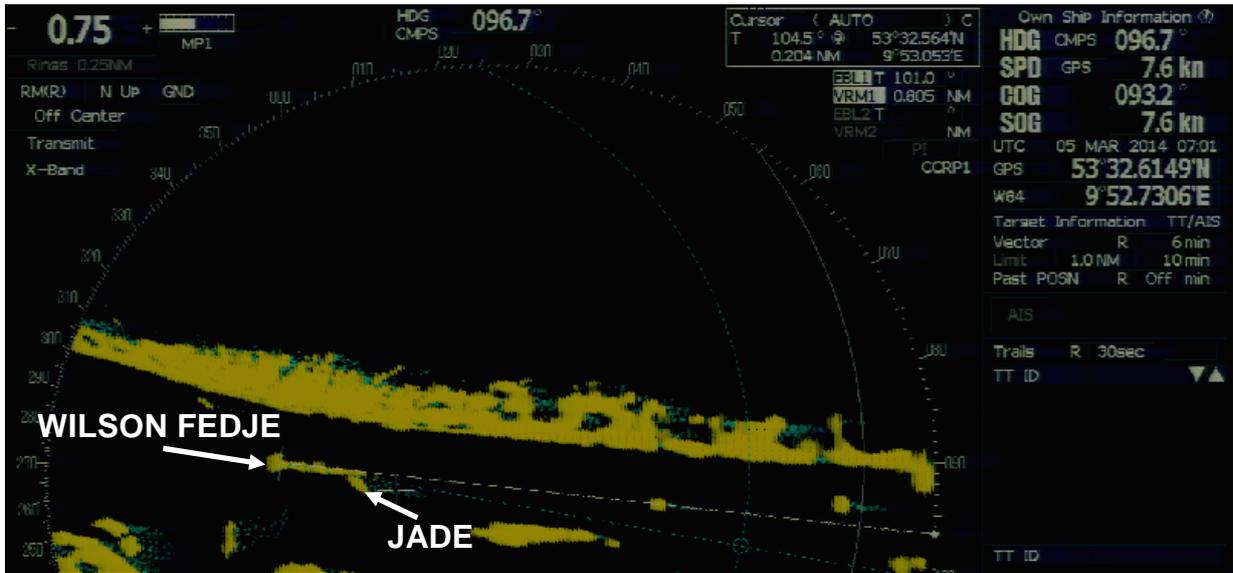
Figure 14: Extract from the WILSON FEDJE's radar image (X-band) at 0801

Seen from the rather unclear radar perspective of the WILSON FEDJE's pilot, the turn of the oncoming vessel, still anonymous at this point, is clearly visible only about half a minute later (about **0801** – see **Fig. 14** below), however.

The still anonymous JADE should have come into view on the bridge of the WILSON FEDJE at a distance of about 30 to 40 metres at about the same time as it was recognised that there was a risk of an immediate collision on the radar.

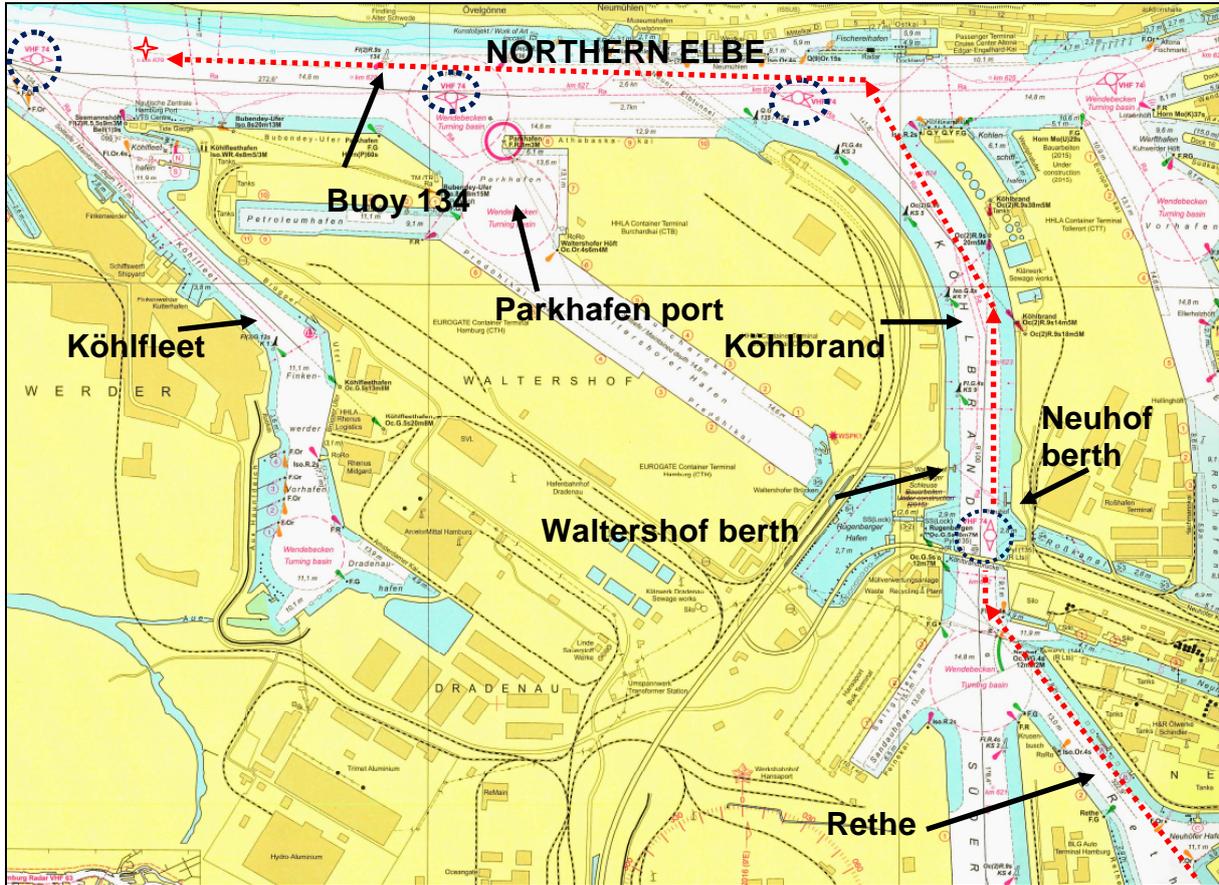
Figure 16: Route taken by the JADE from Rethe to the scene of the accident²⁰

Fig. 16 below illustrates in a simplified form the route taken by the JADE from Rethe to the scene of the accident.

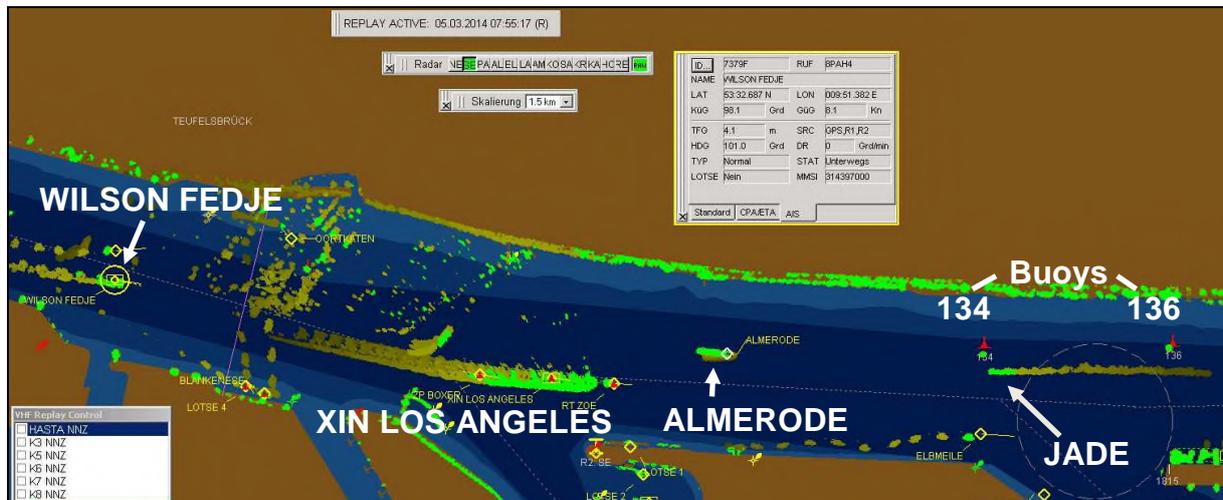
**Figure 17: Radar/AIS recording from Hamburg Port Traffic (0755)
(the JADE is just passing buoy 134)**

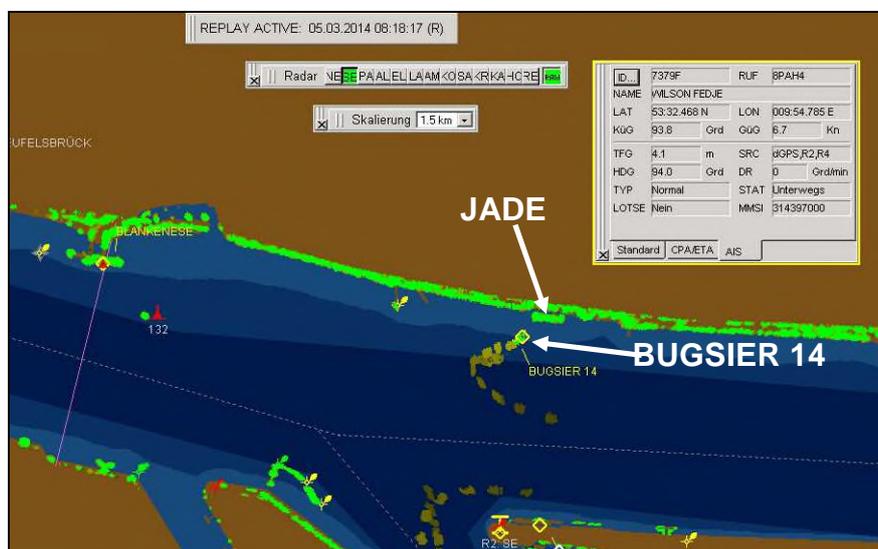
The BUGSIER 14 reached the JADE at about **0819** but was unable to sail right up to the distressed vessel, grounded parallel to the direction of the current on the bank of the River Elbe, due to her draught (see **Fig. 18**).

**Figure 18: Radar/AIS recording from Hamburg Port Traffic (0818)
(the tug BUGSIER 14 en route to the JADE)**

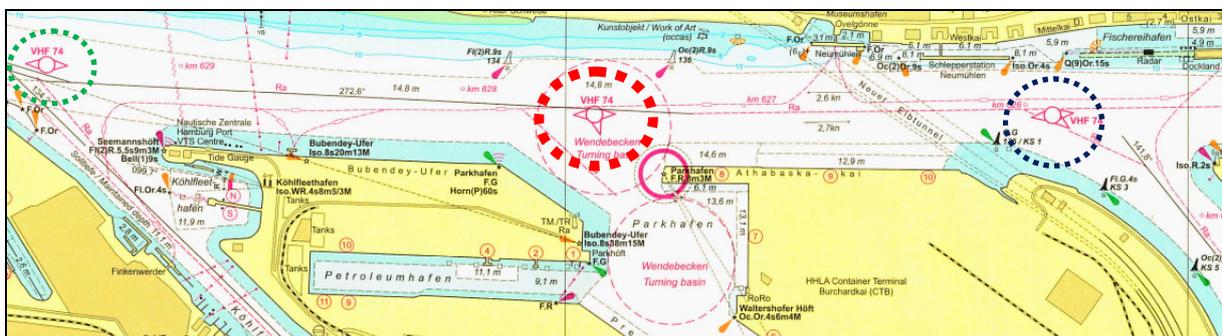
Figure 25: Reporting points in the northern Elbe main fairway (according to Official Nautical Chart No 48 (INT 1455), BSH²⁵)

The analysis of Hamburg Port Traffic's radar image recording reveals that the JADE passed the 'Mouth of the Parkhafen secondary fairway into the northern Elbe main fairway' reporting point at about **0753** (see **Figs. 25 f.**). However, in contrast to the previous report, the position report on channel 74 that was required there was not made (0738/0741; see blue marking in **Fig. 25**). (The JADE did not reach the 'Mouth of the Köhlfleet secondary fairway into the northern Elbe main fairway' reporting point marked green in **Fig. 25** due to the accident.)

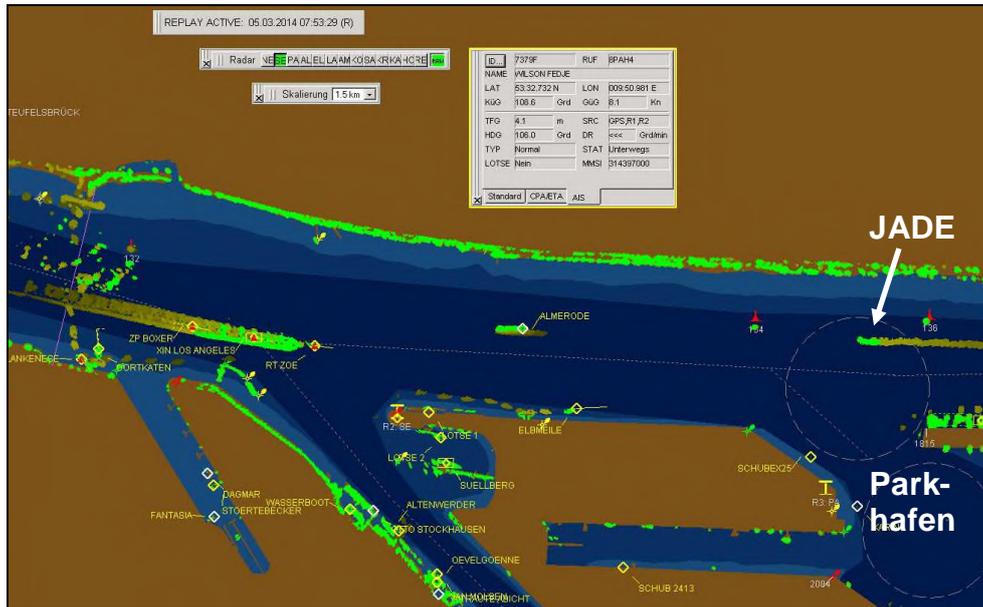
Figure 26: Radar/AIS recording from Hamburg Port Traffic (0753)
(the JADE is passing the 'Mouth of the Parkhafen secondary fairway into the northern Elbe main fairway' reporting point)

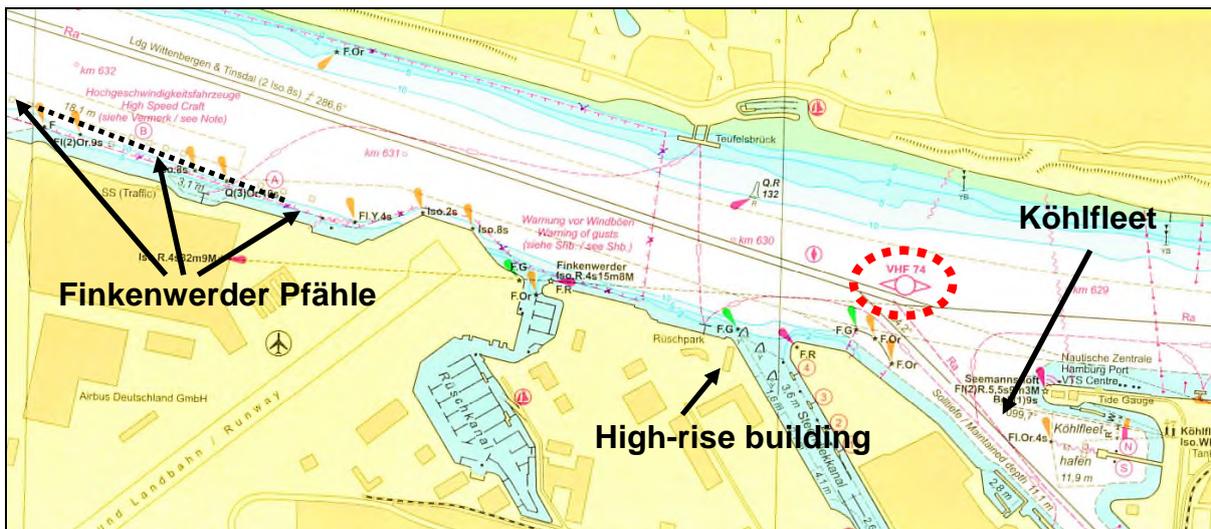
Figure 27: Reporting points of the WILSON FEDJE before the collision²⁶

At about **0756**, the WILSON FEDJE's pilot sent another position report on channel 74 ("at the high-rise building") and notified shipping that the WILSON FEDJE is now moving into the northern part of the fairway, will be making a green-green with the ALMERODE, and then return to the south. As with the previous position report, this one was not generally (or fundamentally) mandatory at the position in question, but in this specific case and the given context served to satisfy the obligation to inform shipping of the forthcoming green-green manoeuvre and to that extent the necessary temporary use of the northern side of the fairway.

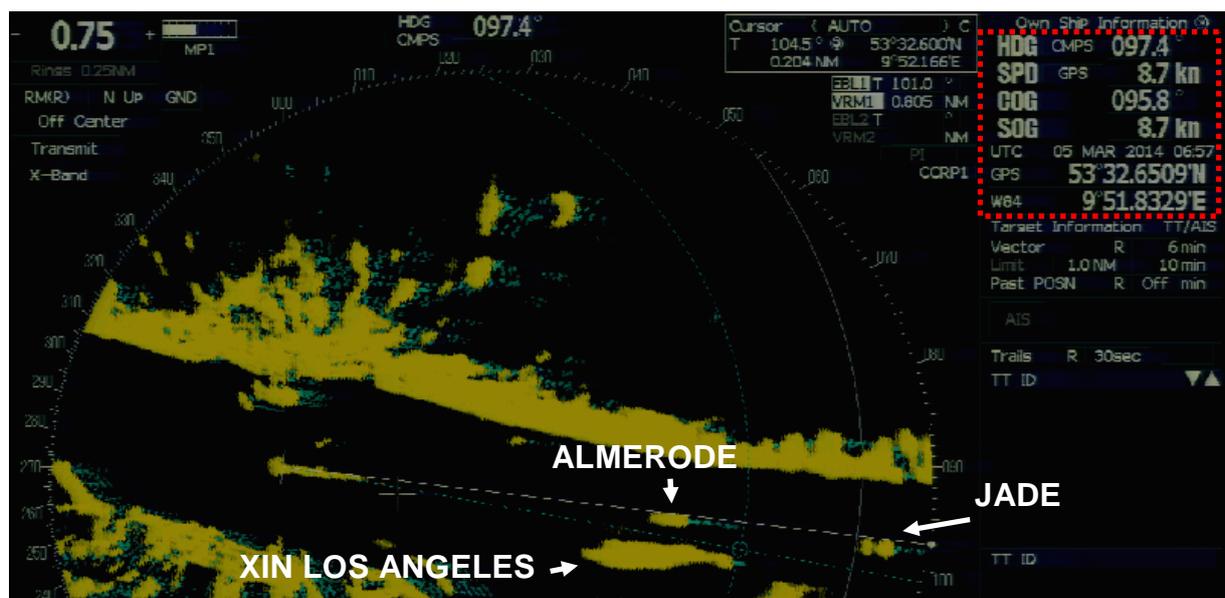
Figure 28: Extract from the WILSON FEDJE's radar image (X-band) at 0757 (echo of the JADE first appears at the edge of the configured range)

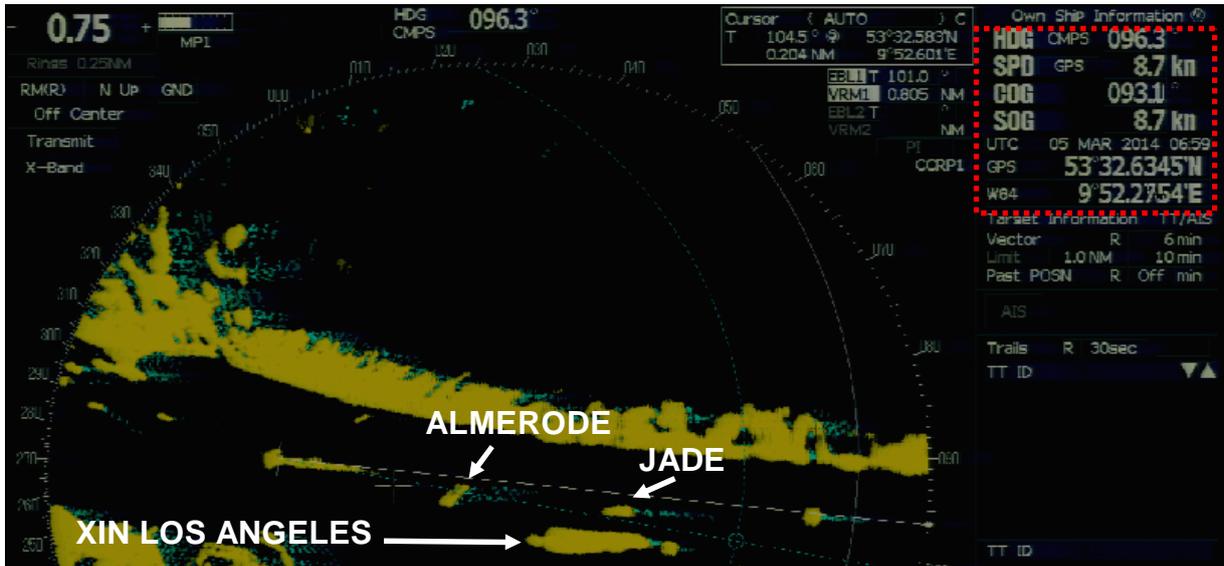
Figure 29: Extract from the WILSON FEDJE's radar image (X-band) at 0759 (echo of JADE is in line with that of the turning ALMERODE)

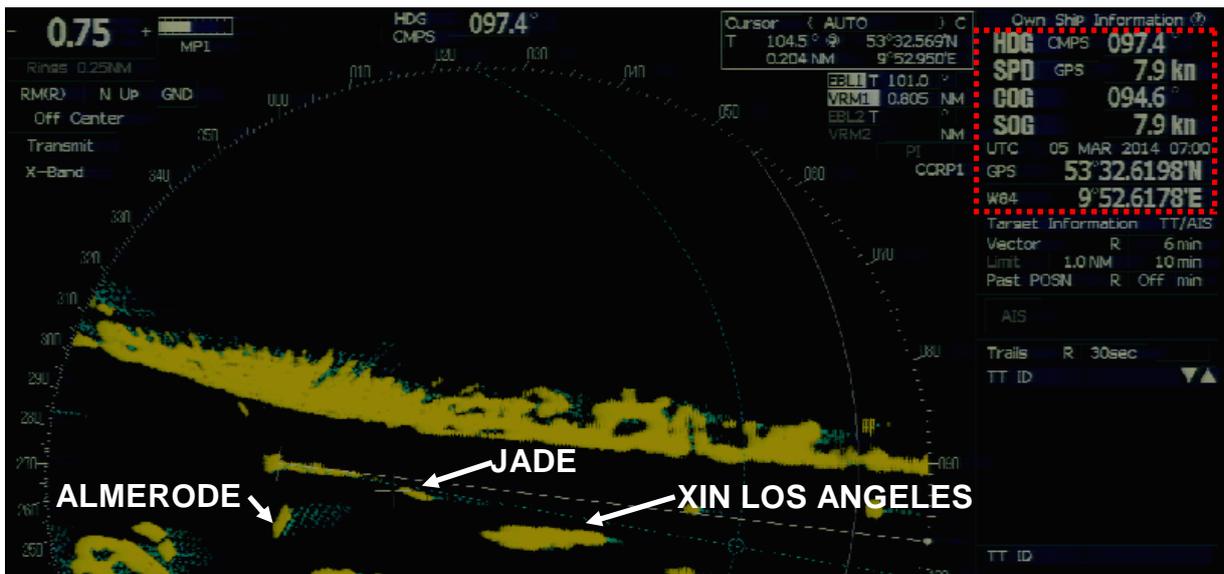
Figure 30: Extract from the WILSON FEDJE's radar image (X-band) at about 080045²⁸

²⁸ Note: In accordance with its functionality, the VDR stores the radar image at approximately 15-second intervals in the manner shown on the radar screen (screenshot). Unfortunately, the GPS-based time on the radar screen does not indicate seconds. However, since the image selected for the report is the third screenshot, indicating 0700 (UTC) as the time, and the screenshot immediately after that already indicates 0701 (UTC), Fig. 30 must inevitably originate from the last quarter of the minute in question.

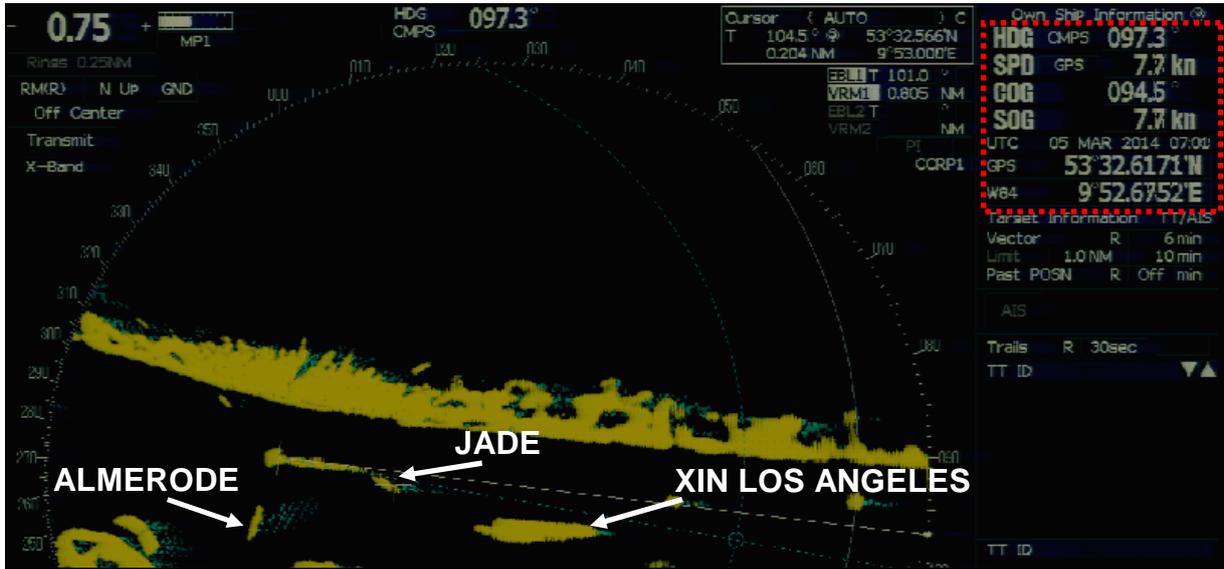
The JADE's course alteration to starboard gradually becomes visible on the following radar image (Fig. 31). The WILSON FEDJE's track data (see information marked red at the top right of the image) show that she essentially maintains her course and speed to begin with, i.e. an immediate risk of collision was not recognised on the bridge of the ship.

Figure 31: Extract from the WILSON FEDJE's radar image (X-band) at about 080110²⁹
