MARINE SAFETY INVESTIGATION REPORT

Safety investigation into the collision of the
Maltese registered passenger ship
CELESTYAL CRYSTAL
with the Marshall Islands registered tanker
STI PIMLICO

In the Çanakkale Strait's Traffic Separation Scheme
on 27 June 2015

MARINE SAFETY INVESTIGATION REPORT NO. 10/2016

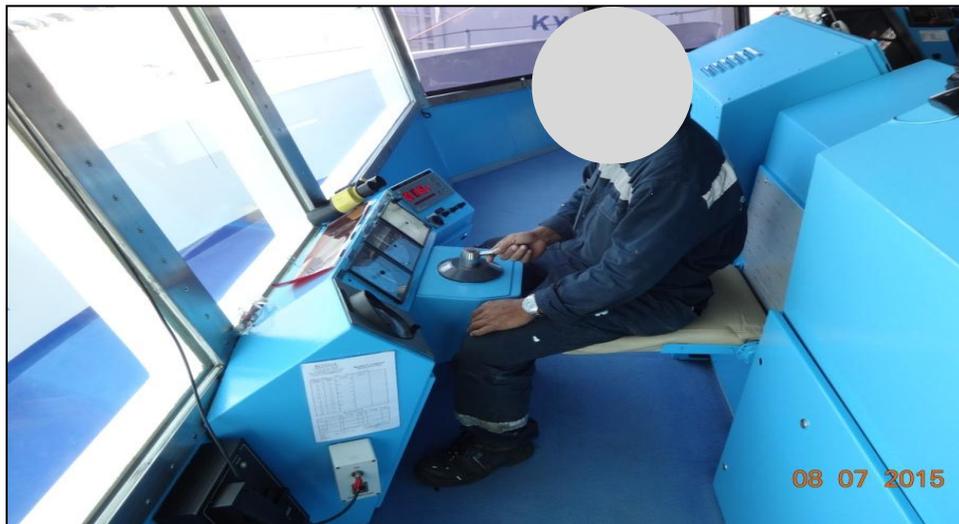
Figure 4: Helmsman at the designated steering position

The hand steering position is located forward of the main console under the bridge windows (Figure 4). The helmsman has to look down to the gyro repeater and rate of turn indicator, which are situated almost at floor level. From this position, the forward view is limited.

The steering position was unusual in that the helmsman sat on a chair in front of the console when manual steering was engaged. This meant that he would have had to look down for most of the time (Figure 4) and therefore be ineffective as a look-out with no assistance to the OOW, apart from steering the vessel. This clearly reinforces the requirement of having a dedicated look-out at all times.

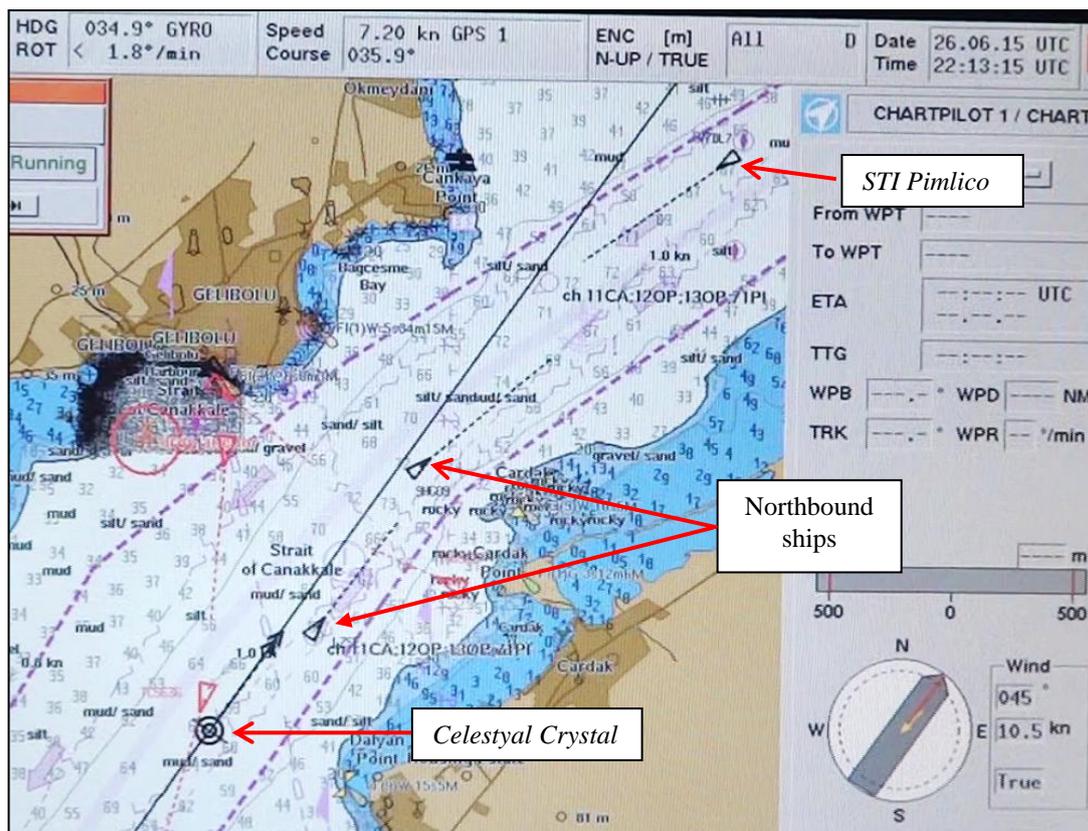
Figure 6: Screenshot of the ECDIS at 0113 as the pilot left the bridge

At 0108, the vessel approached the exit of the Strait and the pilot ordered a course of 035°, which the helmsman acknowledged. Speed at this time was 14.7 knots. At 0111, the master started to reduce speed and at 0112, he gave the order to open the port side shell door in preparation for the pilot to disembark.

The vessel's heading and speed was 035° and seven knots respectively. There were two vessels in the same Northbound traffic lane ahead of *Celestyal Crystal*. One vessel (*STI Pimlico*) was heading South in the Southbound traffic lane (Figure 6).

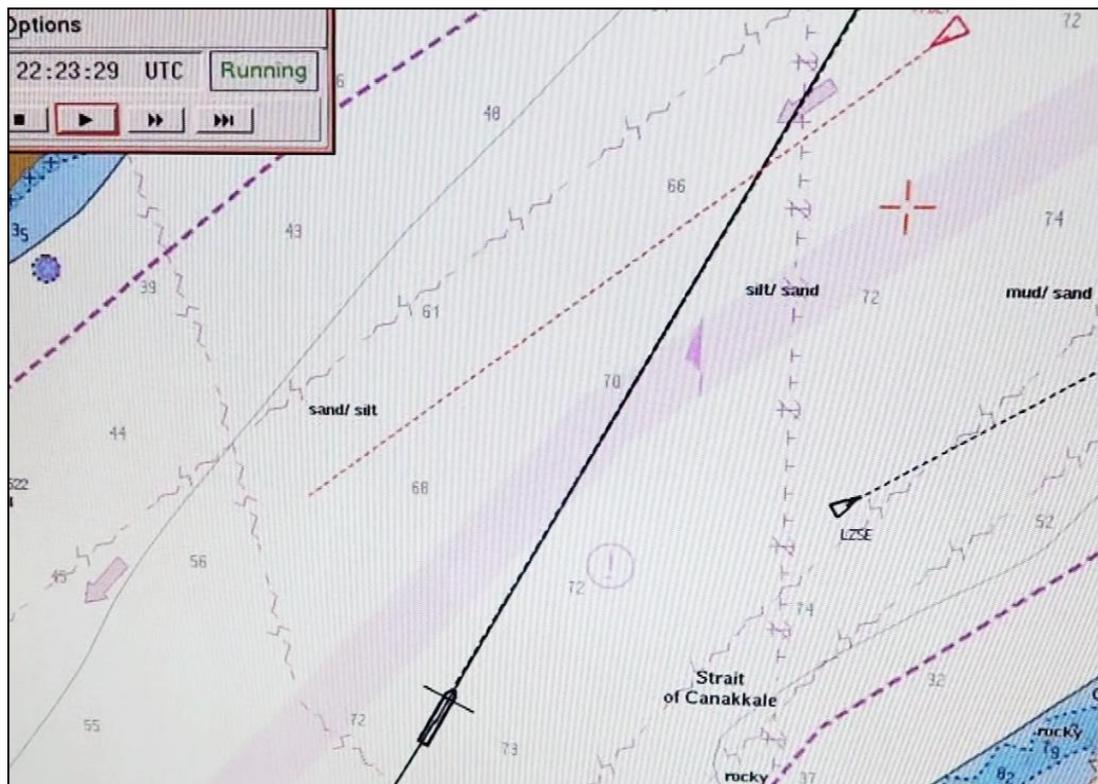
Figure 7: Positions of vessels at 0123:29

At 0123 (Figure 7), the apprentice officer left the bridge. The OOW stated that he noticed⁸ from the radar that *STI Pimlico* was bearing 034° at a distance of 1.06 nm and *Emona* was bearing 060° at a distance of 0.59 nm. However, at this stage, he was becoming concerned about the vessel being overtaken and left the radar position. He also ordered the quartermaster to steer 026°.

Just as *STI Pimlico* (call sign V7DL7), laden with 30,000 tons of naphtha fuel from the Russian port of Tuapse⁹, appeared on the radar screen, the OOW left the radar / ECDIS position and went to the bridge front windows to observe *Emona*.

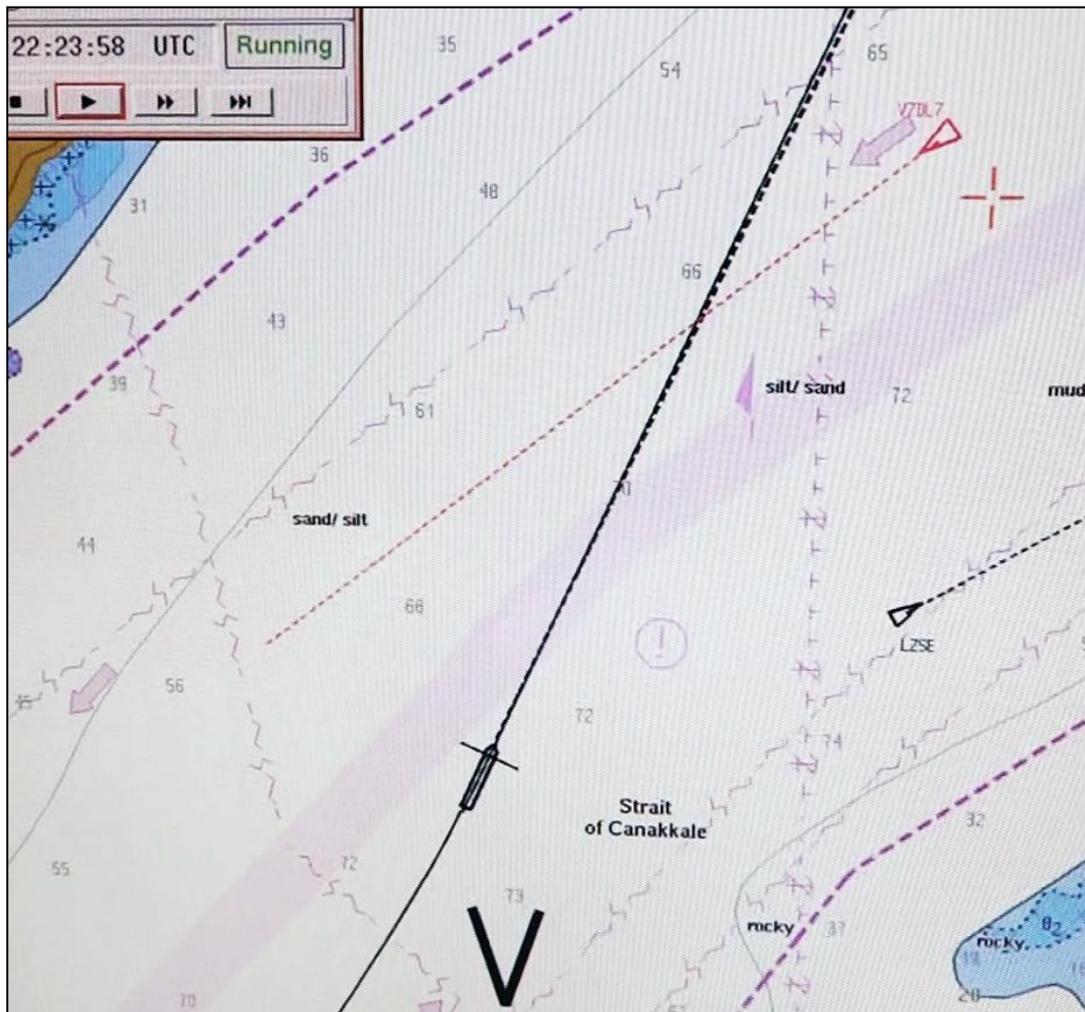
Figure 8: Positions of vessels at 0123:58

Between 0123:23 and 0123:58, the chief mate ordered an alteration of course from 026° to 020° in two degree intervals. At 0123:58, *STI Pimlico* was bearing 033° at a distance of 0.87 nm and *Emona* was bearing 066° at a distance of 0.57 nm (Figure 8).

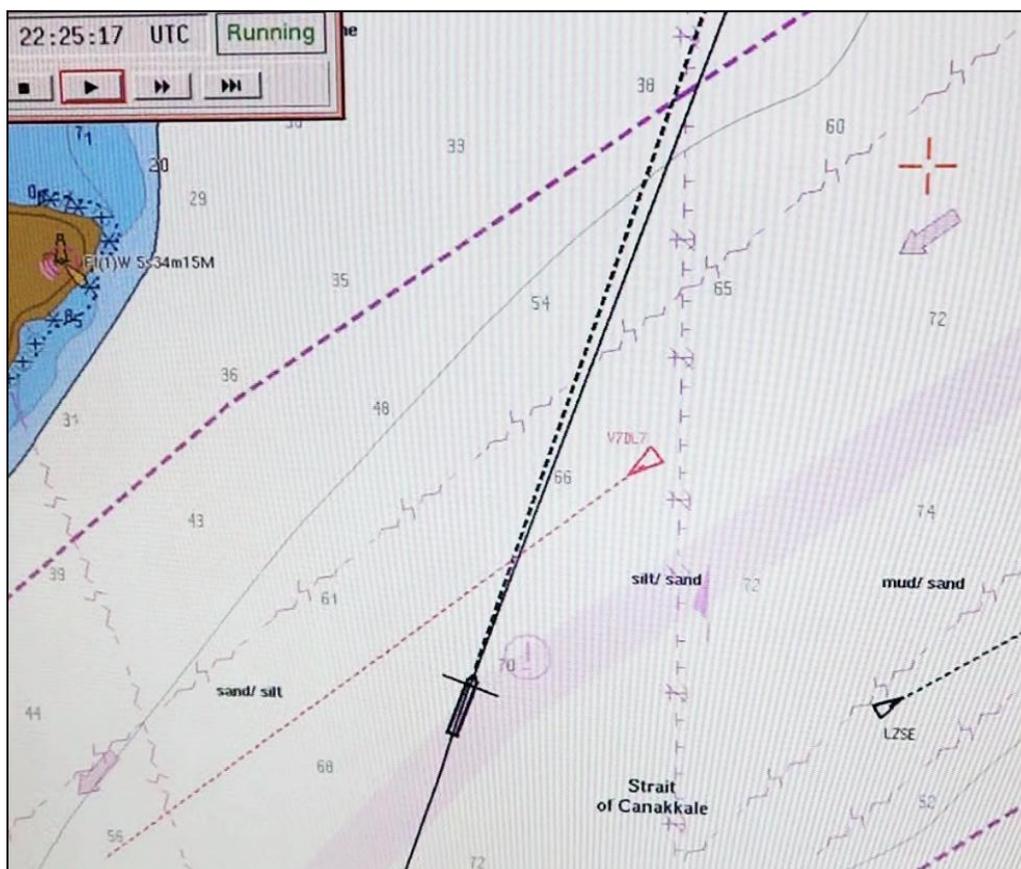
Figure 9: Positions of vessels at 0125:17 (48 seconds to collision)

At 0125:17, *STI Pimlico*’s bearing remained almost stationary at 034° but the distance to *Celestyal Crystal* had decreased to 0.38 nm, whereas the bearing and range to *Emona* were 087° and 0.57 nm respectively (Figure 9). The chief mate then put the propeller pitch to full astern and ordered the helmsman initially to come to hard-a-port. He then realised that this was a mistake, and countermanded the order to hard-a-starboard. *Celestyal Crystal*’s speed of was 14.5 knots.

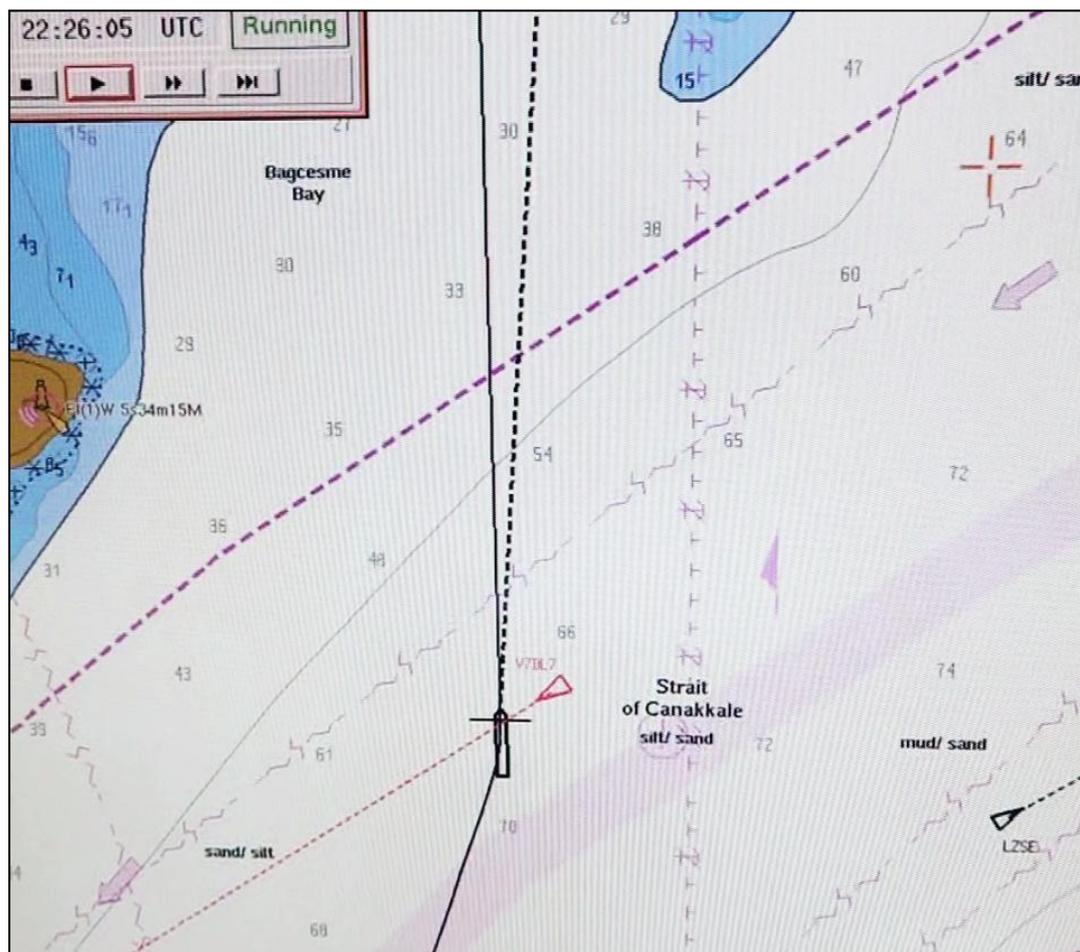
Figure 10: Positions of vessels at 0126:05 (time of impact)

At 0126:05, *Celestial Crystal*'s bow came in to contact with the port side of *STI Pimlico* almost at right angles, at a speed of 11.5 knots (Figure 10).

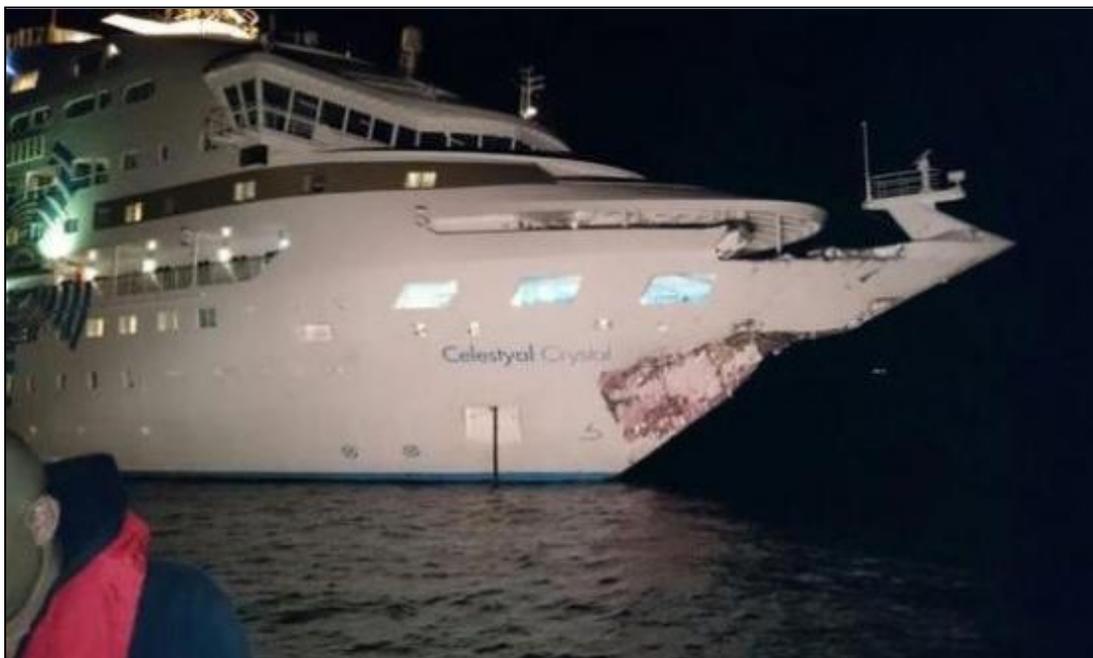
Figure 12: *Celestyal Crystal* at anchor

The master completed the 'Collision Checklist' contained in the SMS and contacted his office. He also requested for a pilot to take the ship to a safe anchorage. The pilot boarded at 0147 and at 0213 the vessel dropped anchor in 40° 23.8' N 26° 39.6' E.

On 02 June 2015, *Celestyal Crystal* completed her temporary repairs and proceeded to Perama, Greece for permanent repairs.
