MARINE SAFETY INVESTIGATION REPORT

Safety investigation into the collision between the
Maltese registered general cargo

KATRE

STATENGRACHT

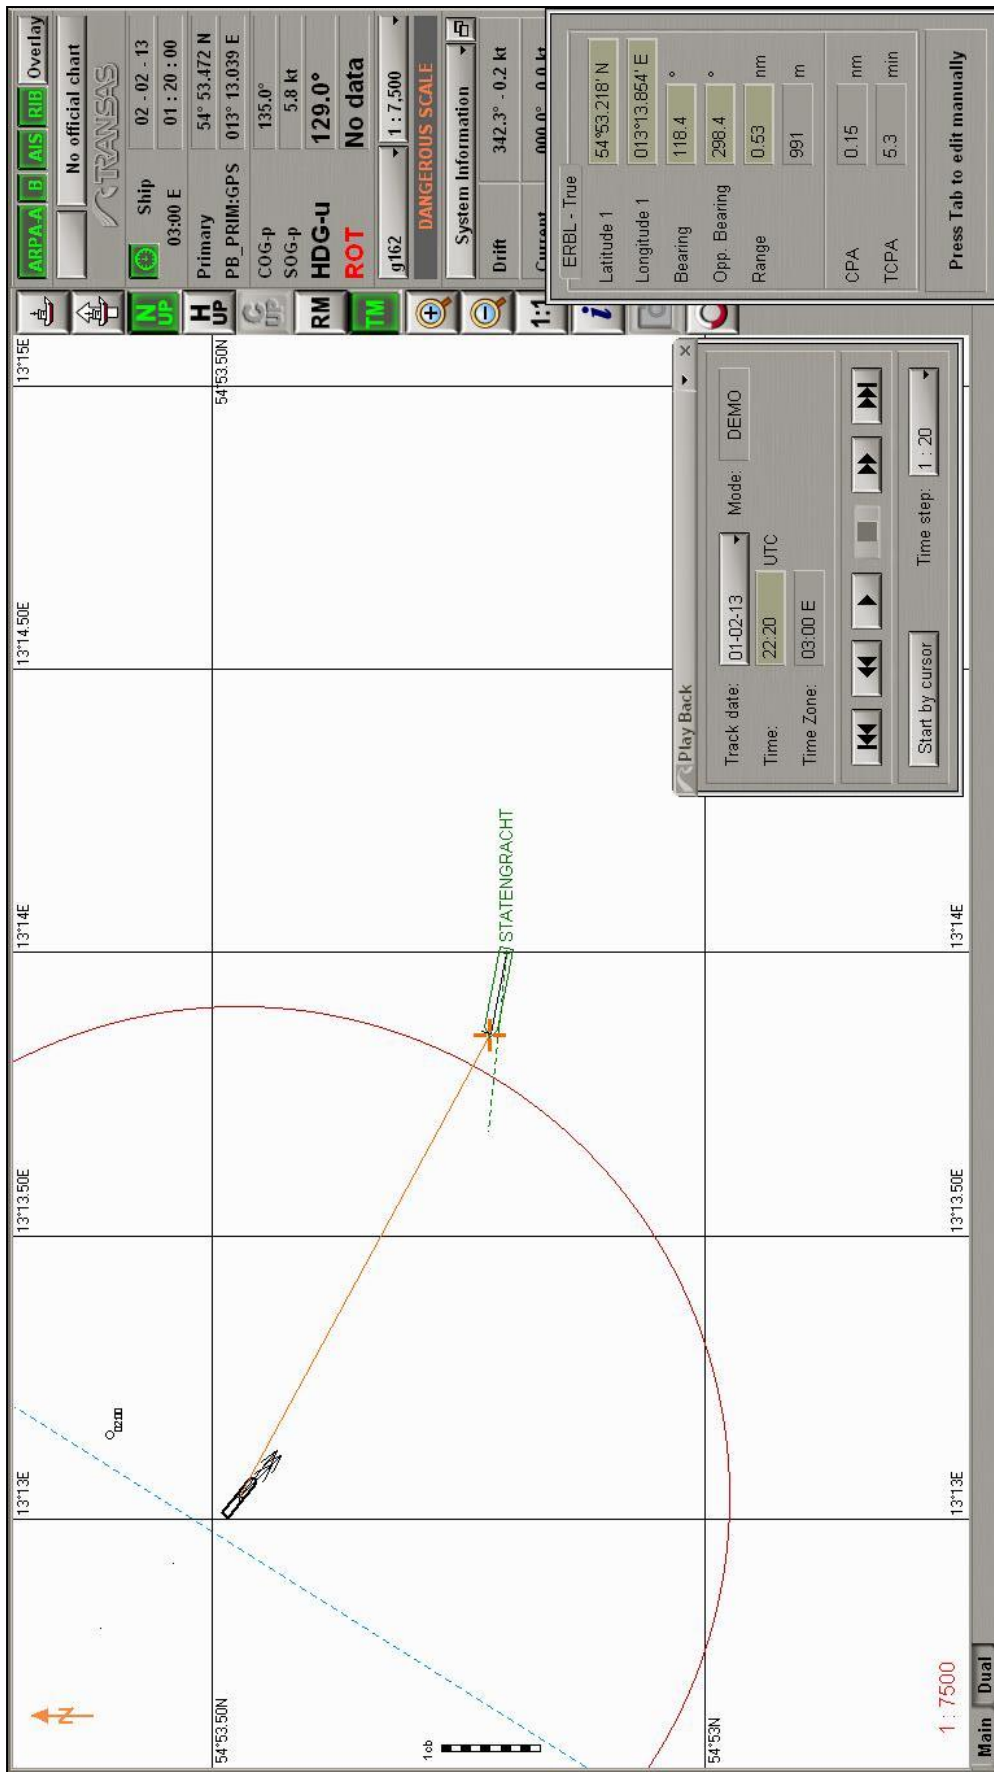
Figure 9: Screen shot at 2320

According to the chief mate, when *Statengracht* was about 1 nm off and with the CPA less than 0.4 nm⁶, he changed over to manual steering and ordered the helmsman to alter course to port by a few degrees to 134°(T). Extracts from *Katre's* ARPA system suggested that this alteration was executed at around 2319. No sound signals were made when this alteration of course took place. The chief mate recalled that immediately after, *i.e.* at about 2320, *Statengracht* started altering course slowly to starboard and then stopped and showed both sidelights (Figure 9). At this time, the chief mate instructed the helmsman to put the wheel hard to port while announcing this on the VHF radio.

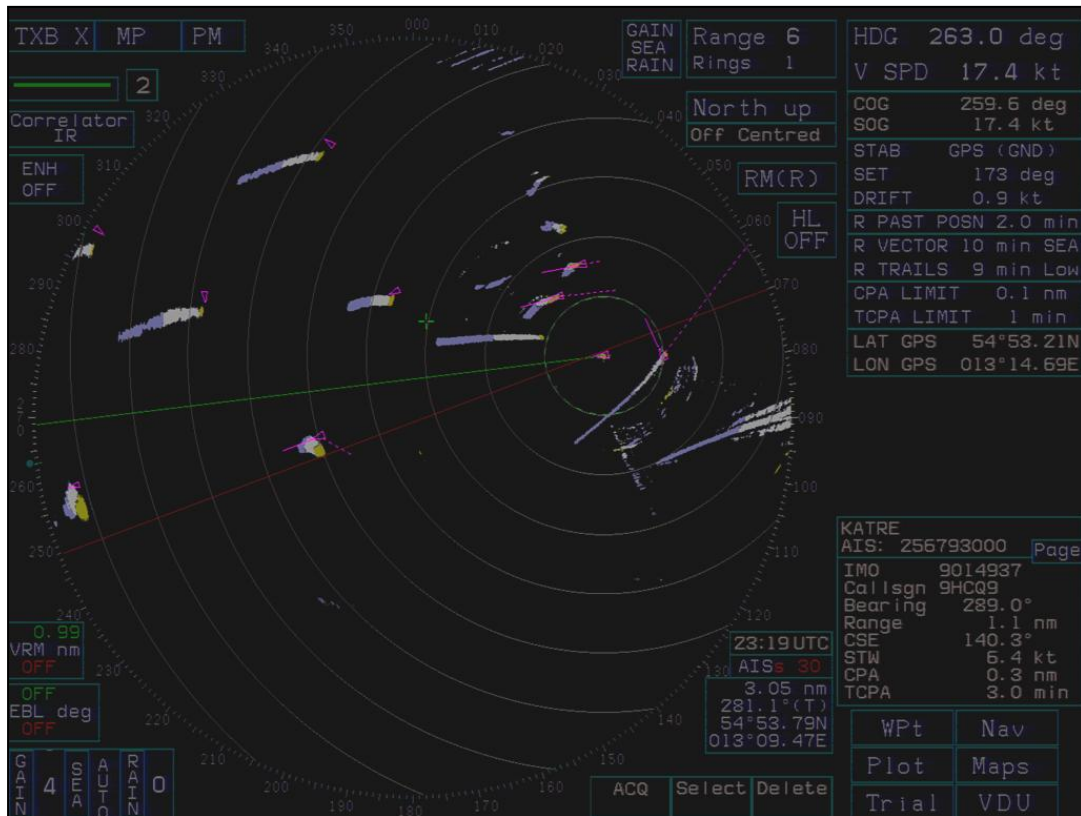
Figure 13: Screen shot at 2319

Four minutes later, at 2317, when *Katre* was only 1.9 nm away with a CPA of 0.4 nm and a TCPA of 5.4 minutes, the OOW started slowly altering course to starboard. *Statengracht* was still making 17.4 knots and on autopilot (Figure 13). This prompted the Master to instruct the OOW to make a broader alteration to starboard so that *Katre* would better understand his intentions. The Master went on to refer to *Nordvik*, which had just made a broad alteration to starboard for *Statengracht* a couple of minutes before.

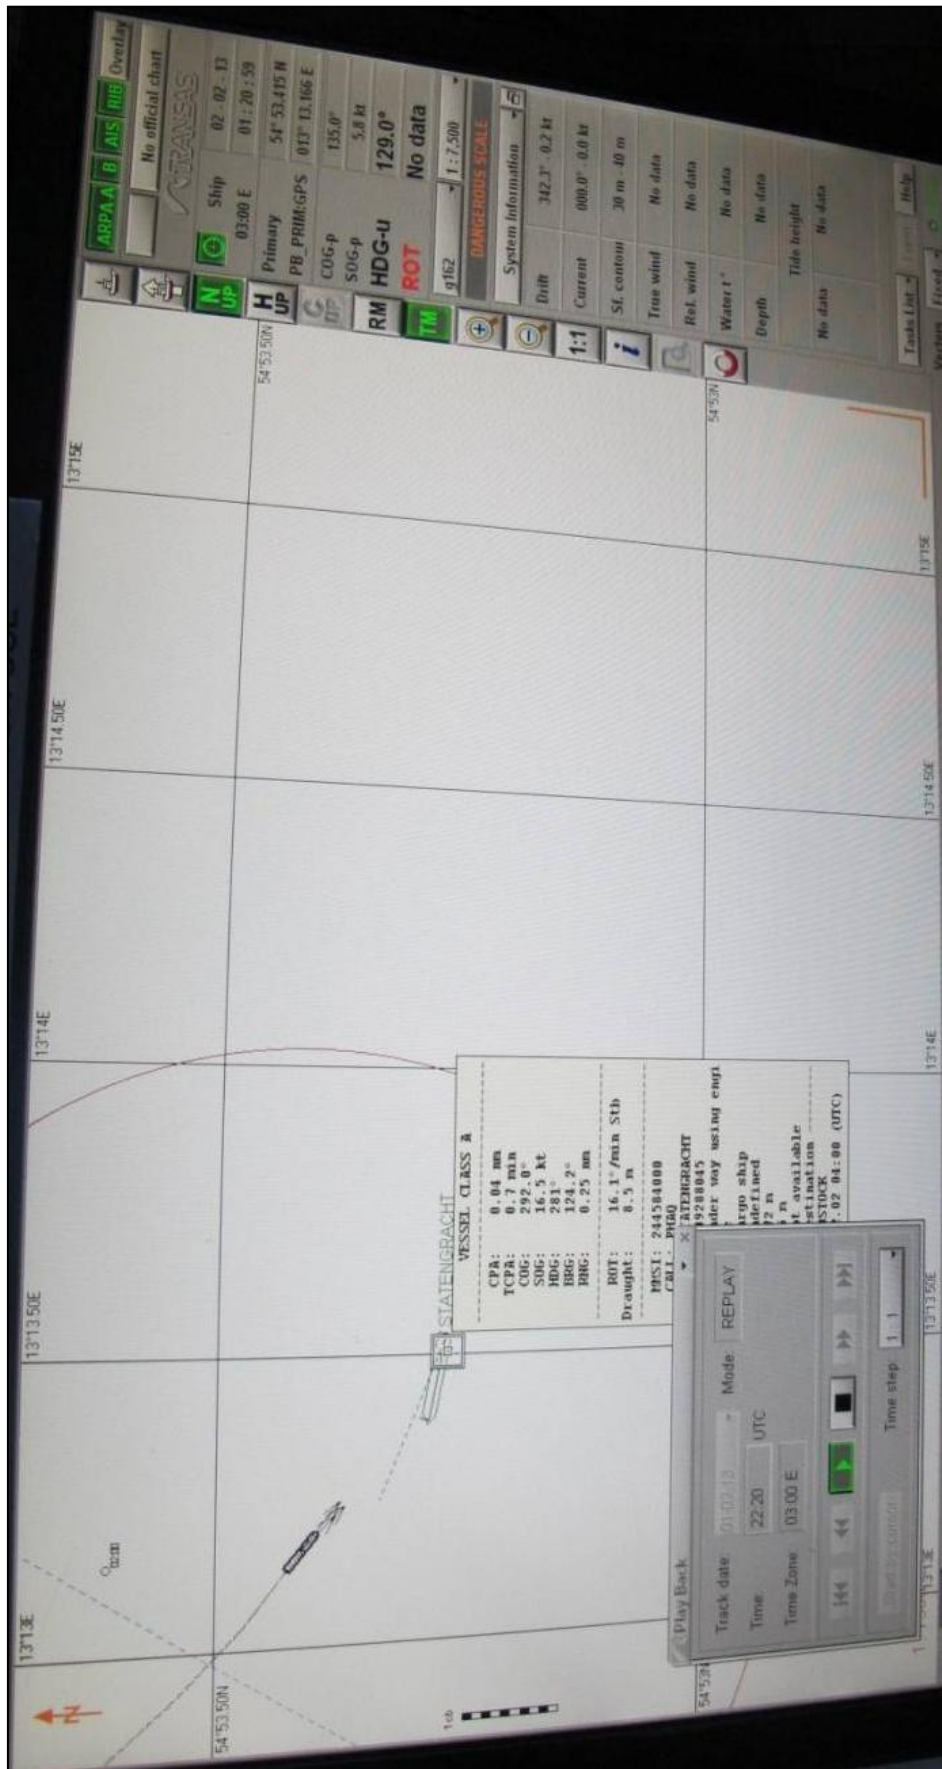
Figure 17: Screen shot at 2320 UTC (0120 ship's time)

With this rapidly developing close quarter situation, it seemed that the chief mate became extremely concerned and decided to alter course to port in order to increase the CPA between the two vessels (Figure 17). Again, no manoeuvring sound or light signals were made to indicate this alteration. Irrespective of the fact that at the time of this alteration to port by *Katre*, *Statengracht* had not yet given a clear indication to *Katre* that it was going to alter to starboard, *Katre* could still have altered her course to starboard as there was nothing to stop her from doing so. Once this manoeuvre was executed and the fact that at the same time *Statengracht* altered her course to starboard, there was no turning back and collision could not have been avoided.
