Report on the investigation of the collision between

Skagern and Samskip Courier

in the Humber Estuary

Report No 6/2007
April 2007

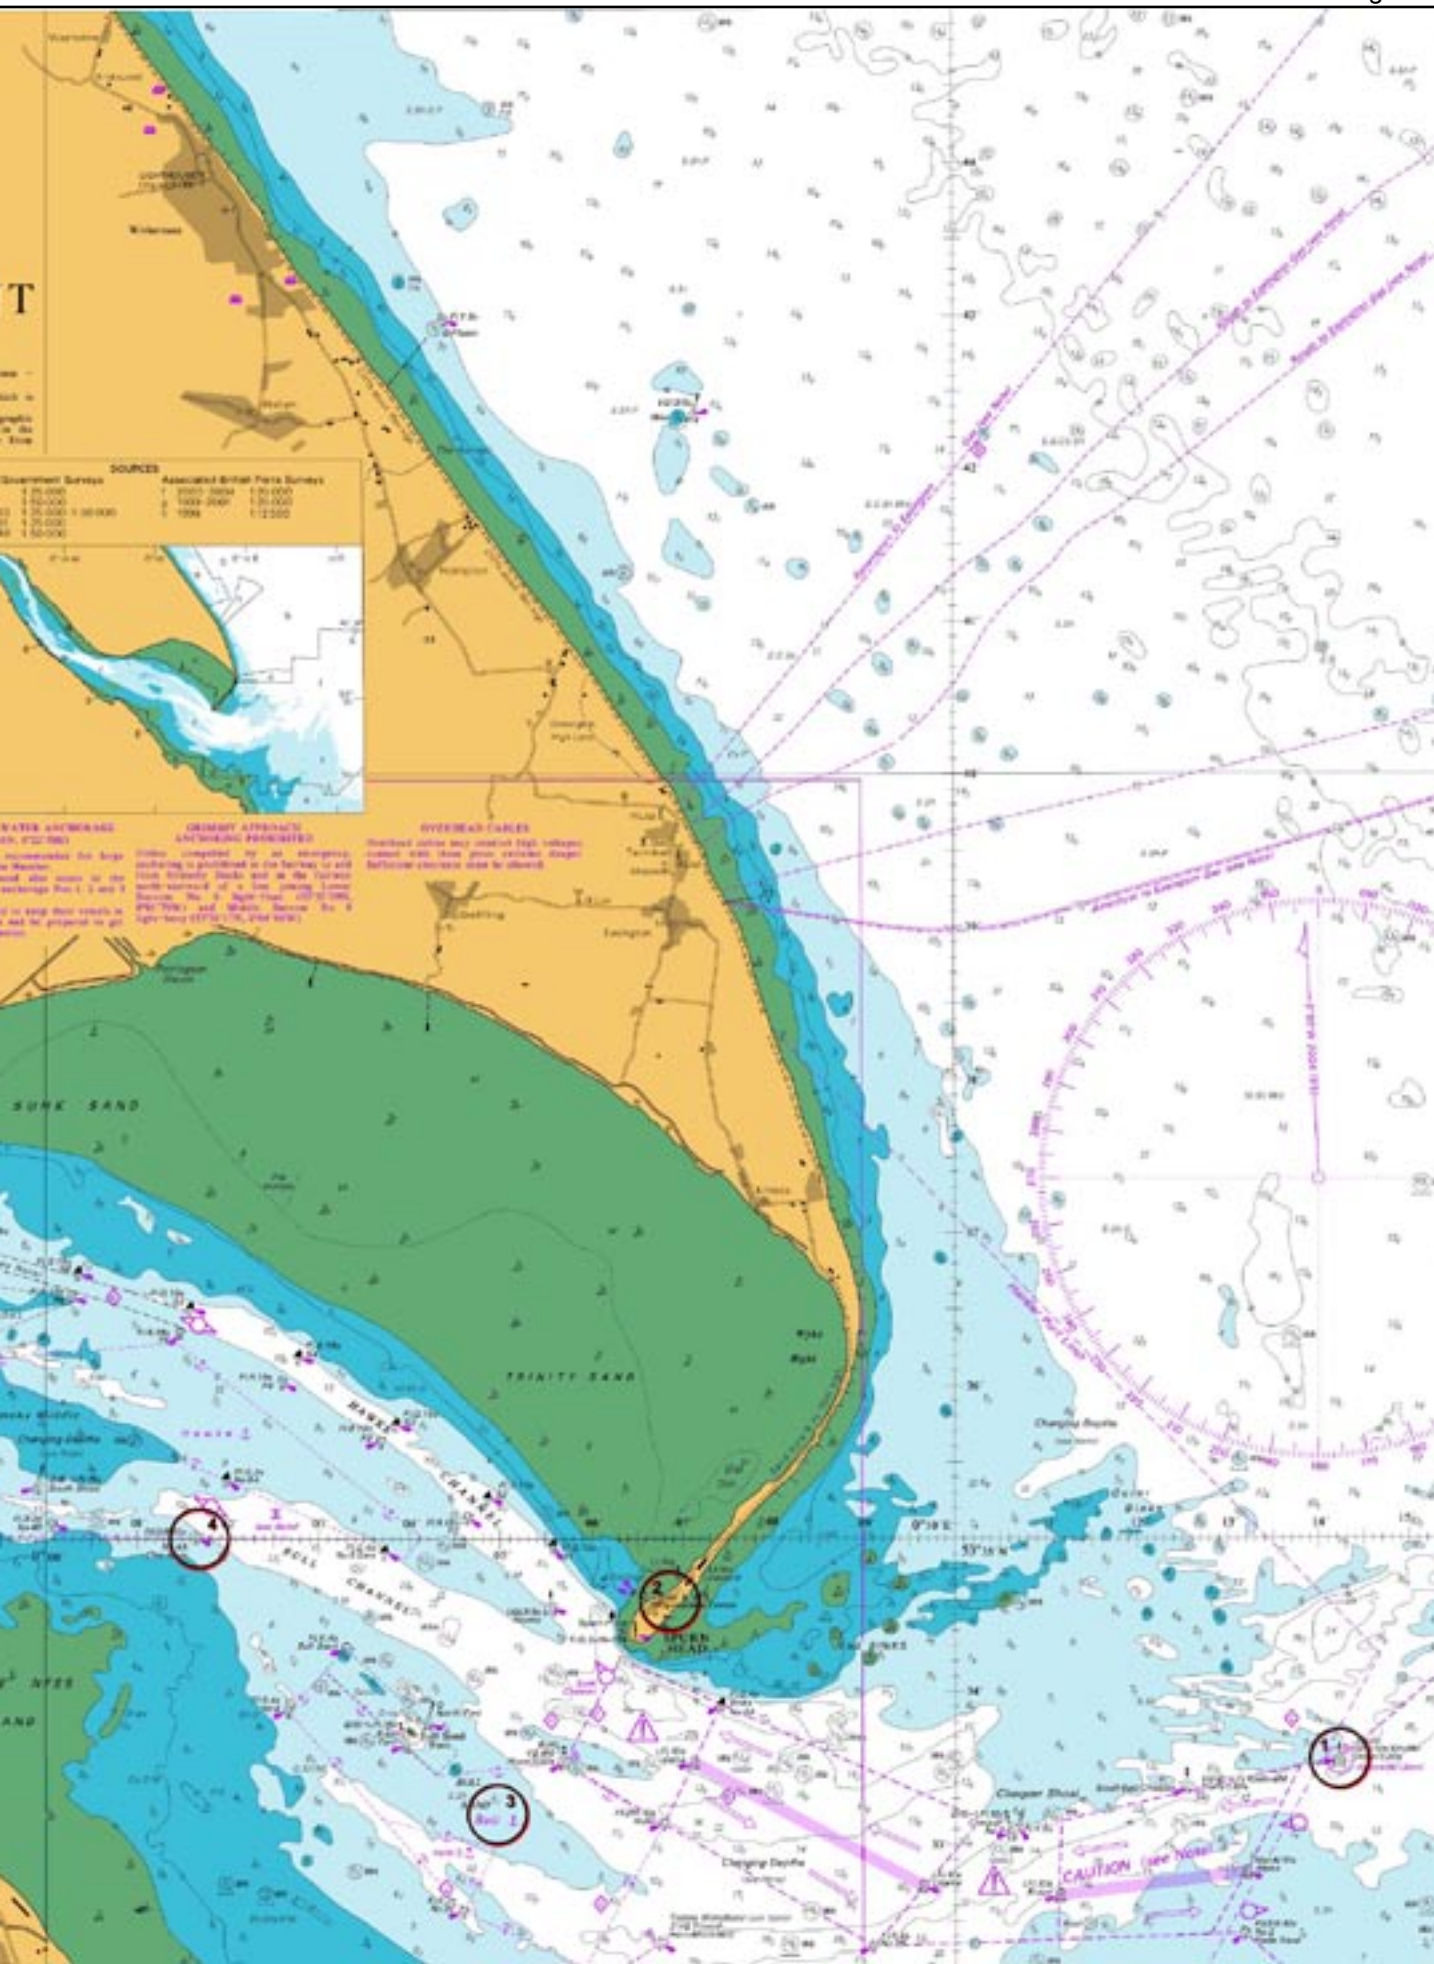
Figure 3

A copy of the chart of the collision area is shown in **Figures 3 and 4**; this report makes frequent references to navigational marks on these figures.

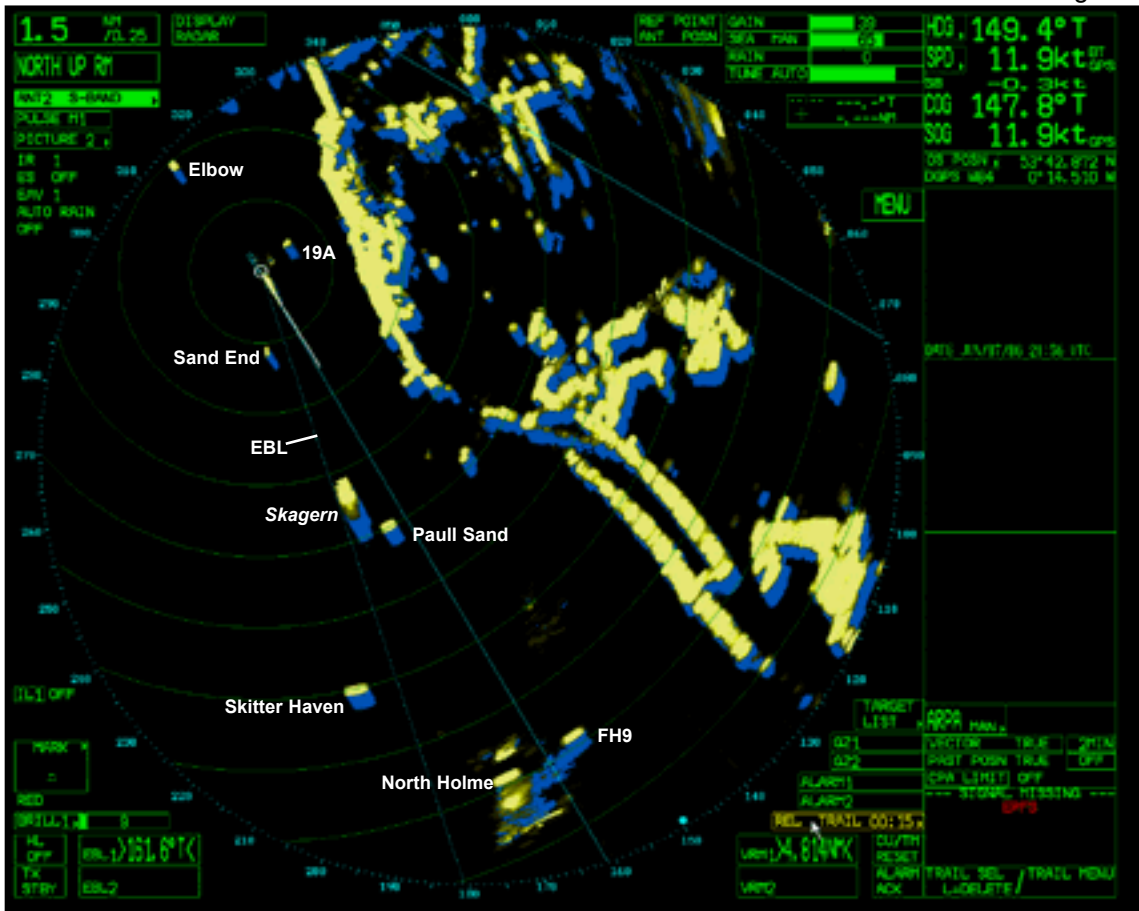
Figure 5

Samskip Courier's EBL applied as clearing bearing to Sand End light float

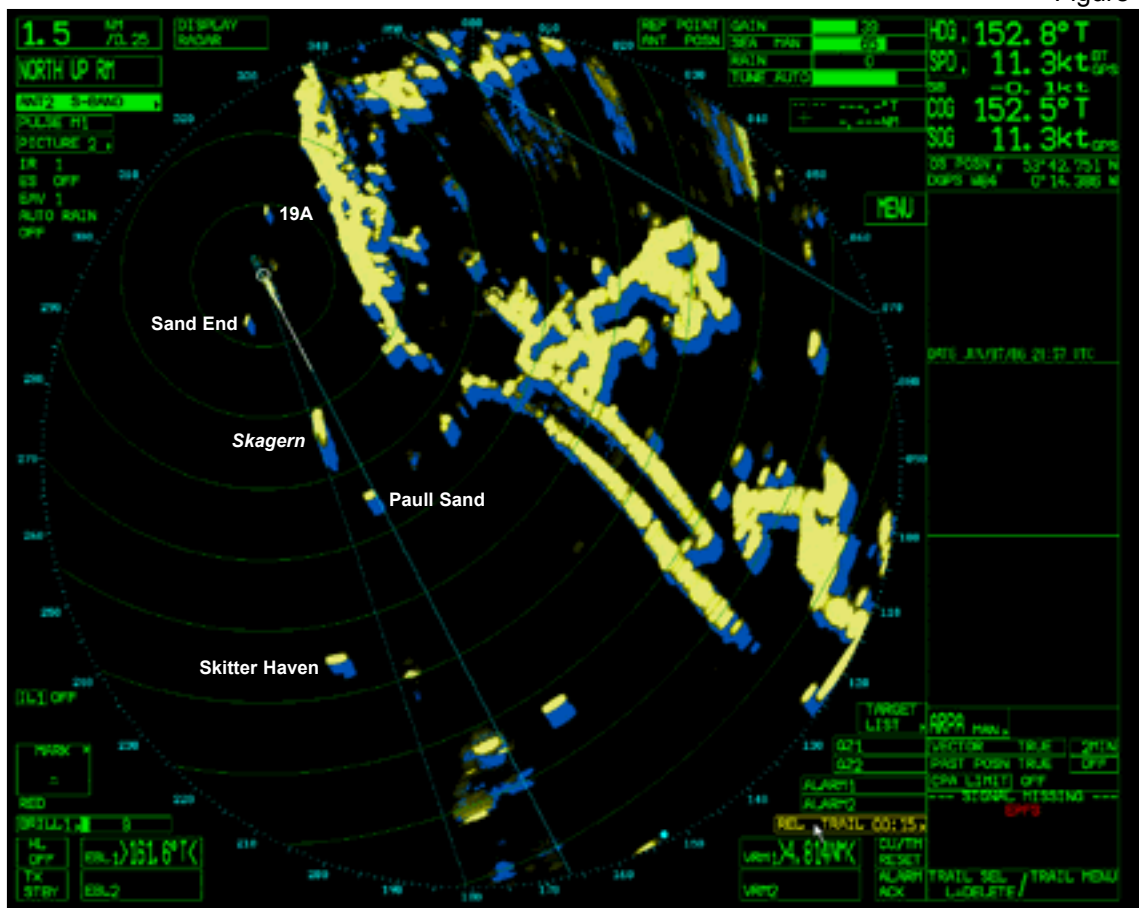
Figure 6

At 22:57:34, when 4.25 cables apart and when the Sand End light float was abeam the ship's starboard bow - exactly 60 seconds before collision (**Figure 6**), *Samskip Courier's* pilot called up *Skagern* on VHF channel 12 and enquired if they were keeping close to the red buoys. *Skagern's* pilot informed him that he was on the north (appropriate) side of the channel. *Samskip Courier's* pilot replied immediately, and confirmed that they were also on that same side of the channel. Eight seconds later, *Samskip Courier's* pilot instructed her master to go to slow ahead and engage hand steering. After a further 3 seconds, *Skagern's* pilot requested a change from VHF channel 12 to channel 10. *Samskip Courier's* pilot became confused with the radio, and fumbled to find channel 10 and, as a result, voice contact was not made again before the vessels collided. In the remaining seconds before the collision, *Samskip Courier's* pilot advised her master, who was now at the helm, to bring the vessel hard to port. The master queried this instruction by repeating it in a questioning fashion. He received confirmation from the pilot, and duly did as he was advised. Immediately after this, the pilot cancelled the instruction because he could now see *Skagern's* red (port) light. Shortly afterwards, the ships collided.

Showing Sand End light float abeam Samskip Courier's starboard bow

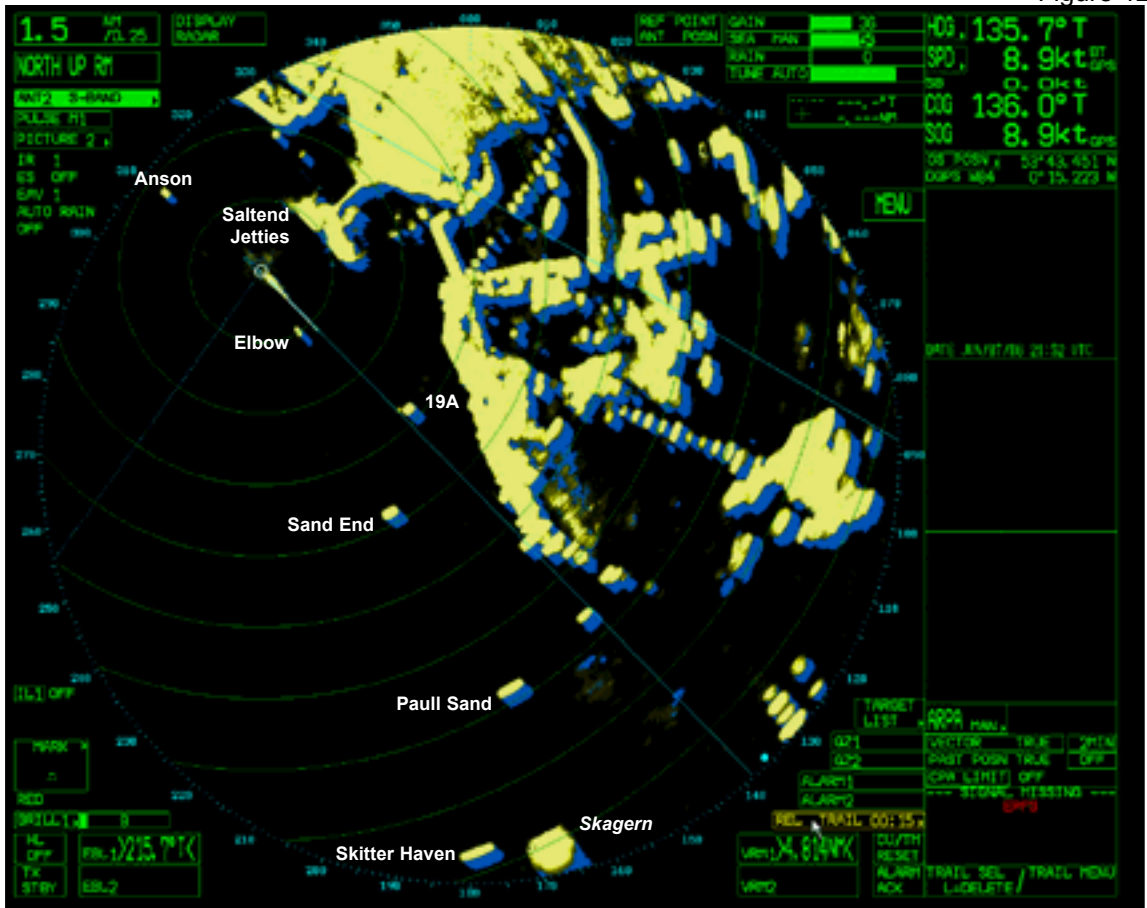
Figure 12

- At 22:52 *Samskip Courier* notified VTS that they were passing Saltend and the jetties were clearly visible at 2 cables; they then increased speed to half ahead (12.7kts). At this same time *Skagern* became visible on *Samskip Courier*'s radar at 2.25 miles range (**Figure 12**), approximately 6.5 minutes before collision.

Samskip Courier increases speed as Skagern appears on radar screen 2.25 miles distant

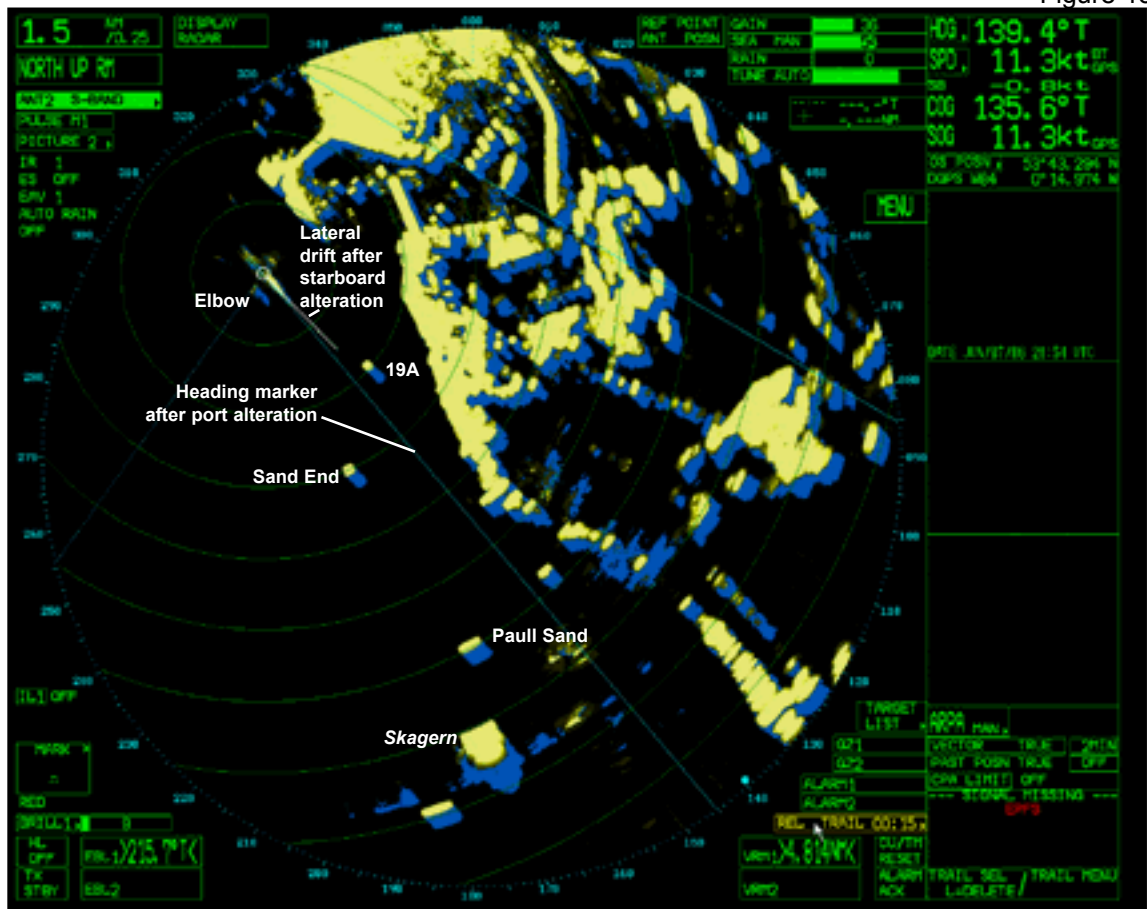
Figure 13

- At 22:53:40 *Samskip Courier*'s pilot gave starboard helm, which was held for 50 seconds as the ship passed Elbow buoy (**Figure 13**). Closing speed was 23.4kts.

Samskip Courier given starboard helm

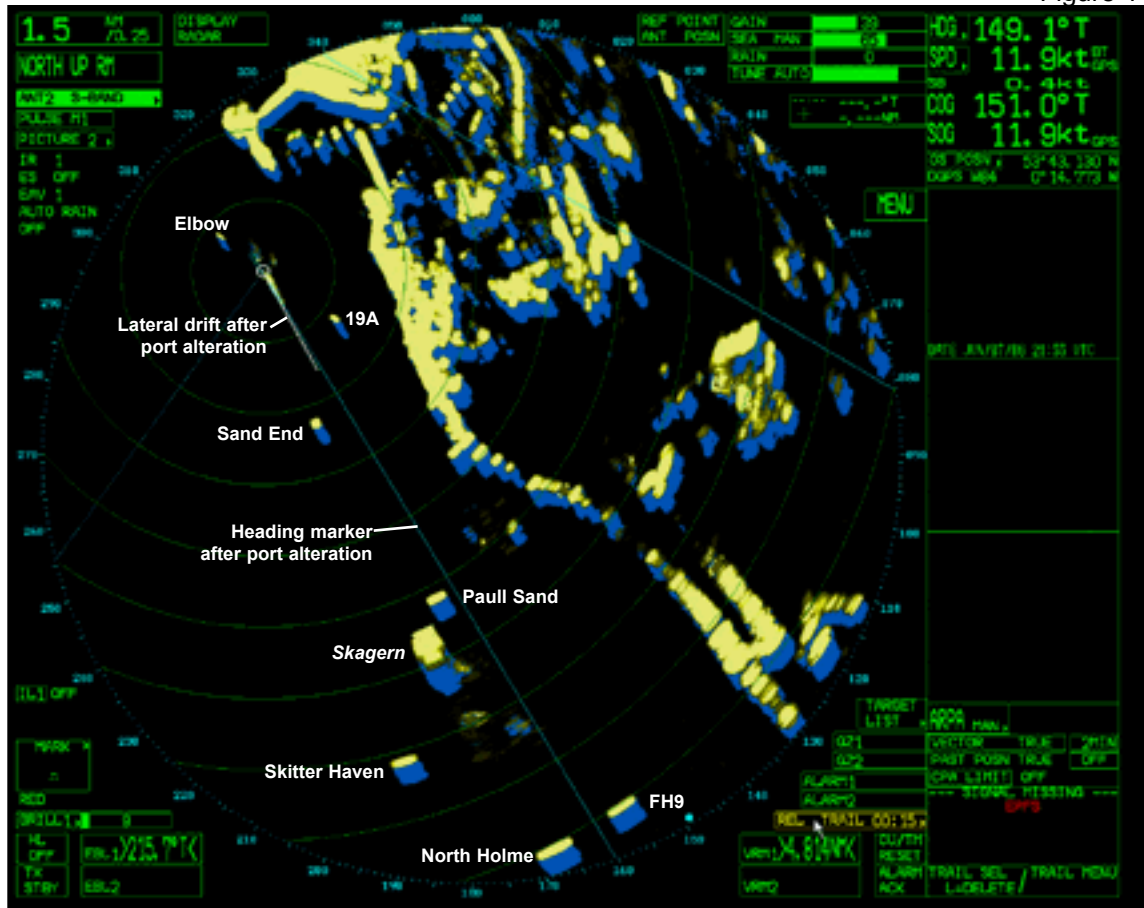
Figure 14

- At 22:54:44 *Samskip Courier*'s pilot counteracted the starboard swing by giving port helm which was held for 26 seconds (**Figure 14**).
- At 22:55:30 both ships were appraised on VHF channel 12 of their respective positions by VTS, approximately 3 minutes before collision (**Figure 15**). Closing speed was 23.5kts. Visibility less than 1 cable.

Samskip Courier given port helm to counteract starboard swing

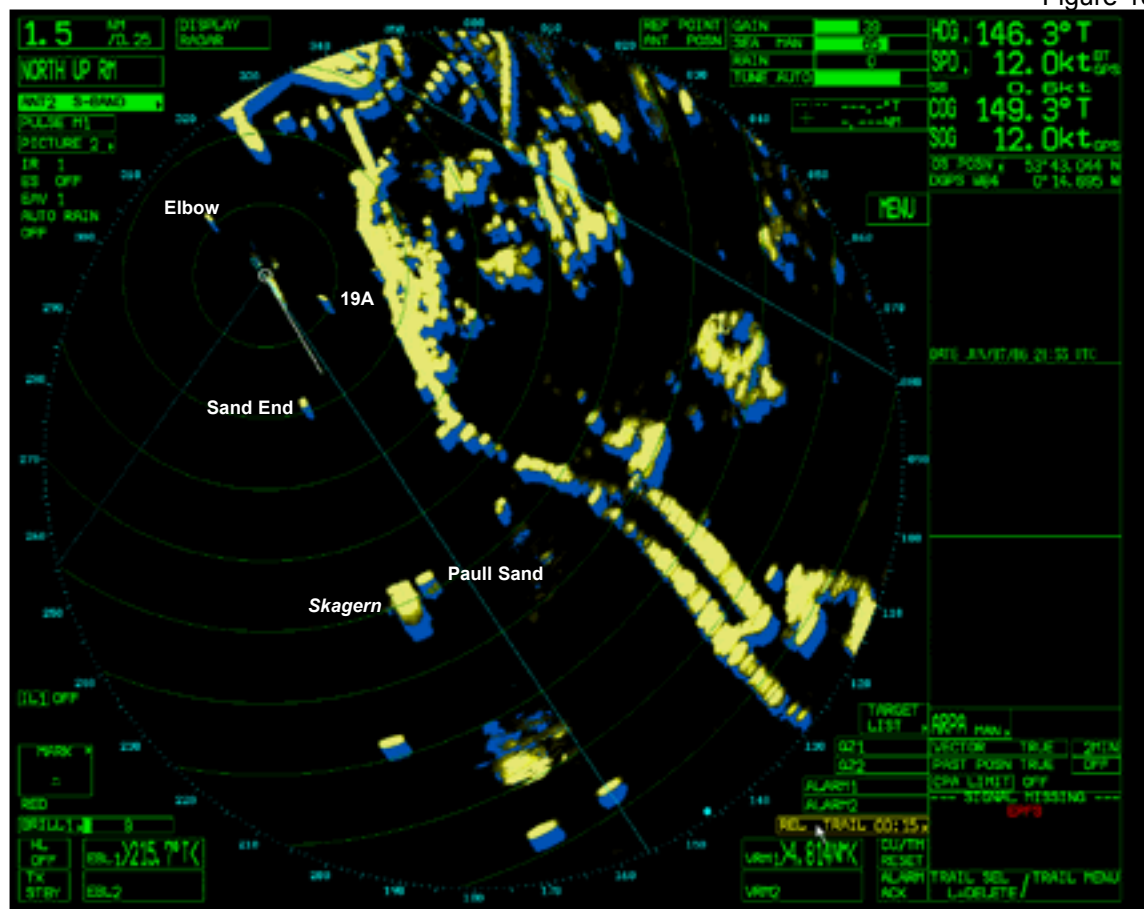
Figure 15

Position of ships when appraised by VTS

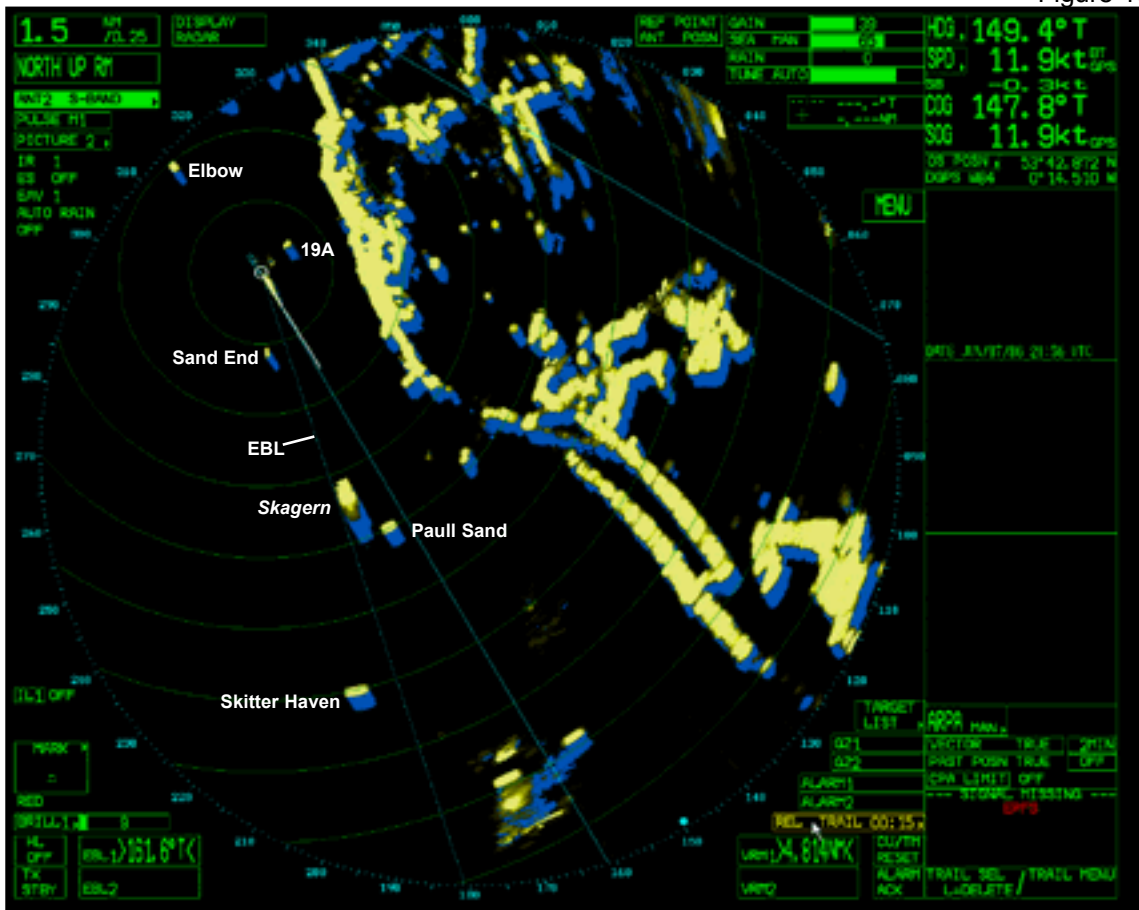
Figure 16

- At 22:56.39 the master of *Samskip Courier* applied the EBL to his radar to establish if they were clear to come round onto the next course (**Figure 16**).

Samskip Courier's EBL applied as clearing bearing to Sand End light float

When 0.8 mile from *Skagern*, the master applied his radar's EBL to establish if they were sufficiently clear of Sand End light float to come round onto a new course for the next waypoint. Coincidentally, the EBL also showed *Skagern* to be on a steady bearing (**Figure 16**). The master observed *Skagern* come up the EBL, but he did not comment or express concern to the pilot. The master's only query during the whole incident was when collision was imminent and the pilot instructed him to come hard to port; he repeated the instruction in a questioning fashion, received confirmation, and then carried out the manoeuvre.

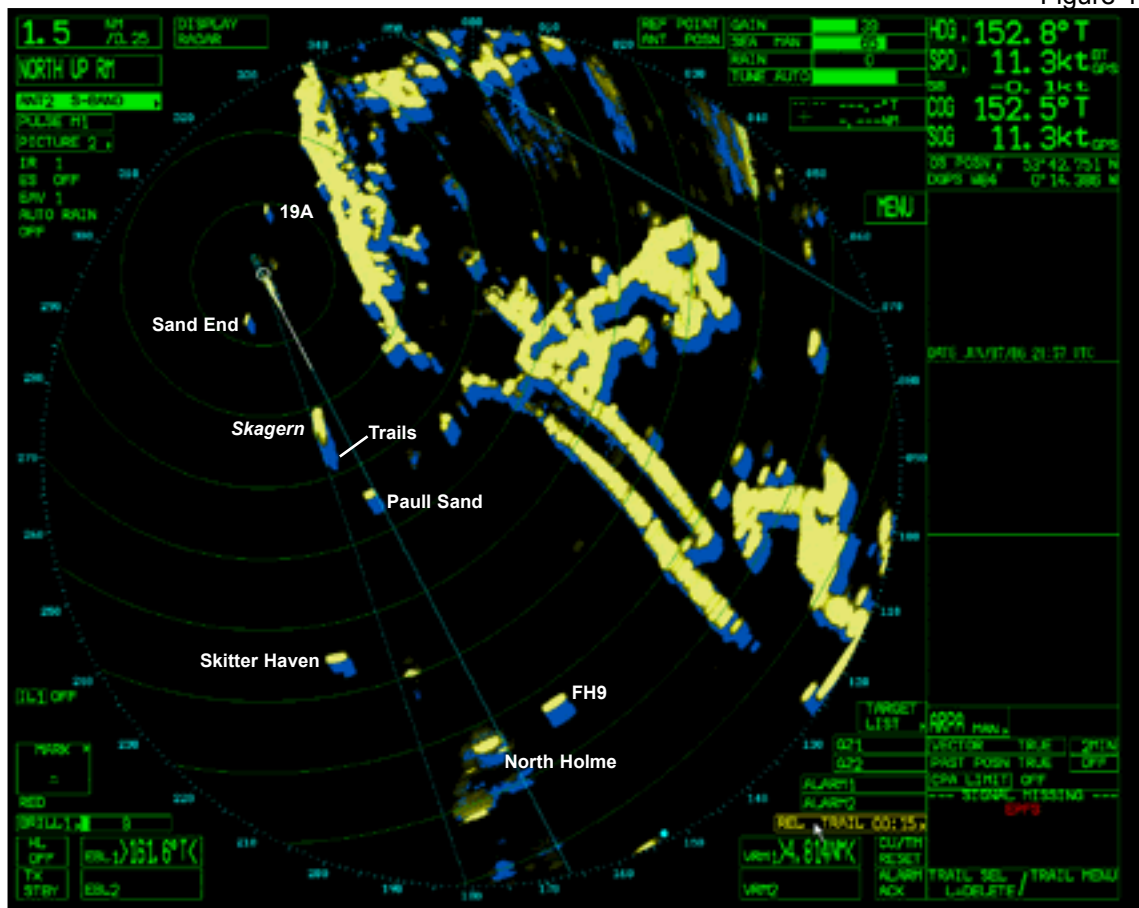
Figure 17

- The first radio contact between the pilots took place at 21:57:34, 60 seconds before collision (**Figure 17**). *Skagern*'s pilot requested *Samskip Courier*'s pilot to change radio channels and requested a reduction in his own ship's speed. *Skagern*'s master went out onto the port bridge wing to try and get a visual sighting of *Samskip Courier*. Closing speed was 22.1kts.

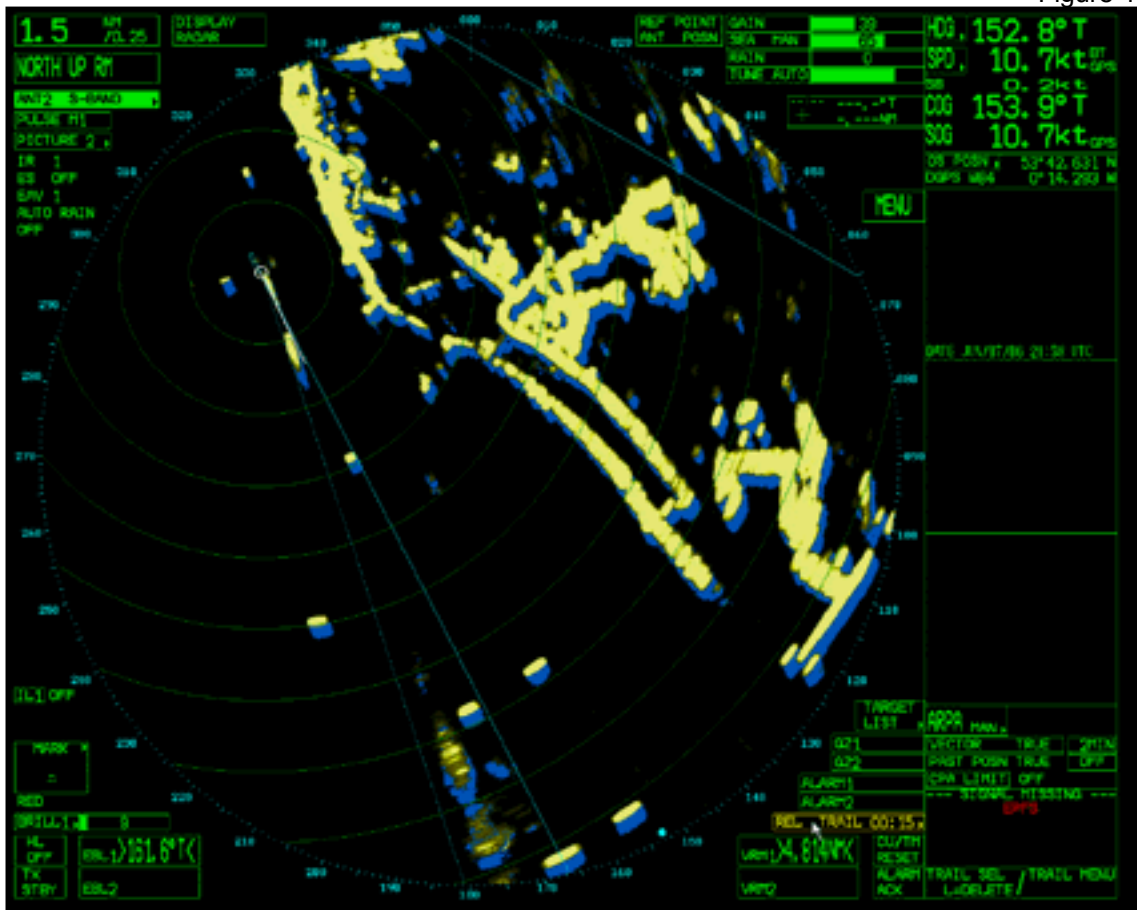
Figure 18

- A period of about 20 seconds was spent by *Samskip Courier*'s pilot trying to select channel 10 on the radio (**Figure 18**). Closing speed 21.0kts.
- At 22:58:31 an evasive manoeuvre of hard starboard and full astern was attempted by *Skagern*'s master; an evasive manoeuvre to hard aport was initiated by *Samskip Courier*'s pilot.

Ships closing as communications are trying to be re-established
