**Report on the investigation of
the collision between
Wintertide and MSC Sabrina
off Texel Traffic Separation Scheme
13 June 2000**

Report No 7/2001

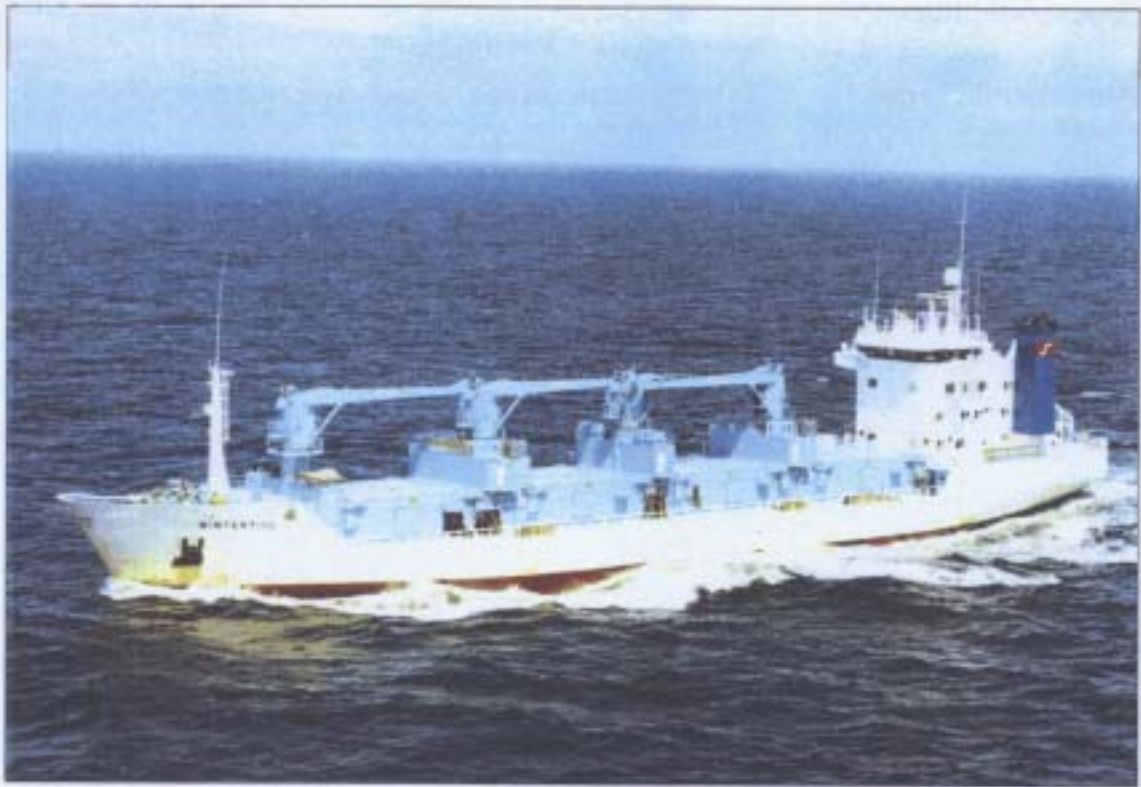
Wintertide

Damage to *Wintertide*

After exchanging identities and details of damage with *MSC Sabrina* via VHF radio, *Wintertide*, resumed passage at a reduced speed until visibility improved. She arrived at Falmouth on 14 June for repairs to her damaged bow.

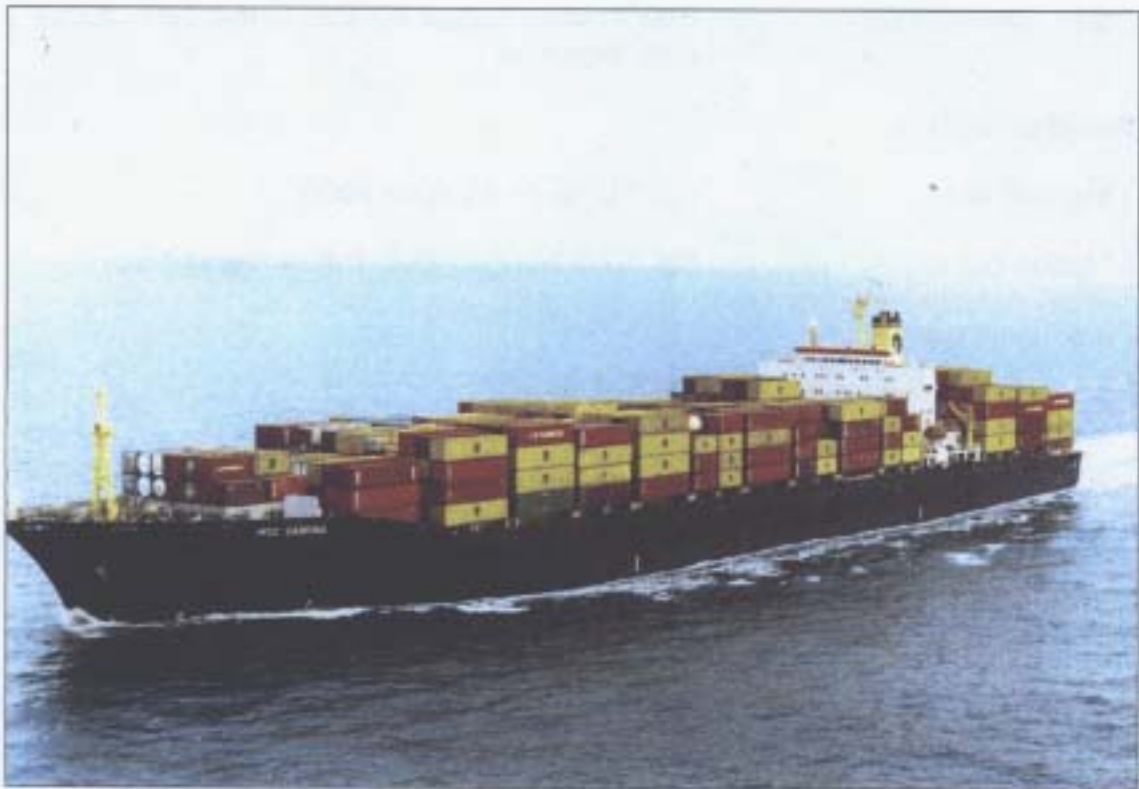
MSC Sabrina

Damage : Loss of watertight integrity above the waterline on the port quarter in vicinity of the steering compartment.

Damage to *MSC Sabrina*

Immediately after the collision *MSC Sabrina* reduced speed, started sounding fog signals, and closed all watertight doors. She then exchanged details with *Wintertide*, and informed the Netherlands Coastguard before proceeding to Felixstowe for repairs.
