**HELLENIC REPUBLIC
HELLENIC BUREAU FOR MARINE CASUALTIES INVESTIGATION**

**MARINE CASUALTY SAFETY INVESTIGATION REPORT
06/2013**

**Collision between
M/V Consouth
&
M/V Pirireis**

Foundering of M/V Pirireis

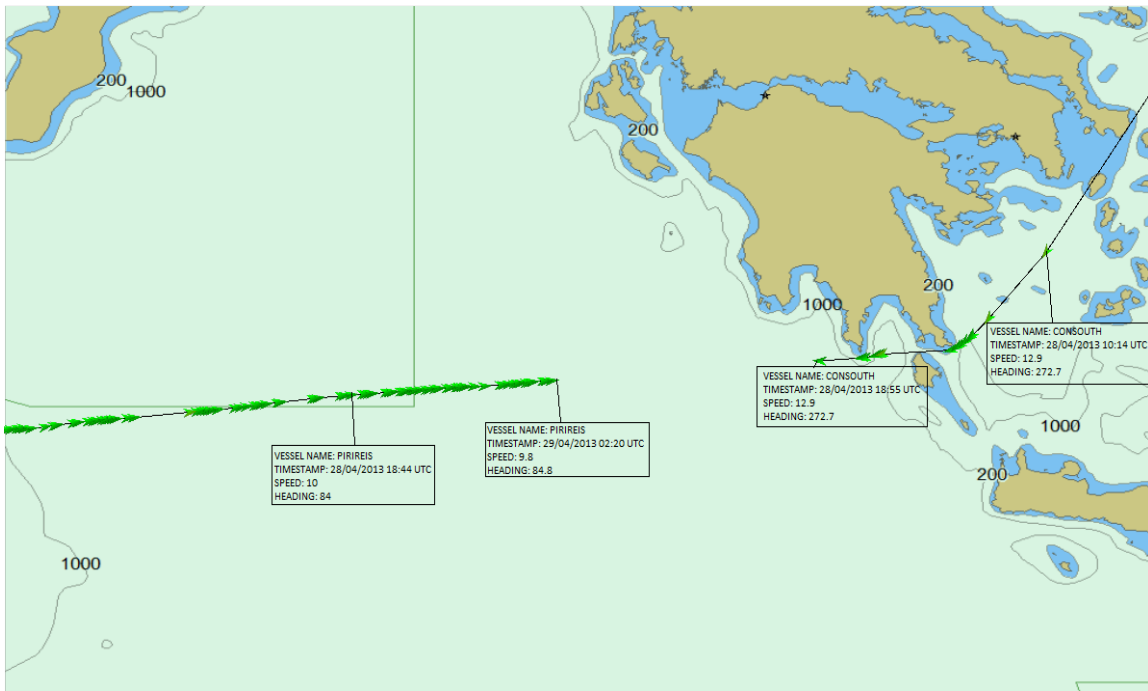
Figure 7. Consouth and Pirireis passages as recorded by AIS System of HCG.

Seeking for electronic evidence in the course of the investigation process HBMCI requested Consouth’s positioning data as recorded by HCG AIS system. However it was found that from 2055 (1855 UTC) on the 28 April 2013 until the time of the occurrence Consouth’s AIS positions for unspecified reasons were not received by HCG AIS system (figure 7).

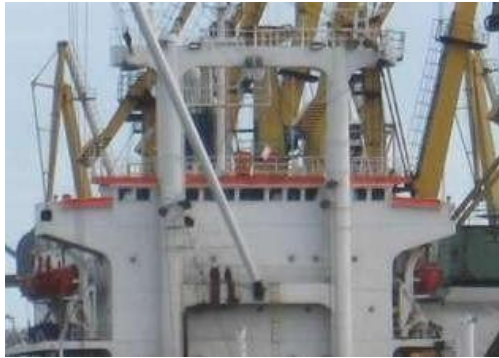
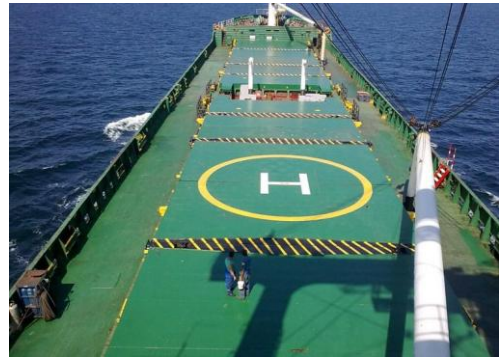
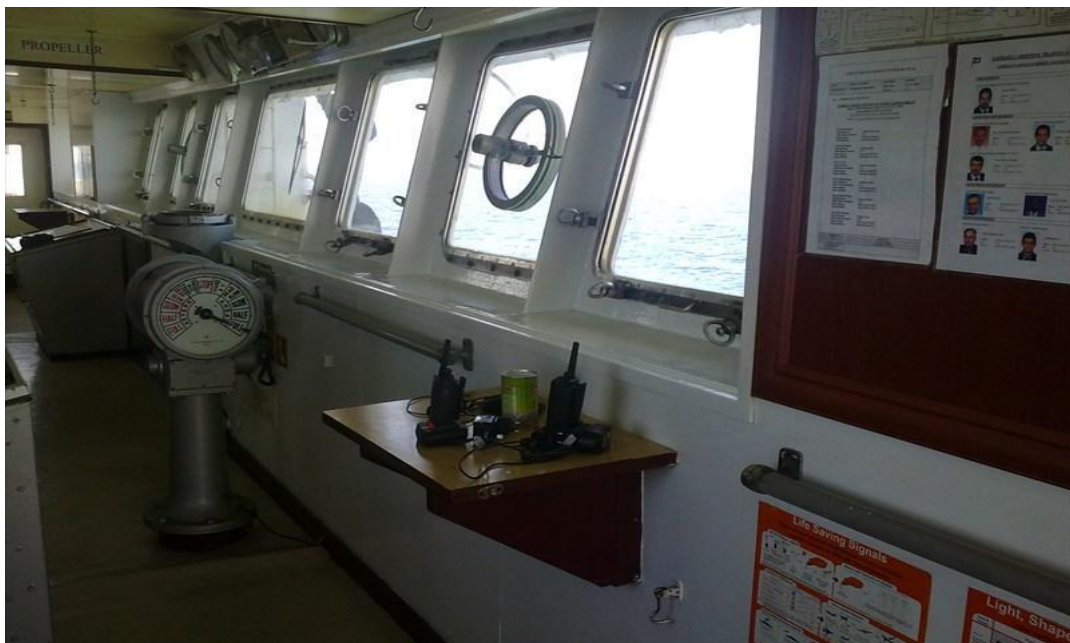
Pirreis' wheelhouse structural arrangement offered a very good horizontal field of vision from the conning position to the navigated sea area ahead.

OOW could maintain a very good visual contact and monitoring of head on vessels on her starboard or port bow with almost reciprocal or nearly reciprocal courses.

Figure 19. Pirreis' bridge windows

Figure 20. Pirreis' horizontal field of vision

Figure 21. Pirreis's conning vision

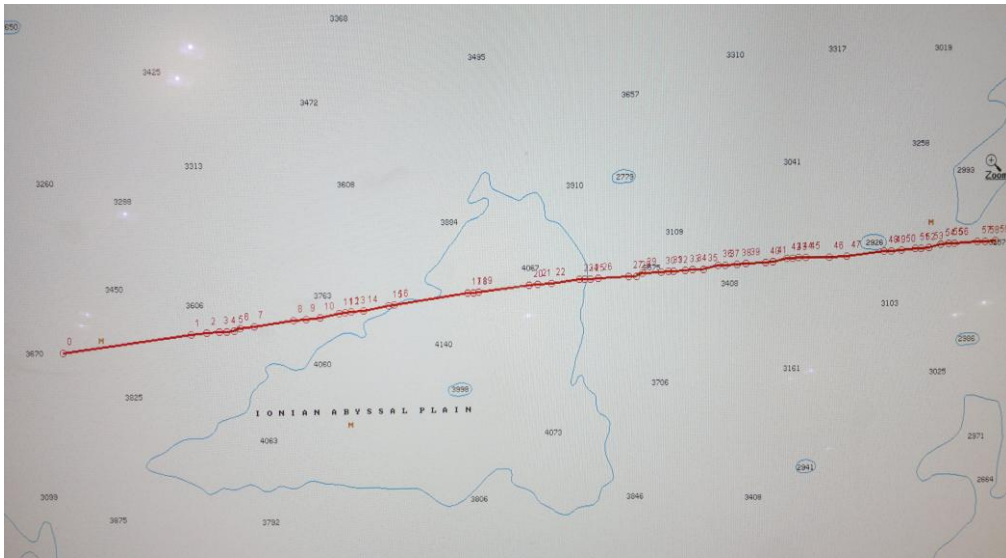
Figure 24. Pirreïs passage based on available data derived from HCG AIS System.

Pirreïs plotted positions based on above table are shown in figure no 24 while figures no 25, 26 and 27 demonstrate the respective passage segments of the OsOW.

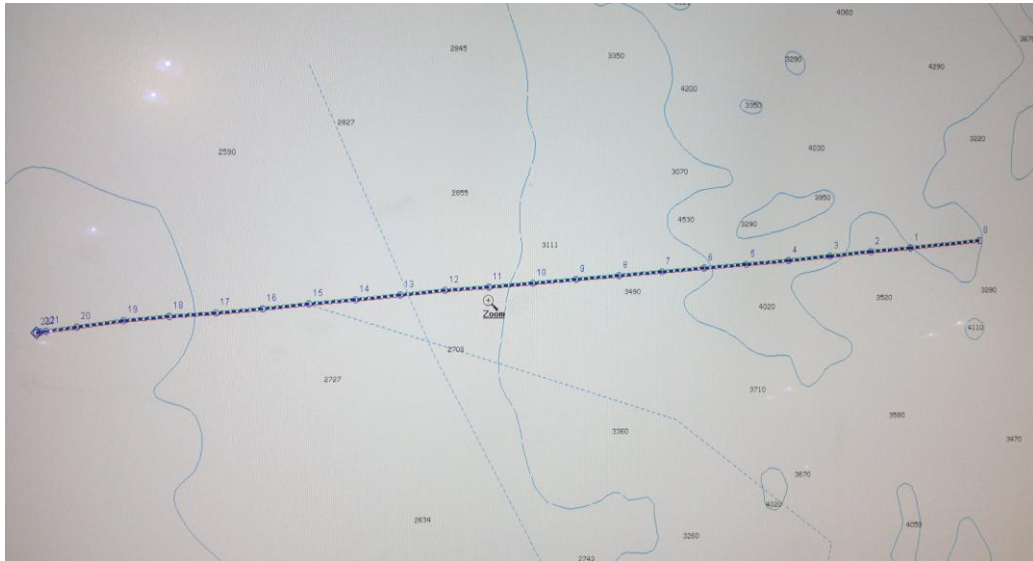
Figure 28. Consouth's passage as extracted from her S-VDR.

Given the above Consouth's positions her course as plotted until the time of the collision is shown in figure 28 while figures 29 and 30 represent the passage segments of the OsOW.
