**MARINE ACCIDENT
INVESTIGATION REPORT**

Vessel type and name: Cargo ship YONG SHENG VII

Vessel type and name: Dredger carrier HOKUEI No.18

Accident type: collision

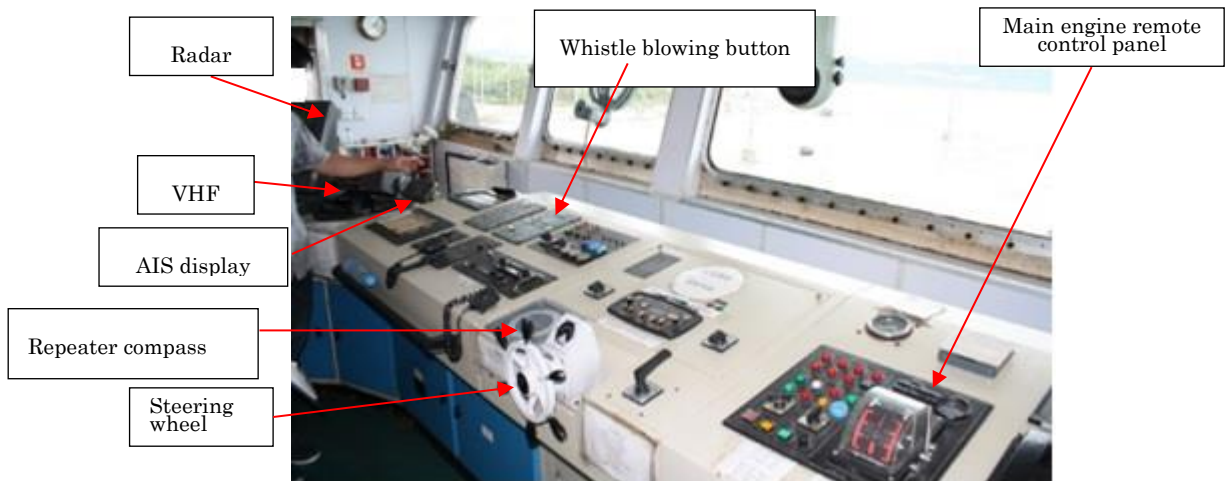
Photo 2.5-3 Bridge of Vessel A

According to the statements of master A, at the time of this accident, there was no trouble or failure of the hull, engine and equipment.

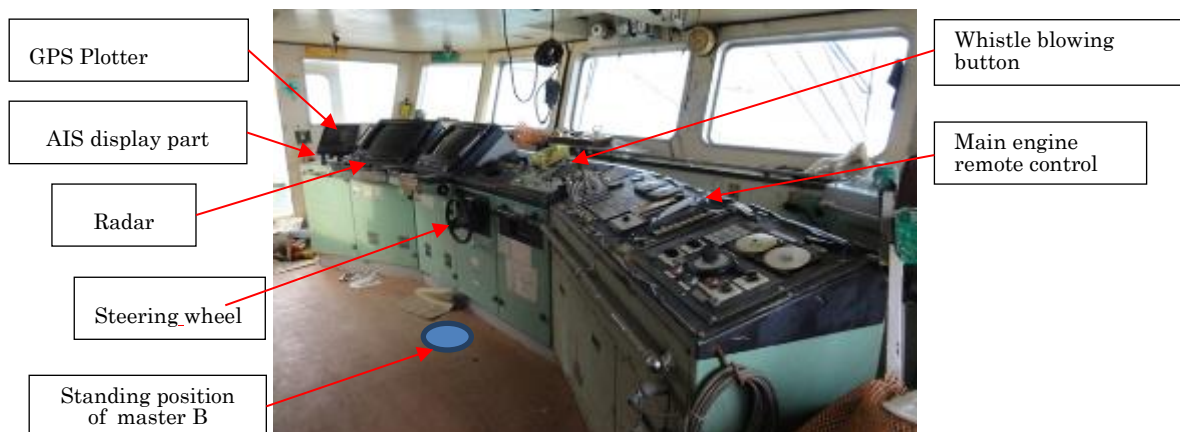
Photo 2.5-4 Bridge of Vessel B (repatriation of after lift-up situation)

According to the statements of master B, at the time of this accident, there was no trouble or failure of the hull, engine and equipment.

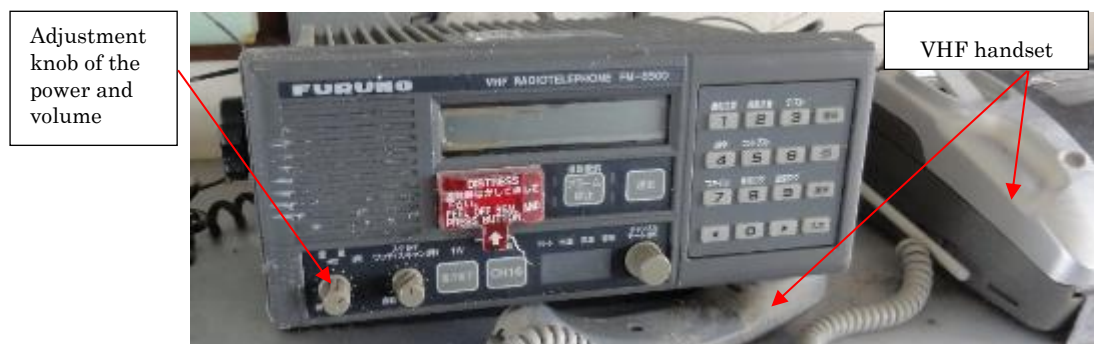
Photo 2.5-5 VHF (repatriation of after lift-up situation)

The power supply was in the condition of put on and the knob of the volume has been set in the vicinity of the large.
