The Bahamas  
Maritime Authority

**Polar Spirit v Zhe Xiang Yu 41020**

**Report on the collision between the LNG tanker Polar Spirit and the fishing vessel Zhe Xiang Yu 41020 on 30 September 2018 resulting in the loss of eight lives**

Date of Issue: 10 August 2020  
Bahamas Maritime Authority  
120 Old Broad Street  
LONDON  
EC2N 1AR  
United Kingdom

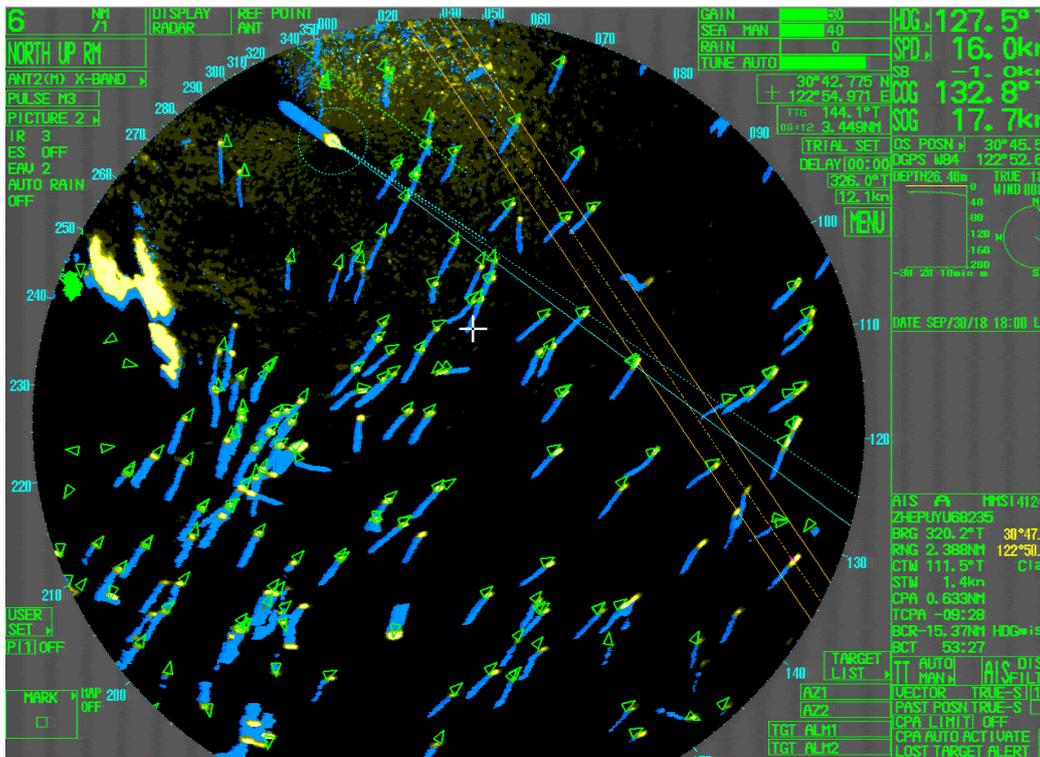
Figure 3: Polar Spirit's X-band radar, 18:00 30 September 2018<sup>1</sup>

At 17:06, the Master handed over the conn to Third Officer (B). The traffic was heavy and the bridge manning was set to Watch Condition 2: one OOW, one lookout and a helmsman maintaining hand steering. The engine room became an unmanned machinery space at 18:00.
