ICE ROSE & KAZANETS

Marine accident report on collision

**MARINE ACCIDENT REPORT ON COLLISION BETWEEN
ICE ROSE AND KAZANETS ON 23 SEPTEMBER 2020**

The report is issued on 9 April 2021.

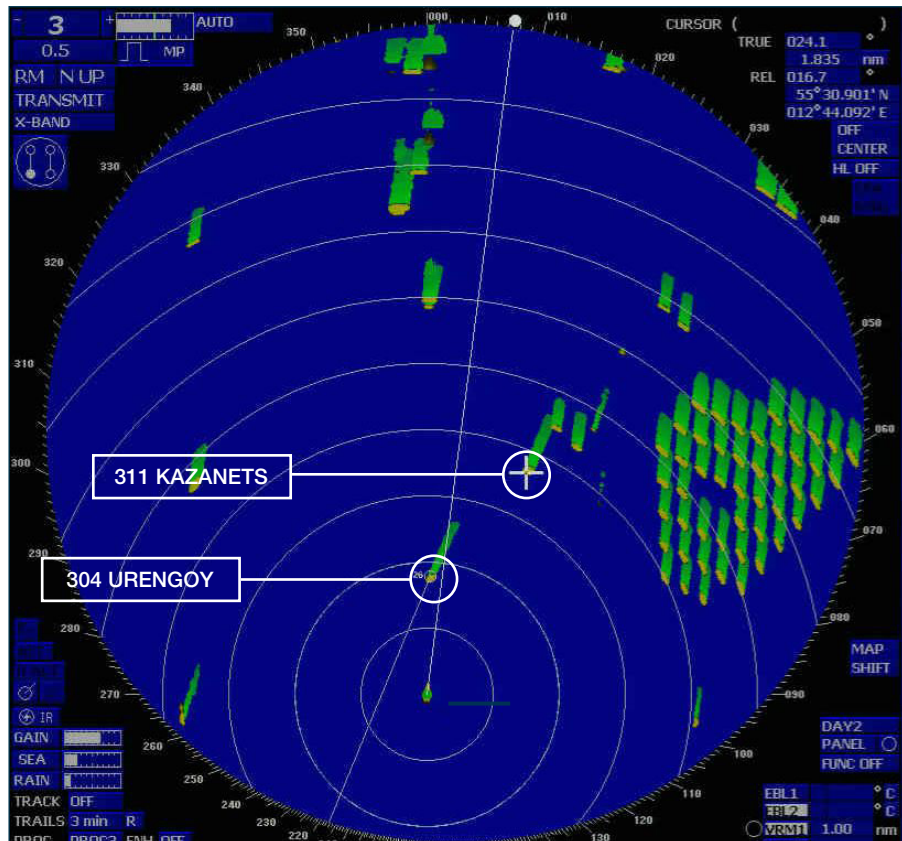
Figure 9: ICE ROSE's radar image at 0941.
Source: ICE ROSE/DMAIB

The third officer on ICE ROSE changed the radar range to 3 nm, and the trails were changed from true to relative (figure 9). He acquired 304 URENGOY's echo as a target and placed the cursor on 311 KAZANETS. The target 304 URENGOY was at this time not selected, and no target information was thus available on the radar display. 304 URENGOY was at this point passing ahead of ICE ROSE at a distance of 1 nm.
