Investigation Report 117/11

Very Serious Marine Casualty

**Collision between the TYUMEN-2  
and OOCL FINLAND  
on 14 April 2011 in the Kiel Canal**

27 June 2014

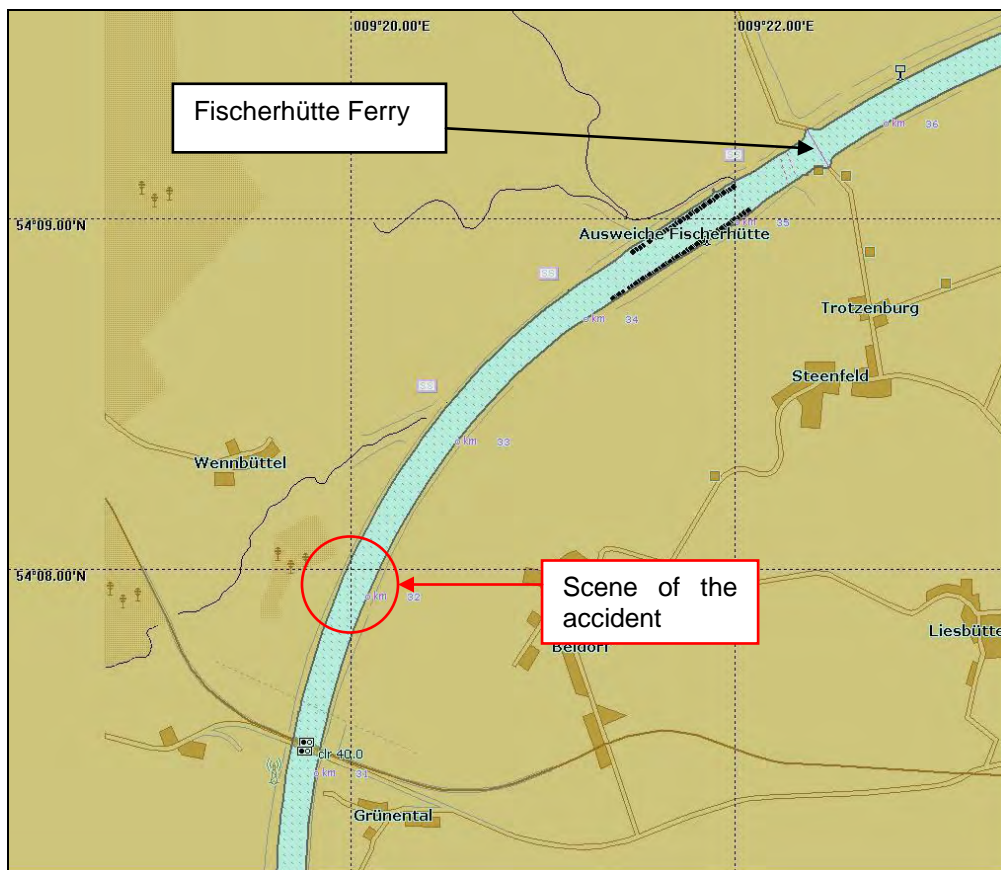
A course alteration to 30° was initiated on the OOCL FINLAND at 065809. This subsequently brought the ship closer to the right embankment in her direction of travel, the so-called southern side. This led to the stern being sucked in and to the so-called 'push away' effect in the period that followed. Despite a hard-over starboard rudder combined with an increase in speed, the OOCL FINLAND turned to port towards the oncoming TYUMEN-2 and collided with her at canal kilometre<sup>5</sup> (ckm) 32.2. The wheelhouse of the TYUMEN-2 was torn off completely during the collision. The course of the OOCL FINLAND was subsequently stabilised and to begin with the ship continued her voyage.

Figure 4: Scene of the accident

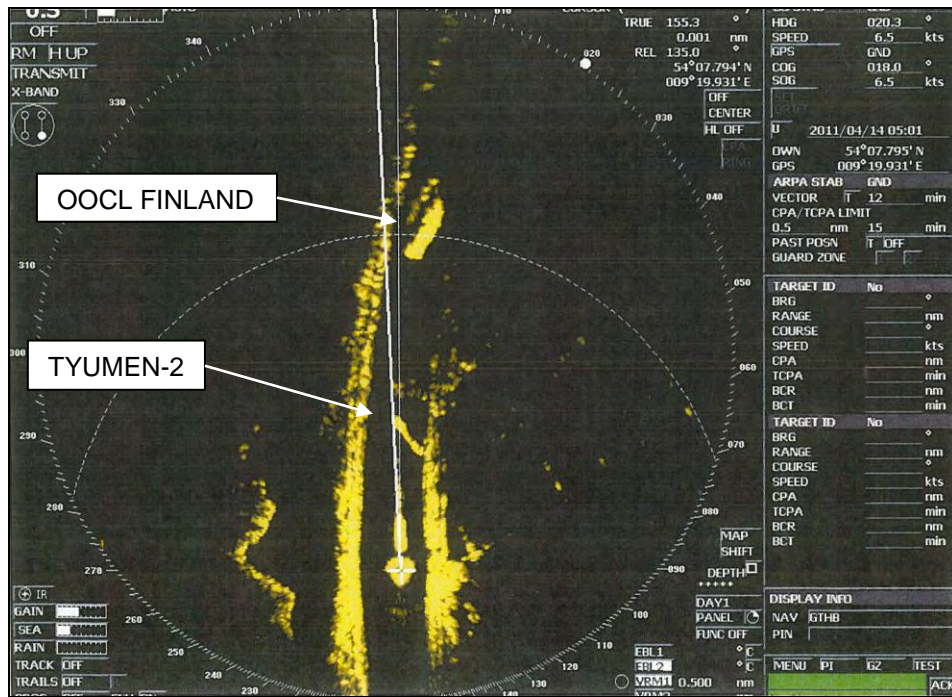
Figure 7: Radar image of the ESHIPS BAINUNAH at 0701

<sup>51</sup> The first call at 070130 (see also Figure 7): "TYUMEN, where are you now?" Following that, two calls on the pilot channel without stating any name ("On the right side?"). Then (070209 and 070240) calls without naming the calling ship.

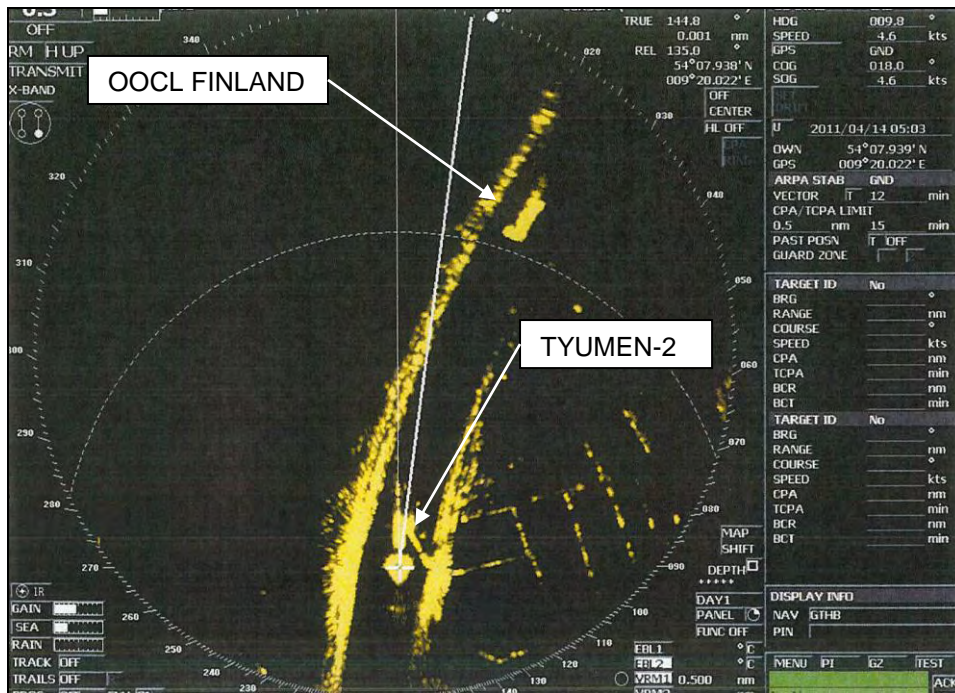
Figure 8: Radar image of the ESHIPS BAINUNAH at 0703

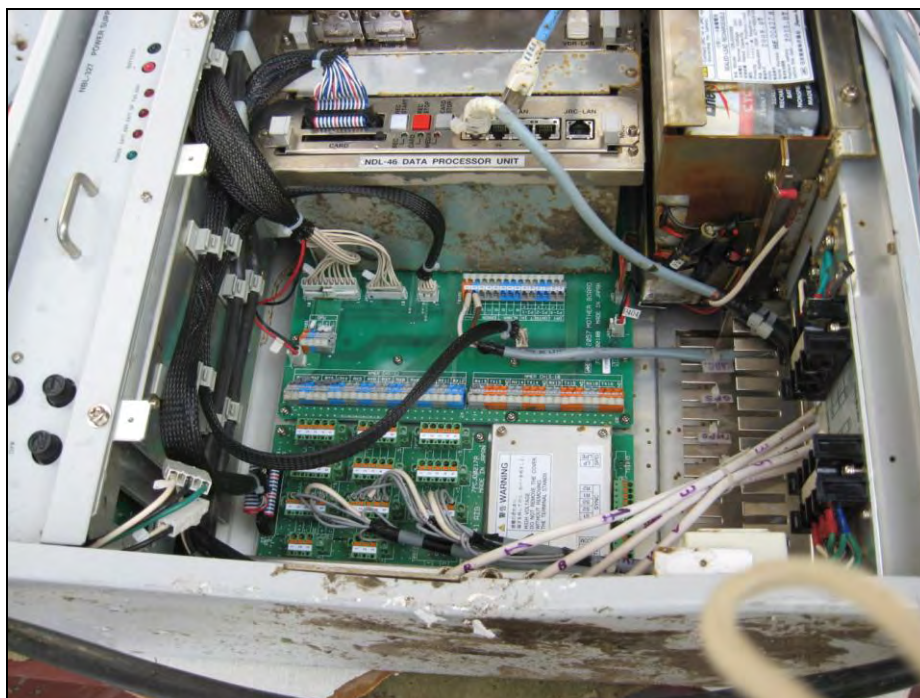
An official from the BSU was also present at the recovery of the TYUMEN-2's wheelhouse from the NOK on 16 April 2011. Together with an officer from the WSP, he was able to remove the CompactFlash memory card (CF card) from the voyage data recorder's central processing unit and secure it properly while still on the salvage pontoon. The central processing unit was mounted on the rear wall of the wheelhouse.

Figure 11: Central processing unit of the TYUMEN-2's voyage data recorder

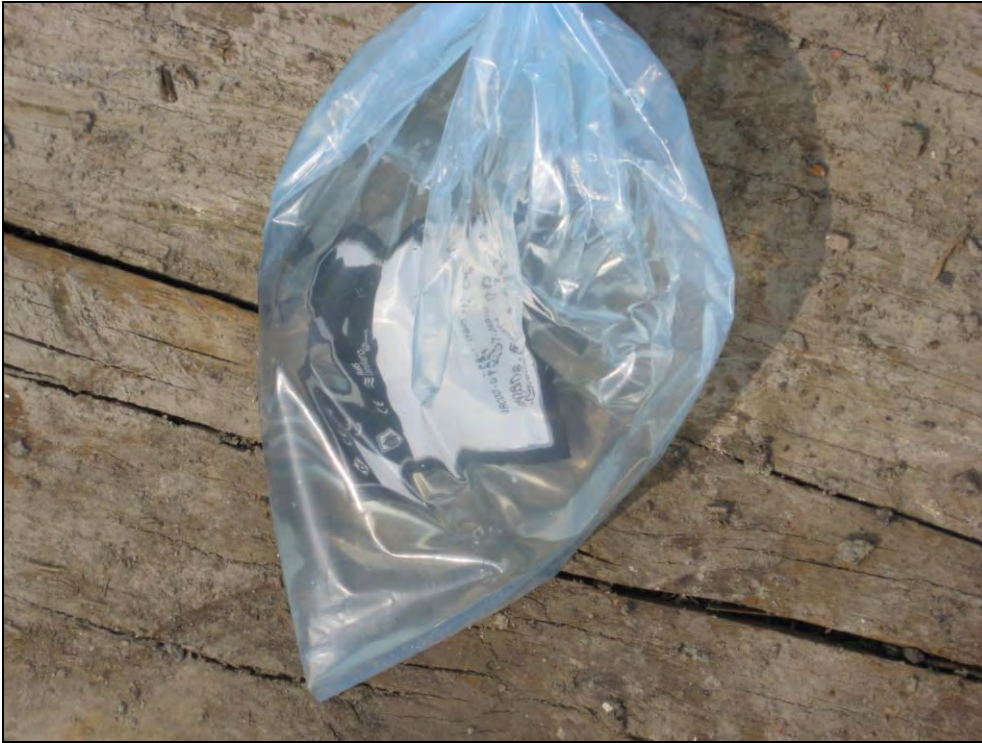
Figure 12: CompactFlash memory card from the voyage data recorder's central processing unit in the water-filled shipping bag

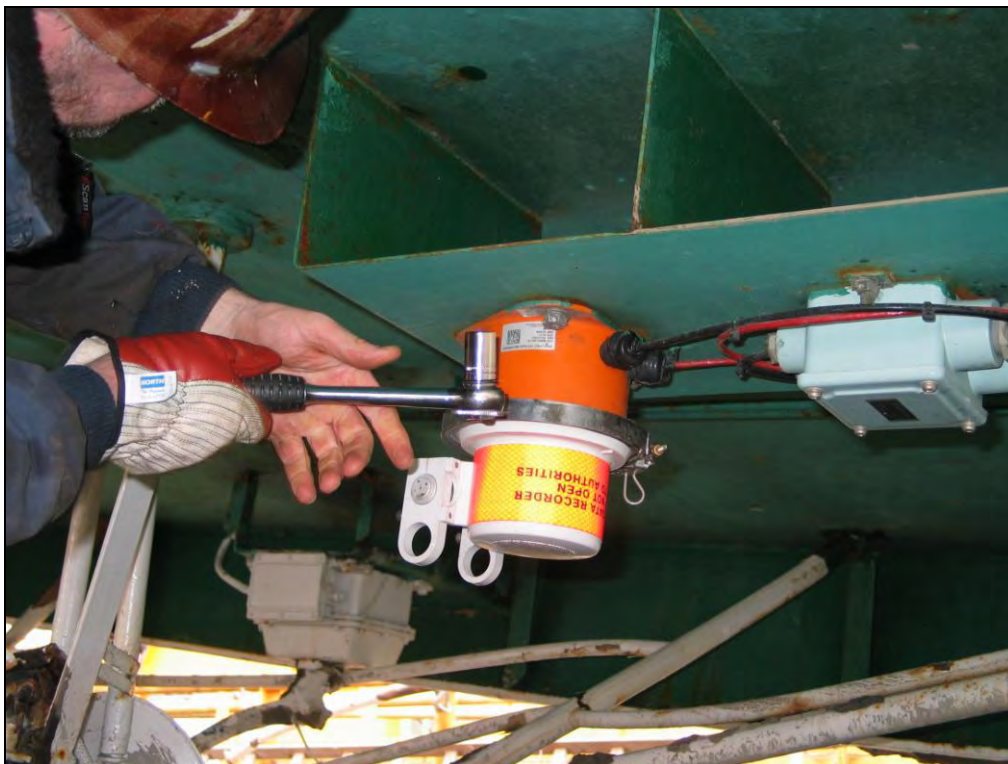
After the wheelhouse was deposited on the grounds of the Nobiskrug shipyard, the final recording medium was removed from the roof of the wheelhouse and secured.

Figure 13: Removal of final recording medium

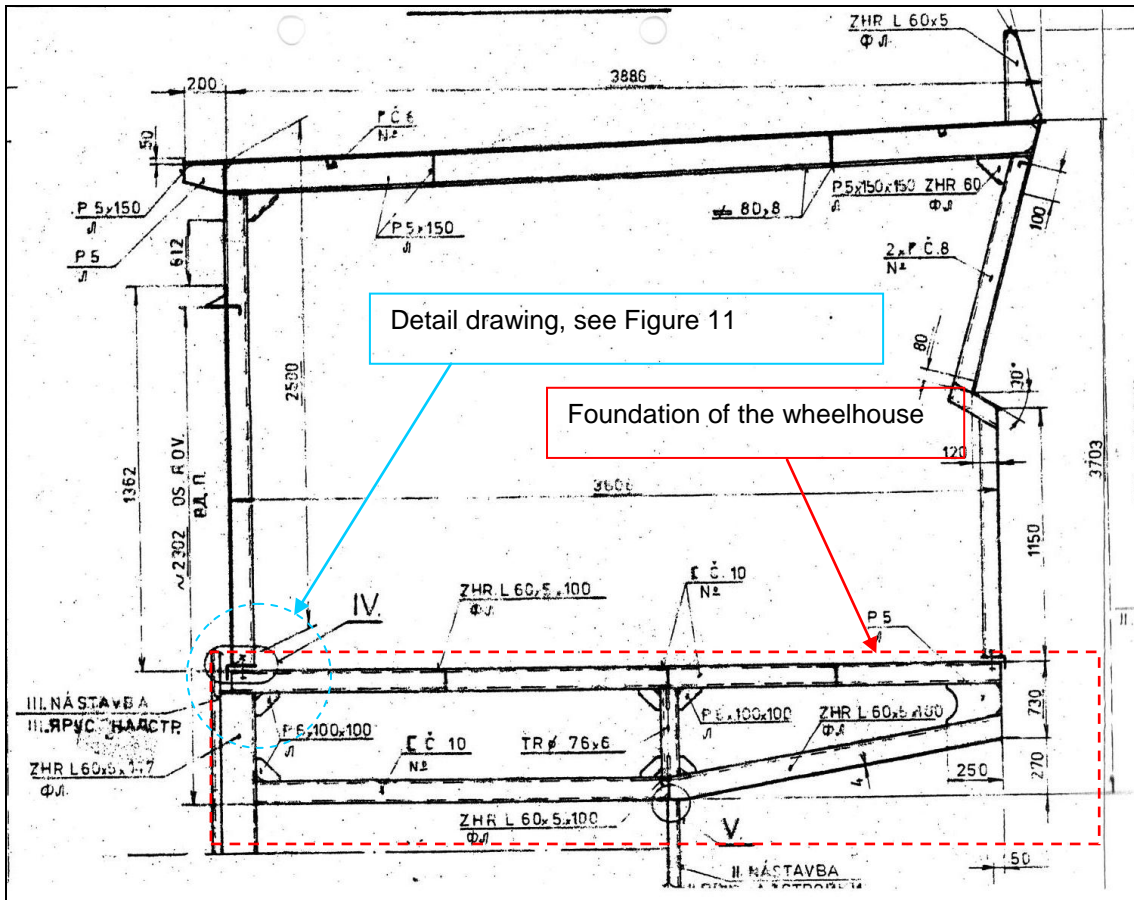
Of course, a wheelhouse cannot be measured against a collision; large windscreens and aluminium structures would be inconceivable were that the case. However, forces should be absorbed by means of the deformation behaviour, amongst other things. That entire deckhouses are pushed overboard in confined areas of operation with speed restrictions is uncommon."

Figure 15: TYUMEN-2, drawing of the wheelhouse (side view)

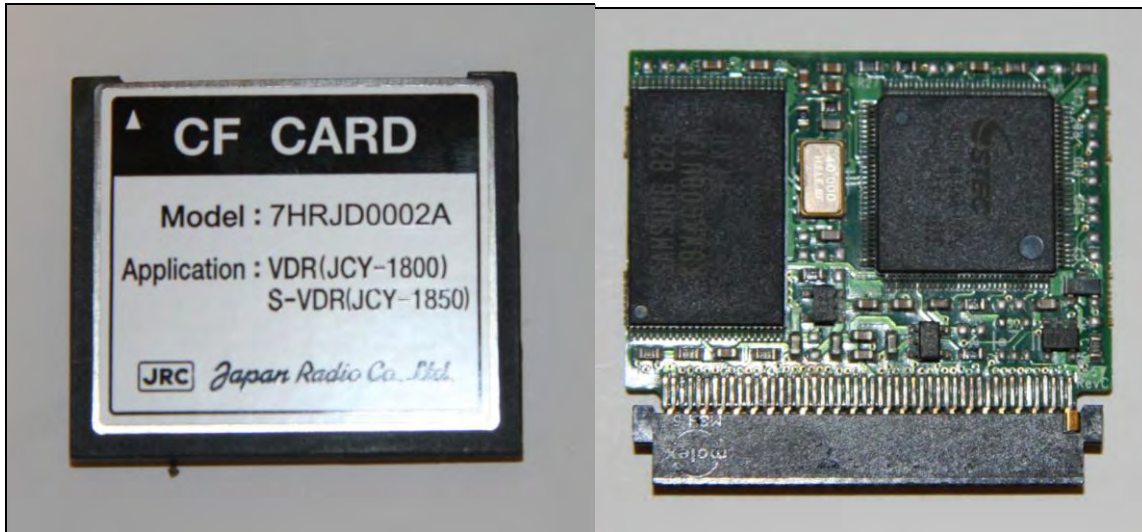
Figure 19: CompactFlash memory card; disassembled in the image to the right

While replaying the backed up data from the CF card, the functioning clock indicated that the data stored covered the period 163000<sup>37</sup> on 13 April 2011 to 050021 on 14 April 2011. However, the audio recording stopped at 045900 and rendering of the other data at 045959. The image then freezes and the time jumps forward to 050059.

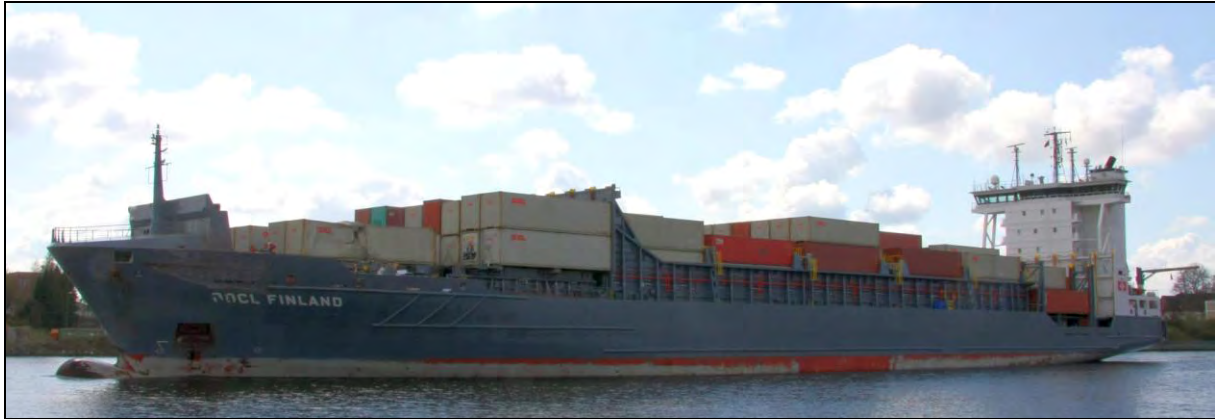
The view ahead was not obstructed by the cargo on the day of the accident (see Figures 26 and 27). The cargo was evenly distributed across the ship and would not have created an exceptional windage area at higher wind speeds.

Figure 26: OOCL FINLAND, load situation on the day of the accident

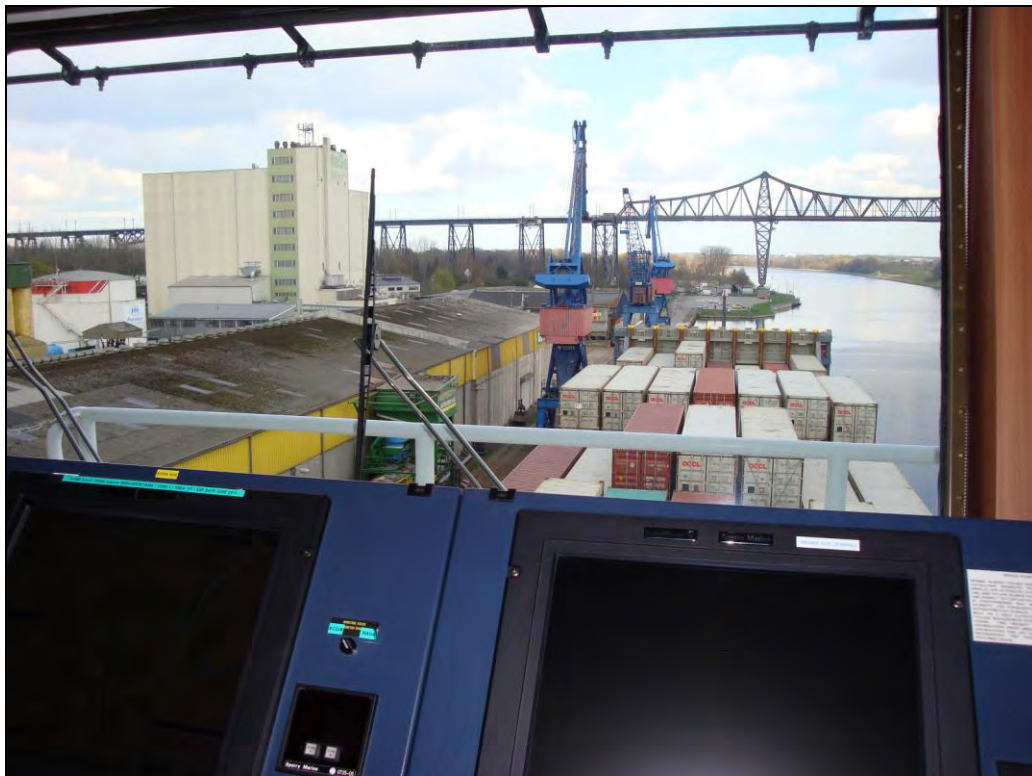
Figure 27: OOCL FINLAND, Rendsburg, view ahead from the pilot's work station

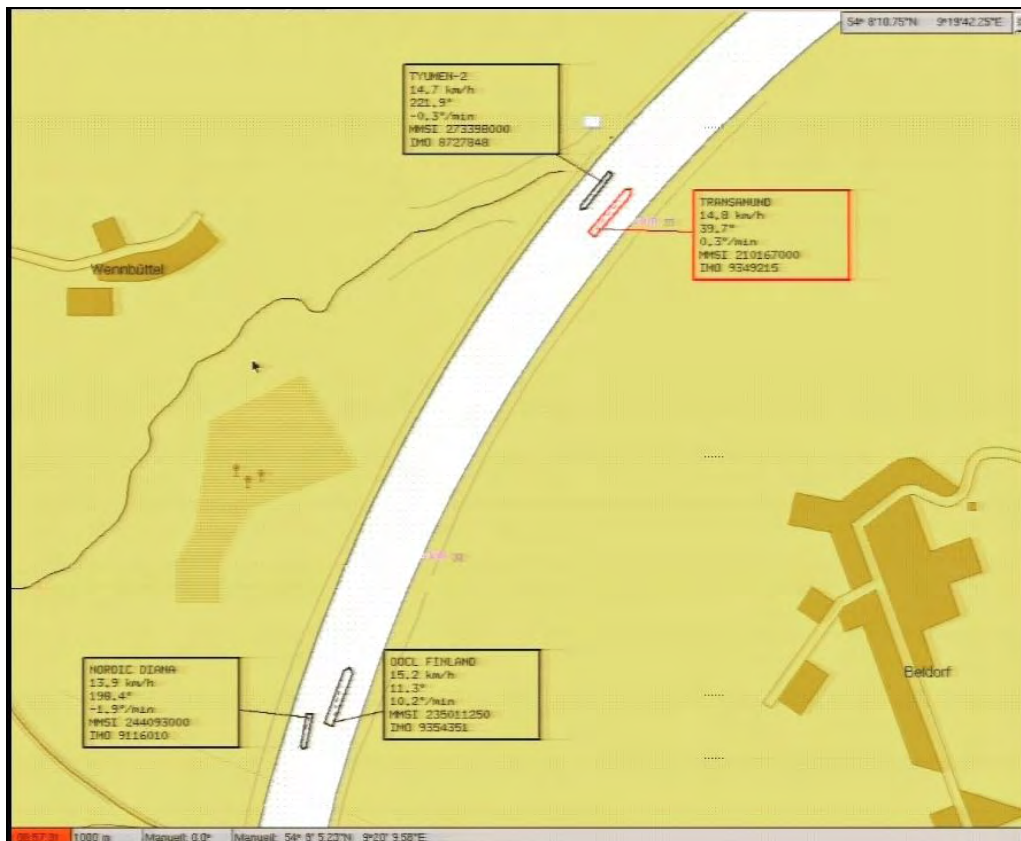
Both vessels were on their respective fairway side. OOCL FINLAND carried out an evasive manoeuvre much more to starboard before the collision occurred. The TYUMEN-2 maintained a constant distance to the northern shore while approaching the OOCL FINLAND. The TRANSANUND had already been passed at 065730 in this way (figure 31).

Figure 31: AIS display at 065730

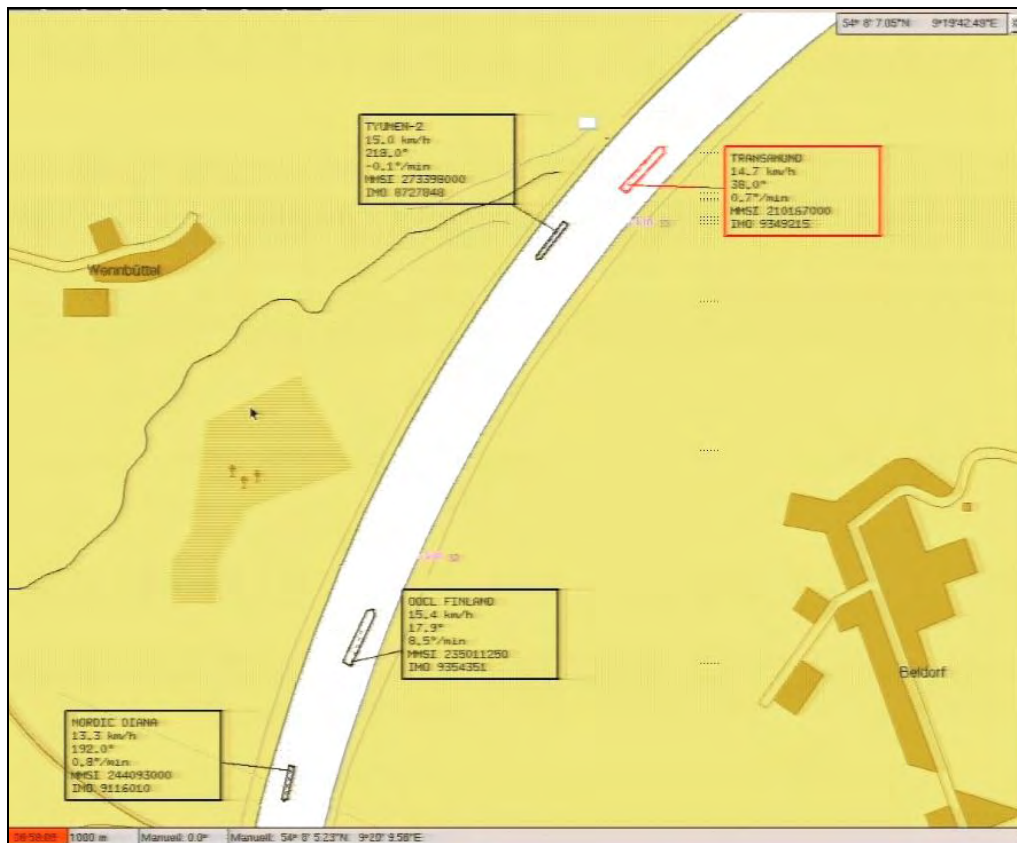
Figure 33: AIS display at 065809

The course of the voyage was uneventful up until the passage of the viaduct at 0655. At 065809, the pilot instructed the helmsman to steer a compass course of 28°. Shortly afterwards, 30° was specified. In this regard, the pilot said to the helmsman: "[...] otherwise, that will not be okay with the others." (See also Spreadsheet 1 and Figure 49.) It is not known whether this statement was based on the fact that the pilot assumed that the OOCL FINLAND or the oncoming TYUMEN-2 was too far towards the middle of the canal. The AIS recording of that time (Figure 33) does not permit such a conclusion.

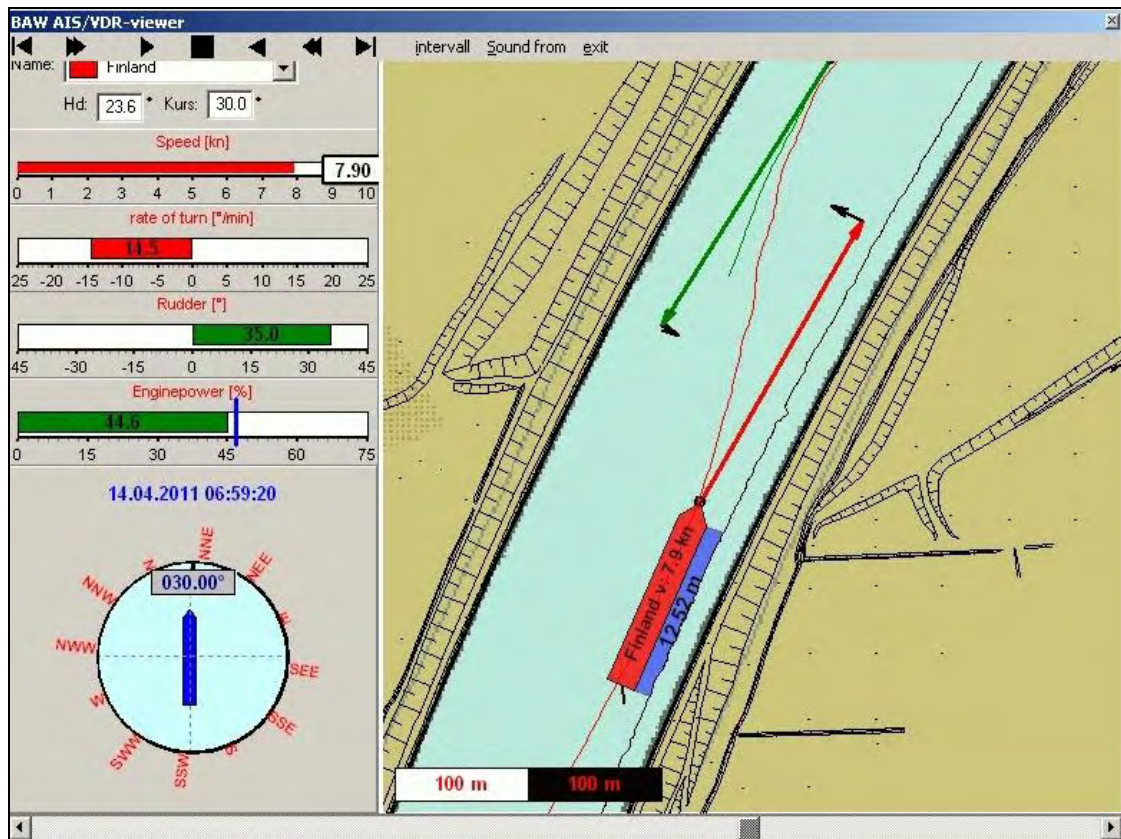
Figure 54: OOCL FINLAND, 065908

<sup>58</sup> See Figure 54.

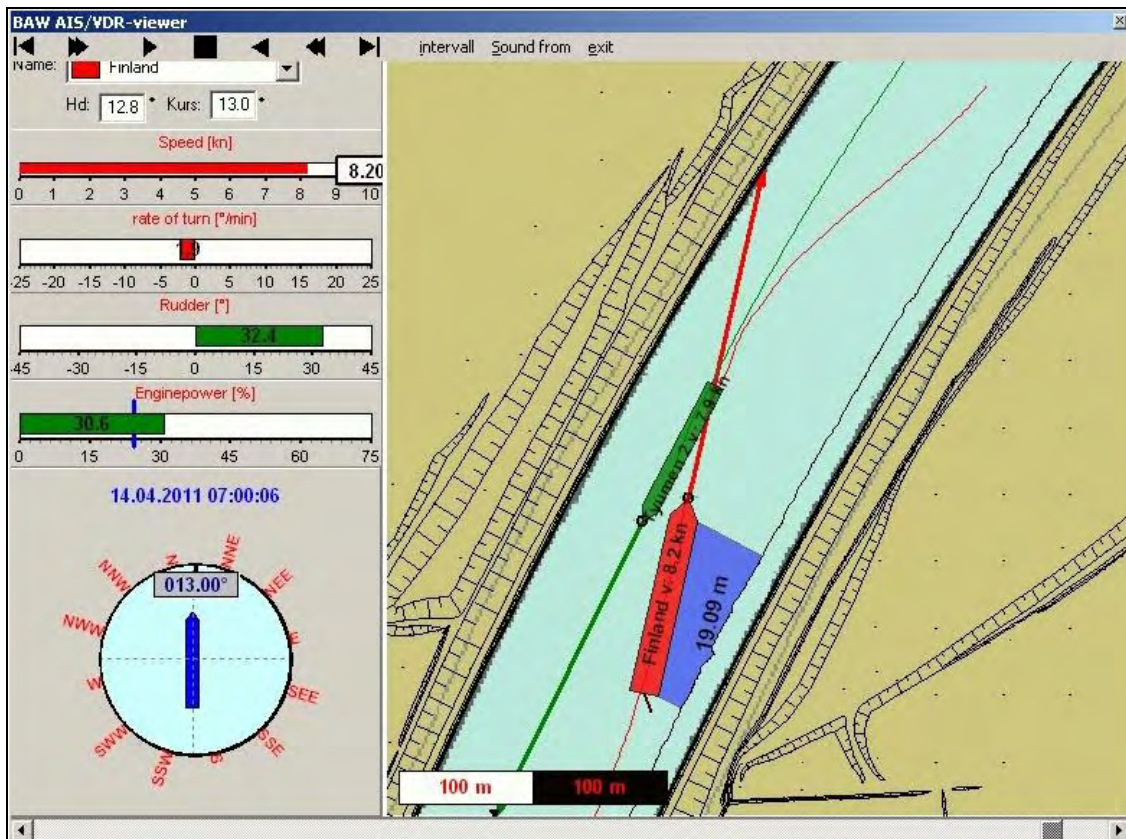
Figure 56: OOCL FINLAND, 065945

<sup>59</sup> See Figure 56.

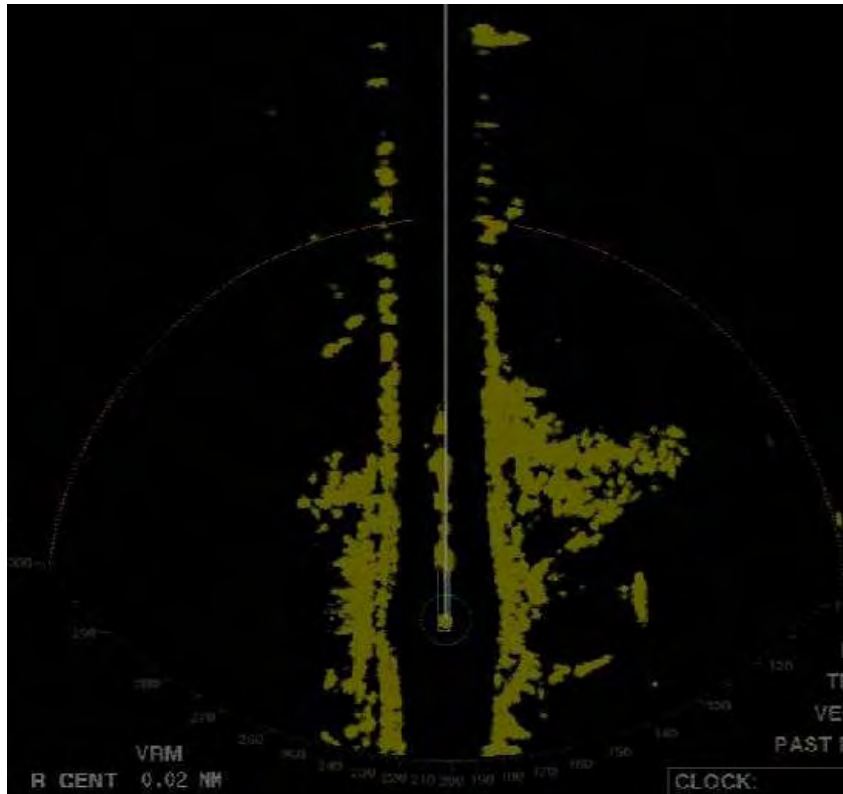
Figure 59: Example: outwardly distorted radar image at the centre point

- distortion of the radar image at the centre point; the canal bank is displayed widened (see Figure 59) or constricted at the centre point (see Figure 60). Both affect determination of the ship's position on the canal;

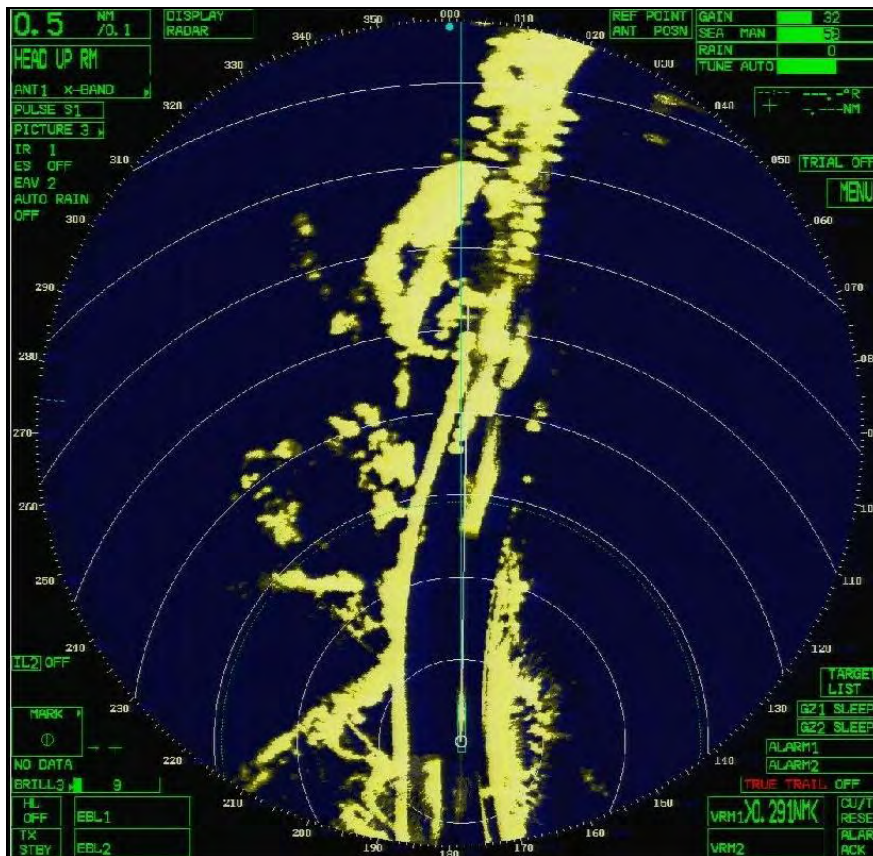
Figure 61: Example of radar image in 0.5 nm range

The position of the ship on the canal was determined by the pilot using the radar. A radar set operated on the 0.5 nm-range like on the OOCL FINLAND, is basically appropriate to provide sufficient information about the position of the vessel in the canal and the other vessels. However, as regards determining the actual distance to the bank, the investigators believe that the existing radar information is only of insufficient value because of the system's limitations, which arise from the height of the radar antenna and small distance to the bank. Owing to the circumstances and due to the limitations inherent to the system, resulting from the height of the radar antenna and the short distance to the shore, the real distance to the embankment can only be determined to a limited extent. Restrictions in displaying the radar image, especially around the display center, (see figure 59, 60 and 61), lead to the fact that the real distance to the shore can only be determined by the head line and the position of this to the shore.

The investigators have no backed up information about the quality of the radar image or the radar range used by the pilot on OOCL FINLAND. The statement of the pilot on his configuration of the radar was justifiable and appropriate. Moreover, there was no evidence of any technical deficiencies.
