Final report RS 2016:05e

STENA JUTLANDICA/TERNVIND – collision in Gothenburg’s archipelago on 19 July 2015

File no. S-127/15

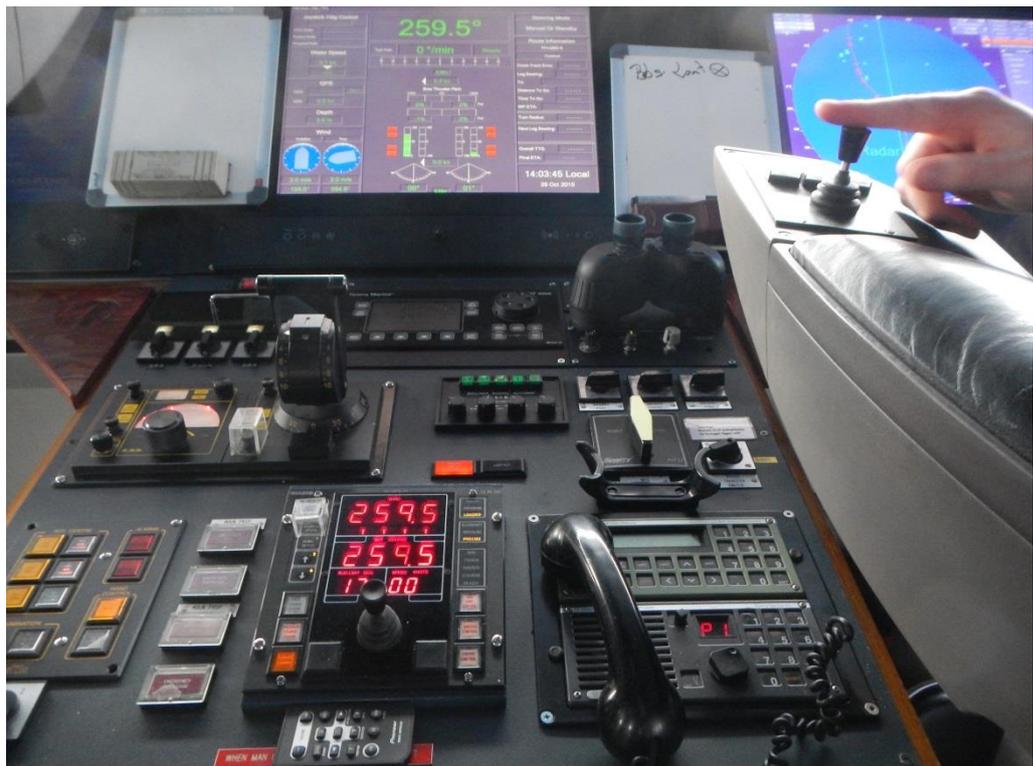
Fig. 8. The desk between the navigators' chairs on STENA JUTLANDICA. The knob that is used to override the steering can be seen marked with fluorescent tape on the right, between the binoculars and the VHF receiver (see also Fig. 10). The finger in the upper-right corner is resting on the joystick for the automatic steering system that was used on this occasion.

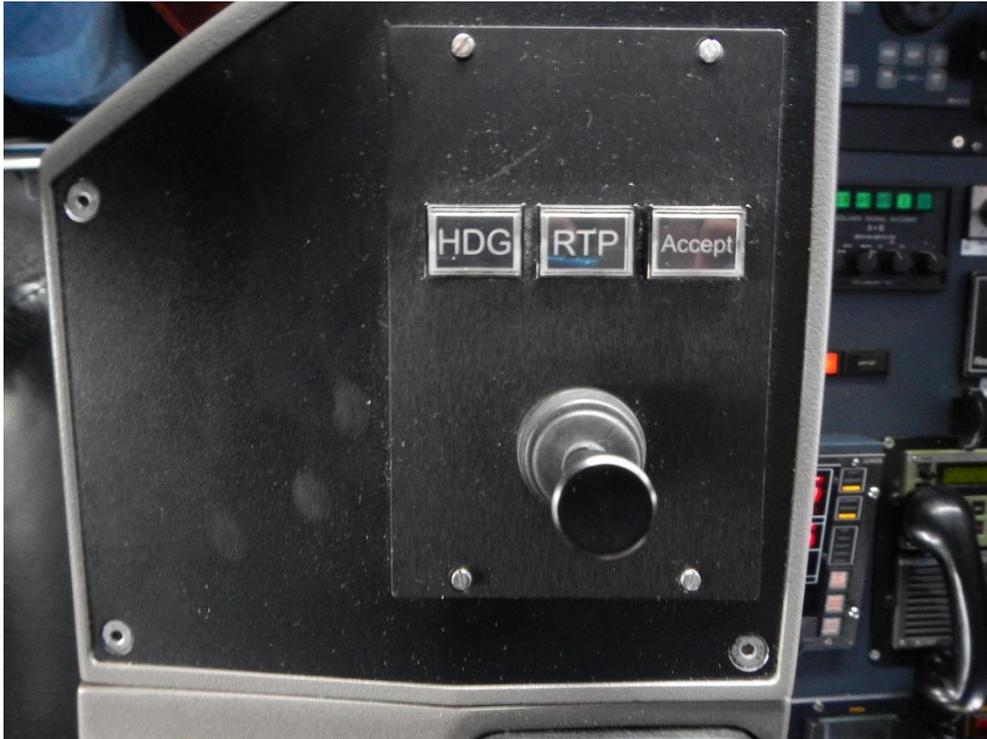
Sperry automatic steering, which was being used in this event, consists of a joystick that is used to change course by pressing on the left button and then moving the stick in the respective direction. The course is displayed on one of the screens, e.g. the radar screen or the ECDIS. The turn radius is regulated by moving the joystick towards the operator (astern), in order to reduce it, and away from the operator (ahead), in order to increase it. The range is from 0.1 M to 4.0 M. When a new course with a turn radius is assigned, this is shown as a line on the radar screen in the form of a "curved headline", i.e. the intended future course. The course change is initiated by pressing on the ACCEPT button (to the right on the armrest, see Fig. 9).

Fig. 9. The joystick for the automatic steering system that was used on STENA JUTLANDICA, located on the armrest of one of the navigator's chairs.

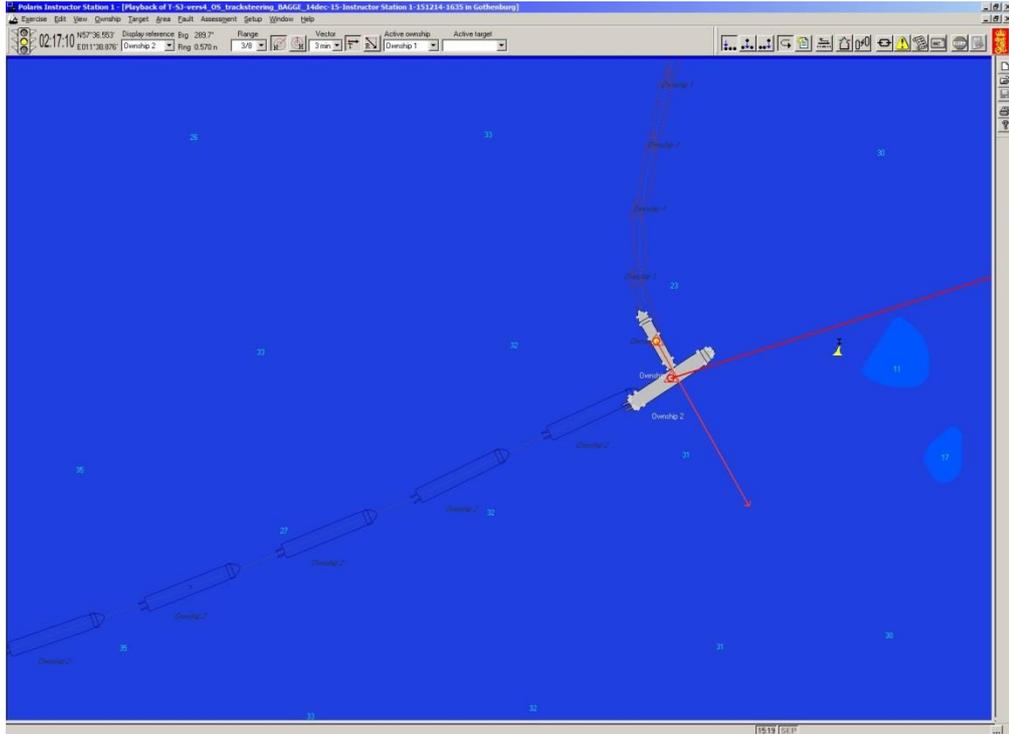
Reconstruction (Simulation 0). STENA JUTLANDICA turns to port with a turn radius of 2.0 M, followed by evasive manoeuvres to starboard and then port. TERNVIND turns to port. A simulation with STENA JUTLANDICA's turn radius set to 1.4 M resulted in the same point of impact. Only a marginal difference in time was present.

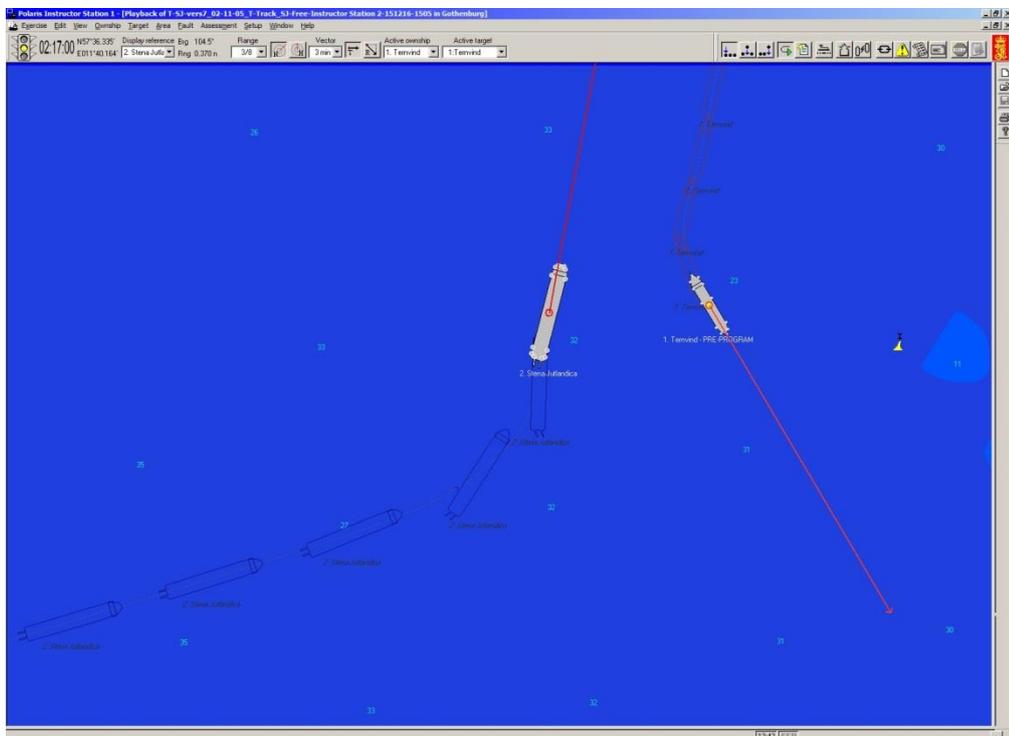
Simulation 1. STENA JUTLANDICA turns to port with manual rudder 20° after the VHF call and passes 0.18 M astern of TERNVIND, which implements the turn to port.

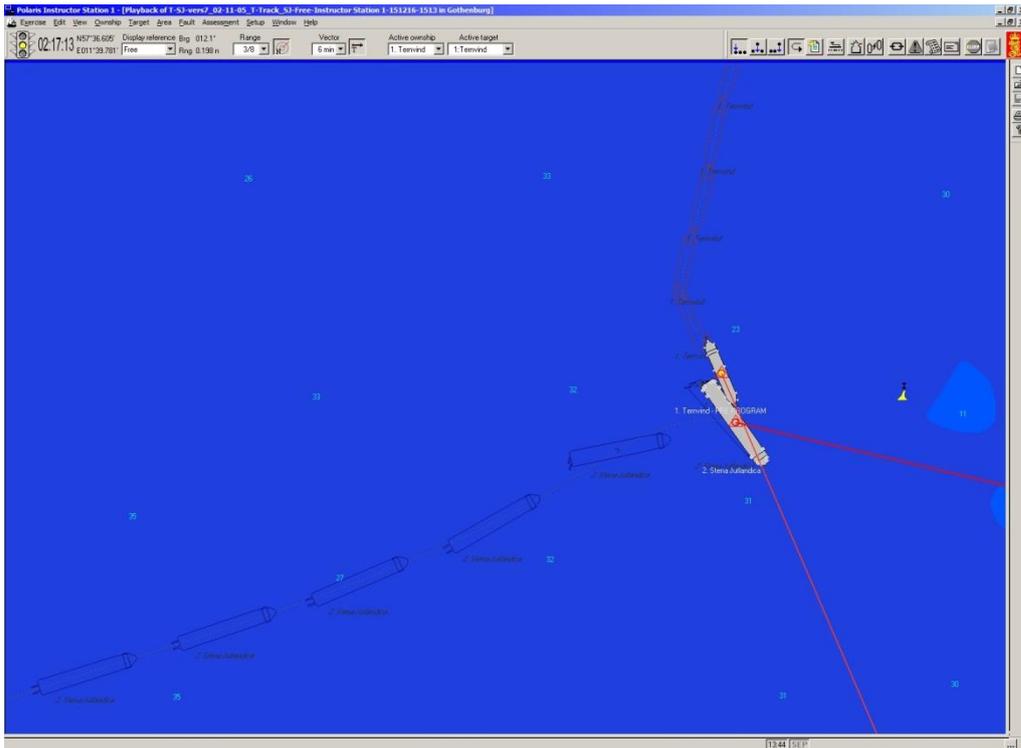
Simulation 2. STENA JUTLANDICA begins her turn to port before the meeting and makes a late evasive manoeuvre manually full starboard before correcting with a turn to port and colliding with her port quarter against the starboard bow of TERNVIND. TERNVIND has implemented the turn to port.

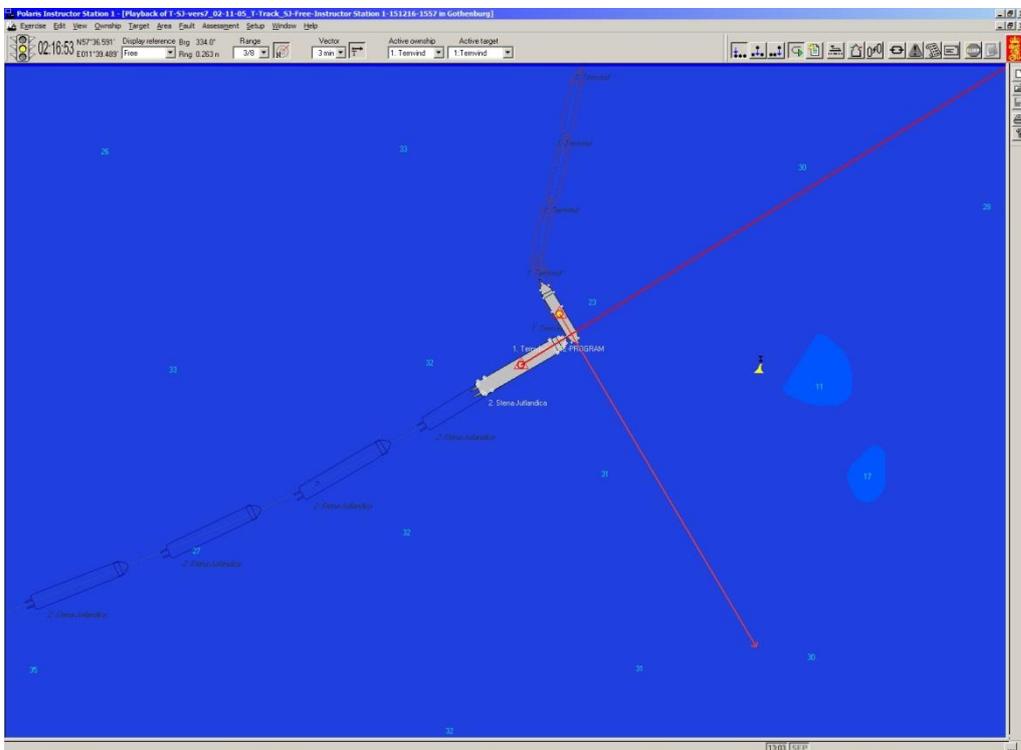
Simulation 3. STENA JUTLANDICA initiates the turn to port before the meeting, but turns to starboard with only automatic steering (radius 2.0 M) following the VHF call and colliding with TERNVIND's starboard side. TERNVIND has implemented the turn to port.
