## *Final Report RS 2017:04e*

PHOENIX II/TERNVAG – Near collision in  
Gothenburg's archipelago on 14 July 2016

Reference no. S-116/16

5 July 2017

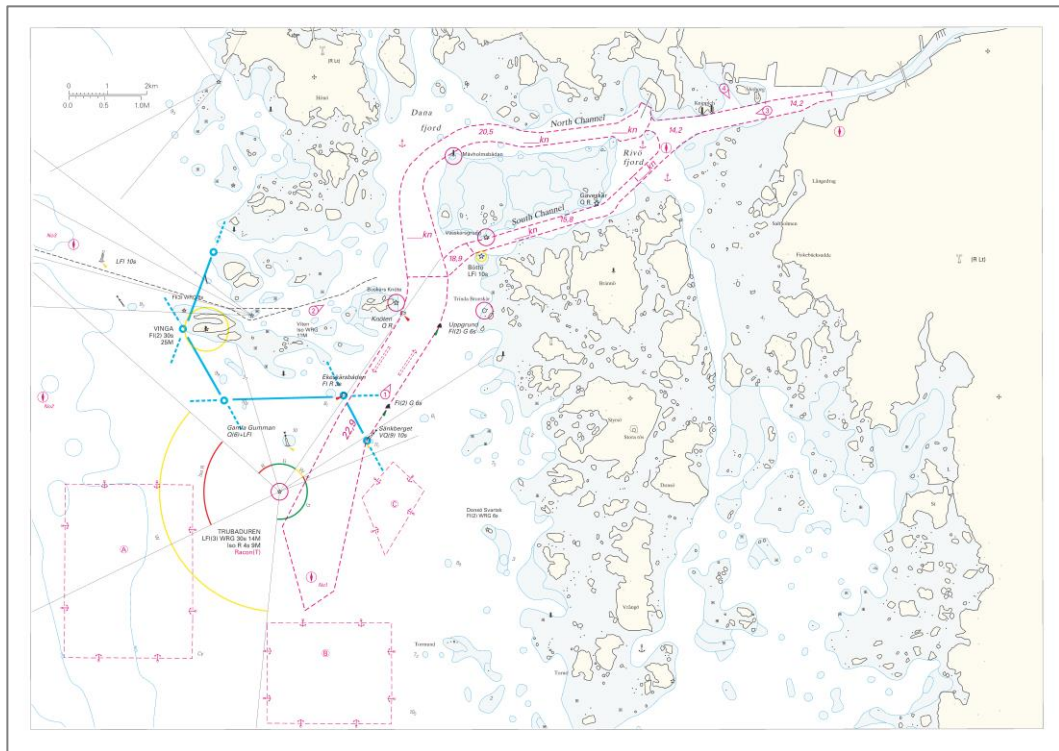
The incident occurred in the outer reaches of Gothenburg's archipelago, just outside of the area in which pilotage is compulsory, a few hundred metres to the south-west of the buoy Sänkberget (Figure 9). Both vessels were subject to compulsory pilotage in the fairway in towards Gothenburg. This location is within Gothenburg's VTS area.

Figure 9. Excerpt from a chart showing the main fairways, report points, compulsory pilotage lines (blue lines), boarding position south Trubaduren and anchorages. The incident occurred just south-west of Sänkberget and outside of the compulsory pilotage line. Image: Swedish Maritime Administration no.: 10-01518.
