## MV *SPRING BOK* and MV *GAS ARCTIC* Collision 6nm south of Dungeness, UK 24 March 2012

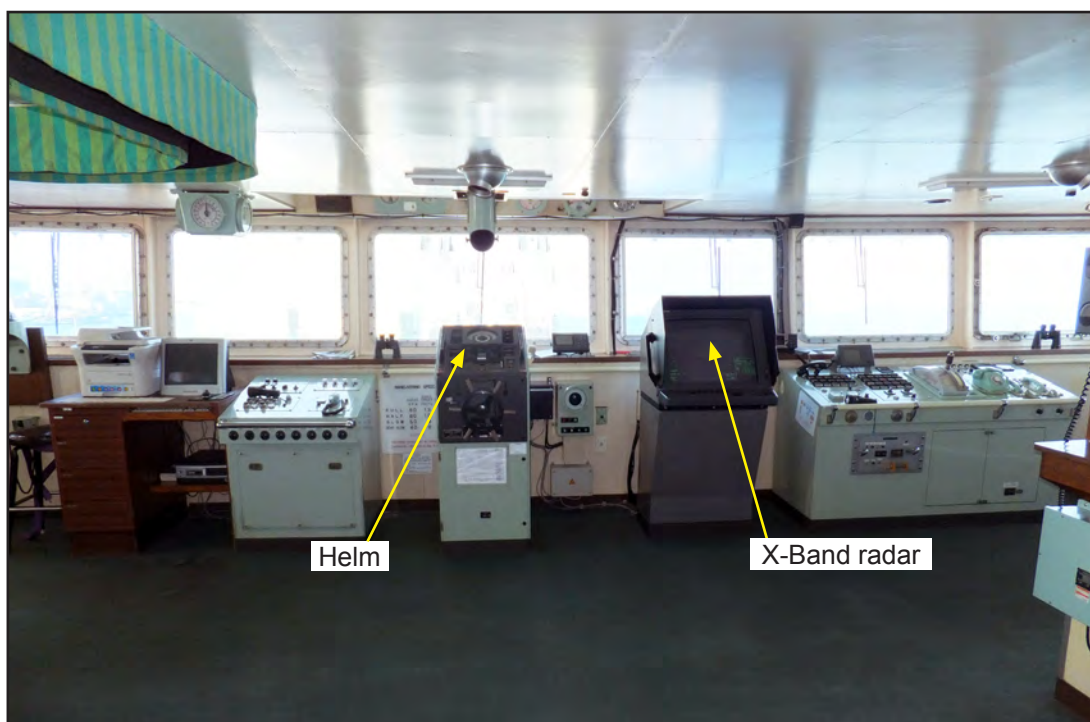
**Figure 3:** *Spring Bok*'s bridge

The master returned to the bridge at 0700 when he took over as OOW. He adjusted the settings of the forward radar set, a Furuno X-Band model with Automatic Radar Plotting Aid (ARPA) (**Figure 3**), and selected target information to display true vectors of 6 minutes and true trails of 3 minutes.
